TECHNICAL NOTE

Radiation testing of STIM210 and STIM300

The objective is to document the results from the radiation testing on STIM210 and STIM300 and the following failure analyses.

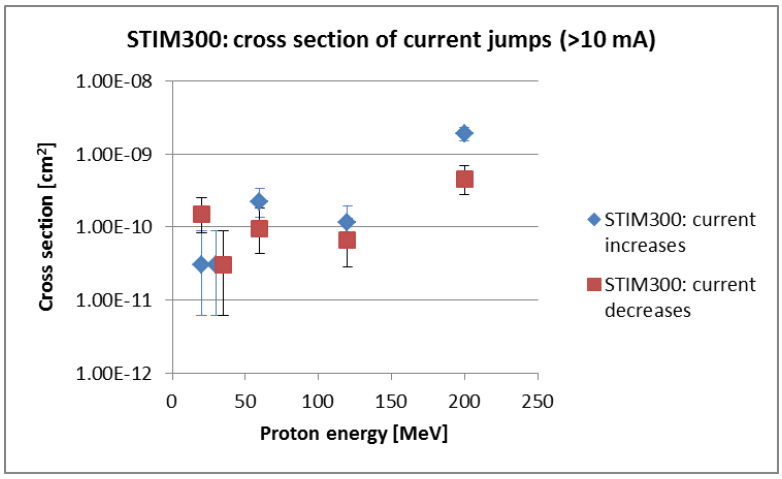
The UUTs had abrupt jumps in the supply current, both increasing and decreasing. After such a jump in supply current, the current remained approximately constant, sometimes slowly relaxing over time. In the majority of cases, power cycling reset the supply current to the normal level. These jumps could be up to the power supply limit of 1 A, accompanied by a drop in supply voltage due to the compliance limit set at the supply. These rather rare cases showed the classical characteristic of a single-event latch-up, where the UUT develops parasitic current routes in the semiconductor structure, leading to a short circuit. The majority of the current jumps were however of moderate to significant height in the order of magnitude of a few mA to a few 100 mA without showing clear signs of a latch-up. However, they may represent parts of the system latching with the current limited by other parts of the system.

The jumps in the supply current could also represent SEFIs, where parts of the system stop functioning or changing to an undefined mode of operation, leading to an increase or decrease of the current consumption.
Therefore, no differentiation between the different amplitudes of the current jumps or supposed latch-ups, has been done, only whether the current is increased or decreased afterwards has been recorded. A threshold of 10 mA was used to clearly distinguish between noise in the measured supply current and the jumps and then count the number of occurrences of these jumps. A calculation of the cross section was made (a measure for the likelihood of an event) for each proton energy by dividing the number of events by the total fluence. The results are plotted versus proton energy in Figure 25 and Figure 26. Error bars are calculated for a confidence level of 0.95 according to ESCC 25100.

Figure 25: SEE: STIM300: Cross section evaluation of the current jumps versus proton energy. The values at 30 MeV overlap exactly and are shifted along the x-axis in this image for better visibility. A threshold of 10 mA from one data point to the next is applied when counting the current jumps.

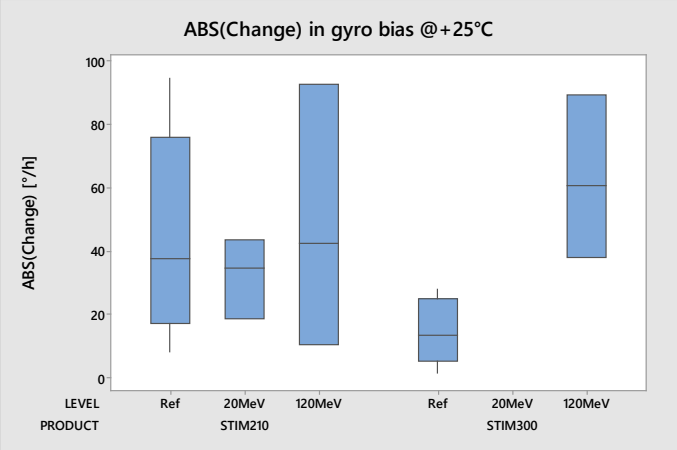
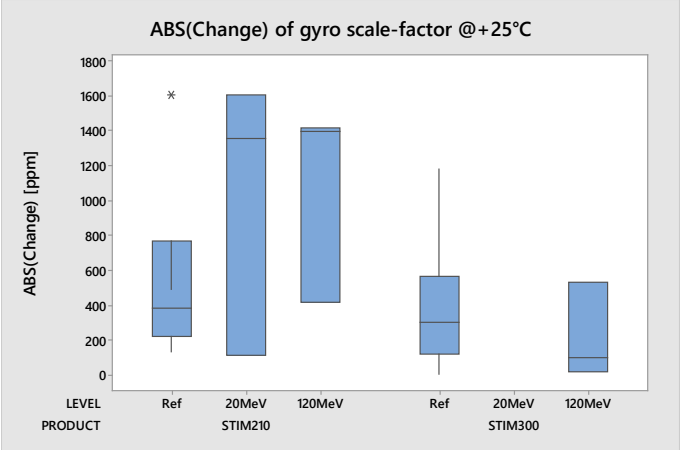
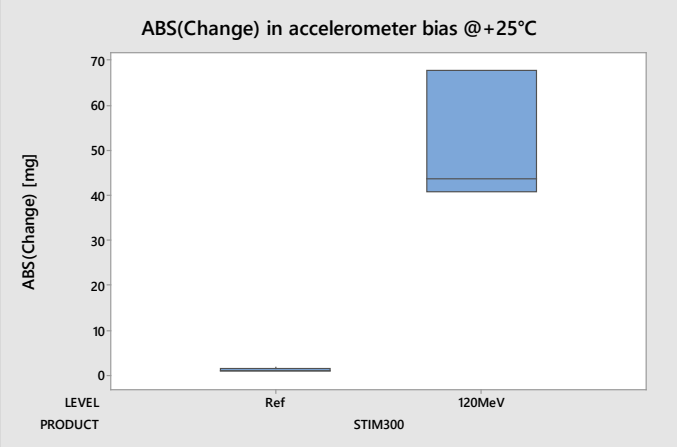
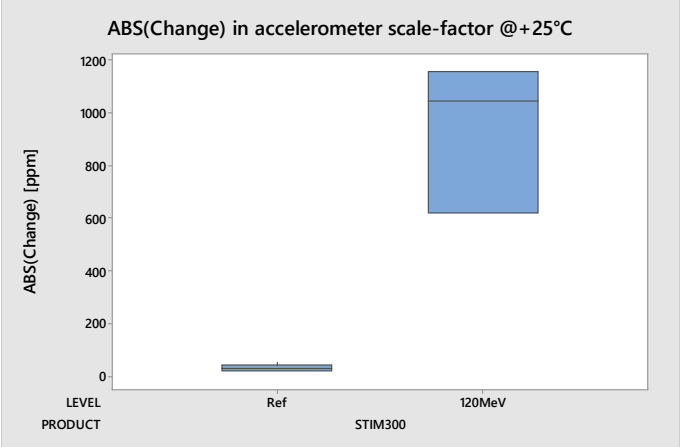
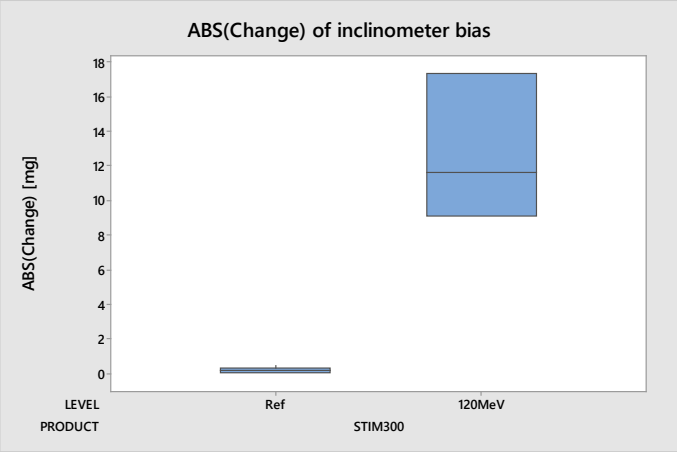
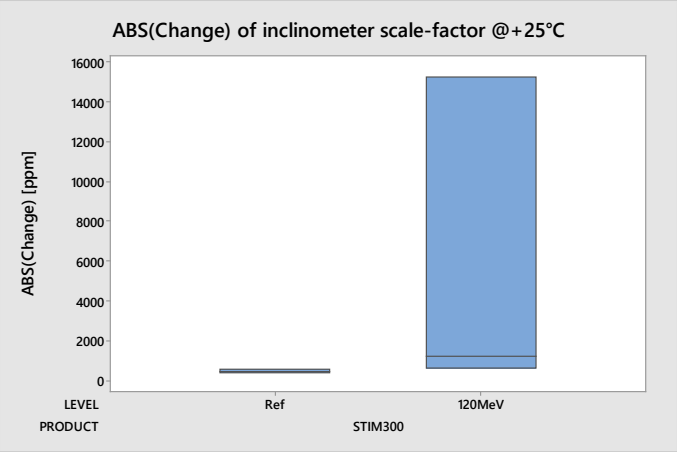
Product	Results		
	Gyro	Acc	Inc
STIM300	OK	NOK	NOK
STIM210	OK	N/A	N/A

The plots in Figure 27 to Figure 32 show the absolute value of the bias and scale factor drift between pre- and post-tests. The boxplots represent the interquartile range with the middle line representing the median. The full comparison of test results can be found in Appendix D.

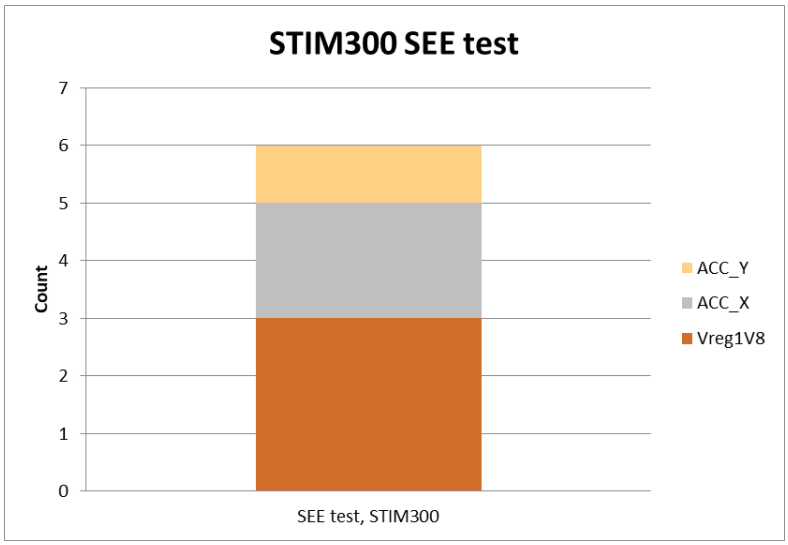
Figure 33 shows all failing electronic components for STIM300 modules that were irradiated in the SEE test. Figure 34 shows all failing electronic components for STIM210 modules that were irradiated in the SEE test. Figure 35 shows a Pareto of all electronic components that have failed during SEE test.

Several modules experienced multiple component failures. No assessment has been made as to whether any failure is derived from the radiation itself or is a consequence of other electronic failures.

Figure 33: Failing electronics in STIM300 during SEE test

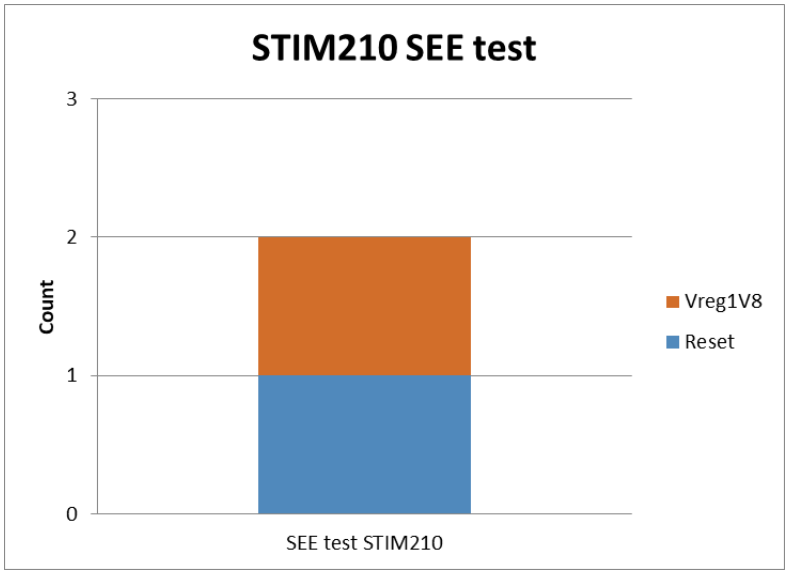
Figure 34: Failing electronics in STIM210 during SEE test

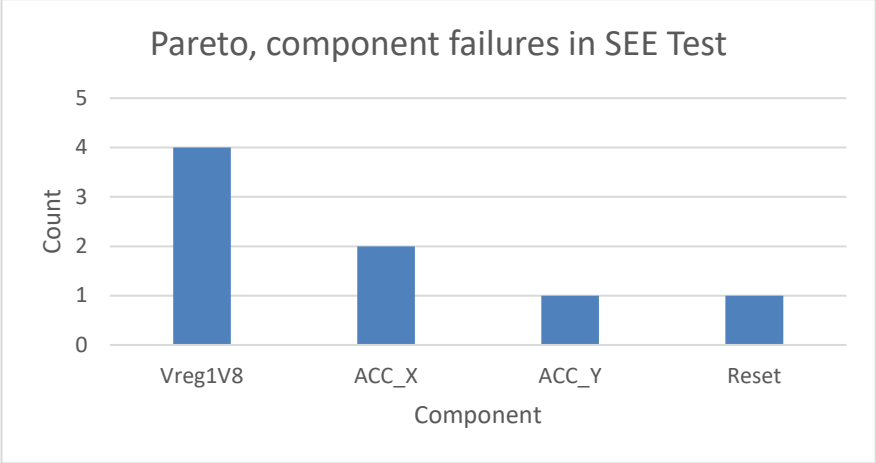
Figure 35: Pareto, Failing electronics in STIM210 and STIM300 during SEE test

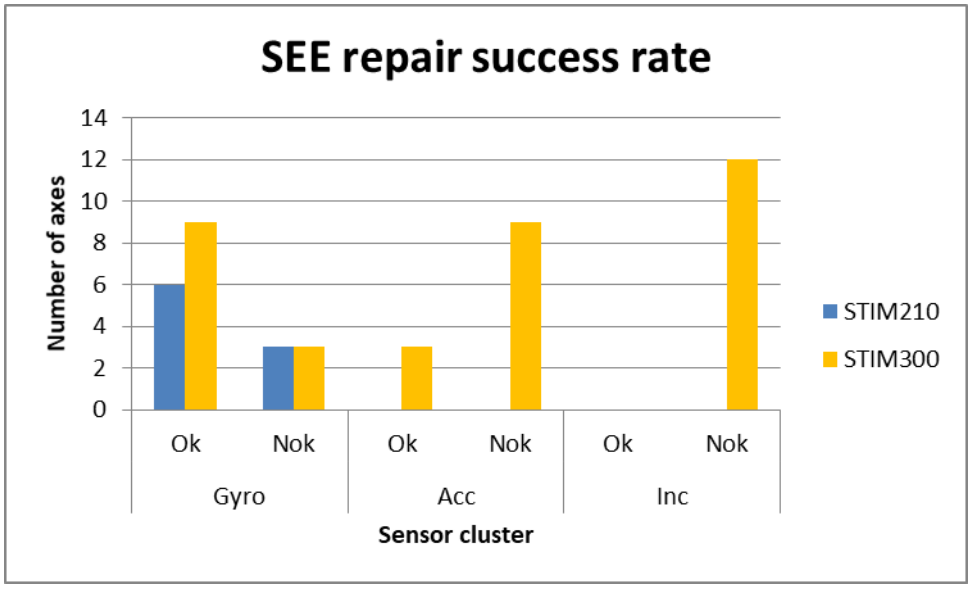
Figure 36: SEE success rate of repairs

After replacing components in all failing units necessary for powering up the STIM300 and STIM210 without error indication, the units were tested in a set of standard production test insertions. Overall results are shown in Figure 36.

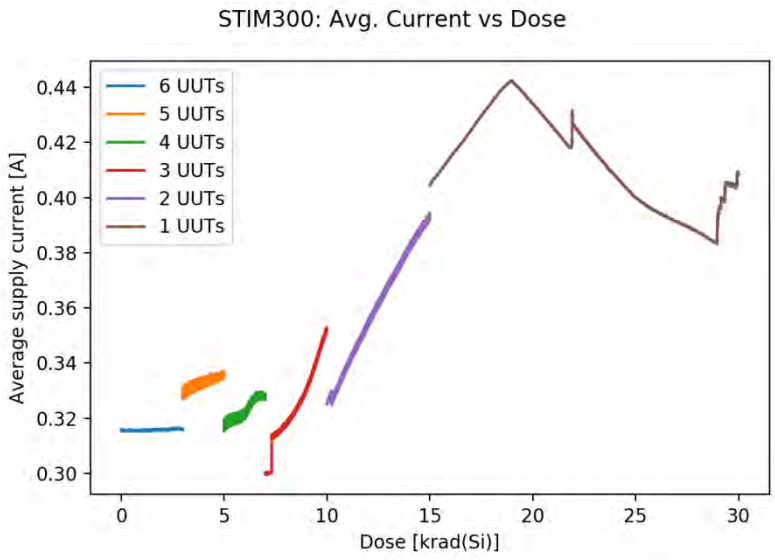
Figure 41: TID test of STIM300:Average supply current per UUT vs. total ionizing dose

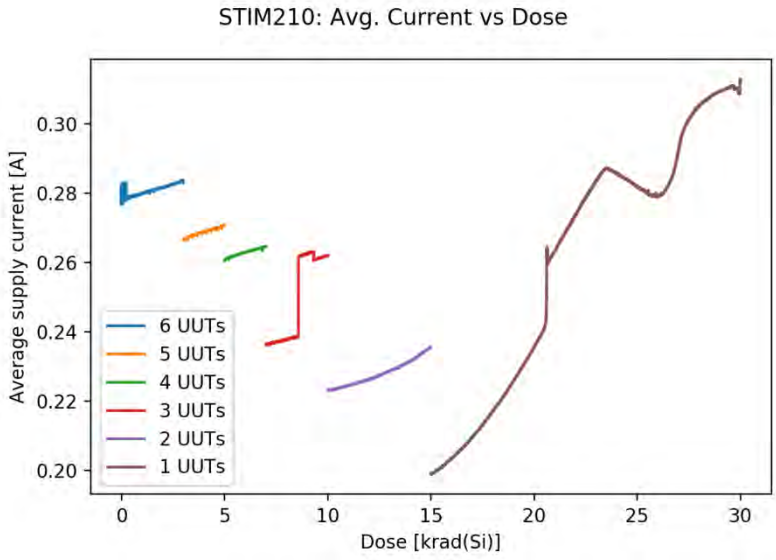
Figure 42: TID test of STIM210: Average supply current per UUT vs. total ionizing dose

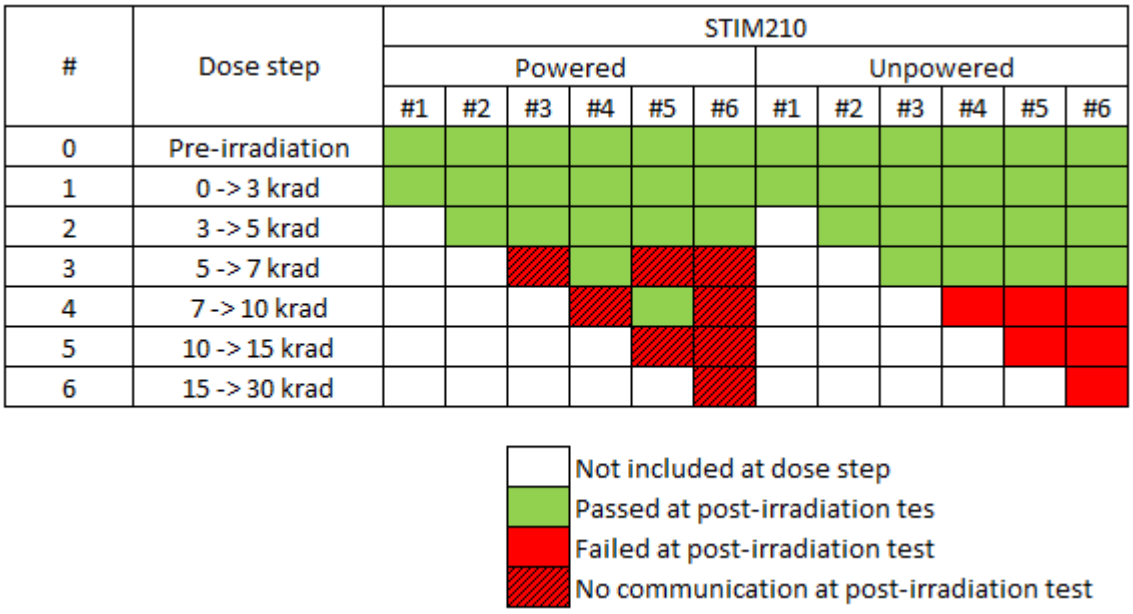
A pre-irradiation diagnostic read-out was performed on all UUT's. A post-irradiation diagnostic test was performed on all remaining UUT's after the completion of each dose step. Given here is only a brief overview on the pass/fail behavior of the UUTs as understood during conductance of the tests. All failing UUTs have undergone failure analysis.

Figure 43: TID test of STIM210: Overview of results

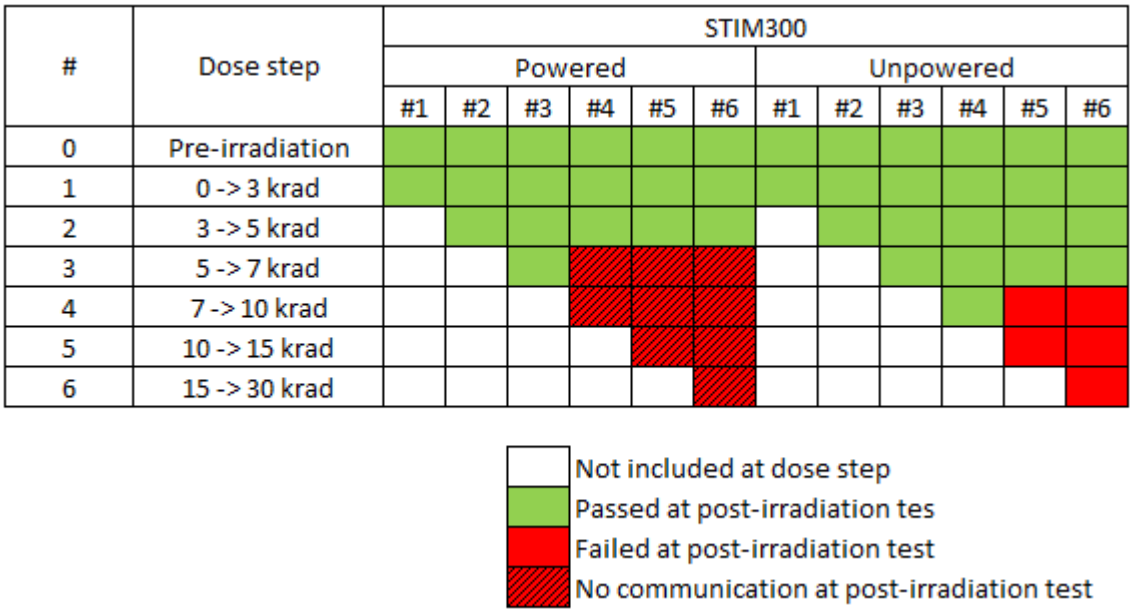
Figure 44: TID test of STIM300: Overview of results

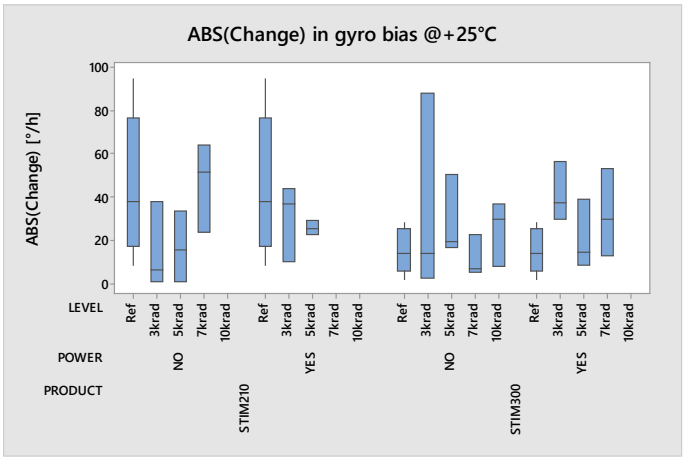
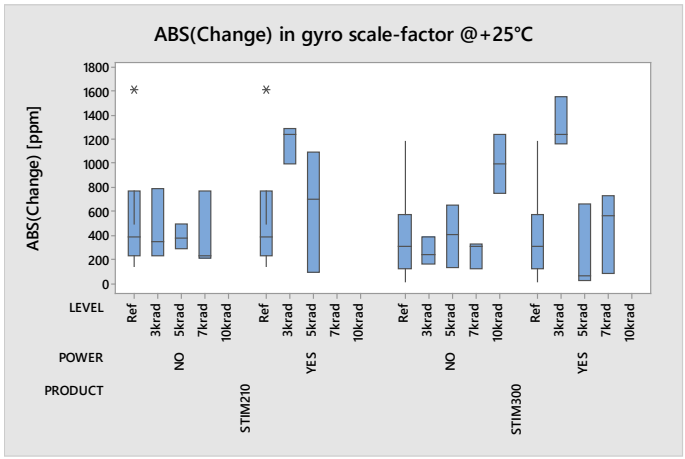
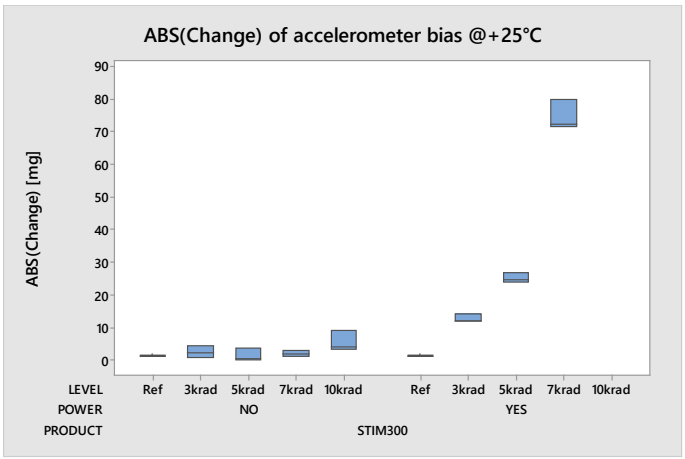
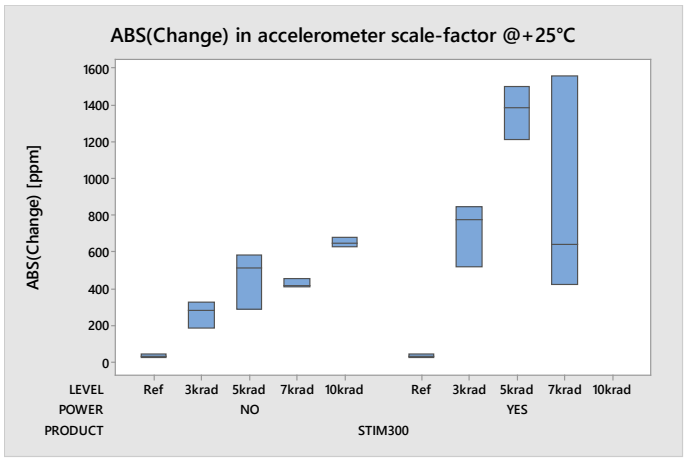
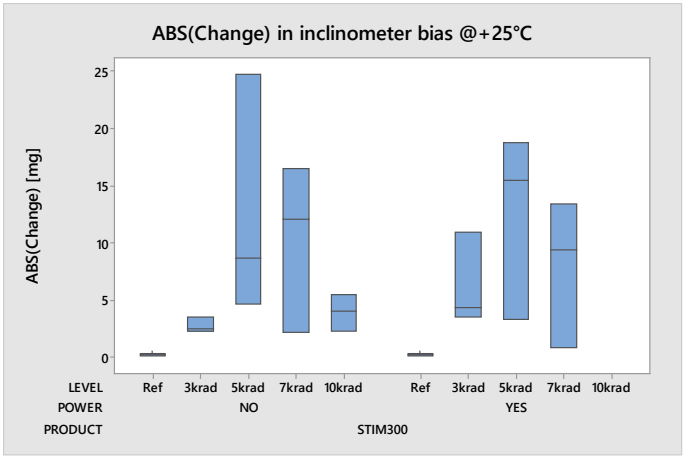
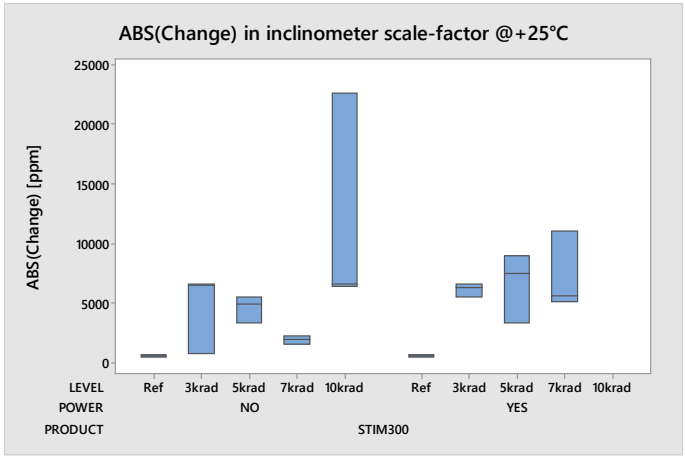
Product	Results		
	Gyro	Acc	Inc
STIM300	OK	NOK	NOK
STIM210	OK	N/A	N/A

The plots in Figure 45 to Figure 50 show the absolute value of the bias and scale factor drift between pre- and post-tests. The boxplots represent the interquartile range with the middle line representing the median. The full comparison of test results can be found in Appendix C.

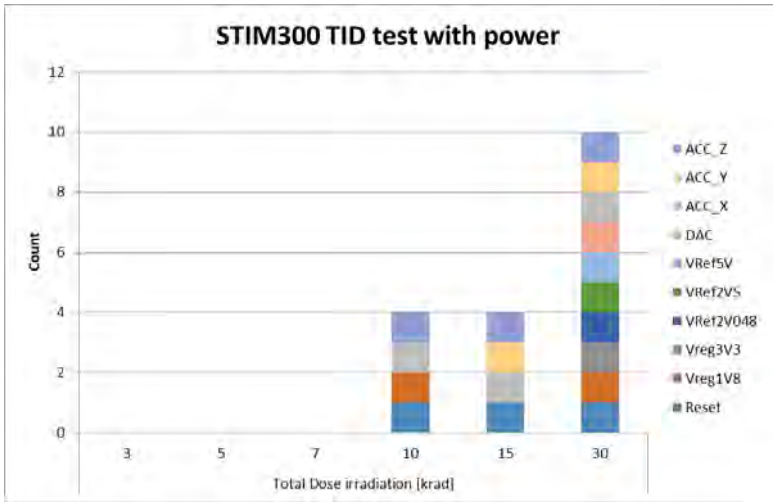
Units indicating HW errors were opened for further analysis and repair. A thorough failure analysis was performed to identify electronic components that failed. The failing electronic components were replaced in order to power up the STIM210/STIM300 with no error indication.

Several modules experienced multiple component failures. No assessment has been made as to whether any failure is derived from the radiation itself or is a consequence of other electronic failures.

Note that the total dose indicated in the plots for the TID tests indicates the total dose each component has been exposed to, not necessarily at what dose the failure first occurred.

Figure 51: Failing electronics in powered STIM300 during TID test

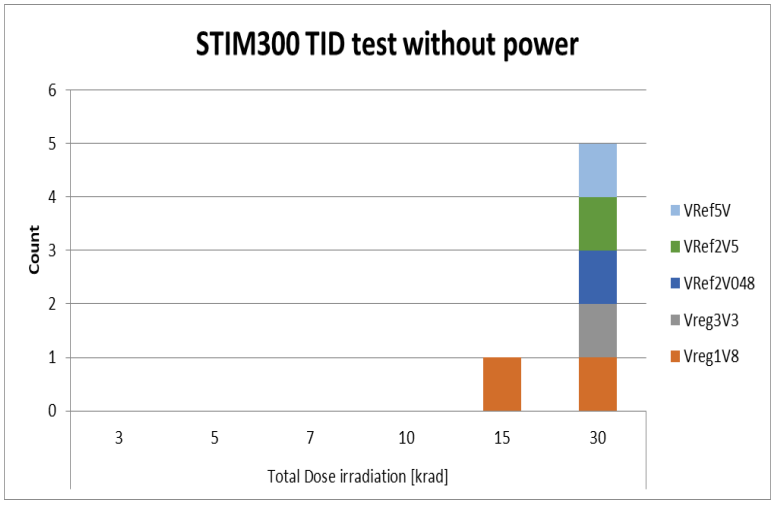
Figure 52: Failing electronics in unpowered STIM300 during TID test

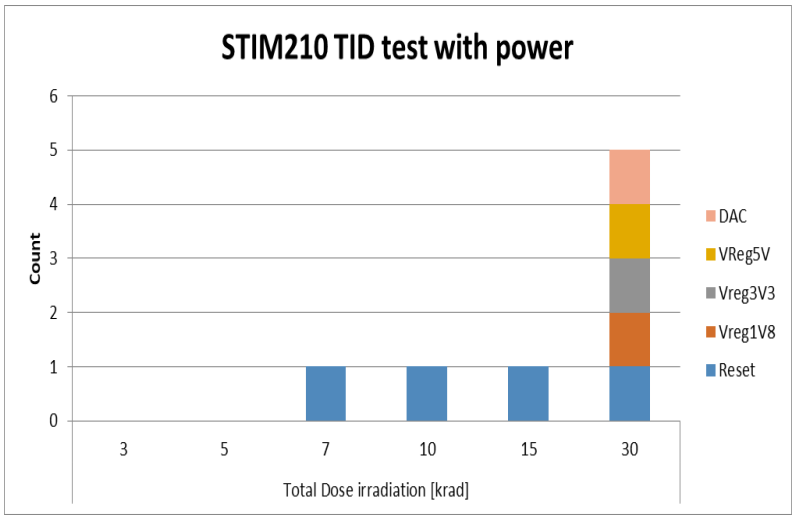
Figure 53: Failing electronics in powered STIM210 during TID test

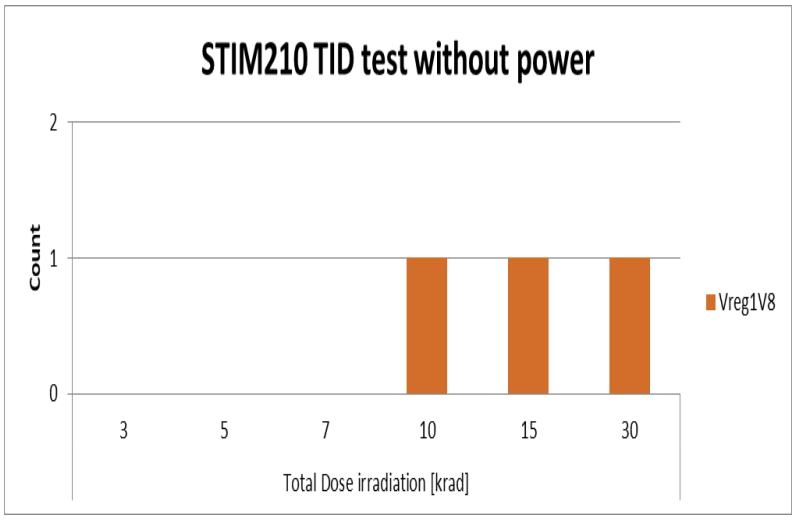
Figure 54: Failing electronics in unpowered STIM210 during TID test

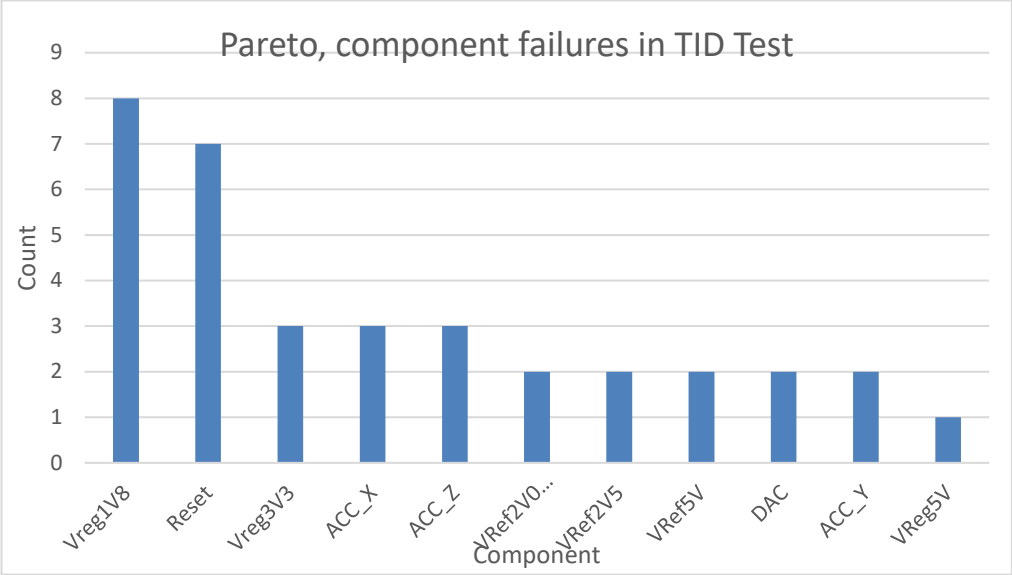
Figure 55: Pareto, Failing electronics in STIM210 and STIM300 during TID test

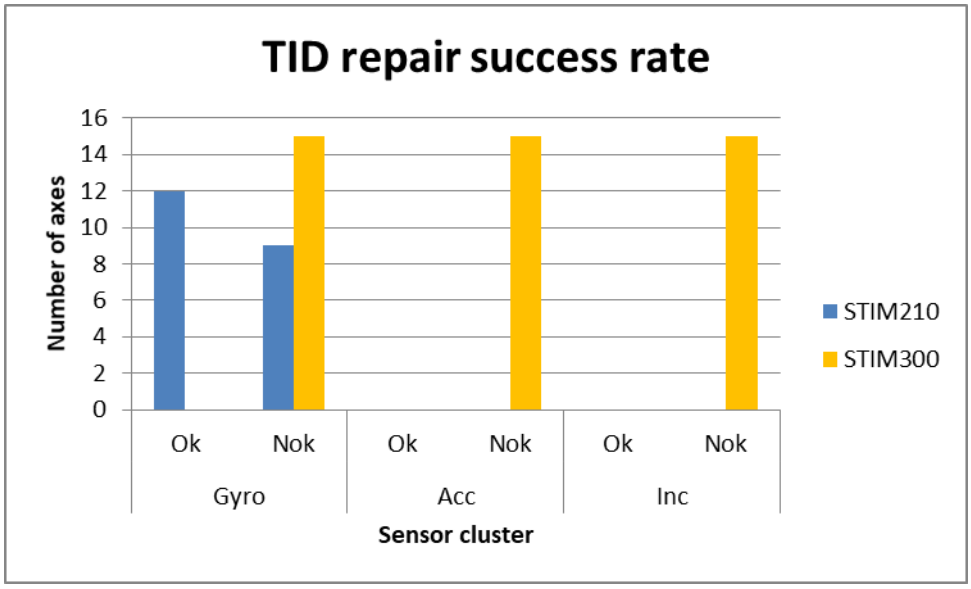
Figure 56: TID success rate of repairs

After replacing components in all failing units necessary for powering up without error indication, the units were tested in a set of standard production test insertions. Results are shown in Figure 56.

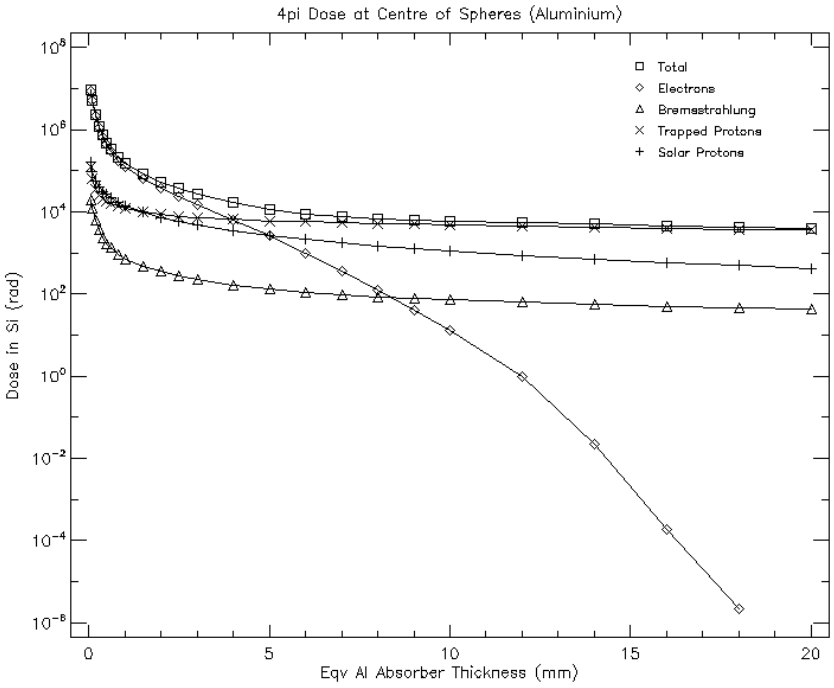
Figure 58: SHIELDOSE2Q results of the total dose behind aluminium on an example LEO mission (800 km, 10 years, heliosynchronous)

The diagnostic test performed after each irradiated dose, ref. Figure 43 (STIM210) and Figure 44 (STIM300), combined with the post-tests performed on parts passing the TID-tests, ref. Appendix C, show that the gyros in both STIM210 and STIM300 withstands a TID level of up to at least 5 kRad while powered and up to 7 kRad in an un-powered condition.

From the simulation, ref. Figure 58, behind 14 mm of aluminium shielding the total dose over 10 years drops below 5 krad(Si).

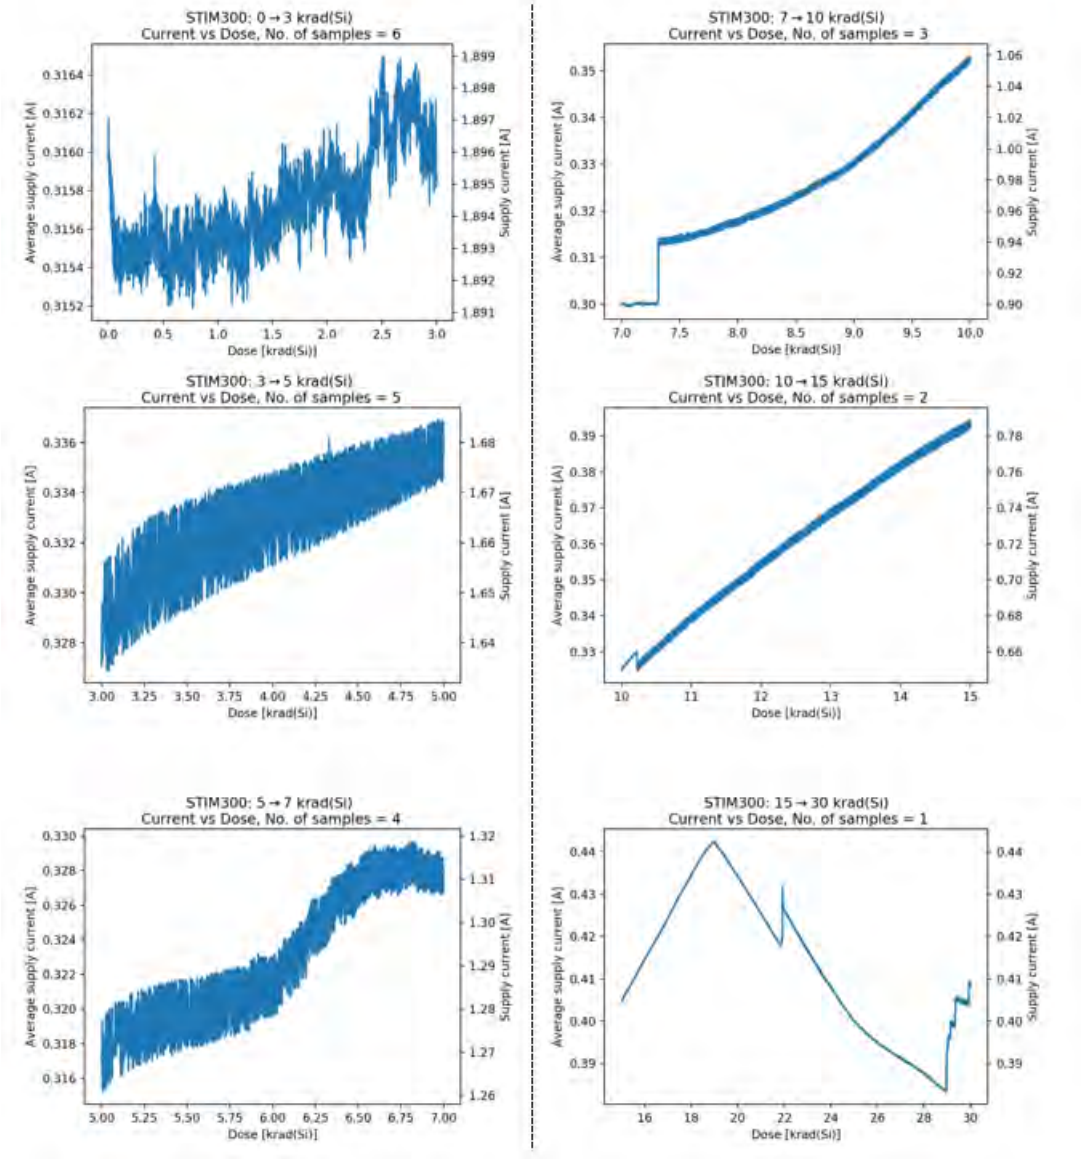
Figure 59: TID test of STIM300: Average supply current vs. total ionizing dose (individual dose steps)

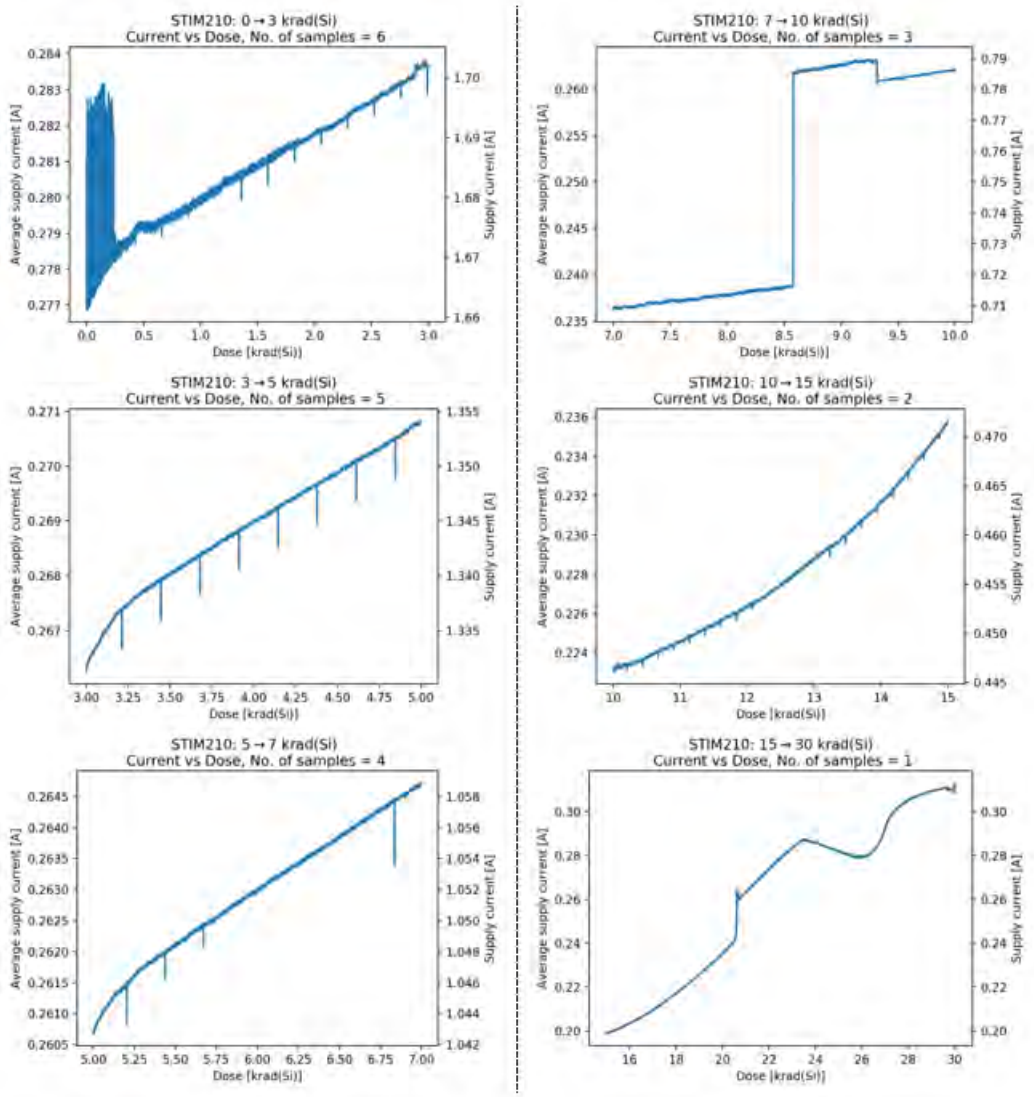
Furthermore to some extent the STIM210 shows a regular pattern of reduced current spikes. From the data it cannot be concluded whether this is a dose or a time effect.

Figure 60: TID test of STIM210: Average supply current vs. total ionizing dose (individual dose steps)

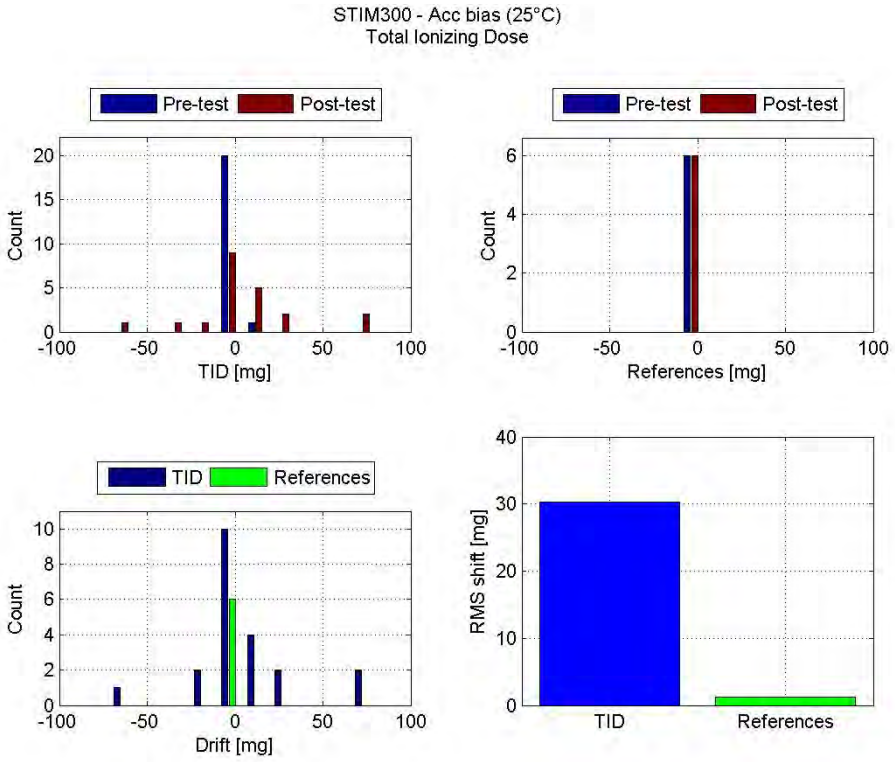
Figure 94 STIM300 Accelerometer bias error at +25 °C before and after TID test

- An rms shift of approximately 30 mg in accelerometer bias at +25 °C is observed (ref. *Figure 94*). Also seen over temperature (ref. *Figure 102*)
- An rms shift of approximately 11.5 mg in inclinometer bias at +25 °C is observed (ref. *Figure 96*)
- Scale Factor error for accelerometer and inclinometer is significantly increased (see Figure 108 and Figure 111)

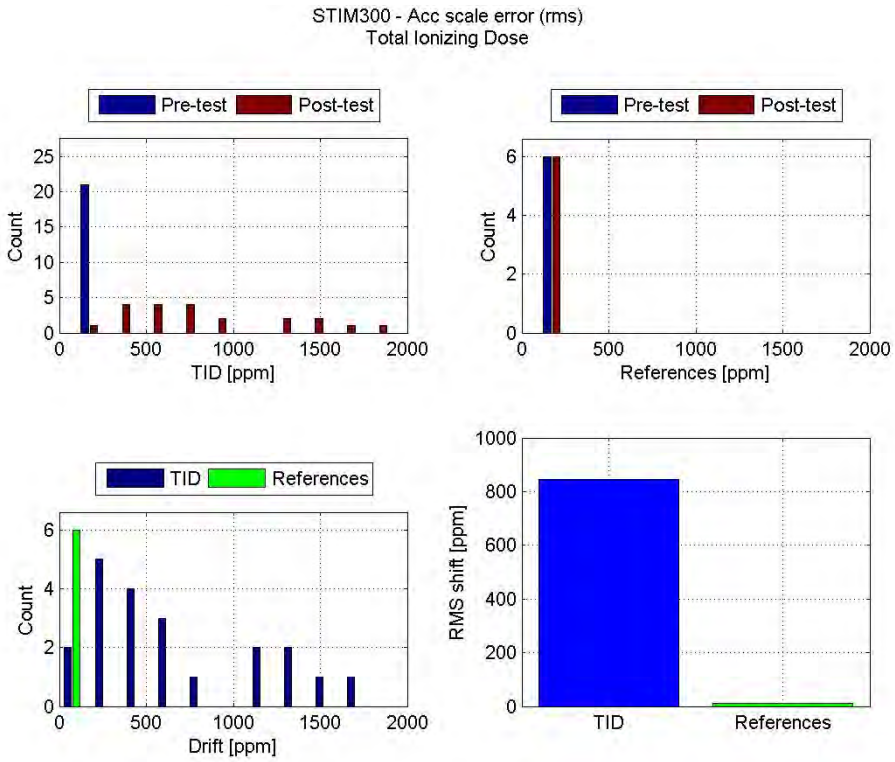
Figure 108 STIM300 Accelerometer scale factor error at +25 °C before and after TID test

The STIM300 accelerometers and inclinometers and/or their circuitry have shown negative effect from radiation. The bias and scale factor have drifted significantly already at 3 krad dose in the TID test. For the accelerometers, a robustness against higher dose levels is observed when the STIM300 is unpowered when compared to powered units (ref Figure 51 and Figure 52).

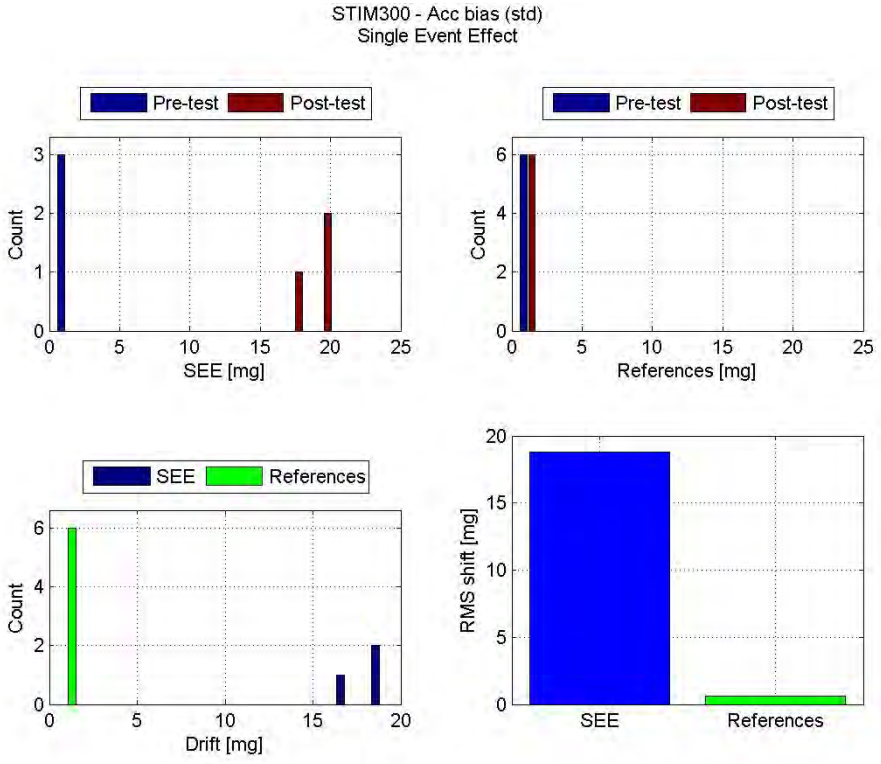
Figure 123 STIM300 Accelerometer bias error at +25 °C before and after SEE test

- STIM300: An rms shift of approximately 70 mg in accelerometer bias at +25 °C is observed (ref. *Figure 123*). Also seen over temperature (ref. *Figure 131*)
- STIM300: A shift in the accelerometer scale factor is observed (ref Figure 138 to Figure 140)
- STIM300: An rms shift of approximately 13 mg in inclinometer bias at +25 °C is observed (ref. *Figure 126*)
- STIM300: A shift in the inclinometer scale factor is observed (ref Figure 141 to Figure 143)
- STIM210 gyro Scale Factor error is somewhat increased for one axis (approximately -1500 ppm), see *Figure 149*

As shifts are seen on all accelerometers and inclinometers, main suspect points towards the common electronics to these sensors, e.g. voltage reference and/or ADC. Investigations into the observed shifts have not been performed.
