## Han Solo (9283, 9288 and 9289) and Ranier (9383, 9388 and 9389)

**Note:** ALL MODEL 9200s and 9300s are now discontinued

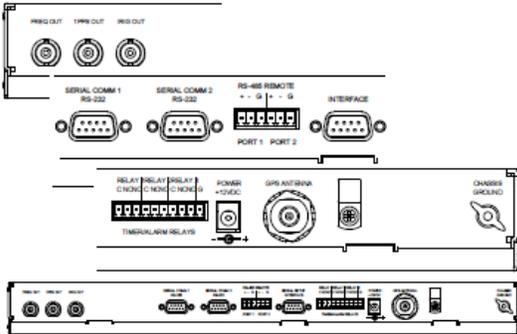
Figure 4-2: NetClock Rear Panel Detail

**1PPS** is a BNC output providing a once-per-second squarewave output.

**FREQ OUT** is a BNC output providing a 10MHz sinewave output.

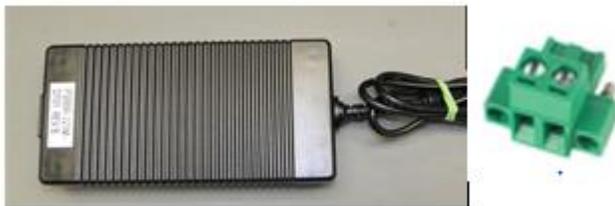
#### To verify the output of the 24vdc power pack

- To measure the 24 VDC, please use a DC voltmeter across the two leads of the terminal block

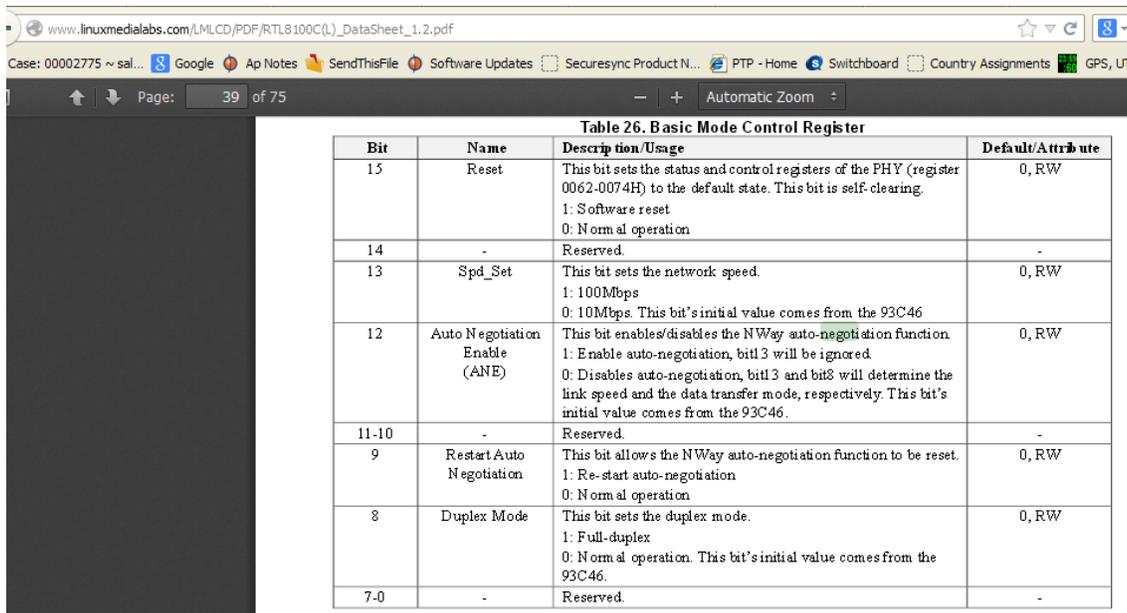
10/100Mbps: RTL8100CL-LF Ethernet Controller based on IEEE 802.3u 100Base-T standard

Supports 10Mbps and 100Mbps **NWay auto-negotiation**

Bit	Name	Description/Usage	Default/Attribute
15	Reset	This bit sets the status and control registers of the PHY (register 0062-0074H) to the default state. This bit is self-clearing. 1: Software reset 0: Normal operation	0, RW
14	-	Reserved.	-
13	Spd_Set	This bit sets the network speed. 1: 100Mbps 0: 10Mbps. This bit's initial value comes from the 93C46	0, RW
12	Auto Negotiation Enable (ANE)	This bit enables/disables the NWay auto-negotiation function. 1: Enable auto-negotiation, bit13 will be ignored. 0: Disables auto-negotiation, bit13 and bit8 will determine the link speed and the data transfer mode, respectively. This bit's initial value comes from the 93C46.	0, RW
11-10	-	Reserved.	-
9	Restart Auto Negotiation	This bit allows the NWay auto-negotiation function to be reset. 1: Re-start auto-negotiation 0: Normal operation	0, RW
8	Duplex Mode	This bit sets the duplex mode. 1: Full-duplex 0: Normal operation. This bit's initial value comes from the 93C46.	0, RW

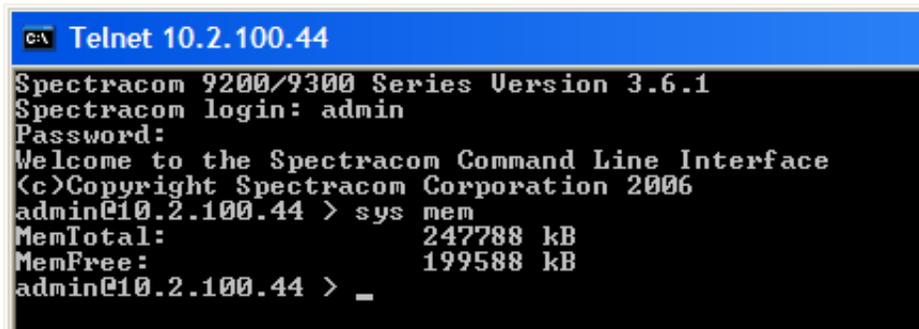
### Command to check the CF card memory being used

- The command is sys mem <enter>

```
C:\> Telnet 10.2.100.44
Spectracom 9200/9300 Series Version 3.6.1
Spectracom login: admin
Password:
Welcome to the Spectracom Command Line Interface
(c)Copyright Spectracom Corporation 2006
admin@10.2.100.44 > sys mem
MemTotal:      247788 kB
MemFree:       199588 kB
admin@10.2.100.44 > _
```

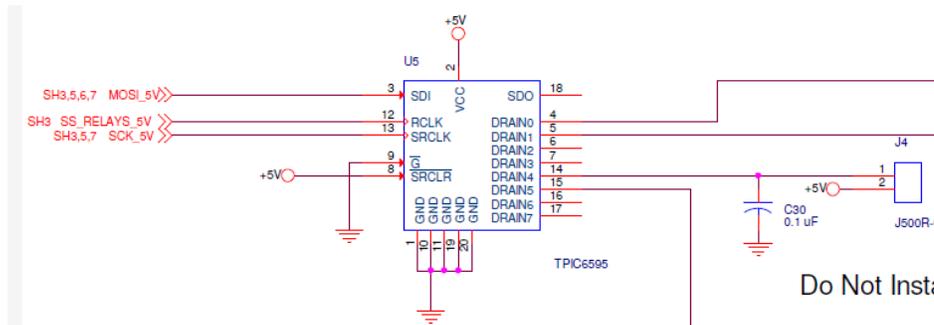
**Note:** 1165 schematic shows the fan for SP360 is apparently temperature controlled – not always on. It's connected via J4 and driven by IC. It's not connected directly to 5vdc.

**Note about schematic:** it doesn't contain the word "fan". So, search the schematic for "J4" instead.

**Email from Mark McGregor (18 Mar 16)** think that the fan must be J4 of the main board, sheet 2 of the schematic (above), connected to U5 pin 14, even though the schematic (1165-1000-0200 and 1165-1001-0300) says "Do not populate J4". This implies the fan is under software control. It may be temperature controlled, as I saw a temperature sensor, AD7814, U4 also on sheet 2. Tom Richardson would know for sure, if anyone would.

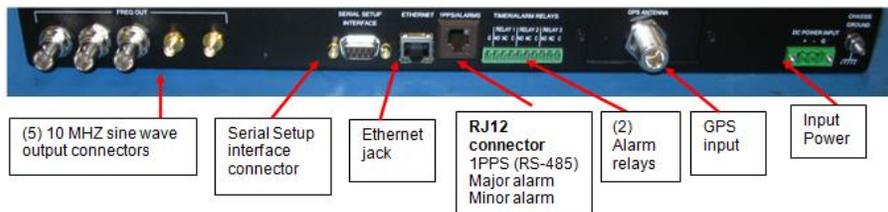
**B) 9383 SP360 Rear panel**

**SP360: Model 9383 with 5 - 10 MHz Outputs, RS-485 1PPS, Extended Temperature Range Rubidium (Rb) oscillator**

Special Request Number SP360 modifies the standard 9383 to output 5 10 MHz sine wave outputs, adds an RJ12 connector with 1 1PPS RS-485 output and 2 alarm relay outputs, and extend the upper temperature range to +55 degrees Celsius. This special also replaces the default Spectracom front panel overlay with a Harris Electronics overlay.

- Modifies the standard 9383 to output 5 10 MHz sine wave outputs,
- Add an RJ12 connector with (1) 1PPS RS-485 output and 2 alarm relay outputs
- Extends the upper temperature range to +55 degrees Celsius.
- This special also replaces the default Spectracom front panel overlay with a Tyco Electronics overlay.
- Removes IRIG, Remote and Serial Time code outputs and the 1PPS input.
- Adds **cooling fan (P/N: B101R-05R5-000H)** to front panel.

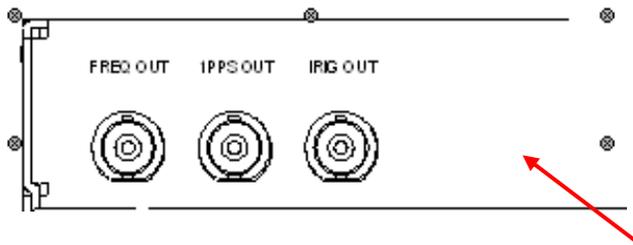
Standard unit has one IRIG output on BNC connector that supports either AM or DCLS (TTL)

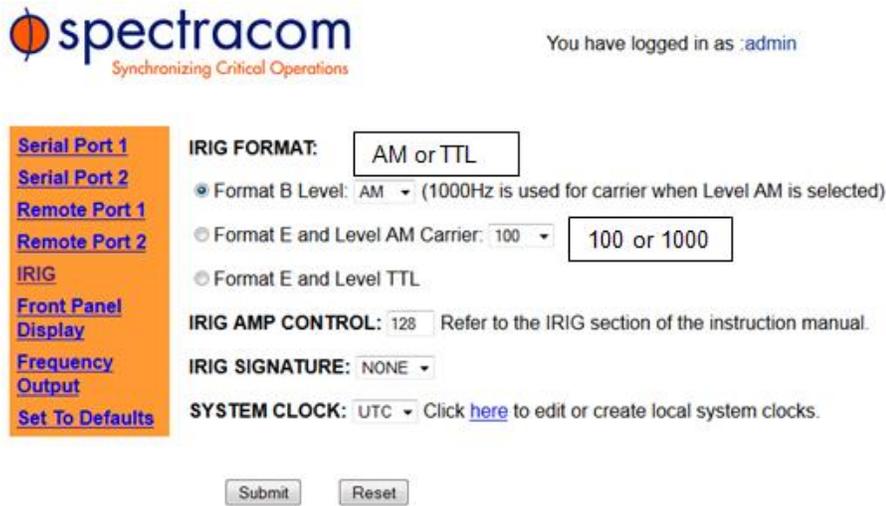
Interface -> IRIG page of the browser

Standard IRIG output (not applicable to Option 11)  
The NetClock’s IRIG output connector can provide the following IRIG Formats

IRIG Code Format	Description of code
B000	IRIG B, TTL, BCD, CF and SBS
B120	IRIG B, AM, 1 kHz, BCD, CF and SBS
E000	IRIG E TTL, BCD, CF and SBS
E110	IRIG E AM, 100 Hz, BCD, CF and SBS
E120	IRIG E AM, 1 kHz, BCD, CF and SBS

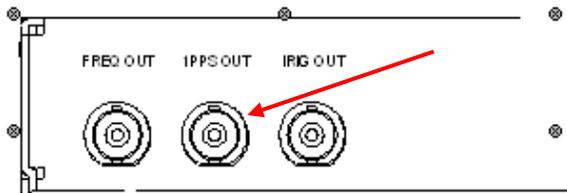
#### \*\*1PPS BNC output (and to other outputs for sync)

- FPGA selects from more than one 1PPS input.
- 1PPS output is not configurable (no config pages in the browser)

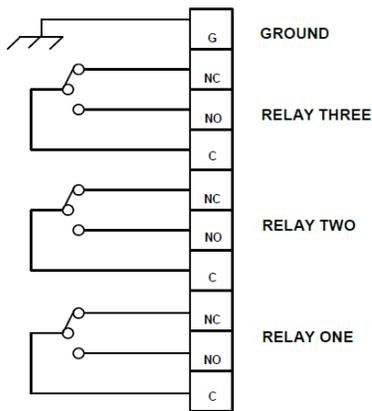
Figure 4-1: Event and Alarm Relay Contacts

- Refer to Section 3.4.17 of the 9300 manual for relay configuration via the browser.
- Refer to Section 4.1 of the 9300 manual for relay pin-out and operation.
- The relays are drawn in the manual schematics as de-energized (Shelf-state).
- The rear panel is screened for the relays when they are activated /energized (either on for a Minor alarm being asserted, Major alarm not active or when the Event is scheduled to be turned on). (For example, C to NC will be a short and C-NO will be an open).

**NOTE:** Relays are shown in the de-energized state (event "off").

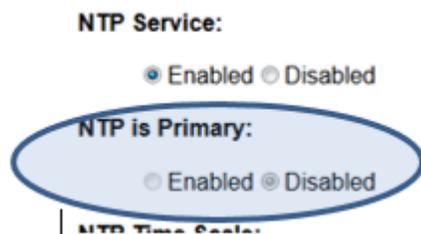
### \*\*\*\*"NTP is primary

- Used to disable the Antenna Problem alarm when the GPS antenna isn't connected.
- Can be Enabled or Disabled as desired (Disabled by default- so the Antenna Alarm is active).
- Controlled in the NTP -> General page of the browser (Just below the NTP Enable/Disable switch)

**A Email Keith sent to danny Loke (24 Sept 14) This** function isn't as complex as it sounds. Normally, the Model 9389 will have a GPS antenna connected to it, in order for it to track and sync to the satellites. However, with NTP input, it can operate without a GPS Reference by just syncing it to other time servers. In this application, it's likely that the GPS antenna won't even be attached to the time server. Without an antenna connected to the NetClock, its internal GPS receiver is going to report a constant open is occurring in the GPS "cable", which will cause the Antenna Problem alarm to be asserted. When this alarm is asserted because either there is a cable issue or no antenna even antenna, the Sync LED flashes red to report this. So "NTP is primary" being enabled stops the front panel Sync LED from flashing red, because the antenna isn't attached ☺!!

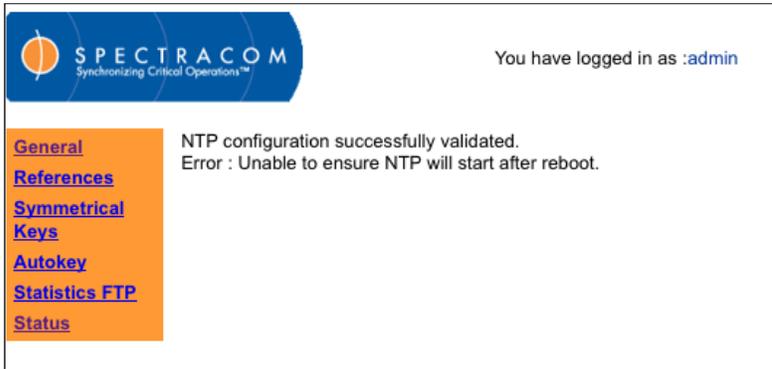
NTP error shown in web browser (“[NTP configuration successfully validated. Error: Unable to ensure NTP will start after reboot](#)”) as shown below:

The screenshot shows the Spectracom web interface. At the top left is the Spectracom logo with the tagline "Synchronizing Critical Operations™". To the right, it says "You have logged in as :admin". On the left side, there is a vertical menu with orange highlights for "General", "References", "Symmetrical Keys", "Autokey", "Statistics FTP", and "Status". The main content area displays the message: "NTP configuration successfully validated. Error : Unable to ensure NTP will start after reboot."

This issue is caused by large time jumps occurring in System Time. The customer that reported this screen being displayed had the NetClock in standard mode, receiver was never able to complete the GPS survey, and had manually entered bad Lat and long values. This caused System Time to be jumping around (giving NTP a poor reference).

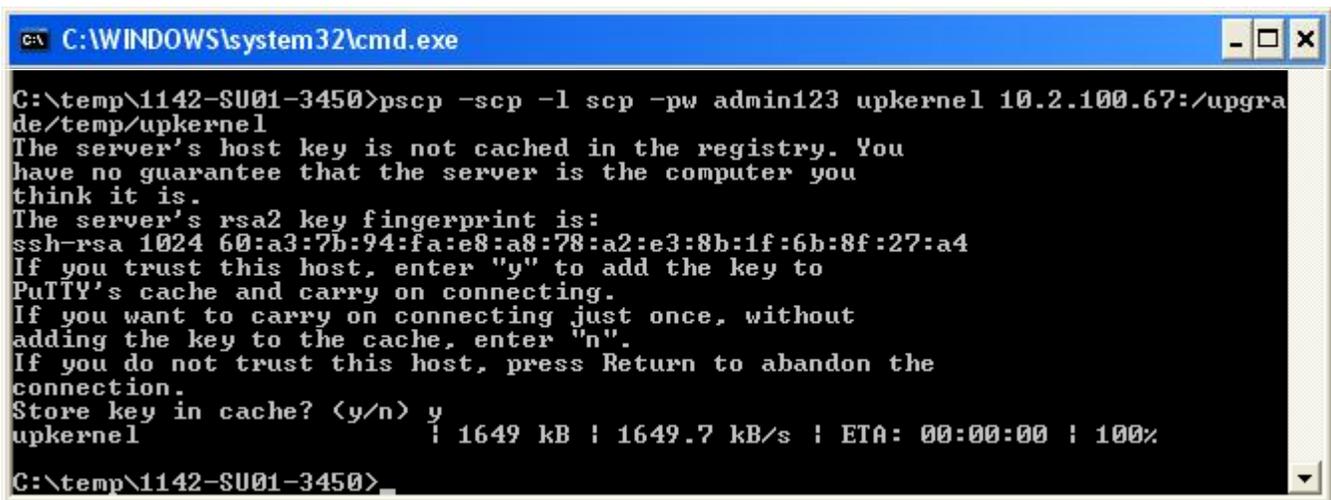
After hitting enter, there should be a brief pause, followed by a question about cache. Type a “Y” as soon as you see this prompt. A manual file transfer should then occur, and a message should be displayed moments later. The message should indicate that 100% of the file was transferred. Refer to the screenshot below which shows a successful (100%) file transfer:

```
C:\WINDOWS\system32\cmd.exe
C:\temp\1142-SU01-3450>pscp -scp -l scp -pw admin123 upkernel 10.2.100.67:/upgra
de/temp/upkernel
The server's host key is not cached in the registry. You
have no guarantee that the server is the computer you
think it is.
The server's rsa2 key fingerprint is:
ssh-rsa 1024 60:a3:7b:94:fa:e8:a8:78:a2:e3:8b:1f:6b:8f:27:a4
If you trust this host, enter "y" to add the key to
PuTTY's cache and carry on connecting.
If you want to carry on connecting just once, without
adding the key to the cache, enter "n".
If you do not trust this host, press Return to abandon the
connection.
Store key in cache? (y/n) y
upkernel          | 1649 kB | 1649.7 kB/s | ETA: 00:00:00 | 100%
C:\temp\1142-SU01-3450>_
```

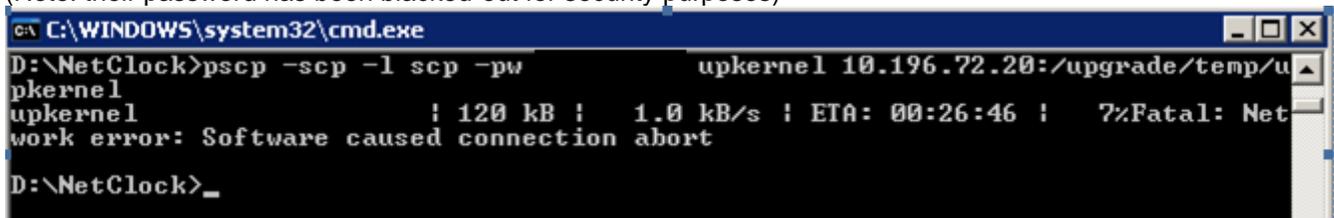
Here's an example of a pscp failure. The file was taking way too long to transfer, so it was timing out. (Note: their password has been blacked-out for security purposes)

```
C:\WINDOWS\system32\cmd.exe
D:\NetClock>pscp -scp -l scp -pw          upkernel 10.196.72.20:/upgrade/temp/u
pkernel
upkernel          | 120 kB | 1.0 kB/s | ETA: 00:26:46 | 7%Fatal: Net
work error: Software caused connection abort
D:\NetClock>_
```

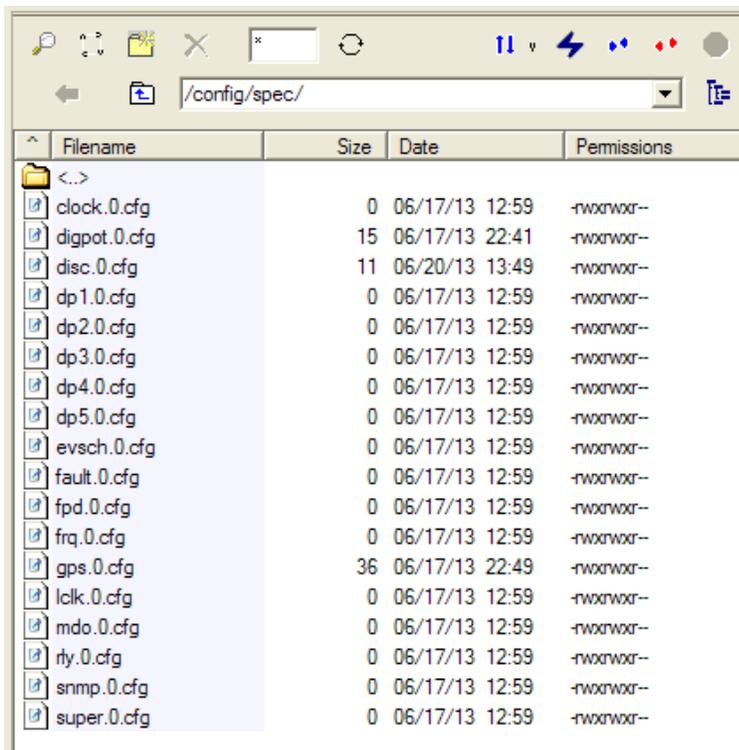
- There is no way to perform backup using the command line interface.
- However, can FTP out the Config files (/config/spec folder, as shown in screenshot below)

Filename	Size	Date	Permissions
<..>			
clock.0.cfg	0	06/17/13 12:59	-rwxrwxr--
digpot.0.cfg	15	06/17/13 22:41	-rwxrwxr--
disc.0.cfg	11	06/20/13 13:49	-rwxrwxr--
dp1.0.cfg	0	06/17/13 12:59	-rwxrwxr--
dp2.0.cfg	0	06/17/13 12:59	-rwxrwxr--
dp3.0.cfg	0	06/17/13 12:59	-rwxrwxr--
dp4.0.cfg	0	06/17/13 12:59	-rwxrwxr--
dp5.0.cfg	0	06/17/13 12:59	-rwxrwxr--
evsch.0.cfg	0	06/17/13 12:59	-rwxrwxr--
fault.0.cfg	0	06/17/13 12:59	-rwxrwxr--
fpd.0.cfg	0	06/17/13 12:59	-rwxrwxr--
frq.0.cfg	0	06/17/13 12:59	-rwxrwxr--
gps.0.cfg	36	06/17/13 22:49	-rwxrwxr--
lclk.0.cfg	0	06/17/13 12:59	-rwxrwxr--
mdo.0.cfg	0	06/17/13 12:59	-rwxrwxr--
rly.0.cfg	0	06/17/13 12:59	-rwxrwxr--
snmp.0.cfg	0	06/17/13 12:59	-rwxrwxr--
super.0.cfg	0	06/17/13 12:59	-rwxrwxr--

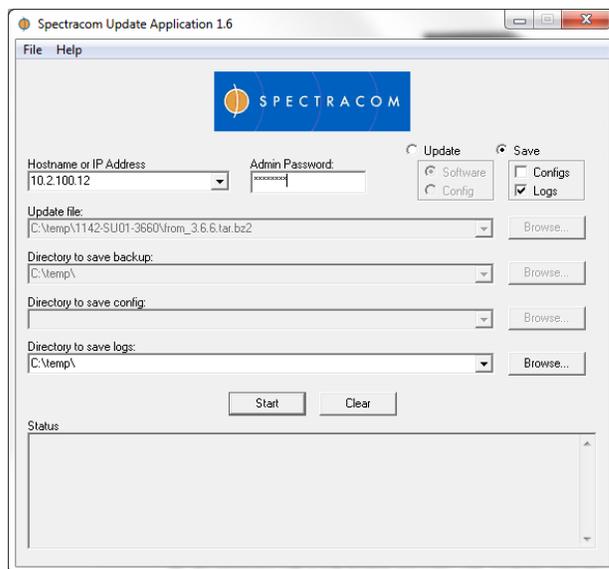
In the upper-right corner of the Specup utility, select Save and Logs. Also enter your Admin password, the IP address of the NetClock and the file on your PC to place the files (as shown below). Then press Start.

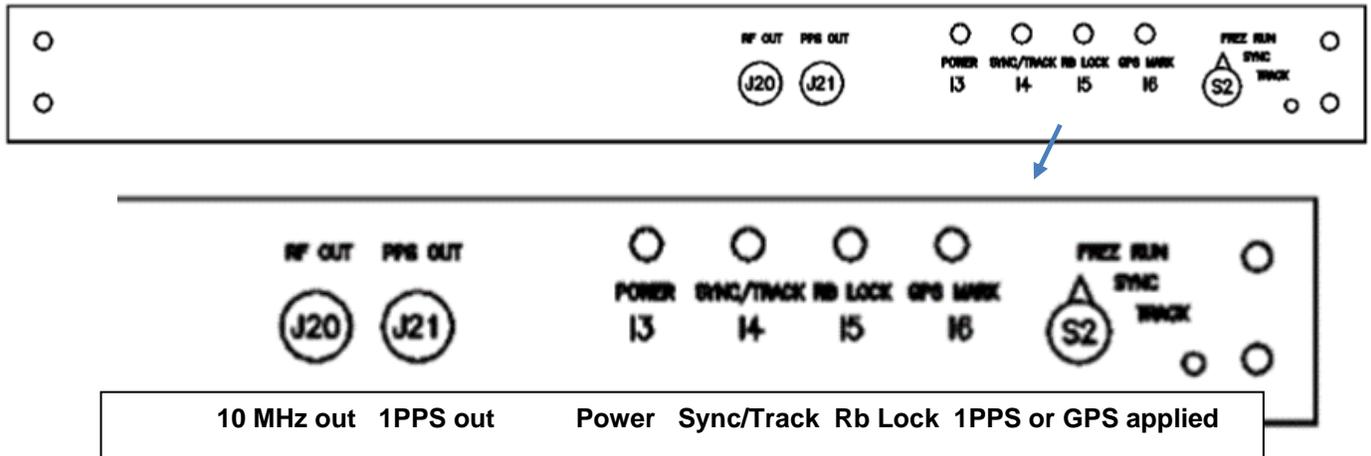
N°	Type	Definition	I/O
J20	BNC	10MHz sine reference output	O
J21	BNC	1PPS output	O
I3	Green LED	Power indicator	-
I4	Green LED	Sync or Track mode enabled	-
I5	Red LED	Rubidium clock locked alarm	-
I6	Green LED	1PPS GPS applied	-
S2	SWITCH	Free run, Sync or track selection switch	-

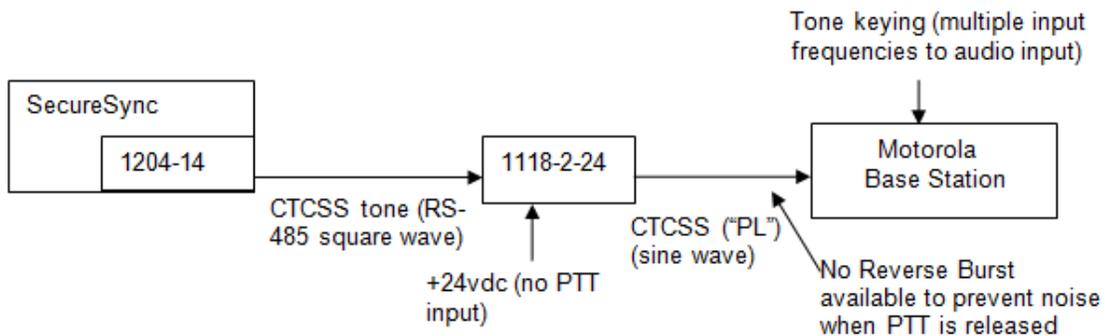
(CTSS is "Always on" AND using Model 1118-2-24 for 24vdc input power)

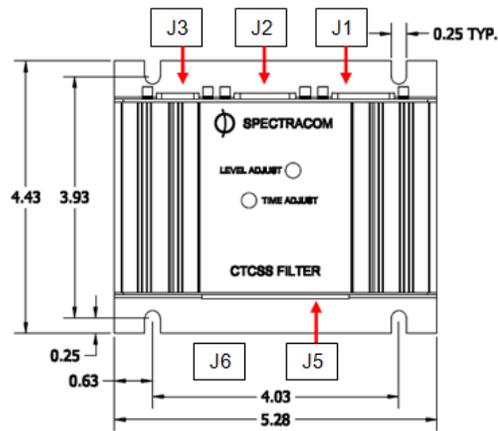
12 pin terminal block

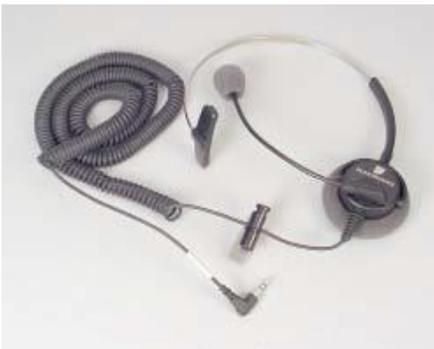
3.5 mm (bigger than a cell phone headset which is 2.5mm). Can purchase headsets from us ( our OP/N ACC 327) or purchase an adapter as necessary.

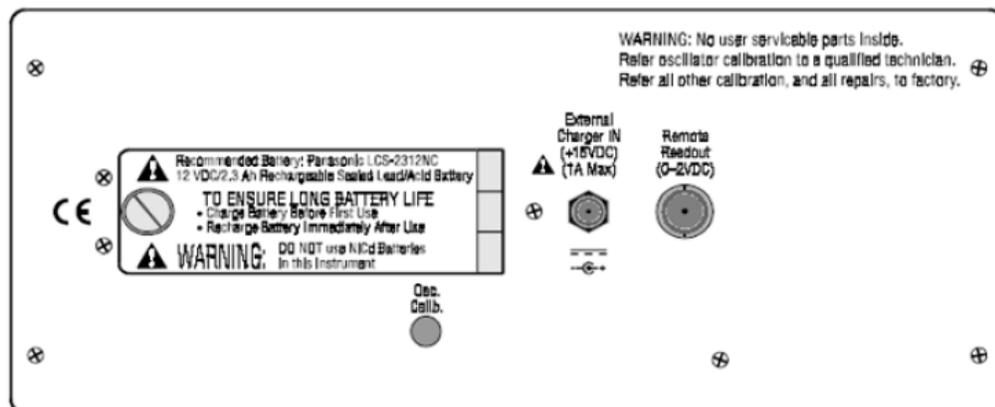
Figure 3-2. Model 2240 Rear Panel

Figure 3-2 depicts the PathAlign-R rear panel connectors and battery access door.

Name	Function
Battery Access Door	Hinged battery access door provides for removal/replacement of internal battery. Door latches via a thumbscrew.
Osc. Calib.	Access hole allowing the use of a trim pot adjusting tool to fine-tune the internal oscillator during yearly calibration. <b>Note: Refer oscillator calibration to a qualified technician!</b>
External Charger IN	Type 5.5 mm x 2.1 mm, two-terminal battery power connector connects the external 15VDC/ 1A Battery Charger to the PathAlign-R (center pin is positive, maximum charge current: 1 amp).
Remote Readout	BNC type connector. Provides a 0-2 VDC output that tracks the front panel LCD Path Loss Meter (1 mV = 0.1 dB). Allows for external readout of path loss using a handheld DVM.

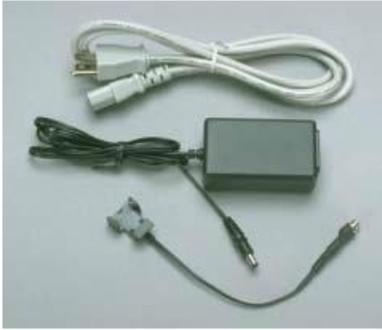
<b>Battery Charger In:</b>	5.5 mm x 2.1 mm rear panel Power jack (15 VDC/ 1A, center positive)
<b>ACS MAINS Input:</b>	90 to 264 VAC / 47 to 63 Hz
<b>AC MAINS Connector:</b>	IEC-320, 3-conductor. Conforms to IEC 320-3:1987/EN 60 320
<b>DC Output:</b>	15 VDC / 1A
<b>DC Connector:</b>	5.5 mm x 2.1 mm Barrel Power connector, 5 foot cord

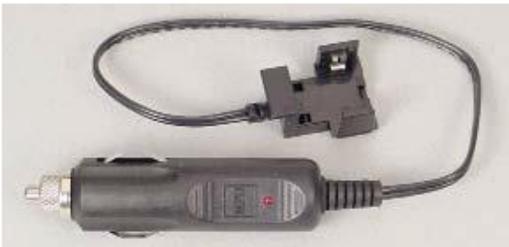
- In-vehicle battery charger with battery clip for charging spare battery (outside instrument)
- **Spectracom P/N** Acc 323
- Refer to “Path AlignR Accessories” Data Sheet: [link to datasheets in SharePoint](#)
- Available for purchase from us: (In Salesforce), refer to: <https://na28.salesforce.com/01t80000001Xvsq?srPos=0&srKp=01t>

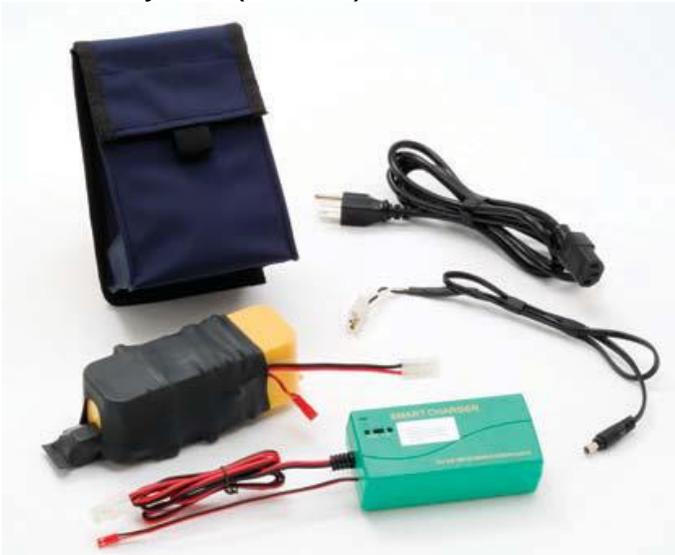
- External battery pack to extend battery life in cold-weather conditions.
- Refer to “Path AlignR Accessories” Data Sheet: [link to datasheets in SharePoint](#)
- Weight is close to 2.5 lbs.
- Our P/N for ACC 400: PEN6-1400-0300 (In Arena): [https://app.bom.com/items/detail-spec?item\\_id=1203165921&version\\_id=10221202828](https://app.bom.com/items/detail-spec?item_id=1203165921&version_id=10221202828)
- Available for purchase from us: (In Salesforce), refer to: <https://na28.salesforce.com/01t80000002GBCG?srPos=0&srKp=01t>

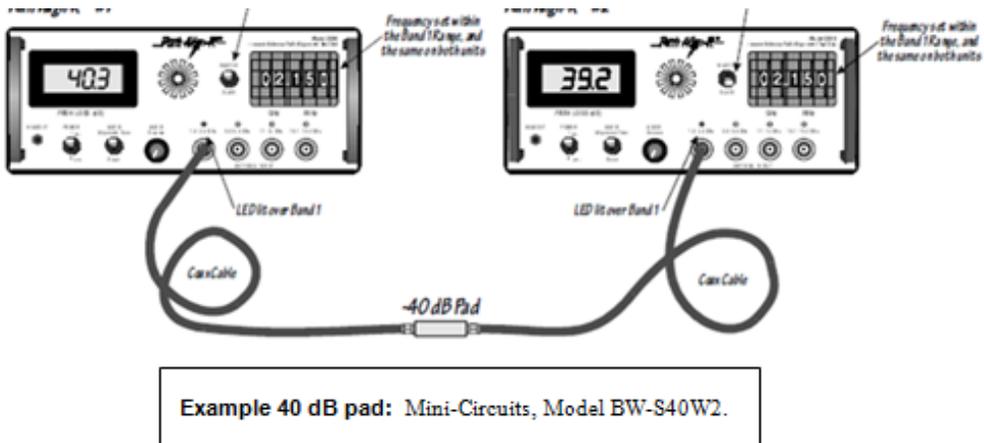
- **Band 1** should show 40dB

Recommended to be performed every time they are used or if a problem is suspected. Direct connect both units together with wave-guide. Expected DB readout at a 3 foot distance is based on which of the four bands are connected together, as shown below:

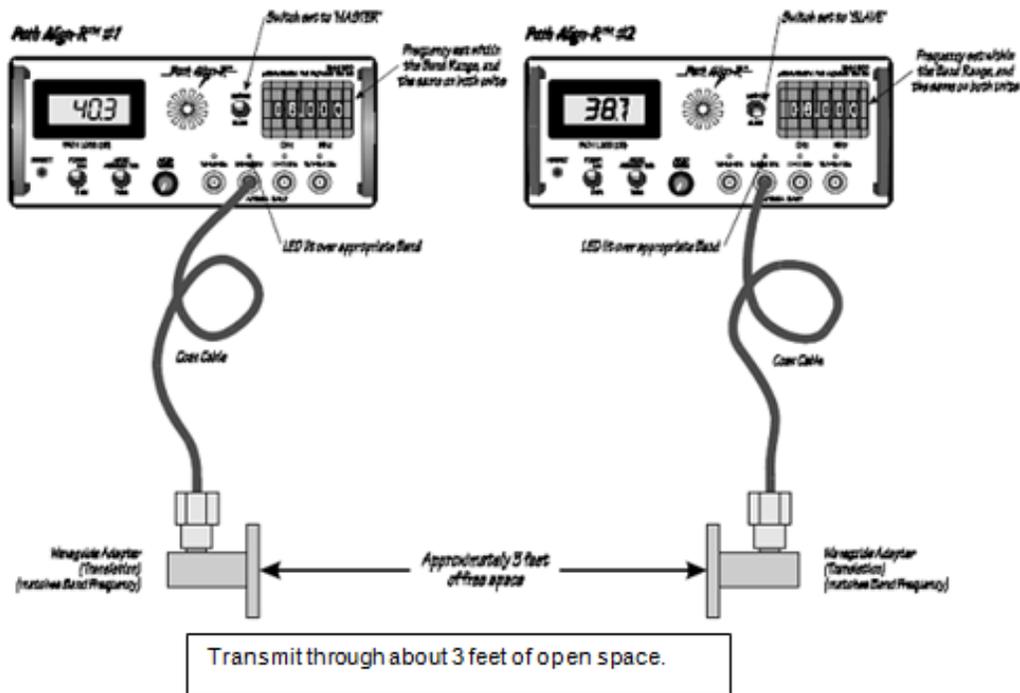
- **Band 2** (5.8-6.6 GHz) should show 40dB
- **Band 3** (11-12GHz) should show 50dB.
- **Band 4** (18.1-19.4GHz) should show 60dB

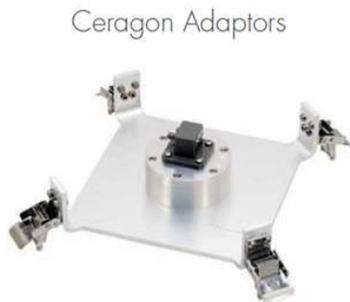
Waveguide-to-Coax SMA Adaptors  
 Acc 351 Ceragon ODU 11GHz  
 Acc 358 Ceragon ODU 18GHz  
 Acc 353 Ceragon ODU 23 GHz

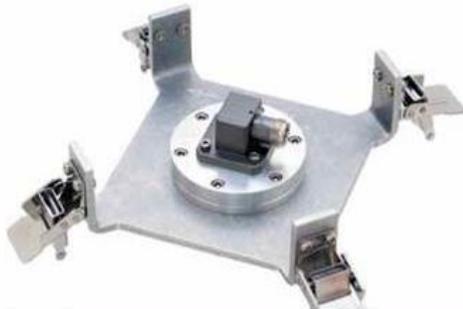
Waveguide-to-Coax SMA Adaptors  
Acc 361 Dragonwave ODU 11GHz  
Acc 368 Dragonwave ODU 18GHz  
Acc 363 Dragonwave ODU 23 GHz

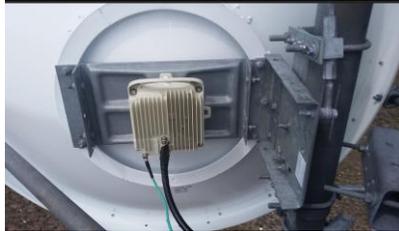
**Reply from Dave L (5/22/17)** ODU Dishes are always a problem. According to the specs on this dish, it uses a CPR90G style adapter, but it needs an adapter to mount to the back of the dish. We do sell some type N to rectangular waveguide adapters but that is all. Unfortunately, we have nothing to direct fit this dish.

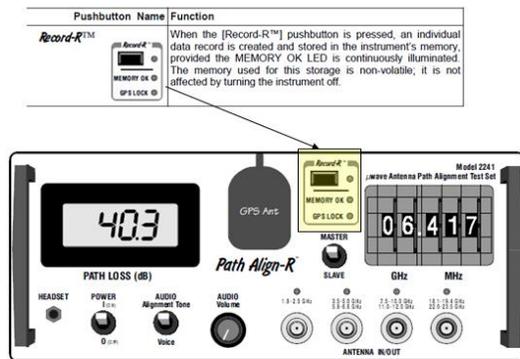
## \*Record-R data logger and GPS lock (for Models 2241 and 2241A only)

- Models 2241 and 2241A include the Record-R™ data logger, which allows the results of the antenna path alignment to be logged into internal memory. The Record-R™ contains an embedded GPS receiver to provide accurate date/time and position information added to the frequency and path loss data. The data is saved in memory for transfer to a PC using the LogView-R™ software.
- This is an Internal/integrated feature (not available for download)
- Non Volatile memory storage (persists through boot-ups)

If the GPS LOCK is flashing (no lock), position is not known and cannot be recorded. If the [Record-R] button is pressed and held for three seconds, until the Record-R LED illuminates, a data record will be recorded along with frequency, path loss, date and time. The data recorded is the information displayed at the instant the Record-R LED illuminates.

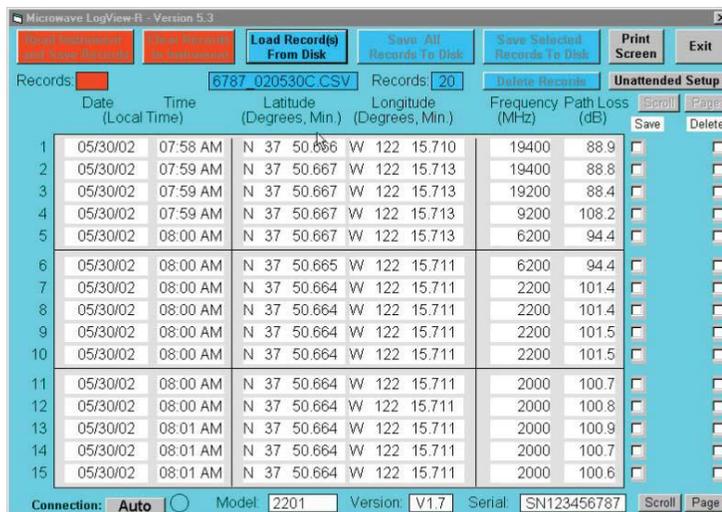
## LogView-R software for Path AlignRs (Log View-R)

The screenshot shows the Microwave LogView-R software interface. At the top, there are buttons for 'Load Record(s) From Disk', 'Save All Records To Disk', 'Save Selected Records To Disk', 'Print Screen', and 'Exit'. Below these are fields for 'Records: 6787\_020530C.CSV' and 'Records: 20'. A table displays recorded data with columns for Date, Time, Latitude, Longitude, Frequency, and Path Loss. The table contains 15 rows of data. At the bottom, there are fields for 'Connection: Auto', 'Model: 2201', 'Version: V1.7', and 'Serial: SN123456787'.

Date (Local Time)	Time	Latitude (Degrees, Min)	Longitude (Degrees, Min)	Frequency (MHz)	Path Loss (dB)	Save	Delete
1	05/30/02	07:58 AM	N 37 50.666	W 122 15.710	19400	88.9	<input type="checkbox"/>	<input type="checkbox"/>
2	05/30/02	07:59 AM	N 37 50.667	W 122 15.713	19400	88.8	<input type="checkbox"/>	<input type="checkbox"/>
3	05/30/02	07:59 AM	N 37 50.667	W 122 15.713	19200	88.4	<input type="checkbox"/>	<input type="checkbox"/>
4	05/30/02	07:59 AM	N 37 50.667	W 122 15.713	9200	108.2	<input type="checkbox"/>	<input type="checkbox"/>
5	05/30/02	08:00 AM	N 37 50.667	W 122 15.713	6200	94.4	<input type="checkbox"/>	<input type="checkbox"/>
6	05/30/02	08:00 AM	N 37 50.665	W 122 15.711	6200	94.4	<input type="checkbox"/>	<input type="checkbox"/>
7	05/30/02	08:00 AM	N 37 50.664	W 122 15.711	2200	101.4	<input type="checkbox"/>	<input type="checkbox"/>
8	05/30/02	08:00 AM	N 37 50.664	W 122 15.711	2200	101.4	<input type="checkbox"/>	<input type="checkbox"/>

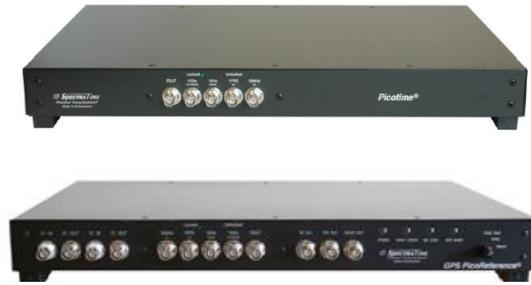
#### GPS PicoReference Pico Second Resolution Test Set

The GPS PicoReference™ is a low-cost, high-performance frequency reference and measurement test set. It integrates a smart GPS and a Rubidium reference, features a flexible 1-30 MHz frequency testing range and a cutting-edge 1ps measurement resolution. It's ideally designed for clock characterization and calibration applications.

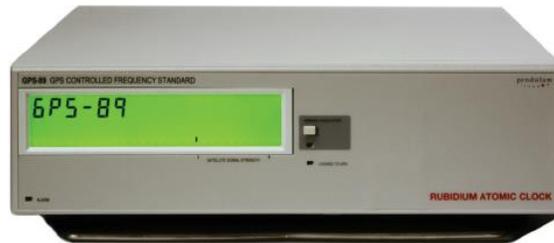
### GPS-Controlled Frequency Standards

Deliver precision frequency and time reference with these GPS-controlled frequency standards. The Pendulum GPS-88 and GPS-89 are fully traceable and extremely accurate frequency standards, with applications in telecommunications, calibration laboratories, automated test systems and design departments.

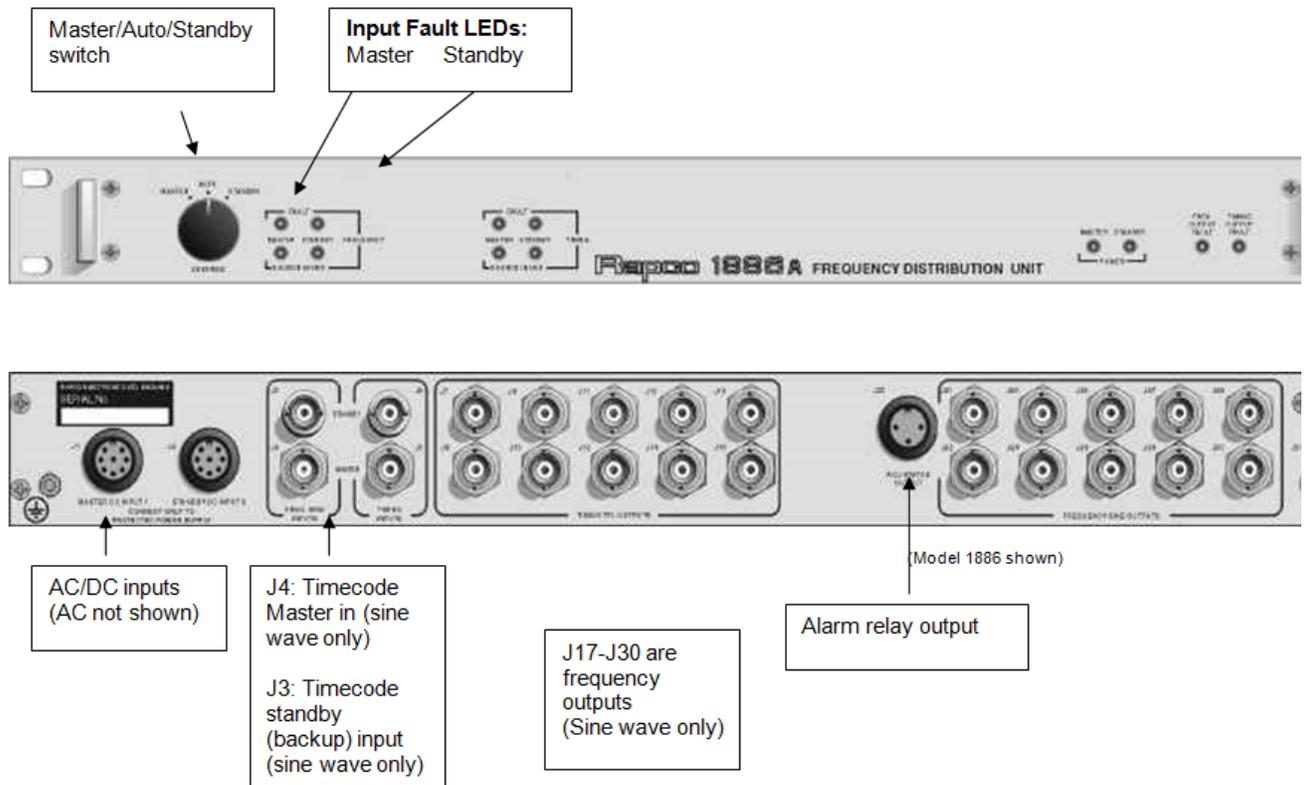
**Note:** Pictures below of front and back are of a Model 1866A (not 1866E). We apparently don't have a data sheet for the 1866E or any pictures in 1866E manual.

- 19" Rack-Mount x 1U Height
- Alarm Contact Unit gives indication of power, input or output faults
- Cables Interconnection cables for power and input signal are available for order
- Amplifier gain Input to loaded output voltage gain  $0 \pm 1\text{dB}$

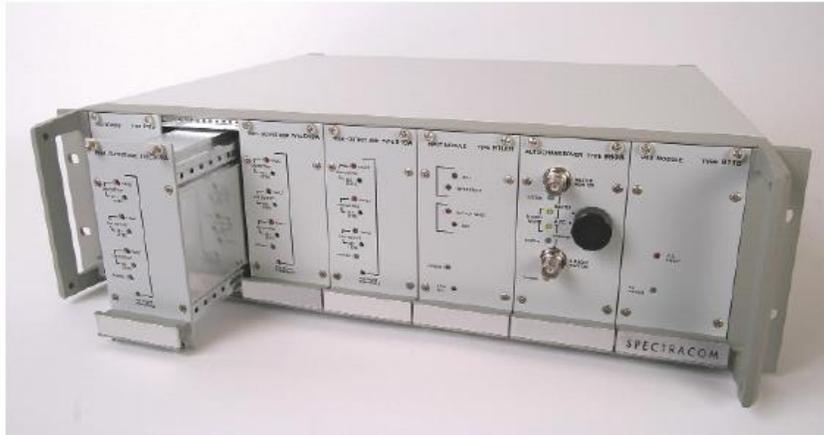
### \*\*Model 900 series Modular Frequency Distribution System (Discontinued)

- Versatile Low-noise Distribution
- Up to 30 channels available from each rack
- Ultra low noise and EMC profile
- Flexible configuration and mounting arrangements
- Auto changeover units for fully redundant switching ensures safe, continuous 24/7 operation
- Wide range of modules available including reference frequencies, 1PPS timing and a variety of timecodes

The 900-series distribution amplifiers are for local distribution of time code signals, 1PPS timing signals, sinewave reference frequency to multiple outputs, up to 30 per cabinet.

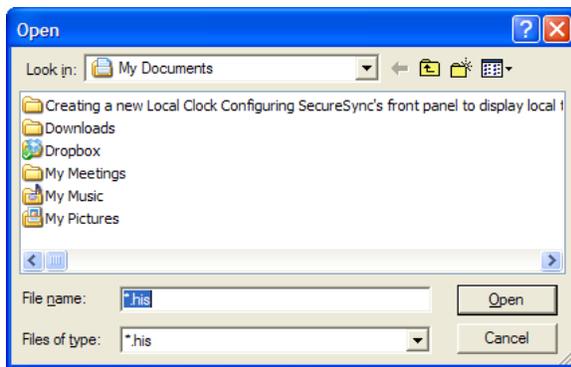
The “.his” is a log that needs to be created as part of creating a “New Profile”. Per the attached document, when you create the new profile, there is a field for “Log File”. Hit the button next to the blank field and choose a temporary location.

You'll notice that the file extension for the log is .his. if you haven't created a new profile and defined the location/name of the temp file, I can now see why you are getting this message. This file is created with the profile- it's not included with the bundle I sent to you.

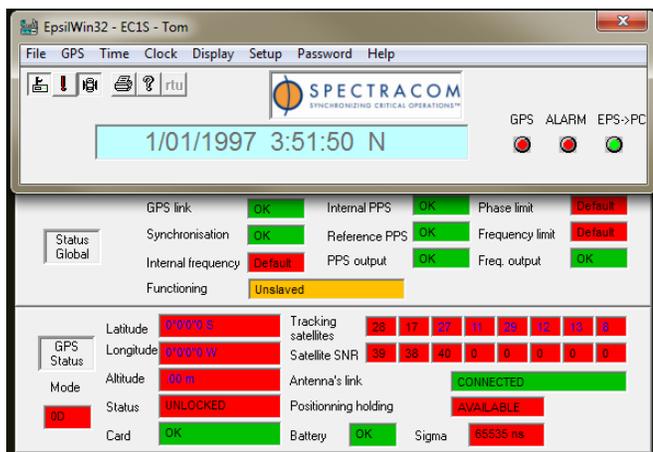
EpsilWin32 software provides interface with Epsilon equipment to show GPS position and satellite tracking information, lock status, etc. refer to screenshot below:

- EpsilWin software shows only 8 sats: it drops the four satellites with the lowest signal strengths, if the receiver is tracking more than 8.

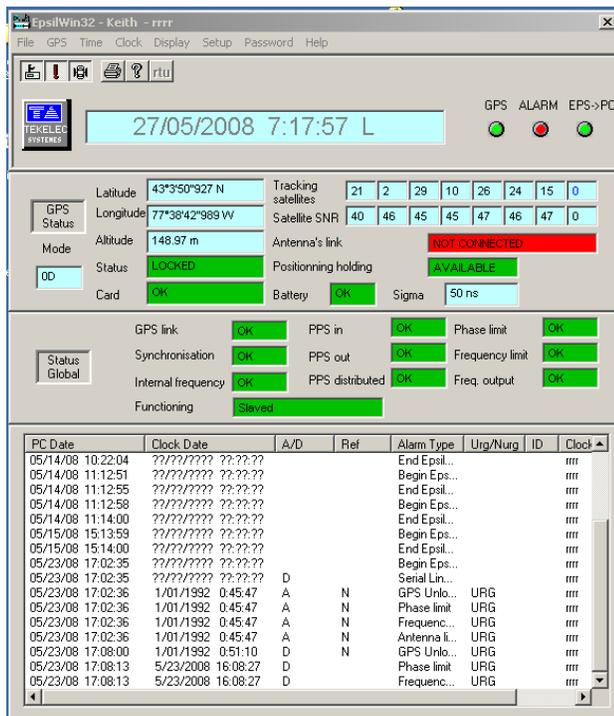
### EpsilWin32 while tracking satellites

The Epsilwin32 “Antenna’s Link” field will display a green “Connected” when the antenna is connected and no opens/shorts detected. It switches to a red “Not connected” when either an open or short is detected (is does not differentiate between opens and shorts).

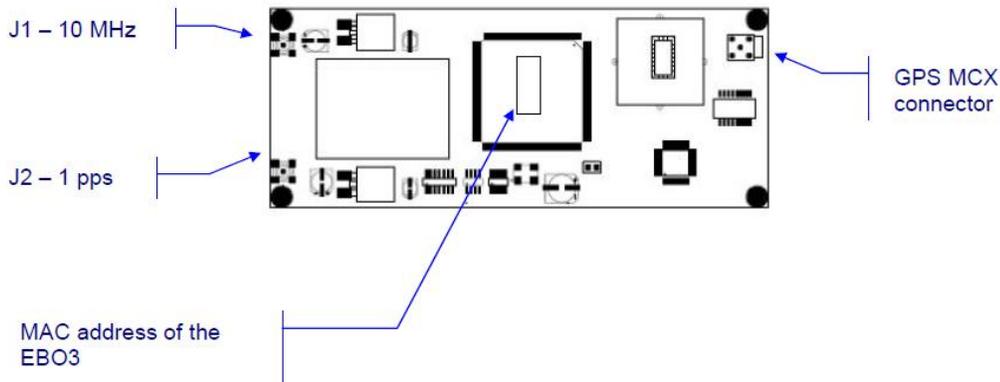
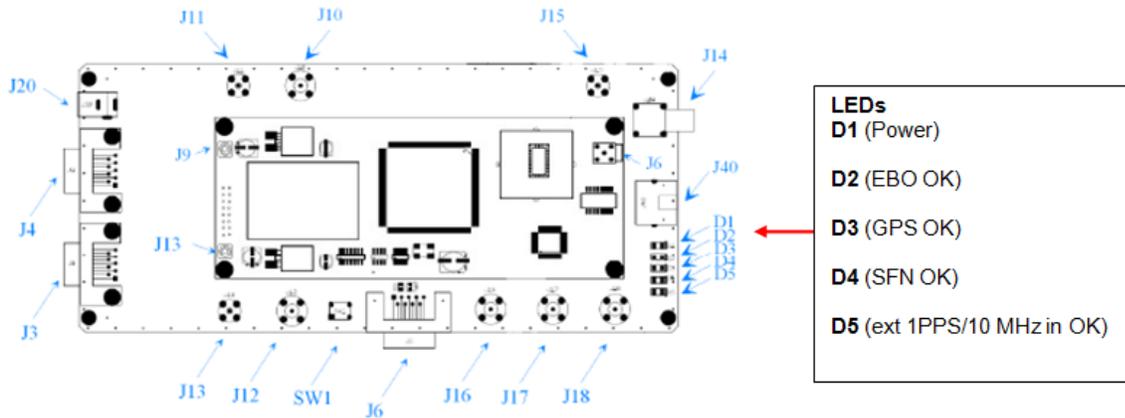
## 1.7 Board View

- Status LEDs (D1 through D5) are located on the same side of the board as the GPS jack

- D1: Power led On indicates the Adaptation Board is correctly powered on
- D2: EBO\_OK led On indicates the good working order of the board
- D3: GPS\_OK led On indicates that the GPS reception is correct
- D4: SFN\_OK led On indicates that the 10MHz frequency is cycle locked to the 1pps, meaning that there are always 10000 000 cycles between consecutive 1pps occurrences.
- D5: EXT\_REF\_OK led On indicates that the External\_1pps\_10MHz and /or optional inputs are connected

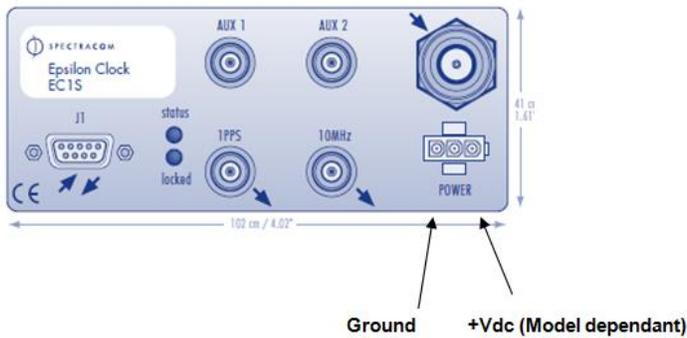
### \*\*Input power and specs:

EC1S Model	P/N	Input VDC
EC1S-SO		18-36vdc
EC1S-SO-12VDC		10-18vdc
EC1S-SO-013		18-36vdc
EC1S-01		
EC1S-02		
EC1S-SO-48vdc		37-72vdc
EC1S-SO-011		18-36v
EC1S-SO-01		
EC1S-SO-50MHz		18-36v
EC1S-SO-012		18-36v
EC1S-SO-12VDC-SQ-IR		18-36v
EC		18-36v

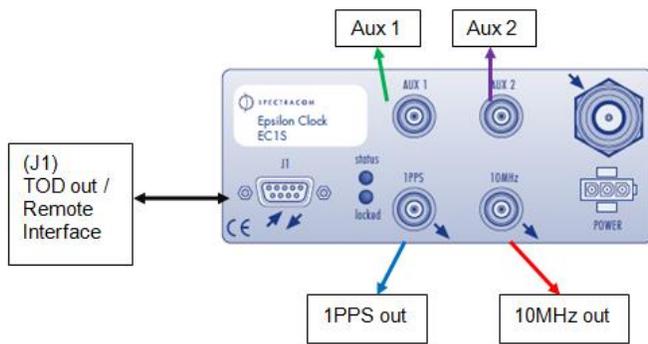
## Front panel outputs

**1PPS output:** 1 Hz pulse starts outputting even before sync to GPS. Output amplitude is about 5vp into high impedance. The pulse width of the 1PPS is very narrow (about 1 microsecond, whereas the 819x series is about 200 milliseconds).

**10 MHz output:** 10 MHz sine wave starts outputting even before sync to GPS. Output amplitude is about 1.2vp-p into 50 ohms.

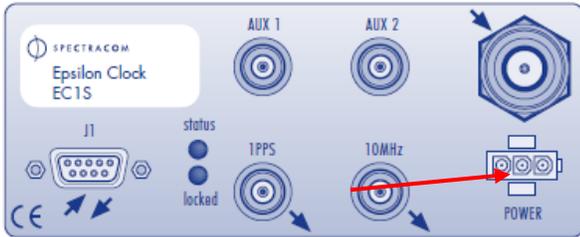
### TOD Data Format (TOD Link output) Connector J1

(9/13/12 KW) (Note per Eric Girard): NMEA format **GPRMC** is the only available TOD output string. Without a special EC1S software change applied, there is no ability to change it any other NMEA output string, such as either GGA or ZDA).

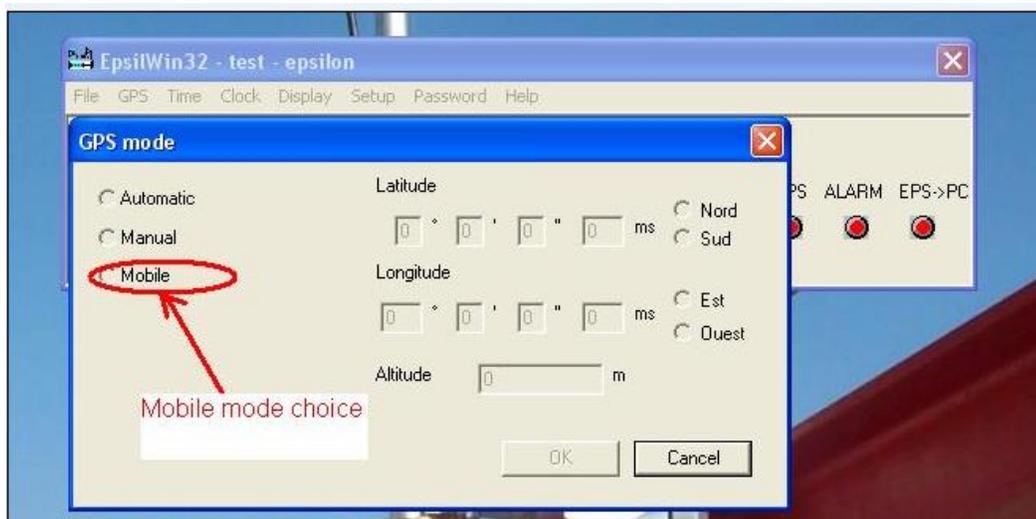
The EC1S CAN work on mobile mode, you can select this mode by EPSILWIN32 interface or by sending a command line with the Serial protocol...

Here is a picture (Below) of the GPS menu that you have to select to enable this function. In this MOBILE mode, the GPS always track a new position. (useful if the antenna is mounted on a boat for example...).

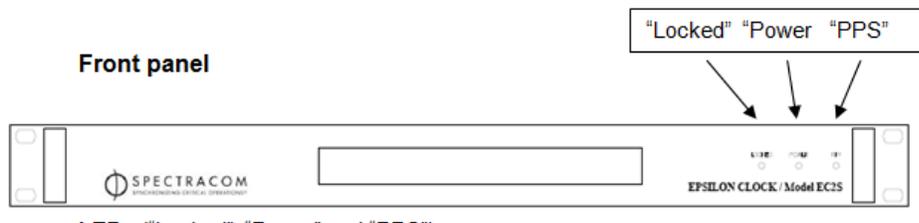
**Front panel**

**LEDs (“Locked”, “Power” and “PPS”)**

“PPS”: About 10 seconds after the power is switched on, the "1PPS" indicator will start flashing once-Per-second. This indicates the normal generation of the 1PPS signal by the built-in oscillator.

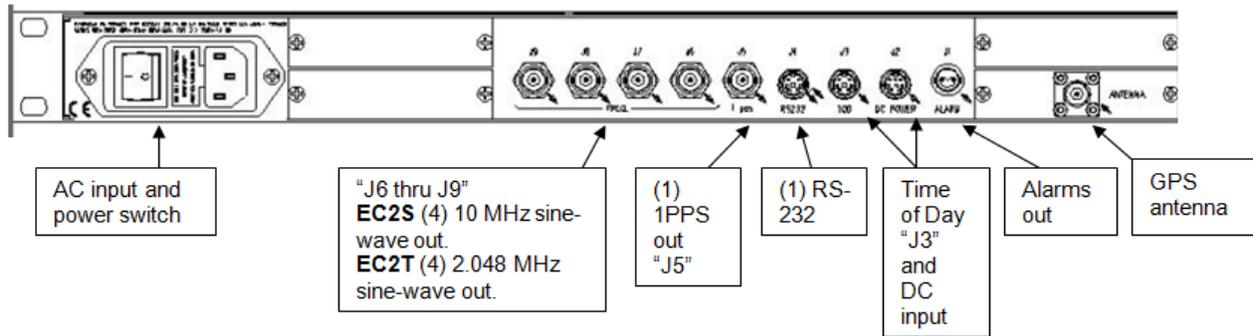
## Rear panel

- 1 GPS antenna input
- 1 main power supply input (90 to 265V / 48 to 63 Hz),
- 1 DC power supply input (36 to 72 VDC),
- 4 x 2048 kHz outputs ( G 703 § 13 / 75  $\Omega$ ),
- 1 1PPS output (TTL / 50  $\Omega$ ),
- 1 time code output (RS232C),
- 1 alarm output (relay contact),
- 1 remote control interface (RS 232C). For EpsilonWin32 software (or HyperTerminal) 9600, 8, 1, Odd parity

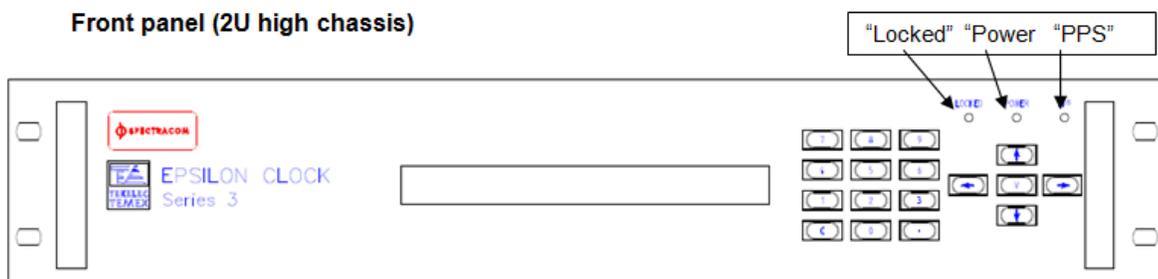
### Front panel (2U high chassis)

### LEDs (“Locked”, “Power” and “PPS”)

**“PPS”:** About 10 seconds after the power is switched on, the "1PPS" indicator will start flashing once-Per-second. This indicates the normal generation of the 1PPS signal by the built-in oscillator.

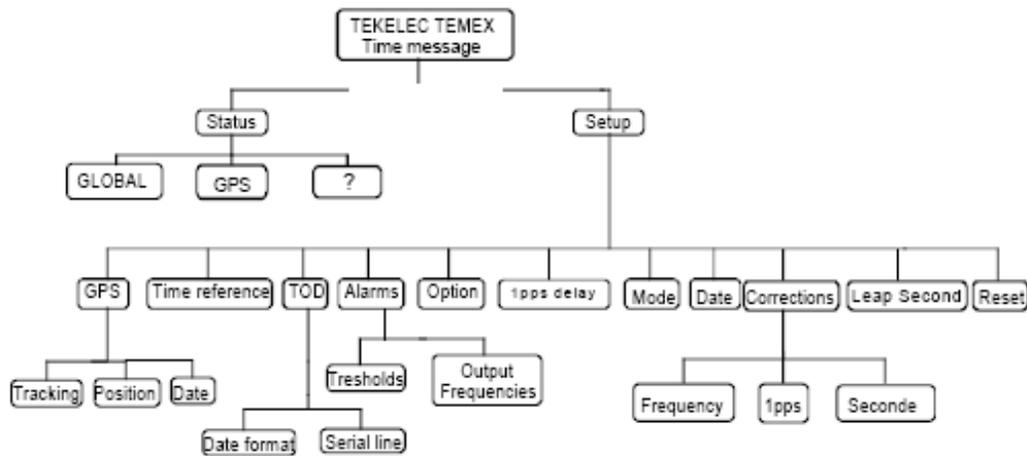
**6.3.5 Menus Organization**

Refer to Section 6 of the EC3S manual for info on the keypad/screen.

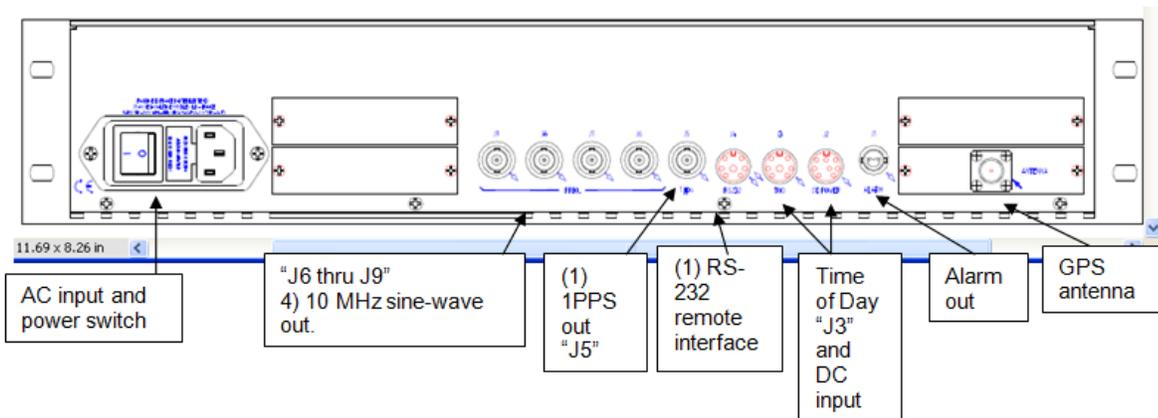
**Back panel**

- 1 GPS antenna input,
- 4 x 10 MHz outputs (>10 dB / 50 Ω),
- 1 1PPS output (TTL / 50 Ω),

- 1 time code output (RS232C),
- 1 alarm output (relay contact),
- 1 remote control interface (RS 232C).

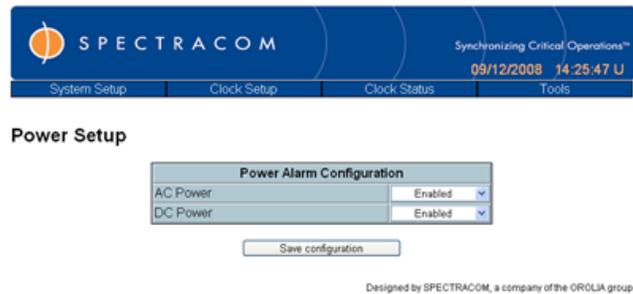
### 4.3.9 Power Setup Page

As determined by the actual power supply connection, the operator must set which power alarm (AC or DC, left and right) should be enabled.

- AC Power:
  - Enable: Check AC power supply: Generates an alarm if AC power supply is not available.
  - Disable: No alarm generated.
- DC Power:
  - Enable: Check DC power supply: Generates an alarm if DC power supply is not available.
  - Disable: No alarm generated.
