## Han Solo (9283, 9288 and 9289) and Ranier (9383, 9388 and 9389)

**Note:** ALL MODEL 9200s and 9300s are now discontinued

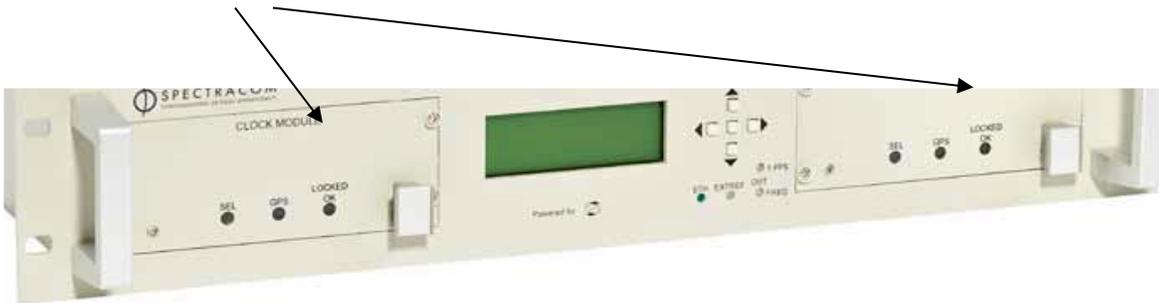
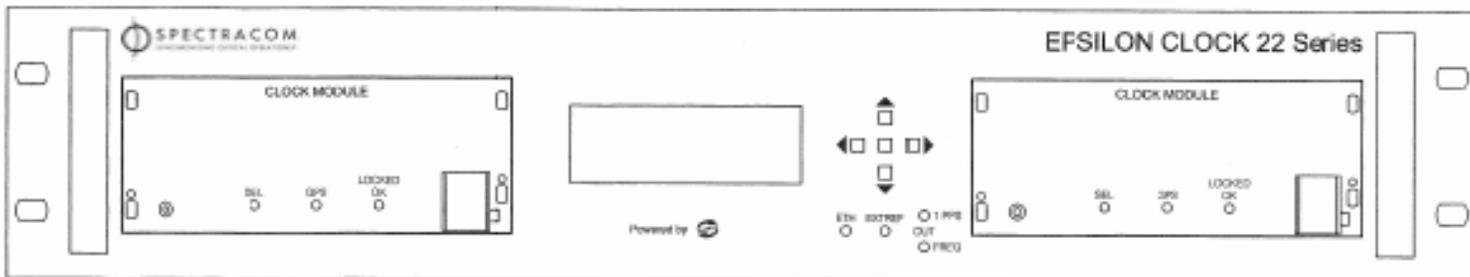
### Clock module for EC22S (EC22S-CLK)

**Note:** At least one Clock module is needed to supply power and generate a Clock signal. The operator must first check that the module to be extracted is a Slave module. If not, the operator should force-switch it to Slave and then extract the module.

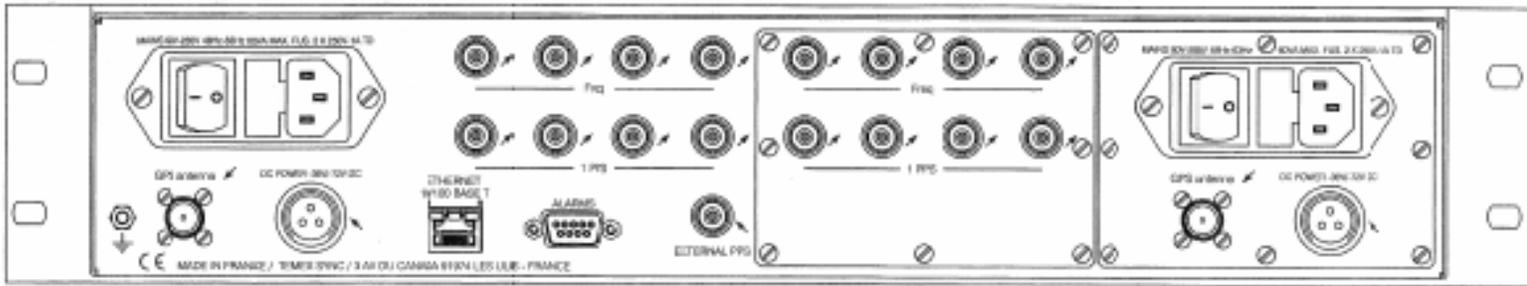
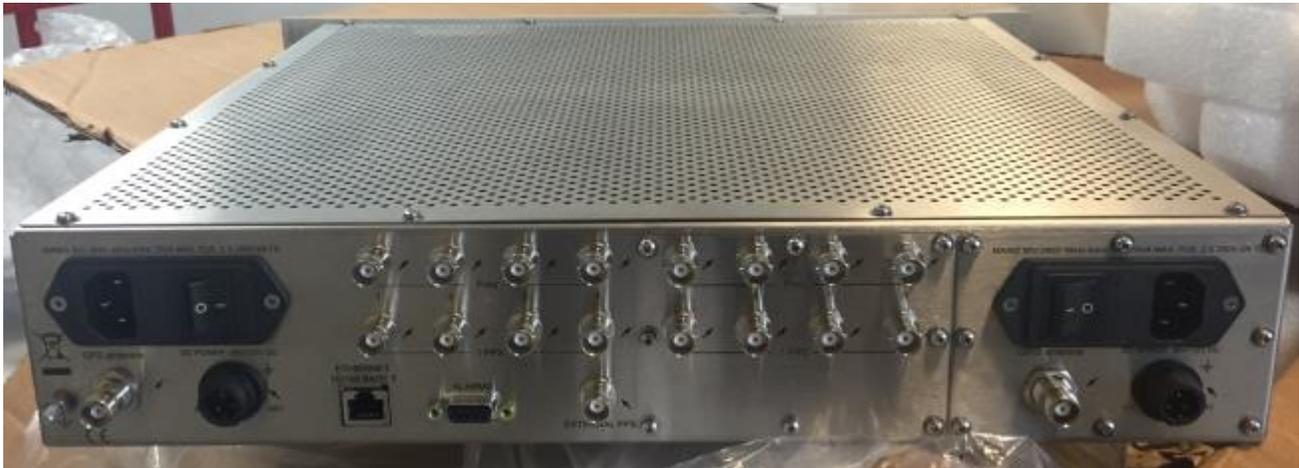
## Rear panel

### 1.7.2 EC22S Back Panel Connectors

<b>AC POWER (90 to 230 VAC)</b>	
Schaffner	AC power entry with integrated fuse
<b>DC POWER (-48 VDC)</b>	
Bulgin circular	Nominal -48 VDC power supply input. One Input and DC/DC converter per Clock module provides redundancy
<b>Freq (4 + option 4)</b>	
50 $\Omega$ BNC	Distributed sinus frequency outputs
<b>1PPS (4 + option 4)</b>	
50 $\Omega$ BNC	Distributed One Pulse Per Second outputs
<b>Ethernet 10/100 BaseT</b>	
RJ45	Network connectivity.
<b>GPS Antenna</b>	
50 $\Omega$ TNC	Antenna inputs for GPS receiver and remote active antenna 5VDC supply
<b>EXTERNAL PPS</b>	
50 $\Omega$ BNC	External 1PPS reference input
<b>ALARMS</b>	
SubD 9	Dry contacts
<b>GROUND</b>	
$\oplus$	Casing grounding.

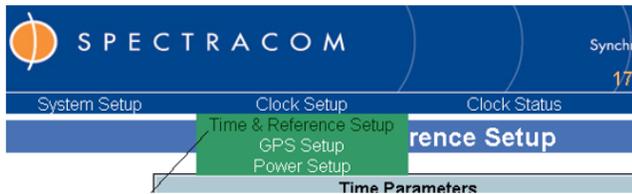
The “SQUELCH” or “MUTE” function is set by the following button in the Clock Setup / Time & Reference Setup

Priority Level : Optional Reference	Disabled
Force a source as input	None
Alarm Phase Threshold (ns)	1000
Alarm Frequency Threshold (1e-9Hz)	10

Distribution Parameters	
Distribution source	Automatic
Squelch Auto mode	Disabled
	Disabled
	Enabled

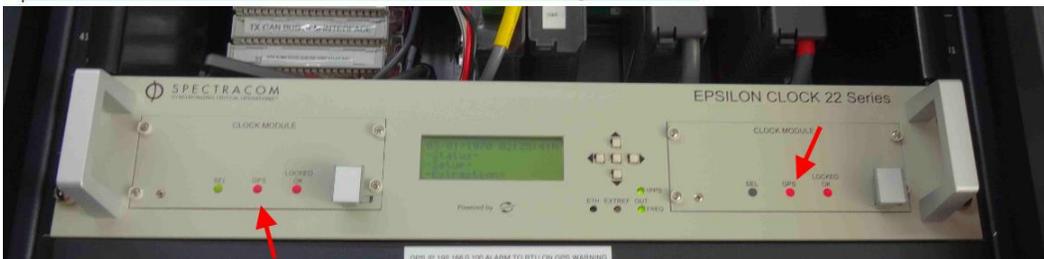
Clock Module Status		
Synchronisation Source		
Oscillator Control Voltage (V)		
Tracking Status		
<b>Alarms</b>		
<b>GPS</b>		
	Left	Right
GPS Lock	Alarm	Alarm
Antenna	Unpowered	Unpowered
GPS Module	Alarm	Alarm
<b>Internal</b>		
	Left	Right
Internal Oscillator	Ok	Ok
Internal 1PPS	Ok	Ok

In this situation, the EC22s is not working as it should be. The unit is also not connected to their network. May I ask you to check these points with your customer?

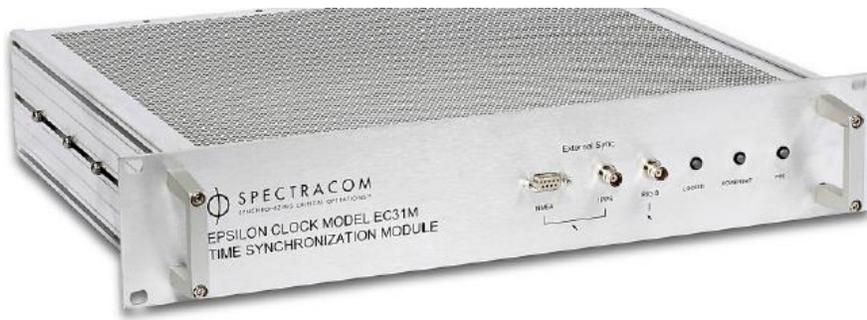
- Developed for use by the Swiss Army/Thales
- Inputs are IRIG A/B NMEA and GPS
- Has one (1) Rb oscillator
- Has one (1) power supply.
- Has two (2) NTP ports
- Has two (2) 10MHz outputs and 2-1PPS outputs available.
- Has NMEA output port on rear panel and NMEA output port of front panel.
- Has one IRIG output connector.
- Setup is via RS-232 connector on front panel.

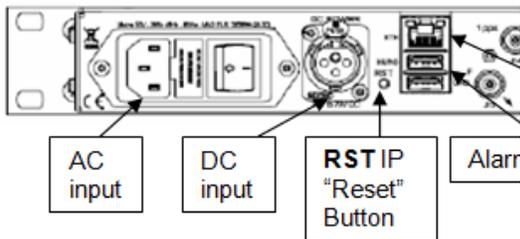
### Input Power (One AC and one DC input connector)

All units have **one AC input and one DC input**.

Redundant power supply switches between one DC and one AC input.

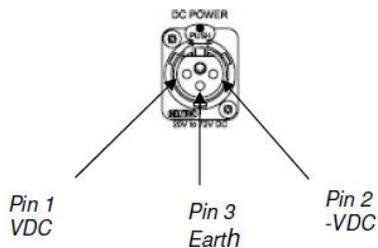
- The DC input of the all silver SAS E was a **three-pin XLR** connector

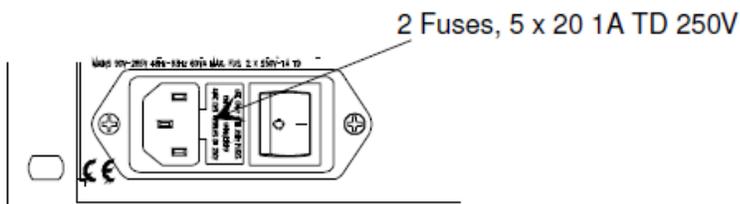
As mentioned in the SASe manual (and shown below), the SAS-17E and SAS-36E do contain two power fuses in the rear panel AC power jack:

“Fuses: 2 x 250 V – 1A TD (Time Delay)”

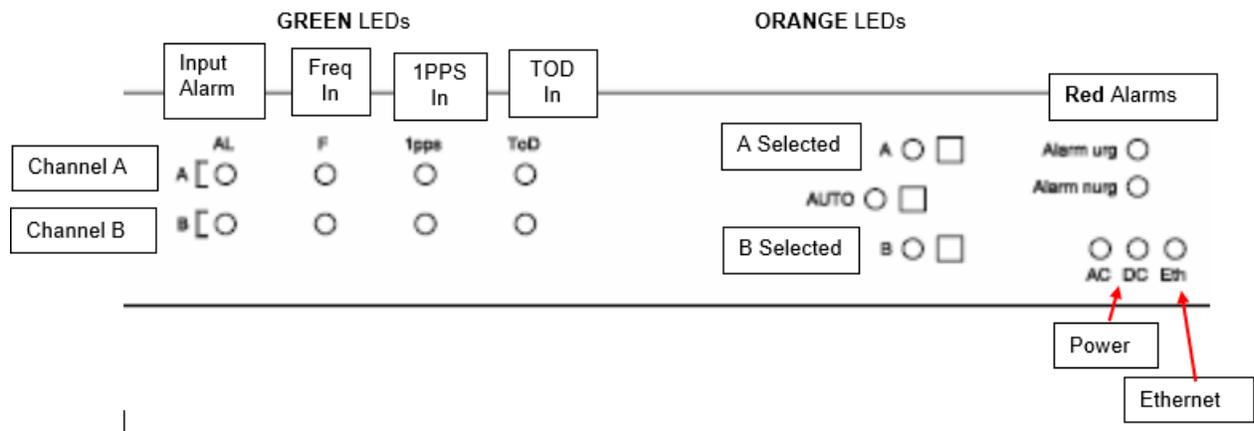
## Front panel LEDs/indicators

### A) Green Status LEDs (on left-side) for each channel (Channel A and Channel B)

- LEDs are ON when signal is monitored and present. If the signal is absent or not monitored, the corresponding LED is off.
- There are **4 green status LED** for each source:
  - **AL:** Result of alarm input monitoring,
  - **F:** Result of frequency monitoring
  - **1PPS:** Result of 1PPS monitoring
  - **ToD:** Result of ToD monitoring

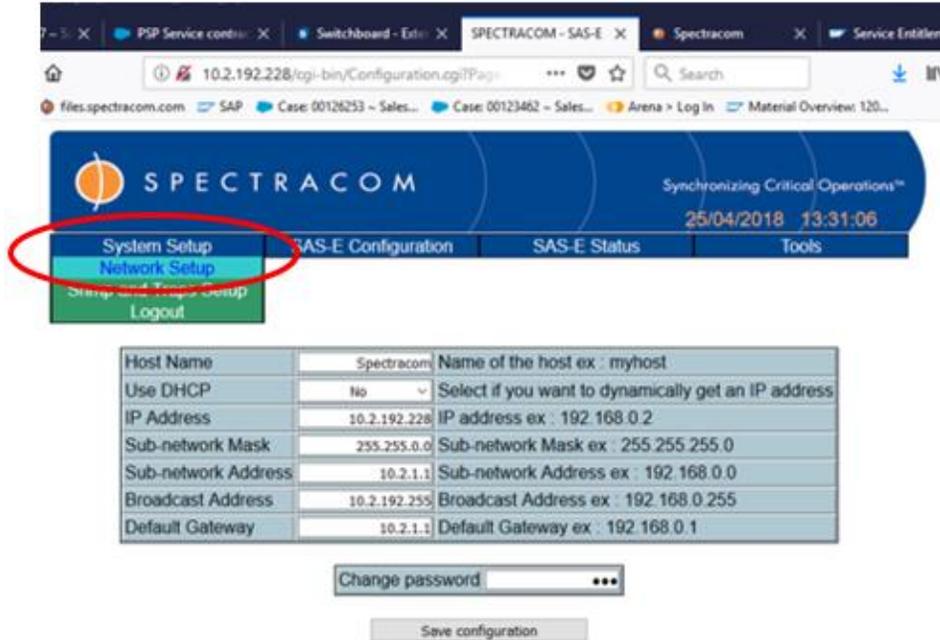
System Setup -> Network Setup page of the browser

The screenshot shows a web browser window with the Spectracom SAS-E Configuration interface. The browser tabs include 'PSP Service contr...', 'Switchboard - Ent...', 'SPECTRACOM - SAS-E', 'Spectracom', and 'Service Entitlen...'. The address bar shows '10.2.192.228/cgi-bin/Configuration.cgi?Page='. The page header features the Spectracom logo and the slogan 'Synchronizing Critical Operations™' along with the date and time '25/04/2018 13:31:06'. A navigation menu is visible, with 'System Setup' and 'Network Setup' highlighted. Below the menu, there is a table for network configuration and a 'Save configuration' button.

Field	Value	Description
Host Name	Spectracom	Name of the host ex : myhost
Use DHCP	No	Select if you want to dynamically get an IP address
IP Address	10.2.192.228	IP address ex : 192.168.0.2
Sub-network Mask	255.255.0.0	Sub-network Mask ex : 255.255.255.0
Sub-network Address	10.2.1.1	Sub-network Address ex : 192.168.0.0
Broadcast Address	10.2.192.255	Broadcast Address ex : 192.168.0.255
Default Gateway	10.2.1.1	Default Gateway ex : 192.168.0.1

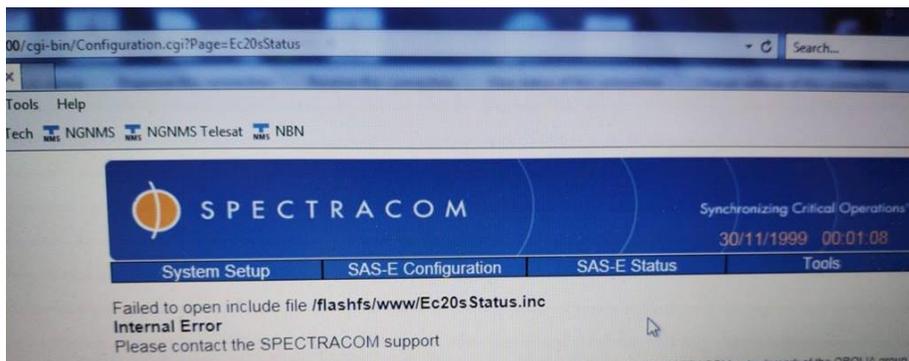
- A) Error message observed on a new SASE: **“Failed to open include file /flashfs/www/Ec20sStatus.inc Internal Error Please contact the SPECTRACOM support”**

**Customer report:** “When connecting to the SAS-17E, we are getting the following error:”

**Customer reported a resolution** “We faced the same issue on the other SAS-17E unit that we have. After changing the unit IP address, issue was solved and both units are working well. We will keep monitor the unit and let you know if anything new will pop up”

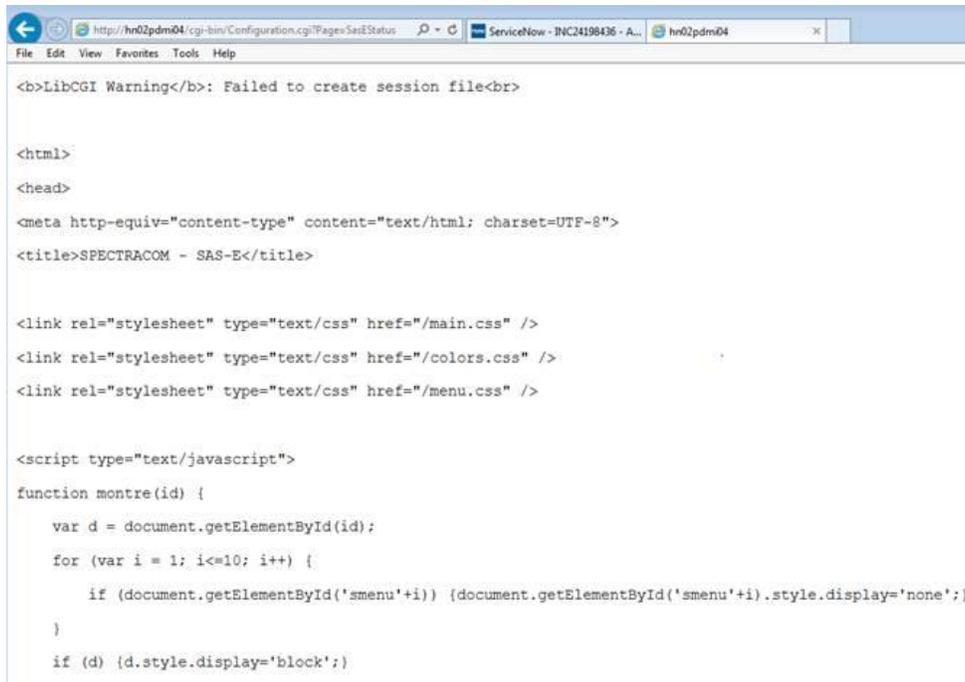
- Refer to Salesforce case **172662**
- Refer to info further below (“No HTTP, but ping and telnet are working fine”) about confirming the switch port SAS-E is connected to is set to auto-negotiate
- The root cause is a too big size of the temp file. Each time you access to the unit, you increase this file. And unfortunately, the size allowed to this, is very low. When the unit reach it, all web pages are unreachable.
- This issue was temporarily fixed with a reboot/power cycle of the unit.
  - Eric Girard provided a patch to prevent it: **Note:** for patch referred to below, go to “**patch to prevent tmp file too big**” at: [..\..\EQUIPMENT\SPECTRACOM EQUIPMENT\Epsilon Clocks and SAS\SAS17E SAS36E SAS17E-IR](#)

```
<b>LibCGI Warning</b>: Failed to create session file<br>

The root cause is a too big size of the temp file. Each time you access to the unit, you increase this file. And unfortunately, the size allowed to this, is very low. When the unit reach it, all web pages are unreachable.

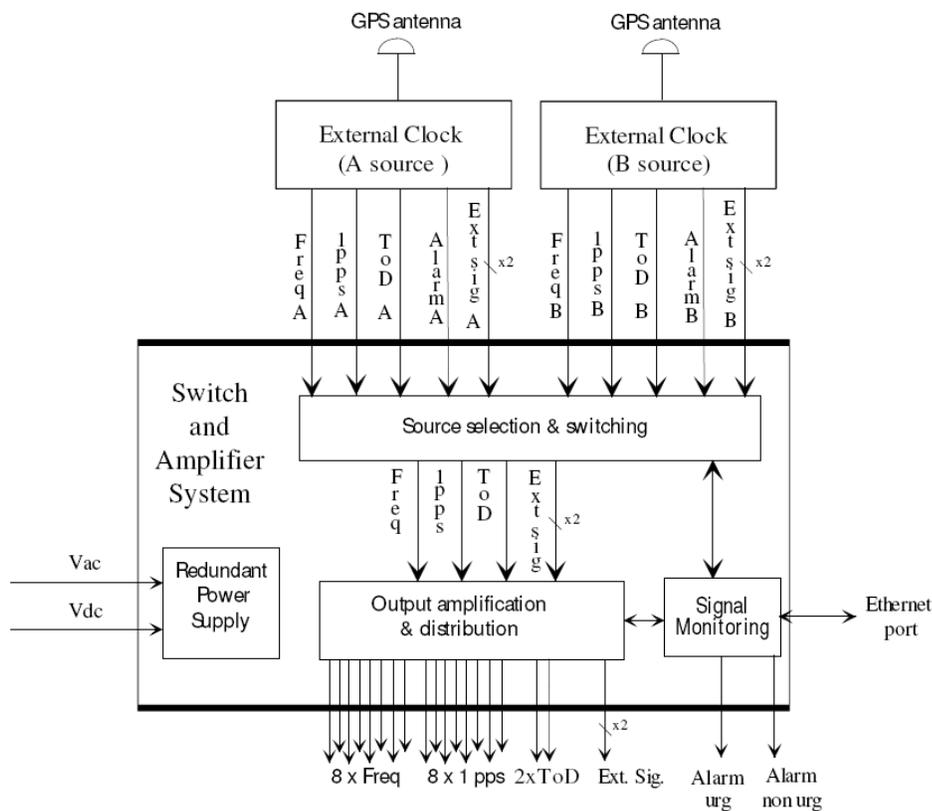
**2 input channels:** 1 Freq input (for 1 to 16 MHz sine wave input) 1PPS in, TOD input, Alarm input, 2 external signals

**Outputs:** 8 x frequency outputs, 8 x 1PPS outputs, 2 x ToD outputs, 2 x external signals.

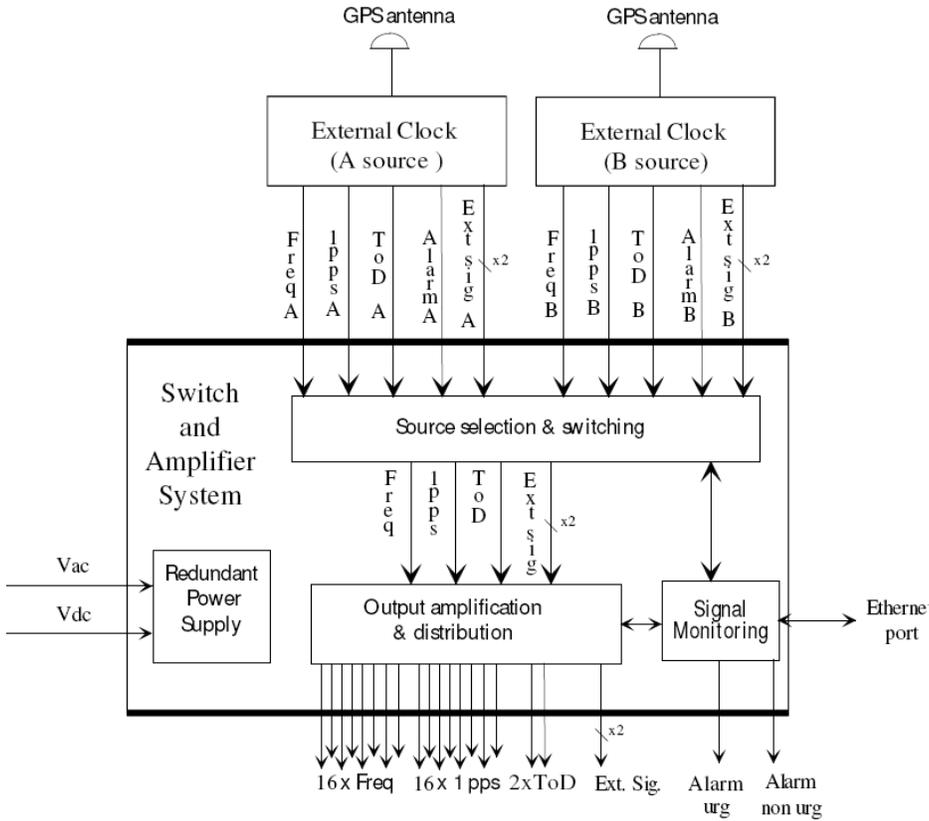
**2 input channels:** 1 Freq input (for 1 to 16 MHz sine wave input), 1PPS in, TOD input, Alarm input, two external signals

**Outputs:** 16 x frequency outputs, 16 x 1PPS outputs, 2 x ToD outputs, 2 x external signals.

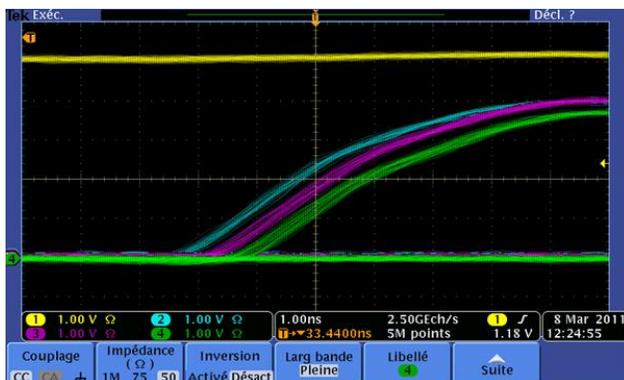
Q (from TOYO 30 Aug 2019) Our customer JAXA inquiry about the test report in page 4

Jitter on each output: 200ps

Delay between each output: 500ps

A. In March 2013 we received these specs for the SAS 1PPS signals: jitter is approx 200pS and the delay from input to output is approx 35nS. The delay variation from output to output is approx 500pS.

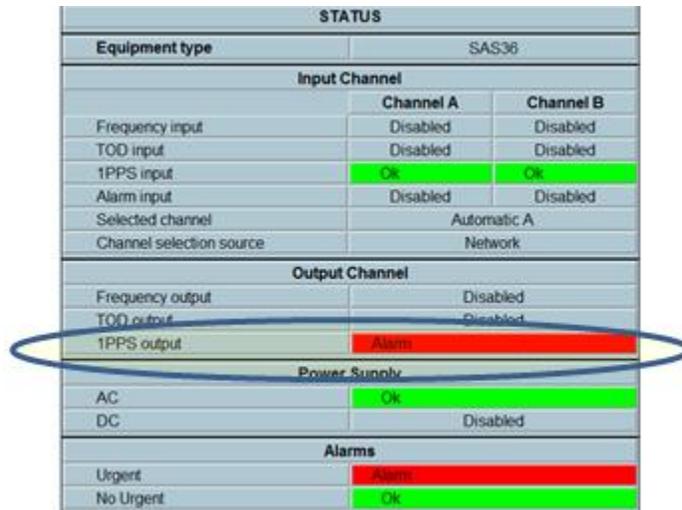
**\*\*\*1PPS Output Fault in Alarm state reported in the “Status page”**

STATUS		
Equipment type	SAS36	
Input Channel		
	Channel A	Channel B
Frequency input	Disabled	Disabled
TOD input	Disabled	Disabled
1PPS input	Ok	Ok
Alarm input	Disabled	Disabled
Selected channel	Automatic A	
Channel selection source	Network	
Output Channel		
Frequency output	Disabled	
TOD output	Disabled	
1PPS output	Alarm	
Power Supply		
AC	Ok	
DC	Disabled	
Alarms		
Urgent	Alarm	
No Urgent	Ok

**Email Keith sent to customer (26 Jul 17)** The “Status” screenshot indicates the “1PPS Output Fault” alarm is asserted. This alarm is asserted whenever there is a short in (or improper termination at the other end) of the coax cable connected to one or more of the 1PPS output ports.

The web browser does not report which 1PPS output port(s) have a cable issue (note the CLI Console port is for internal Engineering use only. It is not accessible by customers). As there may be more than one Output port with a cable issue, the recommended method to troubleshoot this condition is to first disconnect all of the coax cables attached to the 1PPS output ports. Then verify the “1PPS output” indicator is no longer in the “Alarm” (red fill) state.

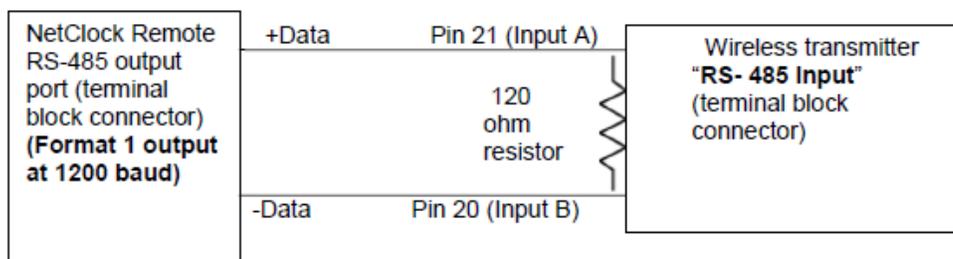
The wiring connection between the NetClock and the transmitter(s) is as follows:

When using RS-485 input, the transmitter needs to be configured to receive RS-485 as its selected input reference. This can be performed using either the web browser or via the front panel setup menu. If a network connection to the transmitter is available, refer to **Error! Reference source not found.** for using the web browser to configure the transmitter to sync to RS-485 input (select RS485 in the drop-down). If the transmitter is not connected to a network, perform the following setup procedure to configure the transmitter to sync to RS-485 input (via a setup menu).

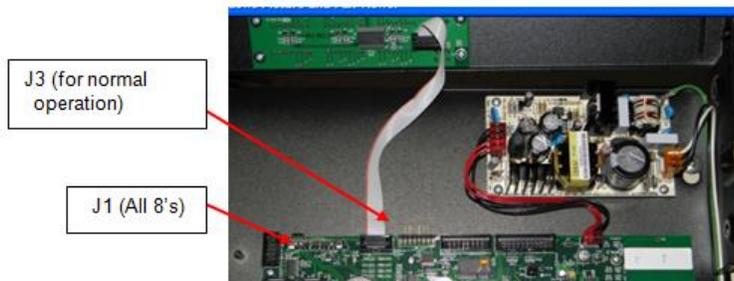
### C) Transmitter is displaying all “8’s”.

Remove the top cover from around the LEDs. Make sure the front panel assembly ribbon cable is connected to J3 (more towards the center of the main board), instead of to connector J7 (in the corner of the main board).

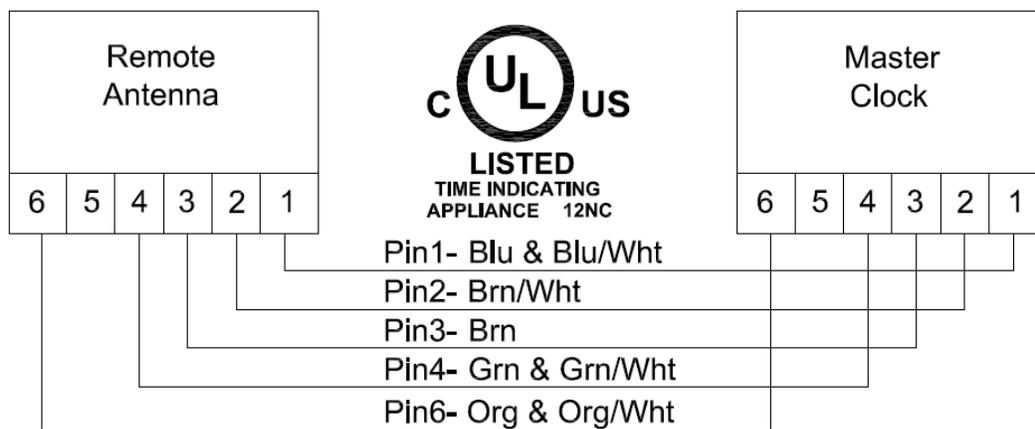
### Wiring the remote antenna to the Rack-mount transmitter

Q. The cable that connects the remote Antenna to the Transmitter requires CAT5 Ethernet cable but there are so many types of CAT 5 out there. What is the Amps and Voltage requirement for this connection?

A Standard CAT5 or CAT6 cable can be used for the connection between the RF transmitter and the antenna. The voltage and current of the transmitter to the antenna is low voltage (12vdc). Even class 2 twisted-pair cabling can be used for this low voltage connection.

Brian White informed Will Hickey that they are including a 25ft cable with the rack-mount transmitter: "25 foot, 5 conductor 18AWG cable". The user has the option to use this, or use their own cable of similar specifications, to a total length of no more than 50 ft.

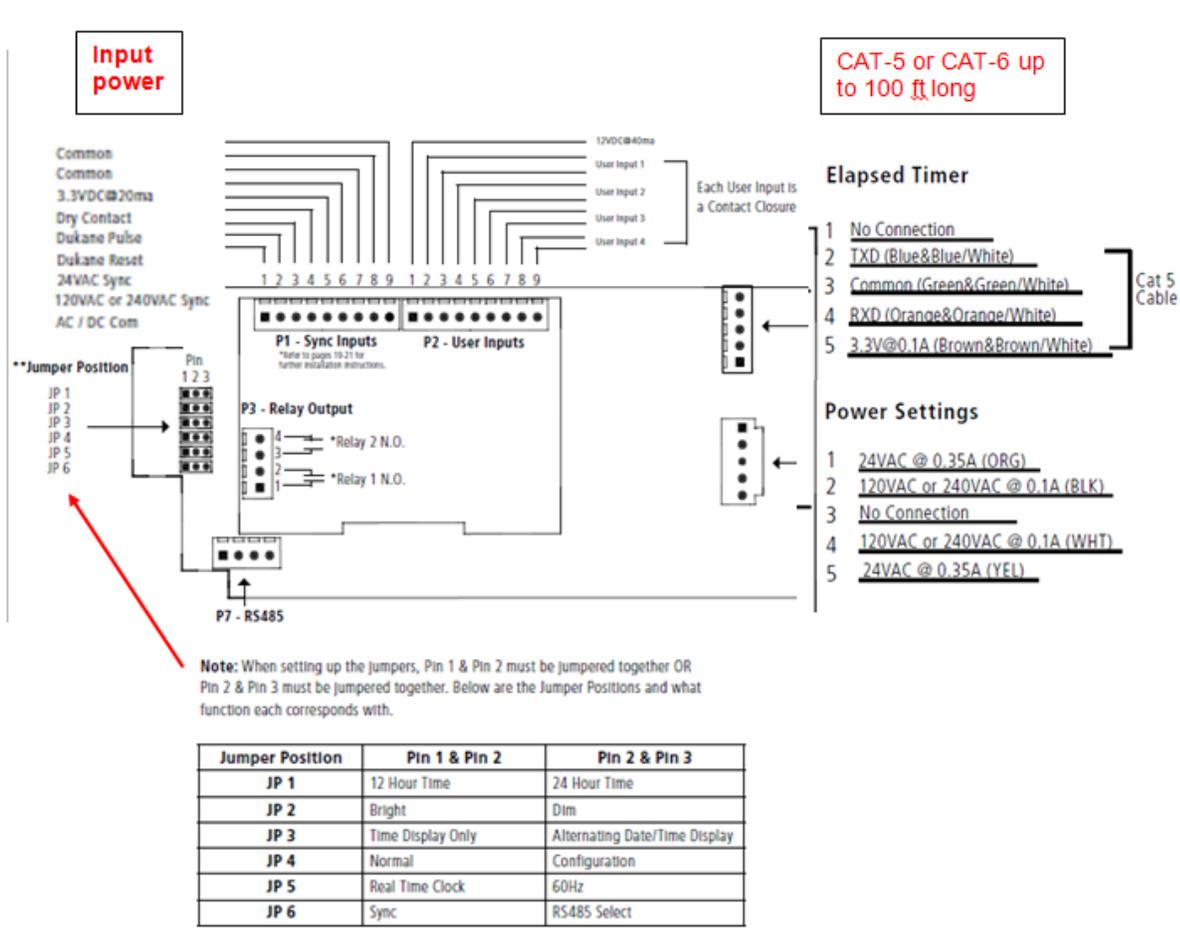
### SBL 3000 series (~Sept 2013)

## \*\*\*\*Input power

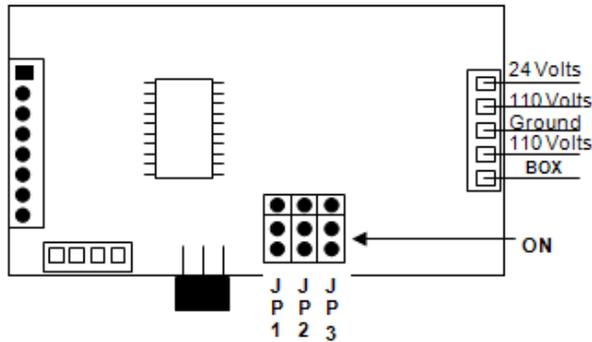
**Four digit displays:** As shown on page 7 of the Wireless clock system (1168-5001-0050 Rev G), there is an internal jumper JP1 that needs to be installed for 12 hour mode.

JP1	JP2	JP3
12/24 Hour Mode	Brightness	Loss of Comm. Alert
ON: 12 hour mode OFF: 24 hour mode	ON: Brightest OFF: Less Bright	ON: 5 minutes OFF: 30 minutes

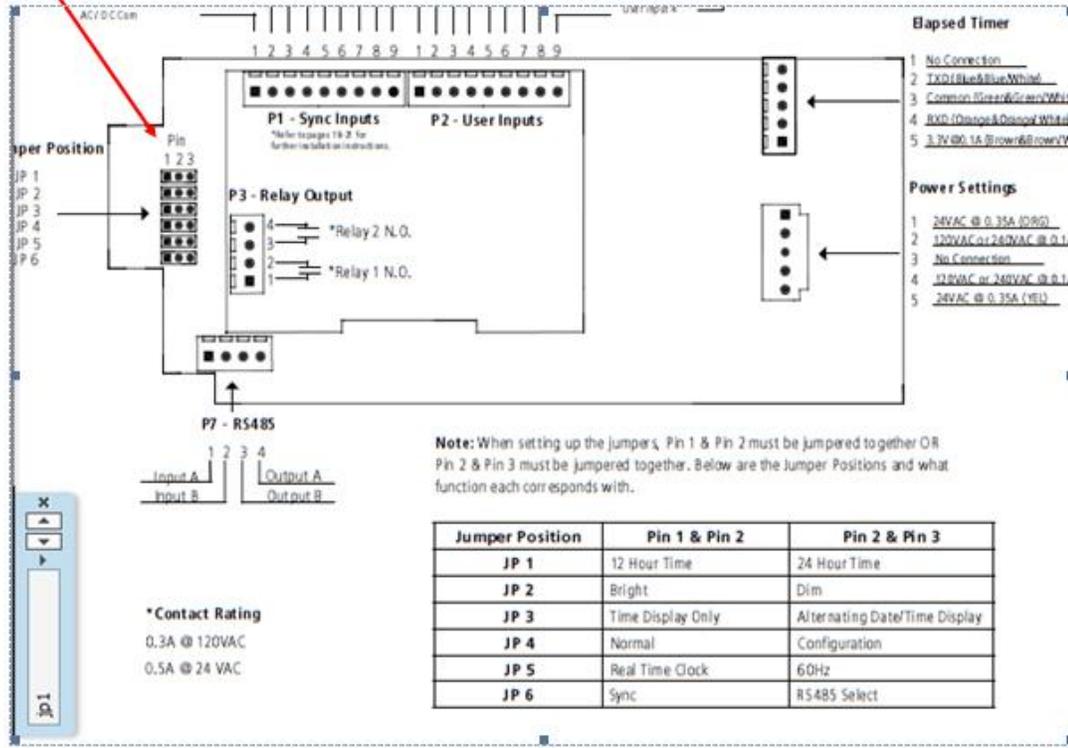
**SBL 3000 series (~Sept 2013)** Looks like there is a new rev of the PCB, which now has 6 jumpers (JP1 through JP6, instead of just 3). Unlike the earlier Models, the clock has to be power cycled for the change to take effect (it reads the pins on startup). Even with 6 jumpers now, JP1 is still for 12/24 hour mode.

**JP1 (12/24 hour) Must power cycle to take effect**  
**Pins 1 and 2 = 12 hour**  
**Pins 2 and 2 = 24 hour**

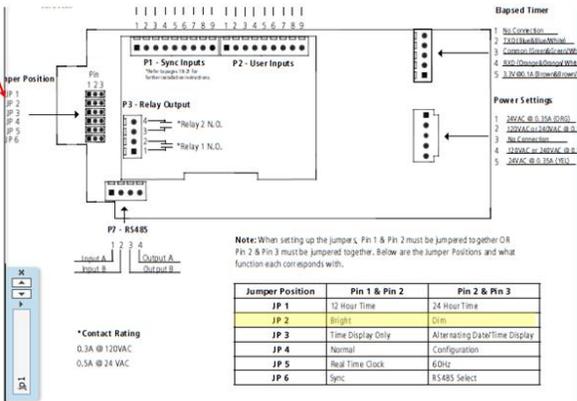
- JP2 is for brightness control

**JP2 (Bright) Must power cycle to take effect**  
**Pins 1 and 2= Bright**  
**Pins 2 and 3= Dim**

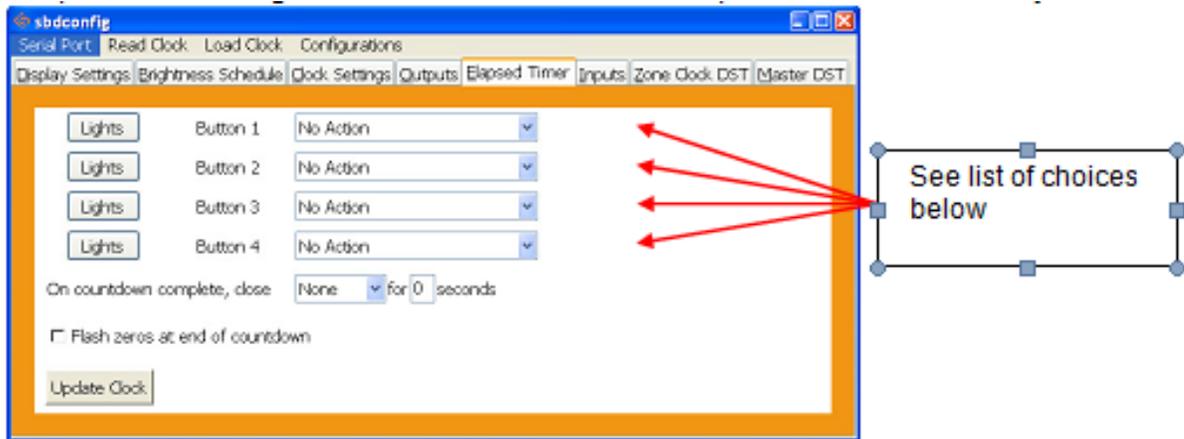
- Uses the sbdconfig.exe software to configure the display clock in conjunction with USB to RS-485 converter. (Connect to J7 on back of the clock).

Open the sbdconfig.exe software. This will load the Elapsed Timer interface utility.

- **No Action:** Choosing this option will perform no functions on the digital clock.
- **Return to Time Display:** This option will cause the digital clock to return to the current time display, regardless of what function it is currently displaying.

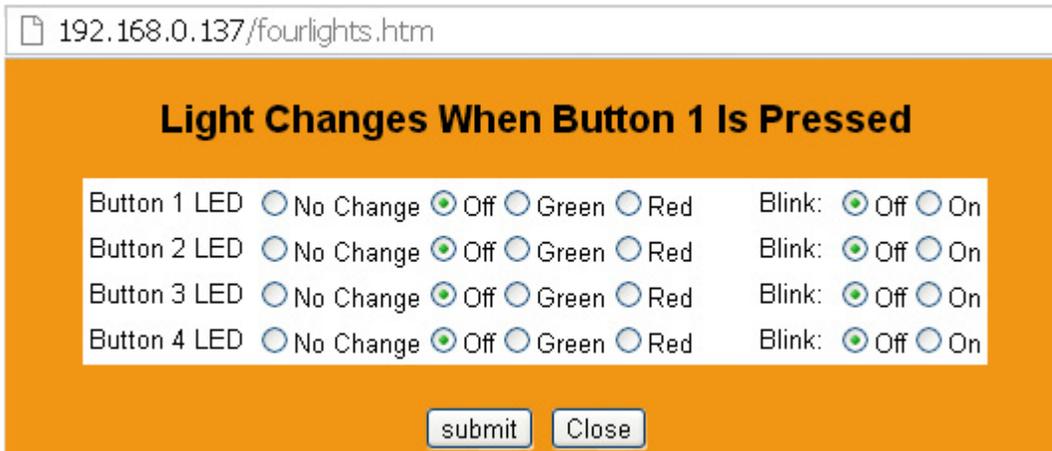
**Configuring the operation of LEDs when each of the four buttons of the controller is pushed (in the “Elapsed Timer” tab of web browser)**

- **No Change:** When selected, a particular button’s settings will remain unaltered from its previous selected state.
- **Off:** This option will turn off the lights on a particular Elapsed Timer button.
- **Green / Red:** This option allows the user to choose either green or red backlighting on the Elapsed Timer when the button is pressed.
- **Blink On / Off:** This option will allow the user to turn on or off the light blinking function. When this is set to Off, the backlight will
- **stay on:** When this is set to On, the backlight will flash.
- **Submit:** This button saves all of the options that were entered.
- **Close:** This button will close the Light Changes window.

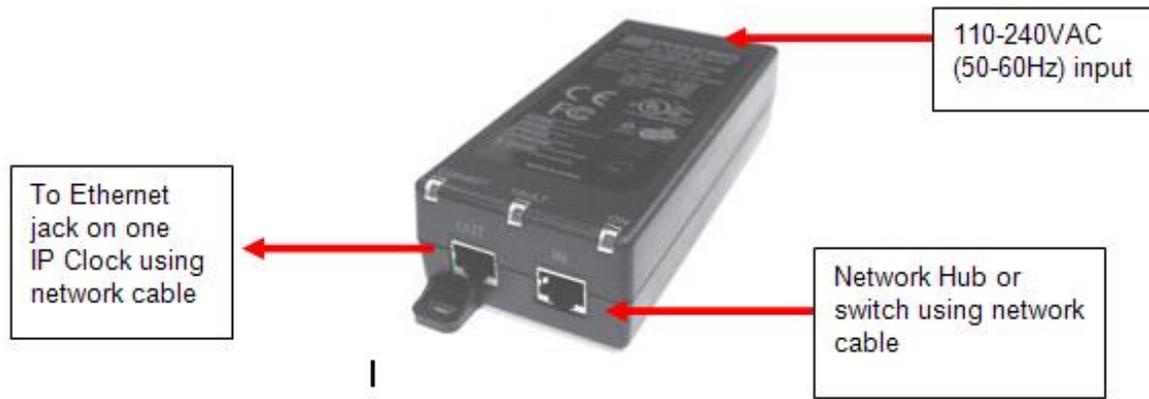
However, if the network does not have a network-wide PoE power source, and it's not desired to add one to the entire network, Spectracom offers individual PoE injectors that can be connected between the network and the Ethernet port of each IP clock. Each power injector needs to be connected to 110-240VAC (50-60Hz) in order to provide 48vdc to each IP display clock. These individual power injectors allow the IP clocks to be able to indirectly run off the building's AC power, via a line cord attached to each power injector. The PoE power injector has an AC line cord input one end and two Ethernet jacks on the other (one Ethernet jack connects to the network and the other Ethernet jack connects to the back of the IP clock).

**Note:** If the network does not have a PoE power source available, one Power Injector needs to be ordered for each IP clock. The Power injectors cannot be shared between two or more IP clocks.

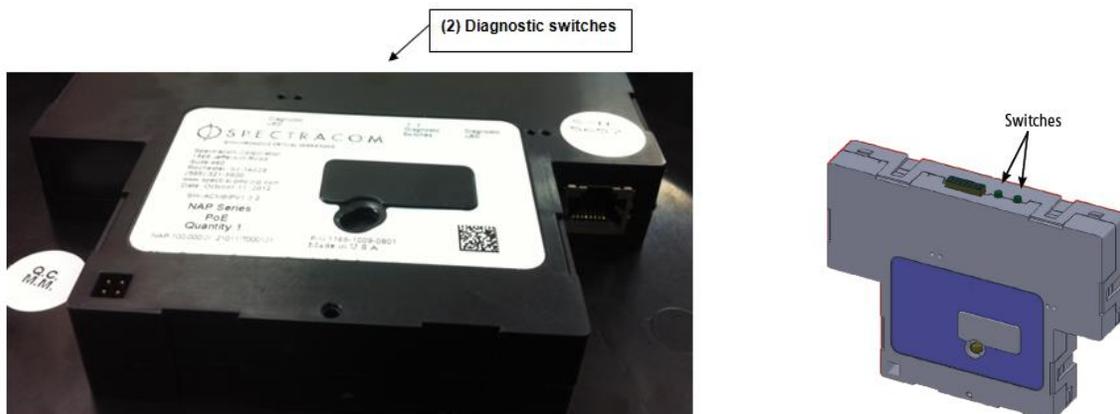
**Notice:** The new design has a cover over the PCB board (The earlier design had no cover over the PCB, so the PCB board was exposed to gain access to the jumper).

The only purpose for this design change was to integrate the separate IP and main boards into one single board for ease of production (it was initially designed for us by adding a daughterboard to their existing design). Now that it's working and selling, it was redesigned for better production

- As of at least Nov 2012, Analog IP clocks no longer have a jumper to set the clock to a static address.
- Analog clocks now use the two Diagnostic switches on the rear of the clock.
- The factory default setting is DHCP enabled (Jumper J7 not installed)
- The Default static IP address is **192.168.0.123**.
- Refer to the "**Keith modified**" email below from Sapling for the improved setting of a pre-defined static address.

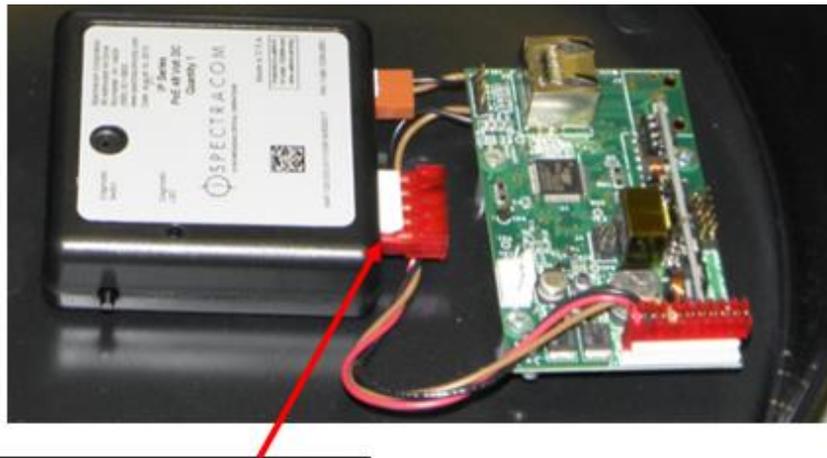
**Notice:** The earlier design had no cover over the PCB (The new design now has a cover over the PCB).

Place jumper in middle position to set IP address to **192.168.0.123**

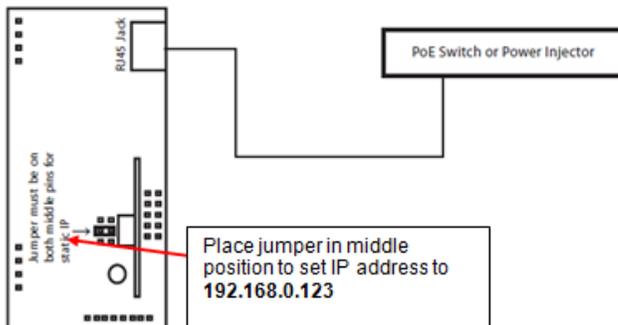
### Jumper to configure the default static address (for all Analog IP clocks shipped before at least Nov 2012)

- The factory default setting is DHCP enabled (Jumper J7 not installed)
- The Default static IP address is **192.168.0.123**

**NOTE:** Place jumper back in starting position after setting desired address via the Web browser.

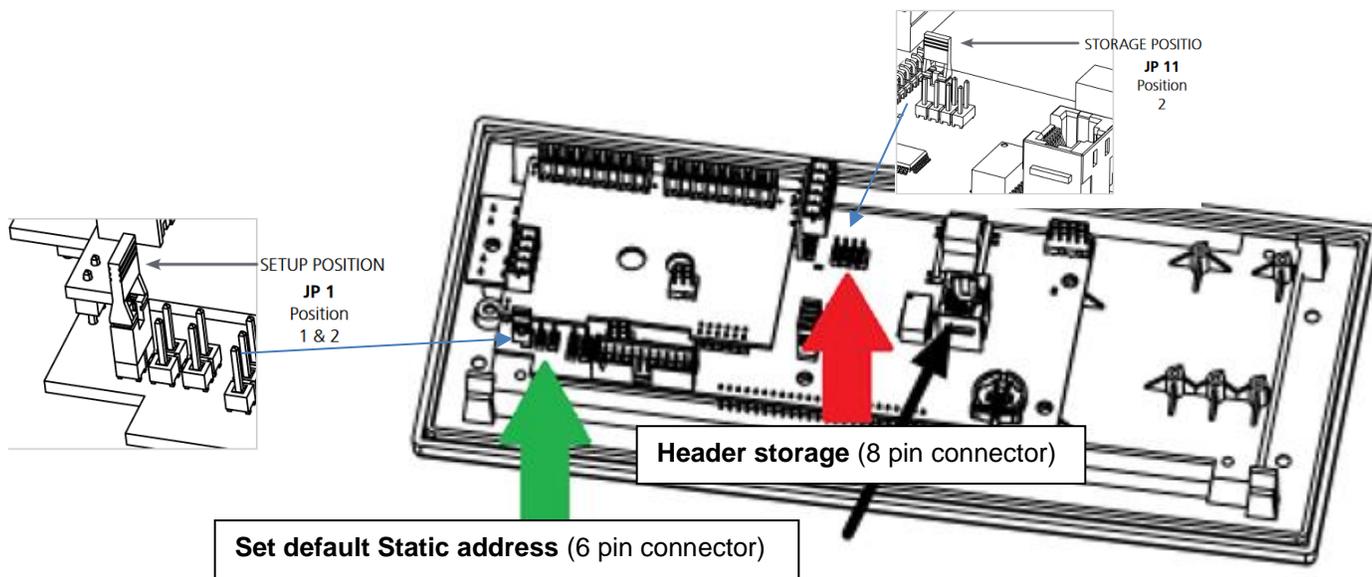
In the image below:

- the **red** arrow points to the **8 pin** connector that is the **storage position** of the jumper.
- The **green** arrow points to the **6 pin** connector (The 6 pin header is located in the corner of the board, closest to the buttons on the front of the display) where the pin is used to **set the clock** to the default IP.

**Reply from Dave L to Michael Pregler:** "I get it now. We move the jumper from the 8 pin to the 6 pin header for setup. Then back to the 8 pin for storage."

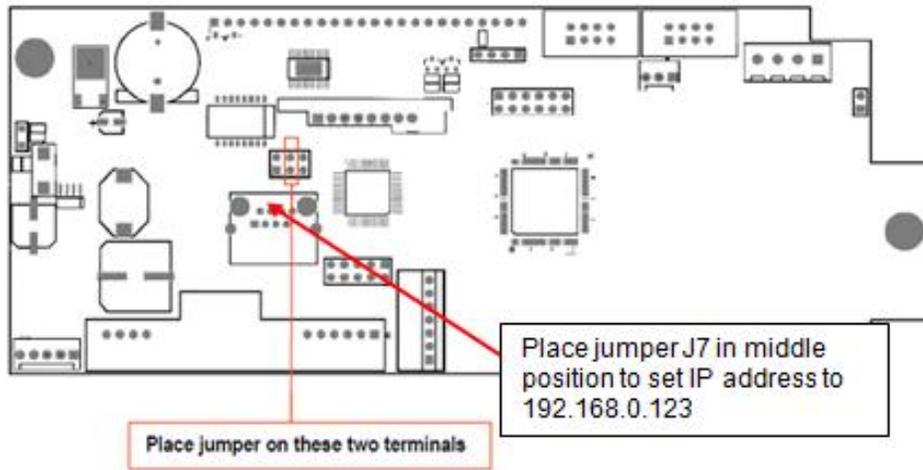
1. Remove the supplied jumper from its factory set position and place it in the following orientation on the circuit board:

**NOTE:** Place jumper back in starting position (far left, I believe) after setting desired address via the Web browser.

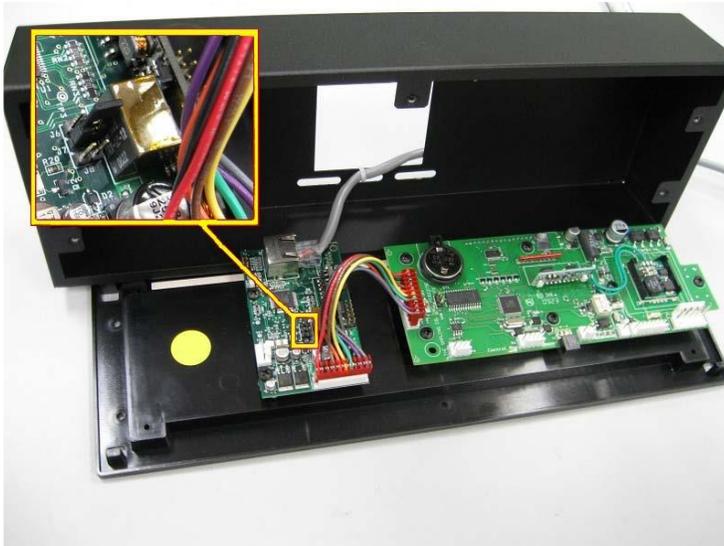
**IP Digital display clock Jumper**

**Note:** Jumper to configure static IP address is labeled as **J7** (it's located between jumpers **J6** and **J8**).

Note: subnet mask with the jumper installed is **255.255.255.0**

- When digital IP clock is powered-up with J7 installed (for static IP address *192.168.0.123*), the segments cycle, then “P 21” is displayed, and then the time is displayed (no IP address is shown).
- When digital IP clock is powered-up with J7 not installed (for DHCP), but no DHCP server is detected, the segments cycle, then “P 21” is displayed, and then the time is displayed (no IP address is ever shown).
- When digital IP clock is powered-up with J7 not installed (for DHCP) and the DHCP server is detected, the segments cycle, then “P 21” is displayed, then time is displayed and then the DHCP address is displayed (IP address is cycled through 2x around 13 to 19 seconds after the time is first displayed).

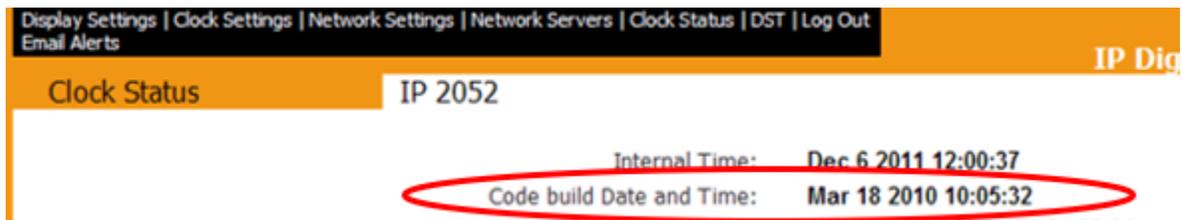
- Code build date (and time of build) is reported in the **Clock Status** page of the browser

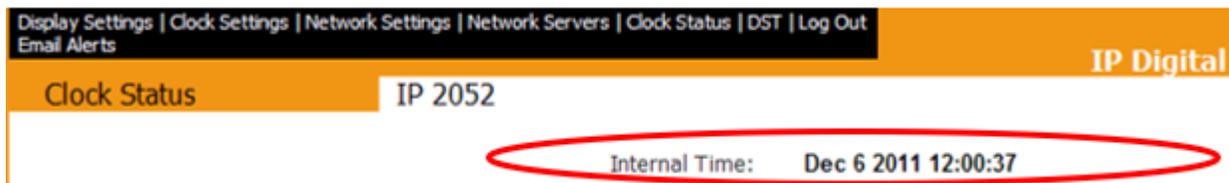
- Internal time/date of IP clock is reported in the **Clock Status** page of the browser

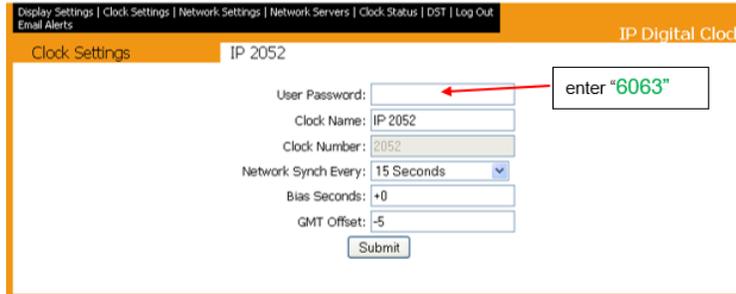
The screenshot shows the 'Clock Settings' page for 'IP 2052'. The 'User Password' field is highlighted with a red arrow pointing to a callout box that says 'enter "6063"'. Other fields include 'Clock Name: IP 2052', 'Clock Number: 2052', 'Network Synch Every: 15 Seconds', 'Bias Seconds: +0', and 'GMT Offset: -5'. A 'Submit' button is at the bottom.

- Default password: **6063** (then press Submit, not Enter key)  
**Note:** After entering password, need to press the **Submit** button in the browser to login- not the Enter key on the keyboard. pressing the Enter key will cause the browser to just remain at the login page.
- The factory default password cannot be changed. But one new user password can also be created (in addition to the master password of **6063**)?
- Once one new password has been created, either this or the default password can be used to login.
- The custom user password can be overwritten by entering a new value in the **"User Password"** field.
- While typing a desired password in the **"User Password"**, the typed characters are not displayed in this field

Note that for security reasons, the new user password characters are not displayed as you enter the desired passwords in the **"User Password"** field. When you press Submit, this new password is available. If this password is ever forgotten or unknown, a user can login using the default **"6063"** factory password and replace the existing user-defined password by entering a new value in this field (and pressing **"Submit"**).

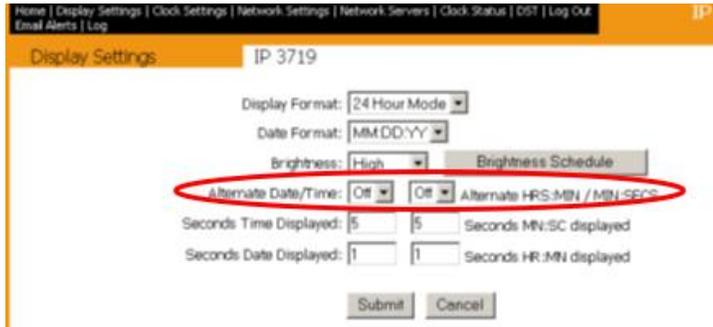
- Alternating Time/Date display and the date display format are configured in the “[Display Settings](#)” page of the browser.

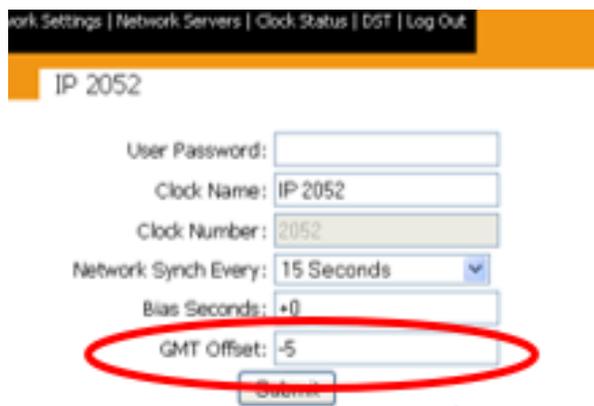
Select “[Clock Settings](#)” page of the browser and then change the “**GMT Offset**” (based on Standard Time)

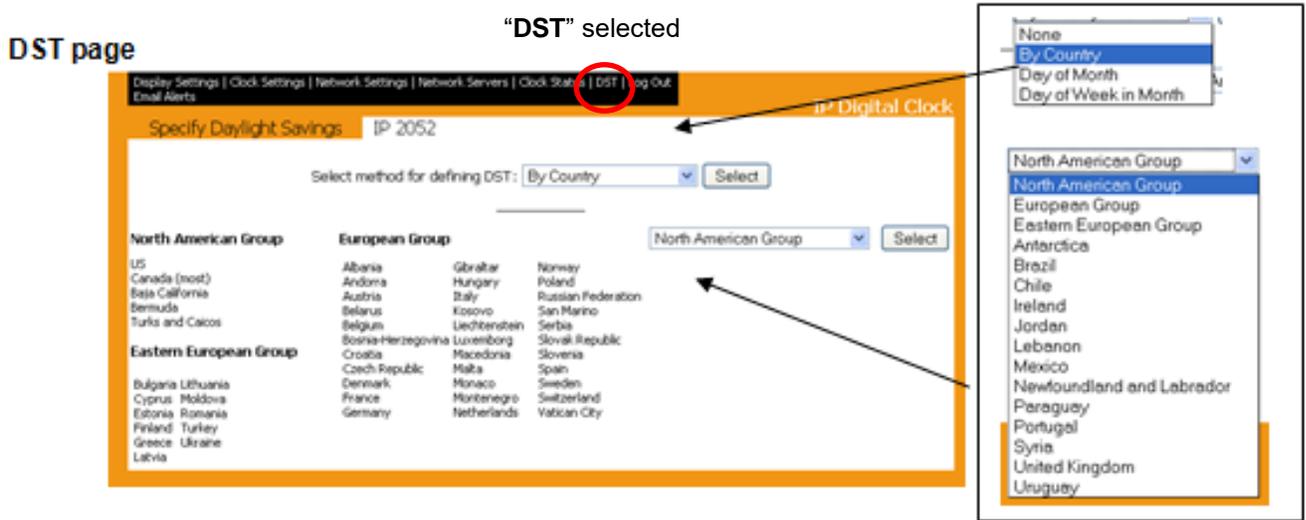
**DST:** If your region adjusts for Daylight Saving Time change, DST correction is configured in the “DST” page of the browser. DST can be configured by manually configuring times and dates for adjustment or by selecting a desired Country (many, but not all Countries are listed).

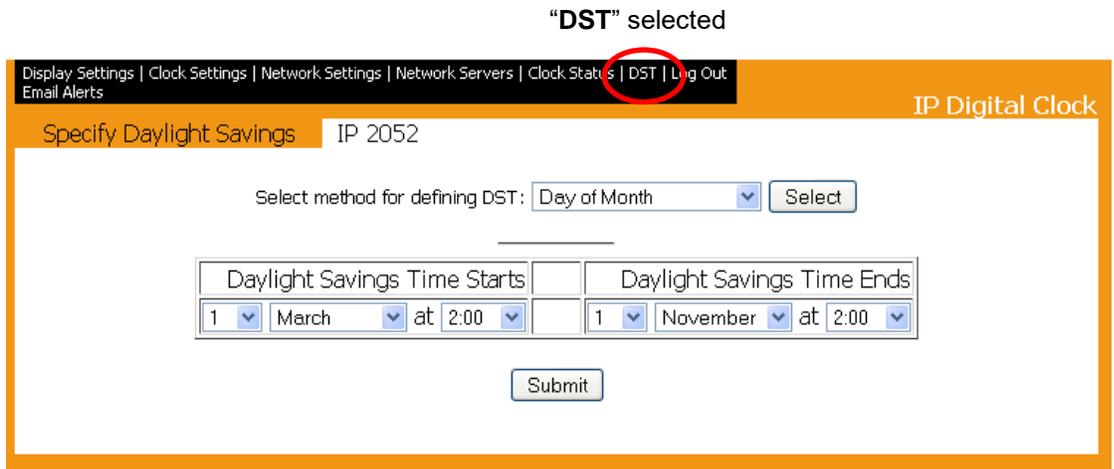
- 2) Manually configure in/out dates using the “Define DST by Day of Month” page
  - Select DST -> “Define DST by Day of Month” (Configure using values shown below)”

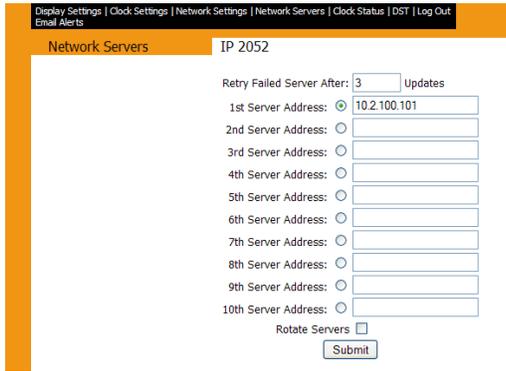
**Note:** The IP clocks initially sync to the configured NTP server upon boot-up on the network. Then, If you open the web browser for any of the IP clocks that are drifting (enter its IP address into Internet Explorer, Firefox, etc), first go to the “Network Servers” tab. Make sure the correct IP address of the NTP server is listed in the first field:

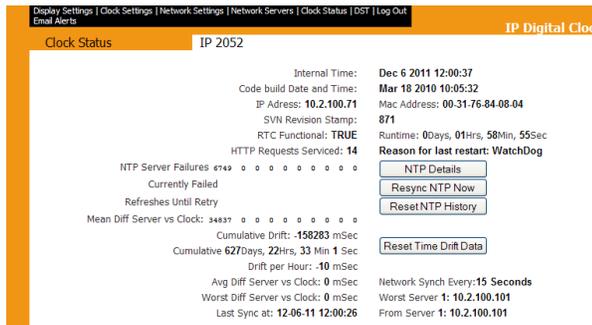
Next, click on the “**Clock Status**” tab. It will look similar to the screenshot below:

The “**Last Sync at**” (at the very bottom of this page) will indicate the last time it was synced to one of the values shown in the “**Network Servers**” page of the browser.
