## Han Solo (9283, 9288 and 9289) and Ranier (9383, 9388 and 9389)

**Note:** ALL MODEL 9200s and 9300s are now discontinued

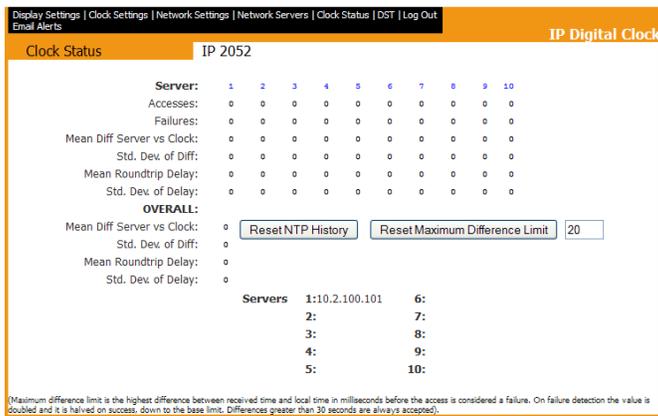
Each time you press “**Resync NTP Now**”, the values on this page should change. The “**Last Sync at**” value should become the time that this button was pushed. Also, there is historical data on the NTP synchronization, (click on “**NTP details**”).

The “**Accesses**” count indicates the number of times the clock was able to sync to one of its configured time servers.

The “**Failures**” count indicates the number of times it tried to sync to one of its configured time servers, but was unable to.

If the **Failures** counter increments instead of the **Accesses** counter, port 123 of a firewall may be blocking the NTP server. Or, there may be a problem with the NTP server.

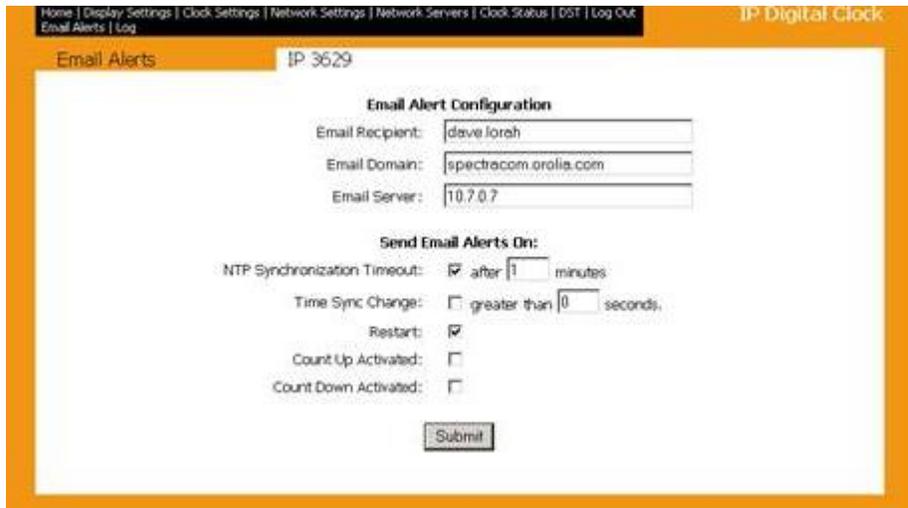
Below is an example screenshot of the “Email Alerts” page of the browser. It shows what types of conditions can cause email alerts to be sent.

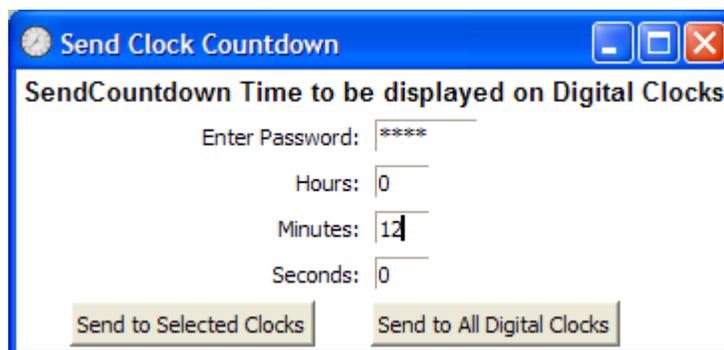
The IP Monitor software can remotely set the starting time for one or more clocks that are configured as count-up/count-down displays. It can also remotely start

**(Note:** This menu is displayed by navigating to the **Send -> Send Countdown** menu in the main page of the Monitor software).

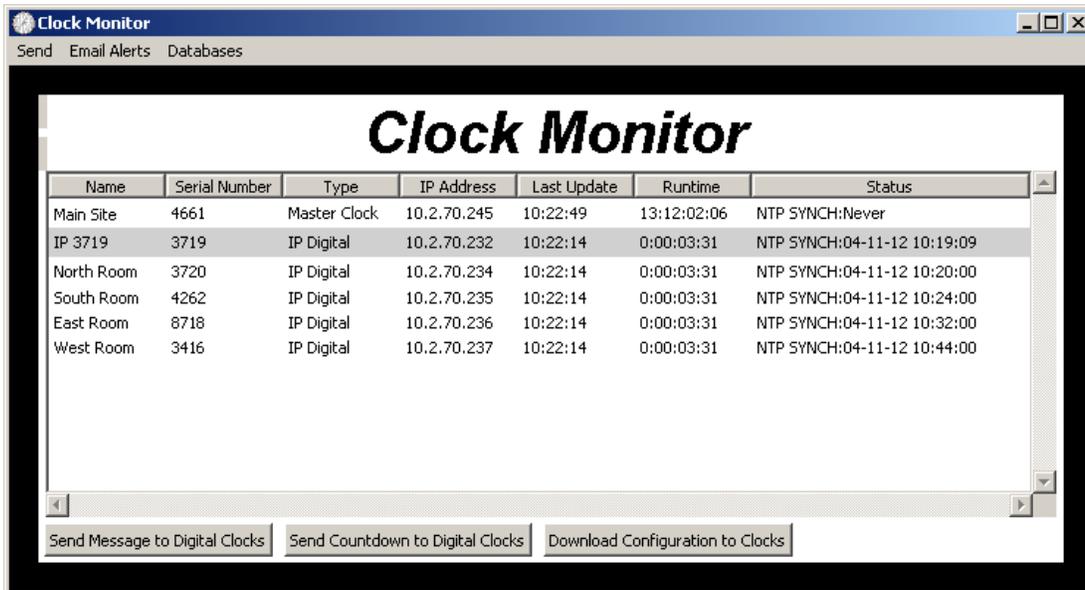
- This is an available program for the IP clocks.
- Refer to: <\\rocfnp02\idrive\Customer Service\EQUIPMENT\SPECTRACOM EQUIPMENT\Sapling display clocks\Display Clocks\IP display clocks\IP Clock Monitor software>
- Just run the monitor.exe program (it is not actually installed on the computer)
- Below is a screenshot of this program (**Note:** I can't seem to find any version info in this program).

**Ports used:** Not yet confirmed by Sapling, but Clock Monitor software appears to use **Ports 80, 445 and 4721**. May also use ports **1050 and 3478** (Power Guardian)?

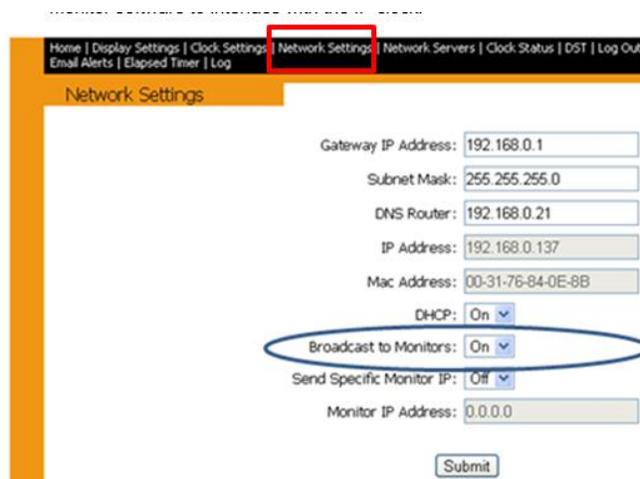
- As shown below, **“Broadcast to Monitors”** needs to be enabled in the **“Network Settings”** tab for the Clock Monitor software to interface with the IP clock.

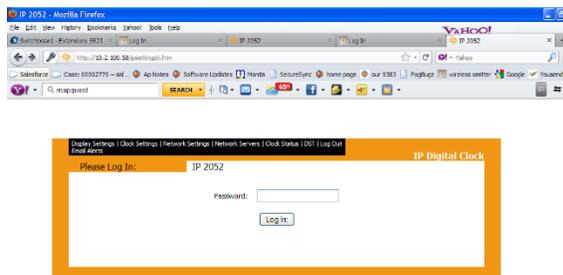
Once listed, this display windows shows the IP clocks that are installed, the Serial Number of each clock, whether each device is the NTP time server - digital - analog display clock, the last time it was resynchronized to the NTP server, how long it's been up and running and if it's currently in sync.

If a listed display clock is clicked-on with the mouse, its web browser is automatically opened to allow communication with that clock.

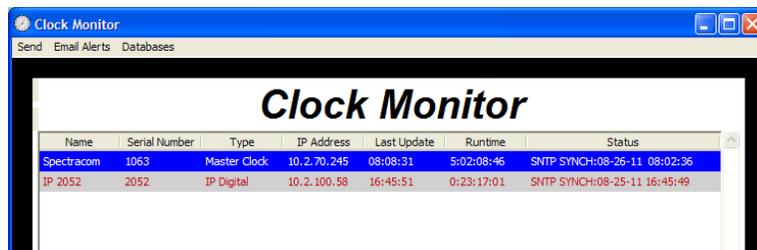
If the display clock is no longer connected to the network or can't be reached for any reason, the text will change to red (you can configure how often the program polls the clocks to make sure they are still connected to the network).

Below is a screenshot of this display window. In this screenshot, the first item in this list is a wireless transmitter this is currently connected to our network and the second listed item is a digital IP clock that has been temporarily disconnected from the network (so its text is now in red instead of being white text, to indicate it can n longer be reached on the network).

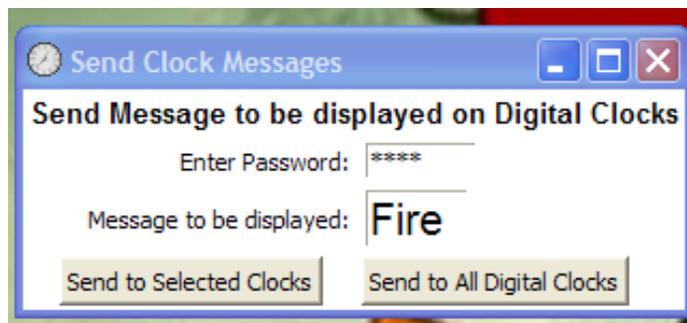
- Another unique capability is the ability to **send up to four characters** to be displayed on one or all digital IP clocks. Below is an example of the configuration to display “Fire” on all display clocks, if it was desired:

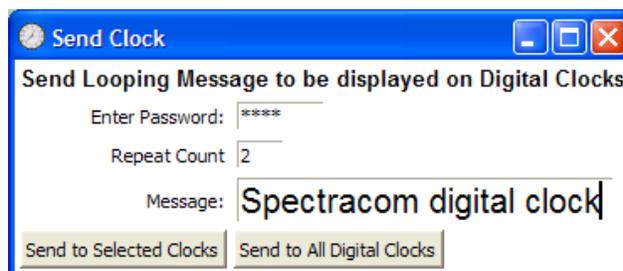
- If it's desired to **display a scrolling message** instead of four static characters, you can send a looping message and configure how many times this message is then displayed. Below is an example of this configuration:

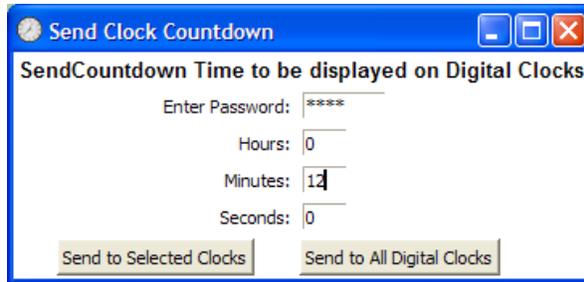
- Yet another unique capability of this program is the ability to **display a count-down time** on one or all clocks. You can pre-set a starting time and have one on all clocks start displaying a time that is counting down.

(**Note:** This menu is displayed by navigating to the **Send-> Send Countdown** menu in the main page of the Monitor software).

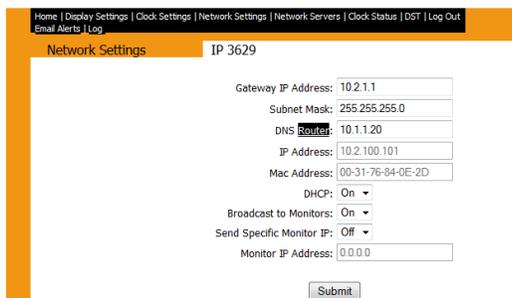
### **Screen shot of IP Clock**

The screenshot shows the 'Network Settings' page for IP 3629. The interface includes a navigation bar at the top with links for Home, Display Settings, Clock Settings, Network Settings, Network Servers, Clock Status, DST, Log Out, Email Alerts, and Log. The main content area contains the following fields:

Gateway IP Address:	10.2.1.1
Subnet Mask:	255.255.255.0
DNS Router:	10.1.1.20
IP Address:	10.2.100.101
Mac Address:	00-31-76-84-0E-2D
DHCP:	On
Broadcast to Monitors:	On
Send Specific Monitor IP:	Off
Monitor IP Address:	0.0.0.0

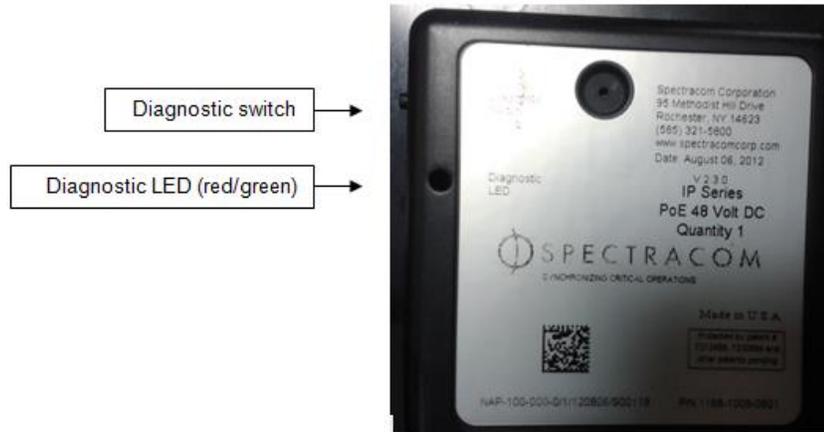
**Note:** If there are two diagnostic switches, refer to “B” further below, instead of this section.  
The photo below is of the rear panel of the newer design

- Refer to the newer rev wireless clock manual for info on newer display clock Diagnostics (1168-5001-0050, Rev F and higher) <I:\Engineering\Archive\New Released\Manuals\1168-xxxx-xxxx>
  - **During normal operation:** The Diagnostic LED is normally lit **constantly red** (blinking/solid red at a random rate). This LED is indicating communication between components inside the clock.
  - **During diagnostic tests:** The Diagnostic LED is normally lit **blinking green**

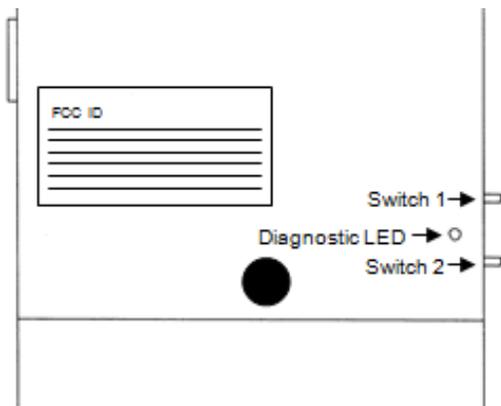
**Note:** If there is only one diagnostic switch on the rear panel, refer to “**A**” further above, instead of this section. The diagram below is of the rear panel of the original design

Diagnostic Mode	Primary function	Method to enter mode (Press diagnostic Switch 1)	Affects / Test results
1	<p><b>Elapsed Time since last sync</b></p> <p>Determines how long (in number of hours) it has been since the clock last received the communication signal.</p>	<p>Press Switch #1 for 1 second</p> <p>The LED should indicate green and flash once every three seconds.</p>	<p>While in diagnostic modes, the clock's hour and minute hands will continue to run normally.</p> <p>The <b>second</b> hand will display how long (number of hours) it has been since the clock received a time signal.</p> <p>After three minutes, the clock will resume normal operation</p>
2	<p><b>Signal Quality</b></p> <p>Determines the quality of the time signal.</p>	<p>Press Switch #1 for 3 seconds</p> <p>The LED should indicate green and flash twice every three seconds</p>	<ol style="list-style-type: none"> <li>1. While in diagnostic modes, the clock's hour and minute hands will continue to run normally.</li> <li>2. The second hand will display the quality of the time signal as a percentage on the dial of the clock. It will move from 12 to 8. If the second hand is on 12, this indicates no signal. If the second hand is on 8, this indicates the best possible signal.</li> <li>3. After three minutes, the clock will resume normal operation.</li> </ol>

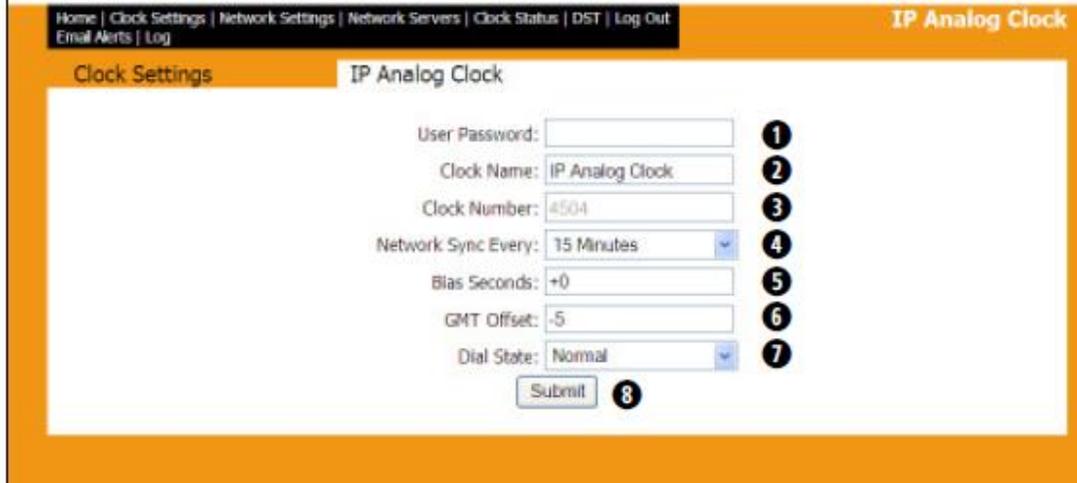
1. Login to the browser and navigate to the **Clock Settings** page of the browser.

- **Dial State:** This setting allows the user to correct the clock. There are 3 options:
- **Normal mode:** The clock will run in normal mode.
- **Find Hands mode:** If the clock is off by a few minutes, the clock will locate the hands and reset to correct time.
- **Set Hands to 12 mode:** If the Find Hands option does correct the time, this option will set the clock back to 12. The clock must be power cycled to resume normal operation.

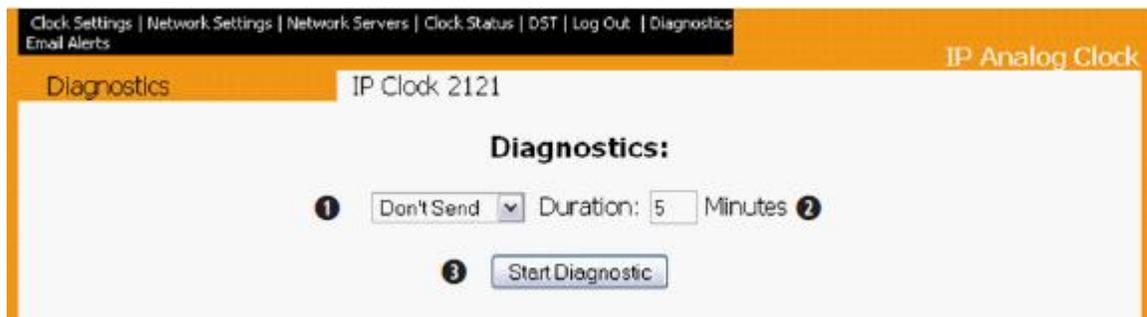
1. Login to the browser and navigate to the Diagnostics page to select the diagnostics tests

**Diagnostic List:** Allows the selection of any of the following diagnostic options:

- **Don't Send:** No diagnostics are sent.
- **Diagnostic:** Resets the clock back to factory default configuration.
- **Diagnostic 9:** This option overrides the diagnostic that is currently running and puts it back to normal operation.

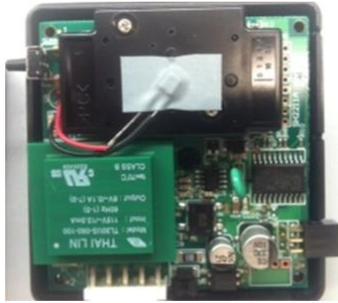
- Likely due to misalignment of the photo sensor taped onto the back of the clock.
- If the photo sensor or tape is even partially lifted, this can happen.
- Refer to [EQUIPMENT\SPECTRACOM EQUIPMENT\Sapling display clocks\Display Clocks\IP display clocks\Clock hands 4 hrs off](#) for additional pictures

This is how the tape should be placed on the gearbox.

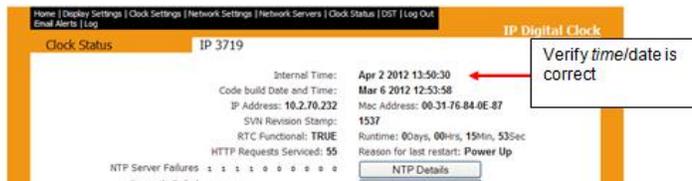
- If the IP clock shipped before Apr 2012, the IP clock may need a firmware update from Sapling
- (Note: Older versions of firmware had setup menus present when both front panel buttons are simultaneously pushed. These menus are not present in IP clocks shipped after ~March 2012).
- Verify the NTP server is Stratum 1.
  - Verify no firewalls in between are blocking port 123.
  - Look at the “**Clock Status**” page in the IP Clock and verify the “Internal Time” (top of this page) is correct.

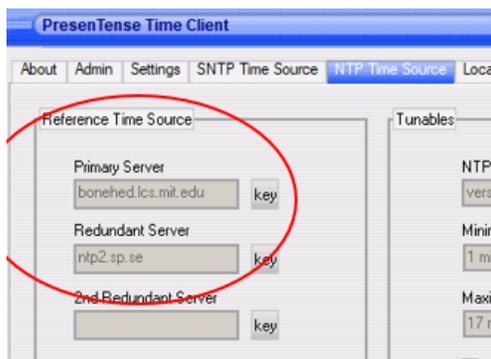
- A) Factory default configuration for **NTP Time Source mode** (before configuring the Primary and redundant time servers in the NTP Time Source tab (notice bonehead.ics.mit.edu and ntp2sp.se are listed)

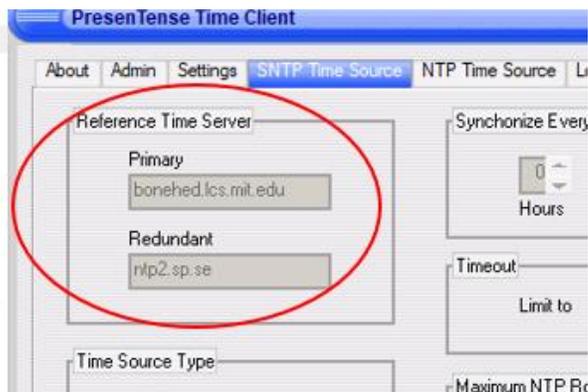
- B) Factory default configuration of the SNTP Time source mode (before configuring the Primary and redundant Servers in the SNTP Time Source tab) (notice bonehead.ics.mit.edu and ntp2sp.se are listed)

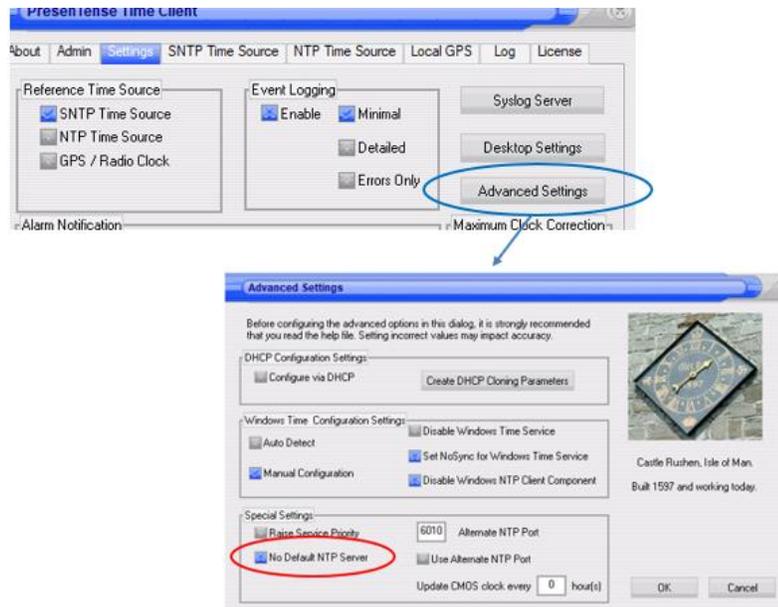
### Settings tab -> Advanced Settings button

*By default if you choose NTP Time Source or GPS Clock without setting a Fallback, PresenTense Time Client will enter a default server for you. Sometimes this is not desirable and can cause alarm messages when operated behind a firewall. Choose this option to stop a default server being entered.*

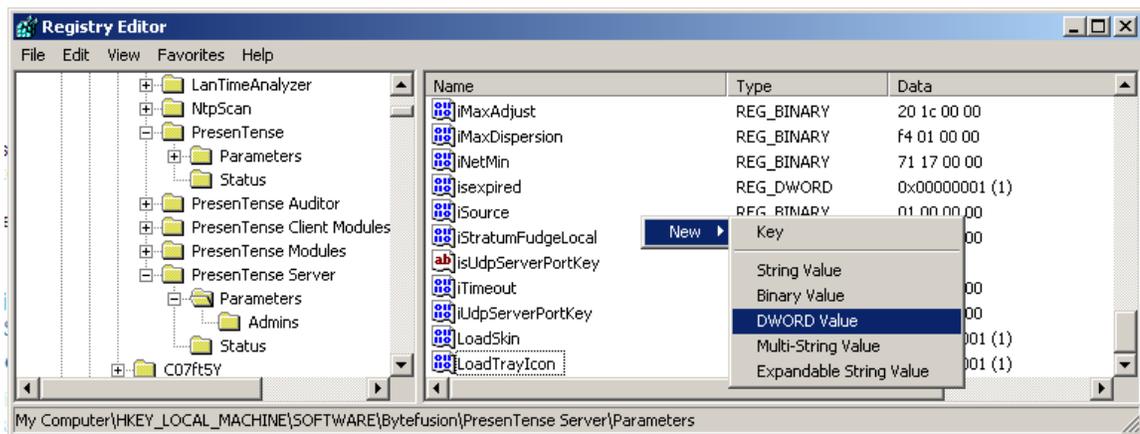
Right mouse-click in the right column and select "New" and "DWORD value". Rename this new value as: bNoDefaultSrv

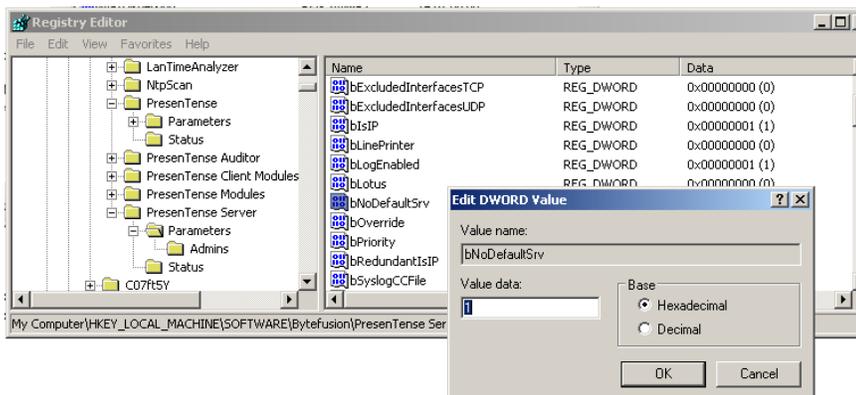
When adding the value, set the type as DWORD (which will show up as REG\_DWORD) and set the value:

- A) to Hex 1 to not add a default server or
- B) to Hex 0 to return to the default value of adding ntp2.sp.se as the redundant time server.

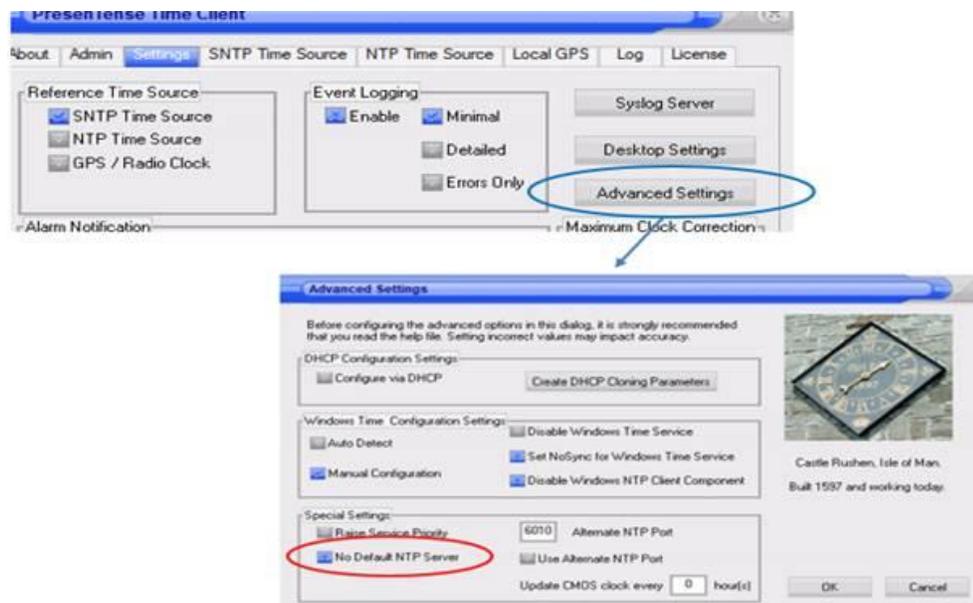
**Email from Keith (31 Aug 17)** Note that by default, the PresenTense Client program will automatically populate a second time server of "ntp2.sp.se" (as shown in the screenshot further above) if you only configure the GUI to point to just one time server. If you have only one time server available (or only one that you wish to sync the client with) there is a setting which can be selected in another tab of the GUI, which will prevent this secondary time source from being automatically entered when only one server has been configured. This is the "No default NTP Server" checkbox in the **Settings** tab -> **Advanced settings** button (as shown below):

Select this box and apply the change. The only effect is it will no longer automatically populate a secondary NTP server with a default Internet time server.

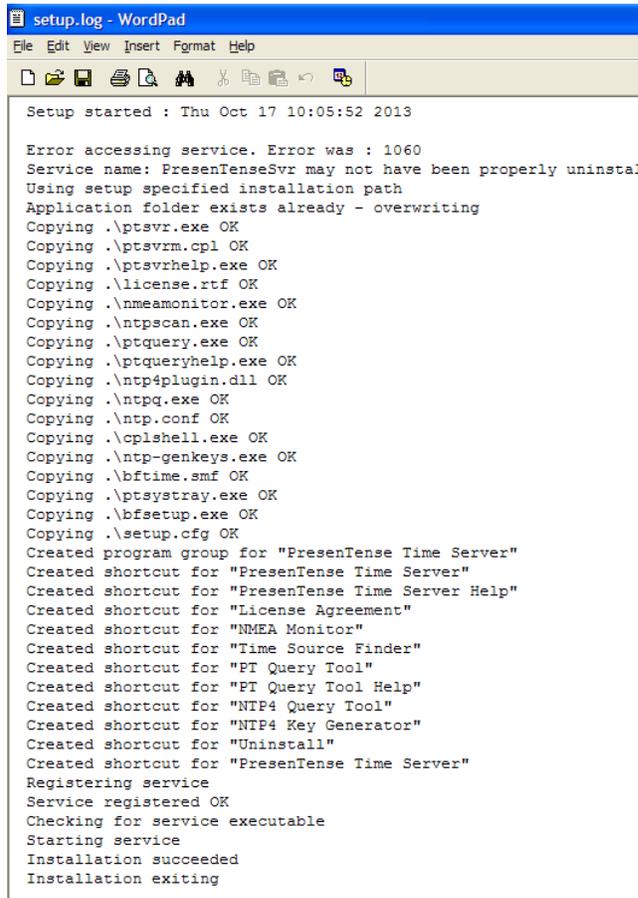
#### Get Install log

Generates a "setup.log" log file in the C:\Temp directory (example log from a Server version 4.1 re-install\_

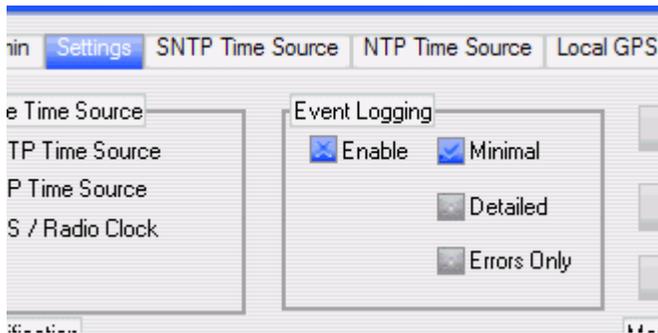
### A) Verify Logging is enabled in the Settings tab of the GUI

Note that if **“Minimal”** is selected, logs will back off after the program has been started and running. To obtain the most log entries, **“Detailed”** should be selected.

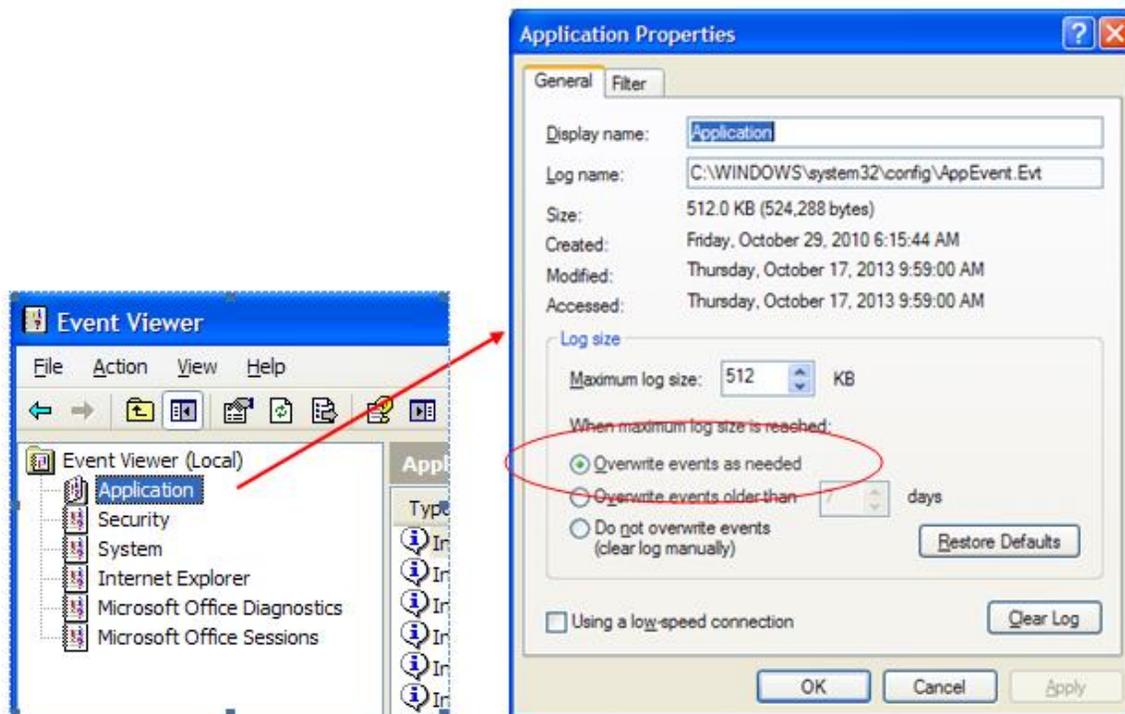
To verify the settings of the Application log, go to **Control Panel -> Administrative Tools**. Then select **Event Viewer**. In Event Viewer, right click on **Application** and select **Properties**. Select **“Overwrite events as needed”**, if it's not already selected.

PresentTense Client logs are stored in Windows Event Viewer. Depending on how the Application Log in Event Viewer is configured, it's possible for this log to become too full of logs. To prevent this from happening, this log should be configured to **“Overwrite as needed”**. When its configured instead as **“Do not overwrite events”** or **“Overwrite events older than”** a specified number of days, the log may become full and will prevent new logs PresentTense logs from being stored, until the log has been cleared.

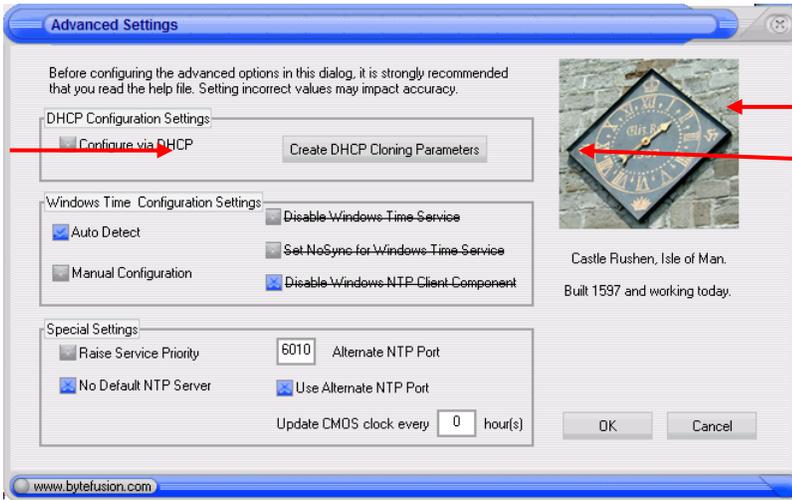
As shown below, in the Presentense GUI, Click on the “Settings” tab, “Advanced Settings” button. Disable "Configure via DHCP" by un-checking this box.

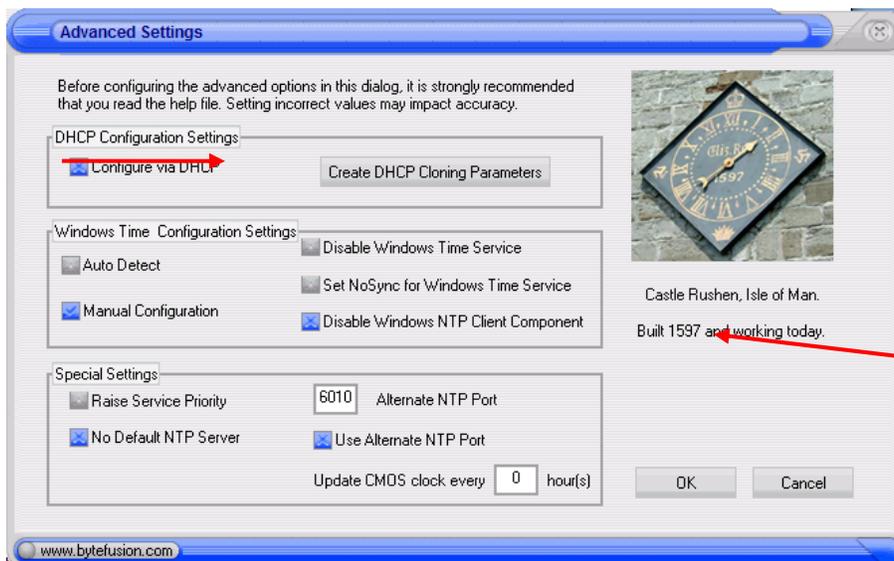
If the Presentense software still can't be started, click on the “Settings” tab, “Advanced Settings” button again. As shown below, in the “Windows Time Configuration Settings” section, select "Manual Configuration" and then select "Disable Windows Time".

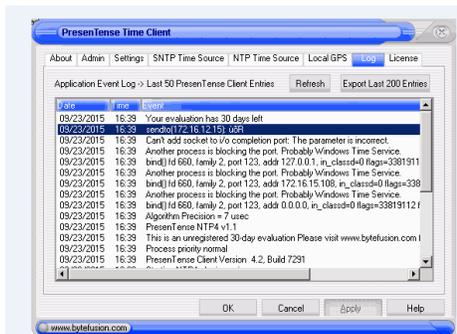
Can't add socket to i/o completion port . The parameter is incorrect  
Another process is blocking the port. Probaly Window Time Service

Email Keith sent to Eric Girard (based on the screenshot above) 23 Sept 15 I started trying to duplicate what they are doing, to determine the cause of the logs. But as I was starting to configure the software, I noticed the reason for these entries. This is actually a simple solution.

Note that more than one time service can't “share” the NTP port (port 123). One time service will prevent another time service from using this port. The logs show that the default Windows Time Service is still running on this PC, which is preventing Presentense from being able to use the port.

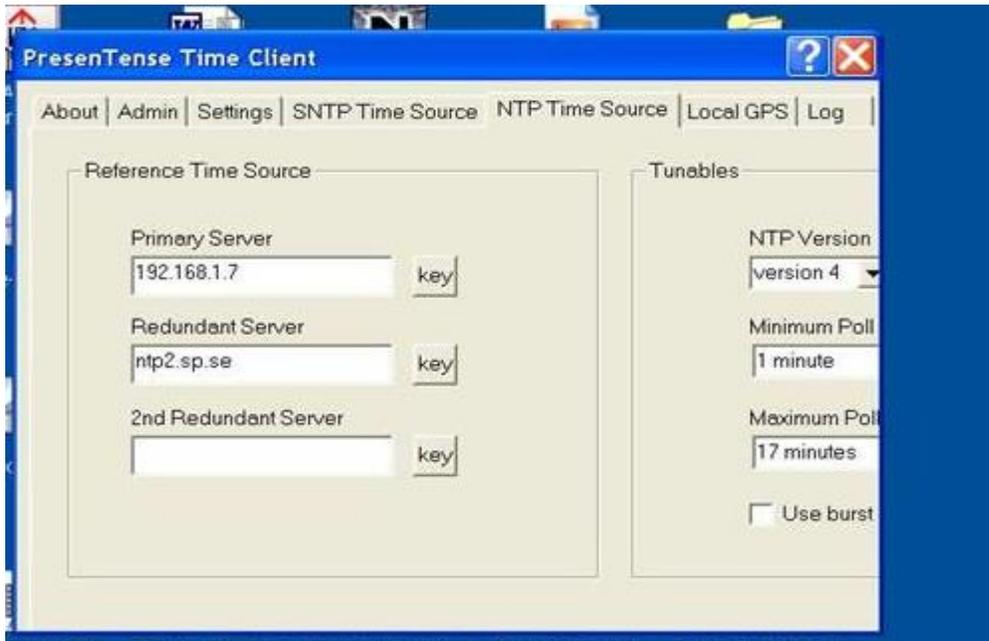
**Email from a customer:** In the interim, I downloaded your 30 day demo package yesterday afternoon and have a question. Please see the below screen capture which shows that the PresenTense application window does not open completely or permit resizing to see the full contents of the program options. Notice there is no Minimize/Maximize icons and when positioning the mouse over the sides or corners, there is no option to manually resize. It would appear that I cannot test the functionality because I can't get to all the settings.

This potential issue is not a factor of the PresenTense software itself. It's an issue between Windows and the installed video card driver.

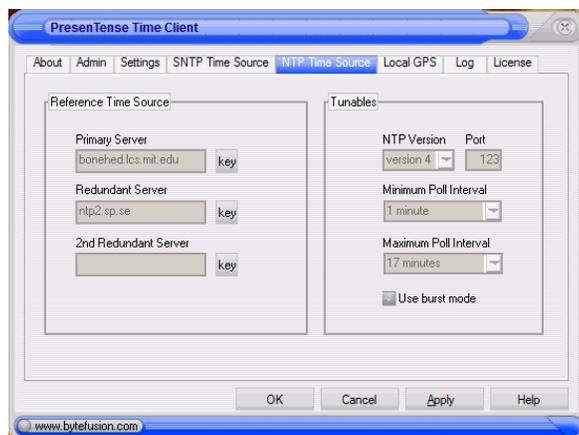
## \*\*\*\* All fields of the GUI are grayed-out in Windows 64 bit

This issue is most likely due to installing the Client NT program using the older executable file (The registered/purchase software or the 30 day trial software).

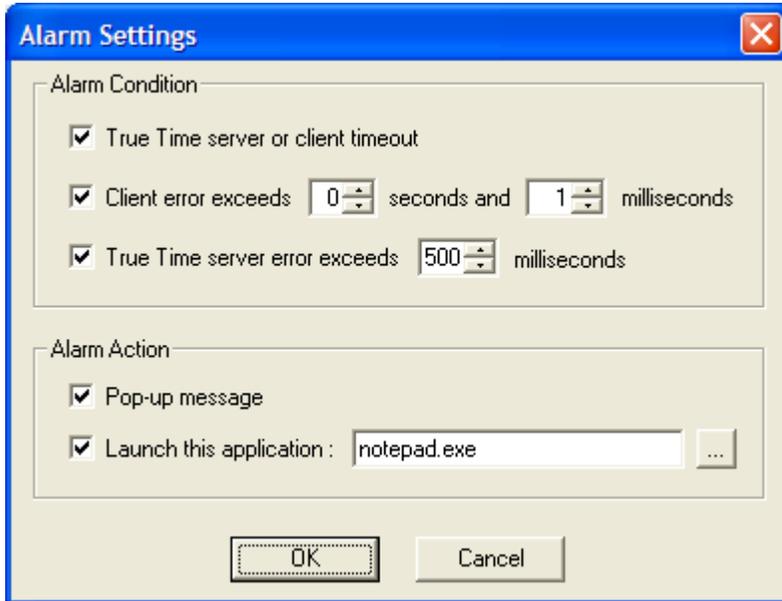
- LANTime Analyzer does not support email alerts
- Alarm Settings page allows a Pop-Up message to be displayed or a specified .exe file to be run, if a PC's time error ever exceeds a user-specified error threshold (the PC must be running either Client NT or Server software for this functionality to occur).

Example pop-up window when alert threshold has been exceeded

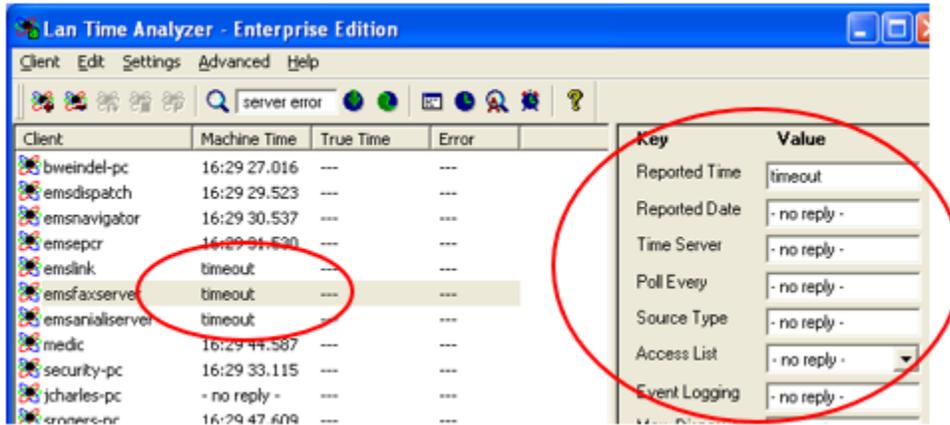
As shown below, LTA may report “timeout” and “no reply” for one or more Presentense clients:

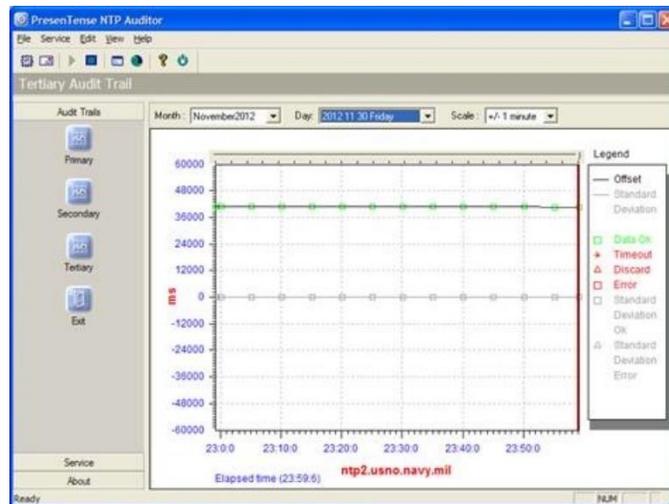
Below is a quick example of the NTP Auditor showing the time error of my PC versus the Primary audit reference (it can also compare the time against up to two other references as well). When a dot matrix printer is optionally connected to the PC, it can print-out a continuous, scrolling hard-copy of these comparison results. So if you need to prove the time error of the PC (if any) at any given point in the past, you would go to the dot matrix paper stack for that time period and simply scroll to the date and time in question, to see how much time error was present at that particular moment.

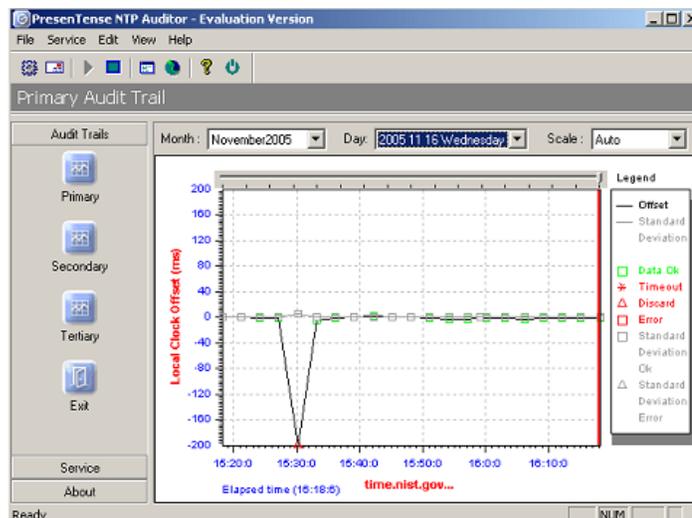
Below is another screenshot which indicates the time of a computer had been changed (at 15:30 on 16 Nov 2005), but then the PC was corrected again, shortly thereafter:

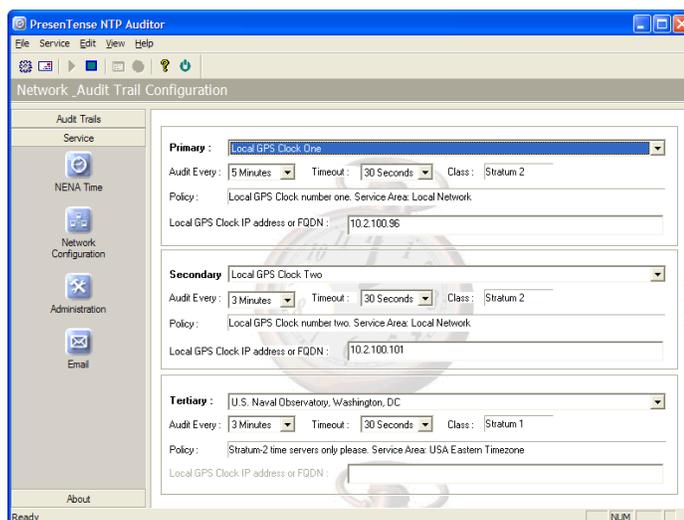
- Up to three (3) Audit servers/Audit references can be configured
- Audit references are configured in the Service menu, Network Configuration page (as shown below).

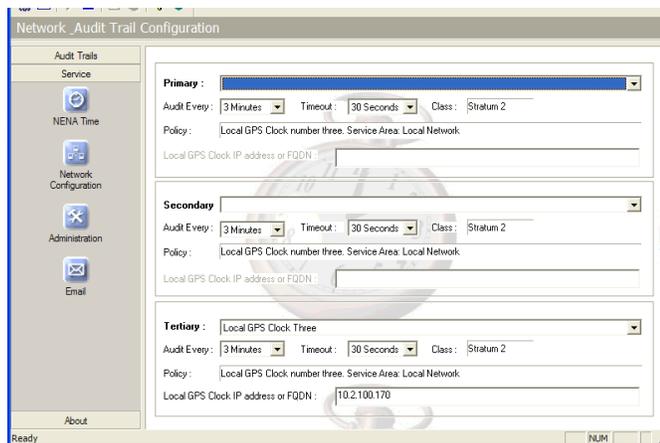
**Note:** in at least Auditor versions 3.8 or below, the software won't allow you to configure the same NTP “Local GPS Clock” (IP address) in more than one field. However, you can list the same NTP server by name in more than one field. If you try listing the same IP address in more than one field, the software removes the first two Local GPS Clocks but leaves the third (as shown below)

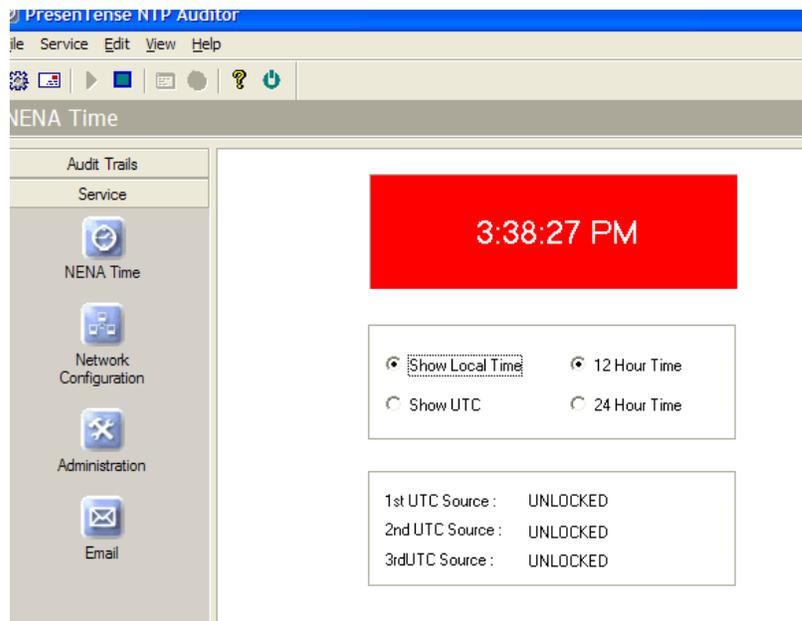
- In the Service menu on the left, select “NENA Time”
- Red “time” background indicates not all three audit references (“Source”) are indicating “Synchronized” (as indicated towards the bottom of the page).
- The background turns blue when ALL THREE audit references (“Source”) are indicating “synchronized” (as indicated towards the bottom of the page). If any of three is not synchronized, the background will be red.

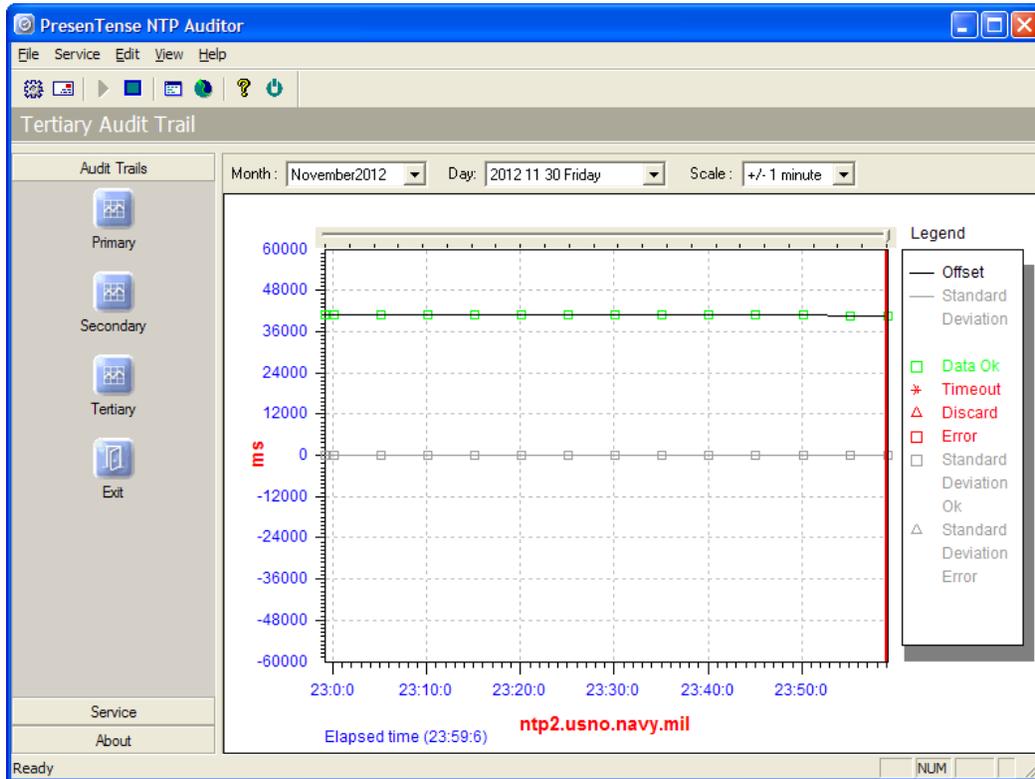
- Audit trails are individually viewed in the Audit Trails menu
- There is one tab for each of the three Audit Trails (as shown below)

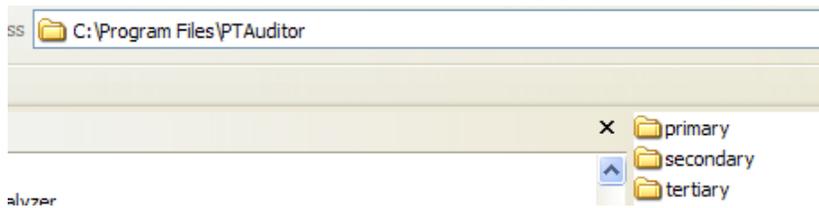
- Audit log data files are stored in each computer, in one of three Audit folders (C:/Program files/PTAuditor)

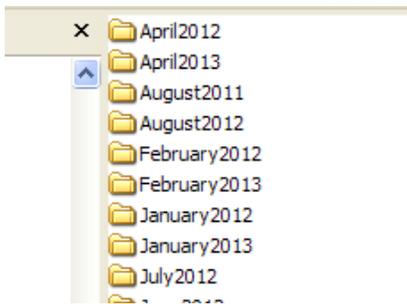
Each folder has sub-folders for sorting the Audits by Month and Year:

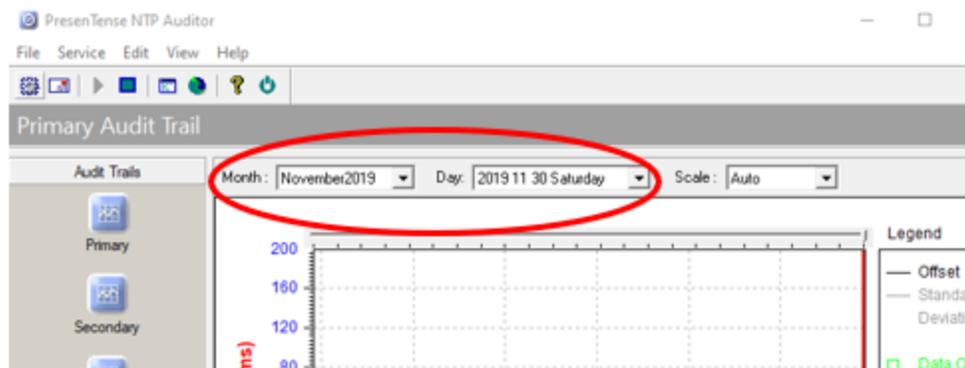
**Example Customer report:** "Another issue we just realized. NTP is days old and we can not change the month." (stops in November)

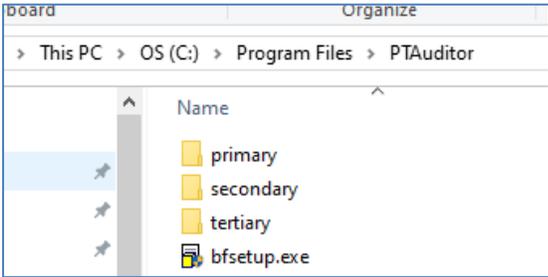
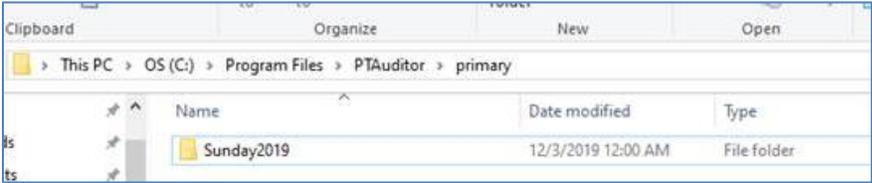
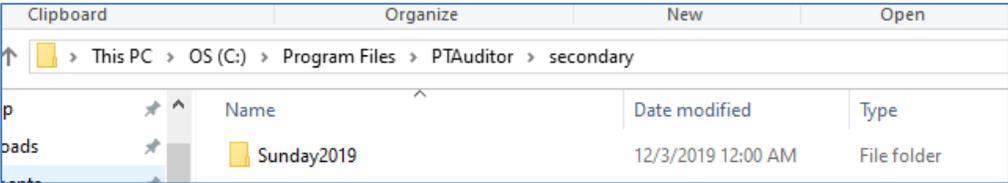
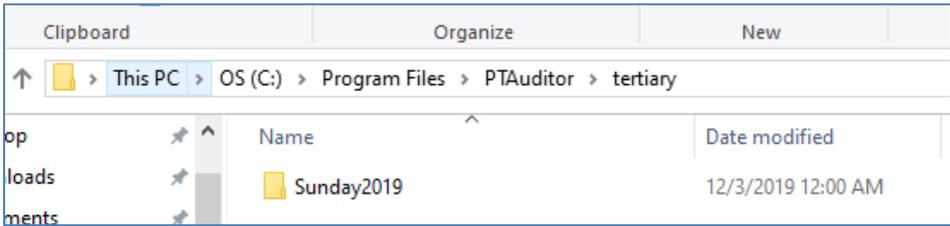
Below are four screenshots from my PC, showing the above description occurred. Simply rename the file in each of the three individual folders, located inside the "PTAuditor" folder (primary, secondary and tertiary)

We have a workaround for the problem. Simply rename the "Sunday2019" file to "December2019" and it will resolve the issue. This is found in the program file location for PresenTense Auditor. This will be corrected in a future release of the software. We will let you know when this is available and send you an updated software file.

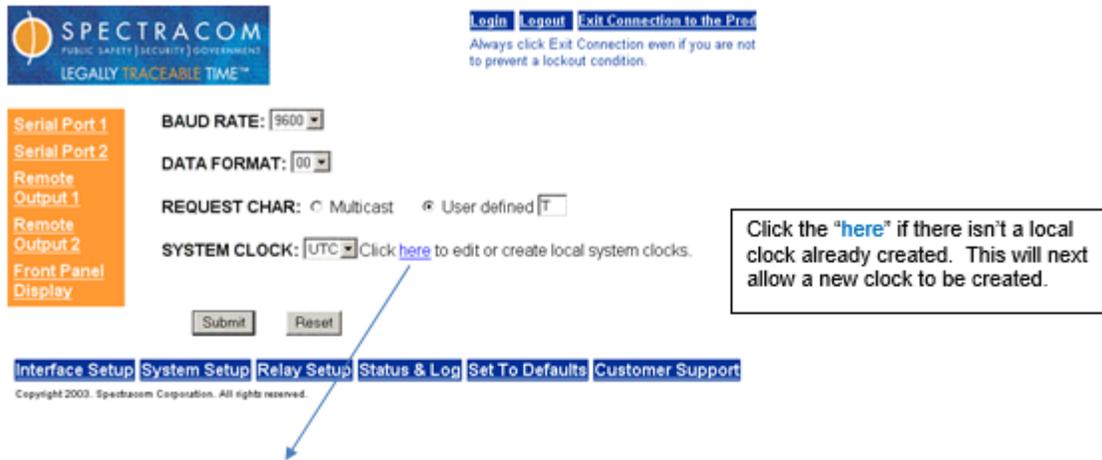
Interface Setup button on bottom of page -> Serial and Remote output on left side of page

The screenshot shows the Spectracom interface setup page. At the top left is the Spectracom logo with the tagline "LEGALLY TRACEABLE TIME™". At the top right are links for "Login", "Logout", and "Exit Connection to the Prod", with a note: "Always click Exit Connection even if you are not to prevent a lockout condition." On the left is a vertical menu with options: "Serial Port 1", "Serial Port 2", "Remote Output 1", "Remote Output 2", "Front Panel", and "Display". The main area contains configuration fields: "BAUD RATE: 9600", "DATA FORMAT: 00", "REQUEST CHAR: Multicast (selected) or User defined (T)", and "SYSTEM CLOCK: UTC". A blue arrow points from the "here" link in the "SYSTEM CLOCK" field to a text box that says: "Click the 'here' if there isn't a local clock already created. This will next allow a new clock to be created." Below the fields are "Submit" and "Reset" buttons. At the bottom is a navigation bar with "Interface Setup" (selected), "System Setup", "Relay Setup", "Status & Log", "Set To Defaults", and "Customer Support".

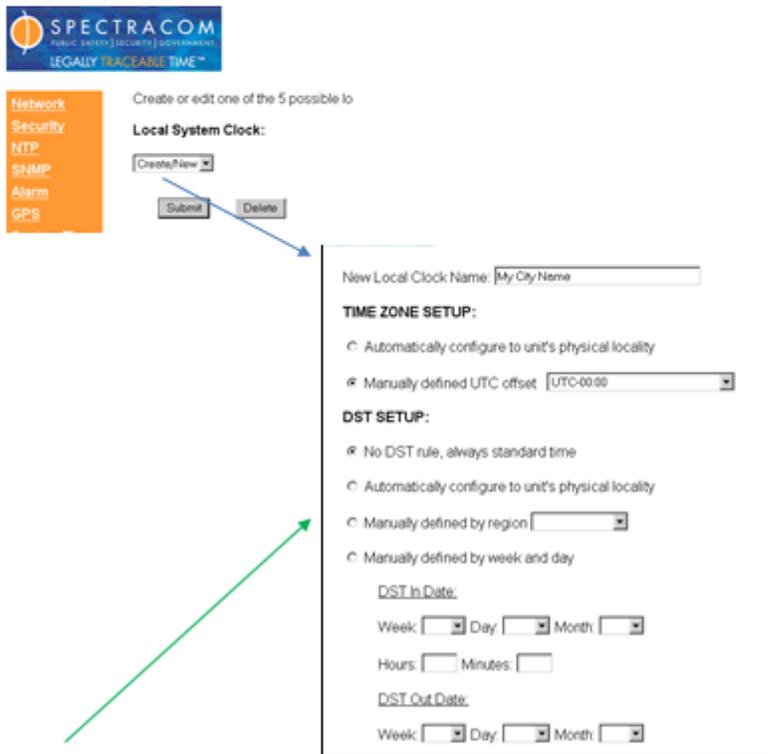
### Local clock configuration

The screenshot shows the "Local clock configuration" page. At the top left is the Spectracom logo. On the left is a vertical menu with options: "Network", "Security", "NTP", "SNMP", "Alarm", and "GPS". The main area contains the text "Create or edit one of the 5 possible lo" and "Local System Clock:". Below this is a "Create/New" dropdown menu and "Submit" and "Delete" buttons. A blue arrow points from the "Submit" button to a detailed configuration form. The form has a field for "New Local Clock Name" with the value "MyCityName". It has two sections: "TIME ZONE SETUP:" with radio buttons for "Automatically configure to unit's physical locality" and "Manually defined UTC offset" (selected, with a dropdown showing "UTC-00:00"); and "DST SETUP:" with radio buttons for "No DST rule, always standard time" (selected), "Automatically configure to unit's physical locality", "Manually defined by region" (with a dropdown), and "Manually defined by week and day". Under "DST In Date:" are fields for "Week", "Day", "Month", "Hours", and "Minutes". Under "DST Out Date:" are fields for "Week", "Day", and "Month". A green arrow points from the "Manually defined by week and day" option to the "DST In Date:" fields.

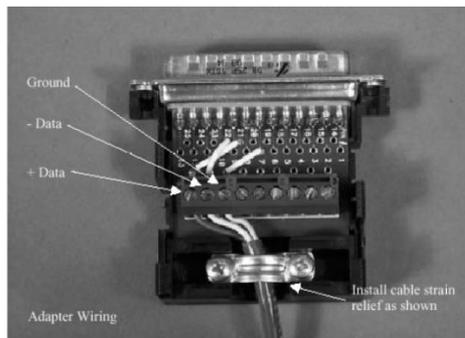
Pin 1 (RxL) of the adapter to pin 1 (+) on the Remote Outputs connector  
Pin 2 (RxH) of the adapter to pin 2 (-) on the Remote Outputs connector  
Pin 3 (GND) of the adapter to pin 3 (G) on the Remote Outputs connector

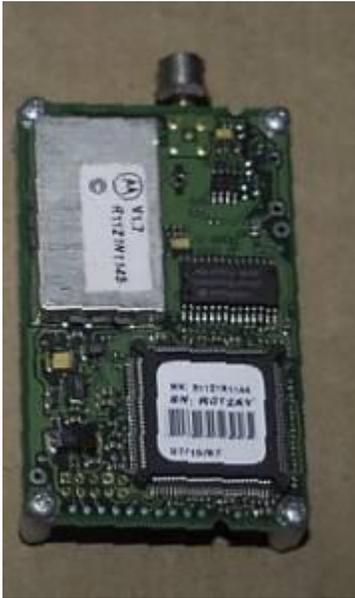
- **Our P/N 069053:** Motorola GT Plus receiver (Motorola P/N R3111G111X)
- **Our P/N 069052** Motorola GT receiver (Motorola P/N R3111G1112.01 ONLY- Other P/Ns are not compatible with the 8183)

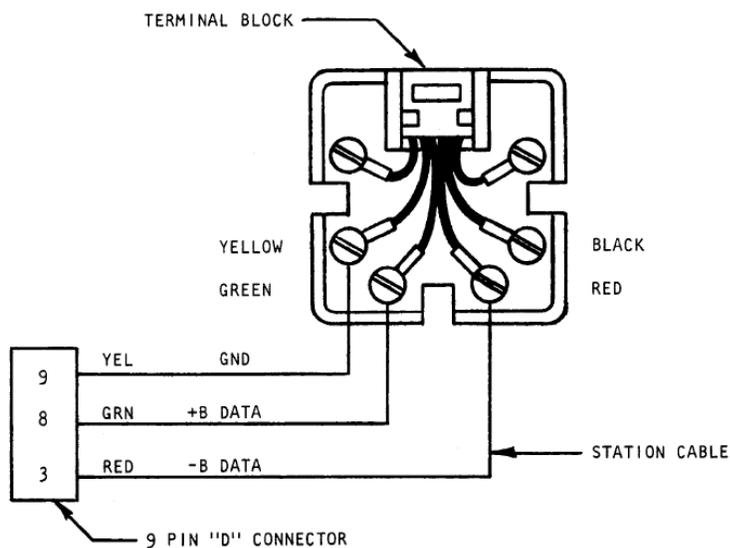
### Wiring/pin-outs

Signal	<a href="#">Remote port of all GPS-based NetClocks (Models 8183, 9183 9483, etc) (Terminal block connector)</a>	<a href="#">WWVB-based NetClock/2 RS-485 Remote Output port (DB9F)</a>	<a href="#">Color of wire inside Modular Jack (Telephone jack)</a>	<a href="#">RJ-11 Connector on Model 8176 (J4 connector) *** See Notes A and B below</a>
+Data	Pin 1	Pin 3	GREEN wire	Pin 3
-Data	Pin 2	Pin 8	RED wire	Pin 4
Ground	Pin 3	Pin 9	YELLOW wire	Pin 2
