## Han Solo (9283, 9288 and 9289) and Ranier (9383, 9388 and 9389)

**Note:** ALL MODEL 9200s and 9300s are now discontinued

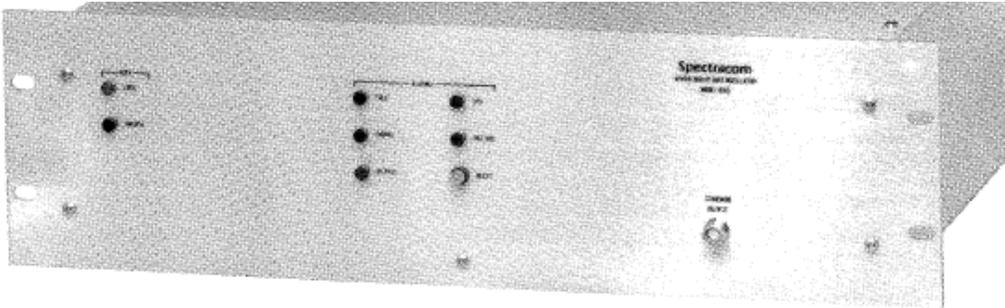
### \*\*Model 8165

- Output (Front Panel): One 10 MHz BNC output
- Outputs (Rear Panel): Five 10 MHz BNC outputs

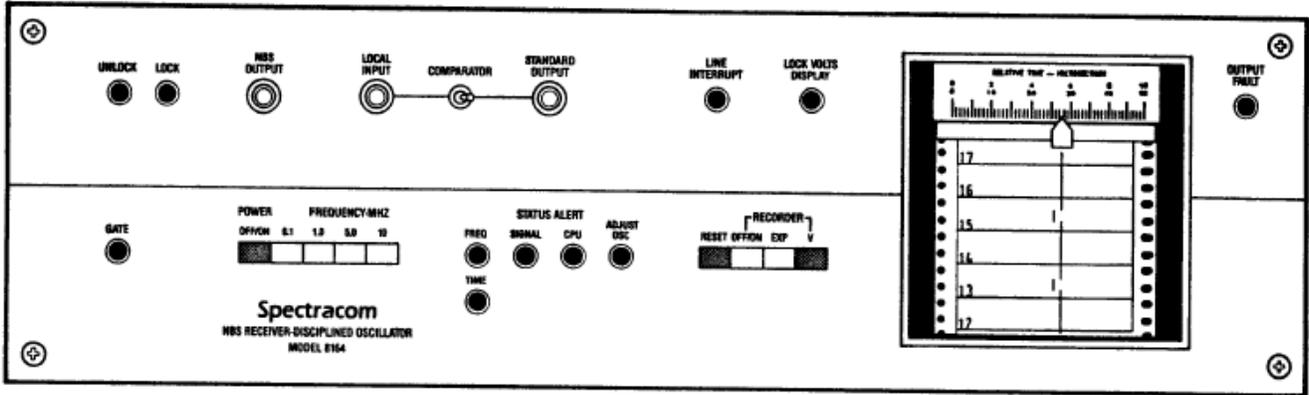
**\*\*Model 8164**

**Output (Front Panel):** One BNC output for 0.1, 1.0, 5 or 10 MHz (as selected by the pushbutton switches)

**Outputs (Rear Panel):** Separate BNC outputs for 0.1, 1, 5 and 10 MHz

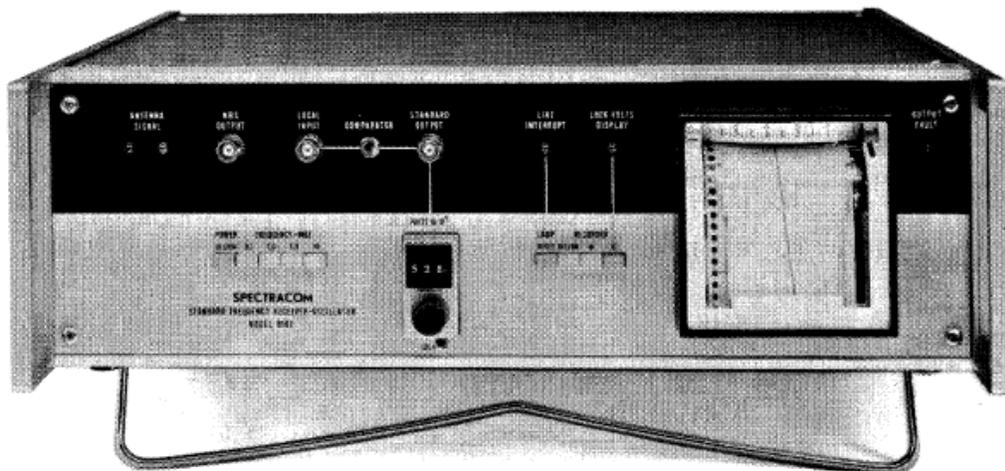
## **\*\*Model 8161**

**Output (Front Panel):** One BNC output for 0.1, 1.0, 5 or 10 MHz (as selected by the pushbutton switches)

**Outputs (Rear Panel):** Separate BNC outputs for 0.1, 1, 5 and 10 MHz

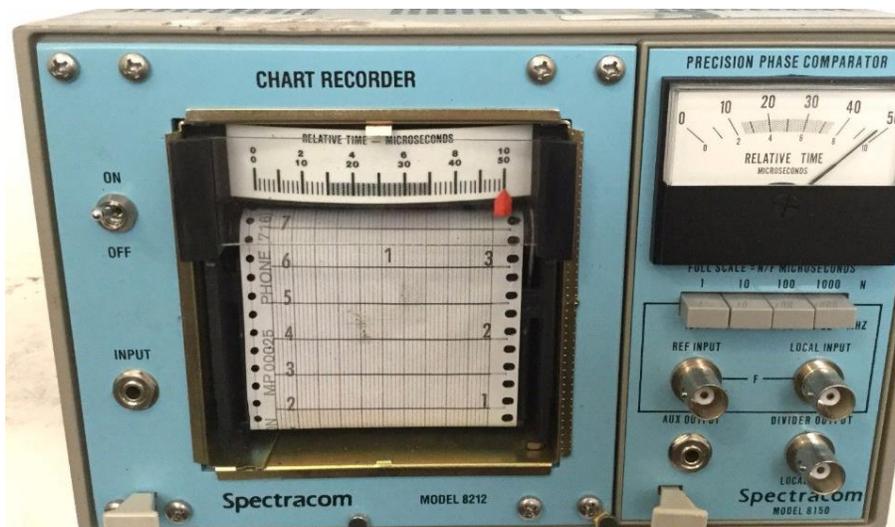
## Model 8212 chart recorder

- Vendor Model Number: 2750
- 8212 manual: refer to <I:\Customer Service\EQUIPMENT\SPECTRACOM EQUIPMENT\8212 Chart recorder for WWVB receivers>
- There is no Spectracom manual for the chart recorder, just the manufacturer's manual for the Model 2750

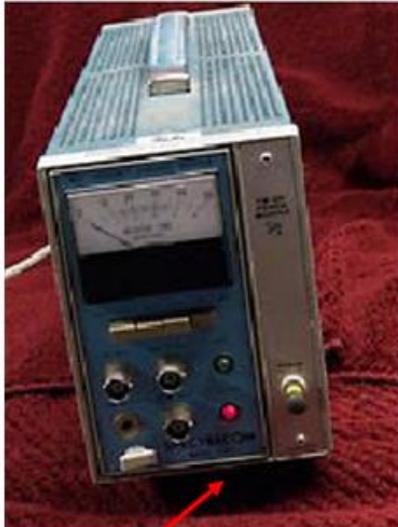
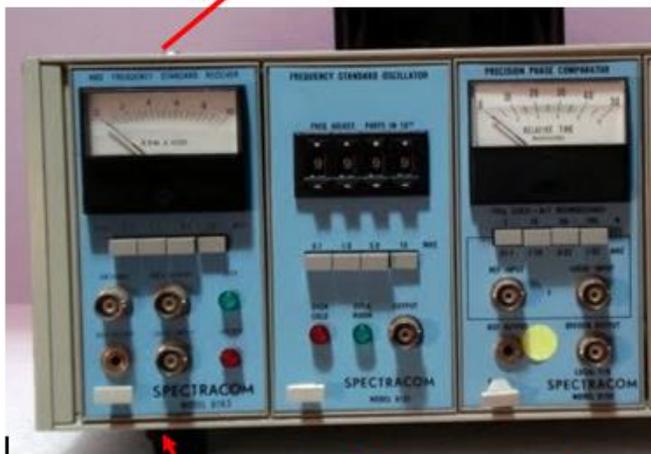
## Model 8163 WWVB Receiver/Comparator (discontinued)

Model 8163 WWVB  
Receiver/Comparator

Model 8131  
Frequency Standard  
Oscillator

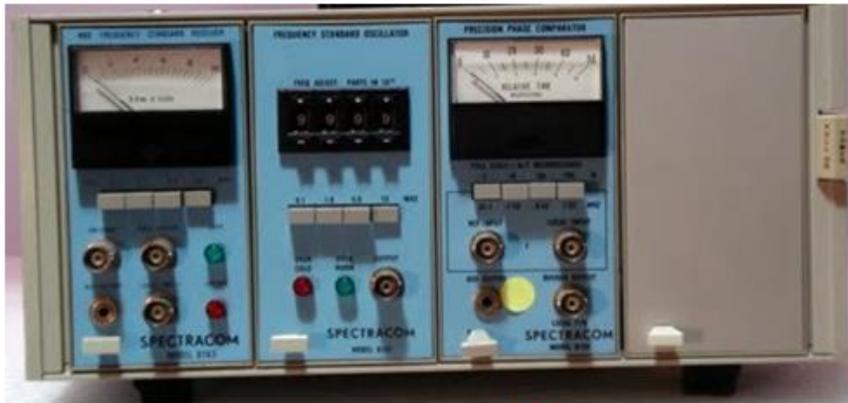
## Model 8150 (Precision Phase Comparator) (discontinued)

- This device was a plug-in module for the Tektronics TM-500 series Mainframe

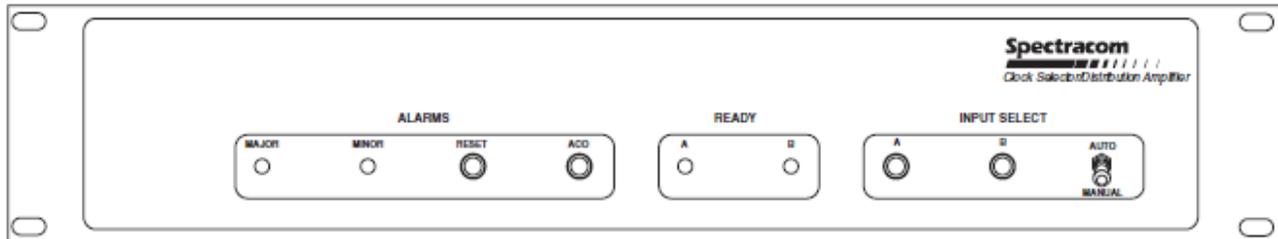
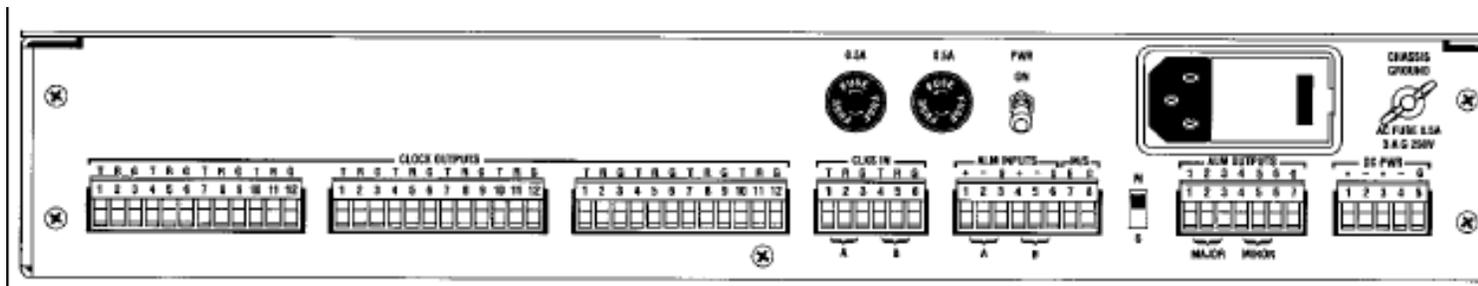
### Terminal block connectors

(1) 5 pin terminal block connector (DC input power). Spectracom Part Number P13005.

(3) 12 pin terminal block connectors (Clock Outputs). Spectracom Part Number P13012.

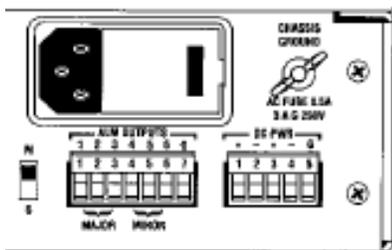
### 8144 Power Requirements

- DC input is on the 5 position terminal block (Spectracom P/N P13005 terminal block connector)

**Standard power:** 115/230 VAC  $\pm$ 15% 50/60 Hz, 6 watts

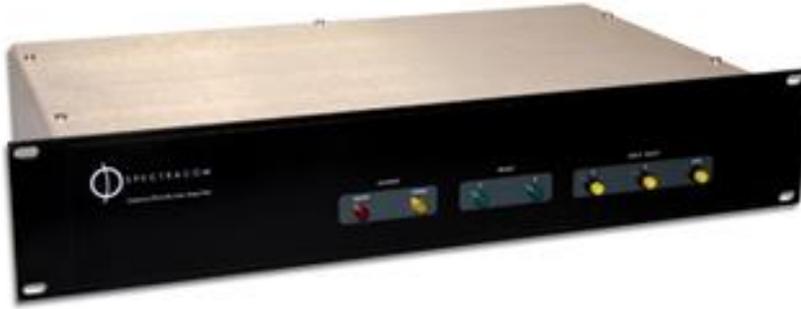
## Model 8143 (distribution amplifier) Discontinued

**Note: Model 8143 was discontinued ~Apr 2015. Refer to ECO 000345**

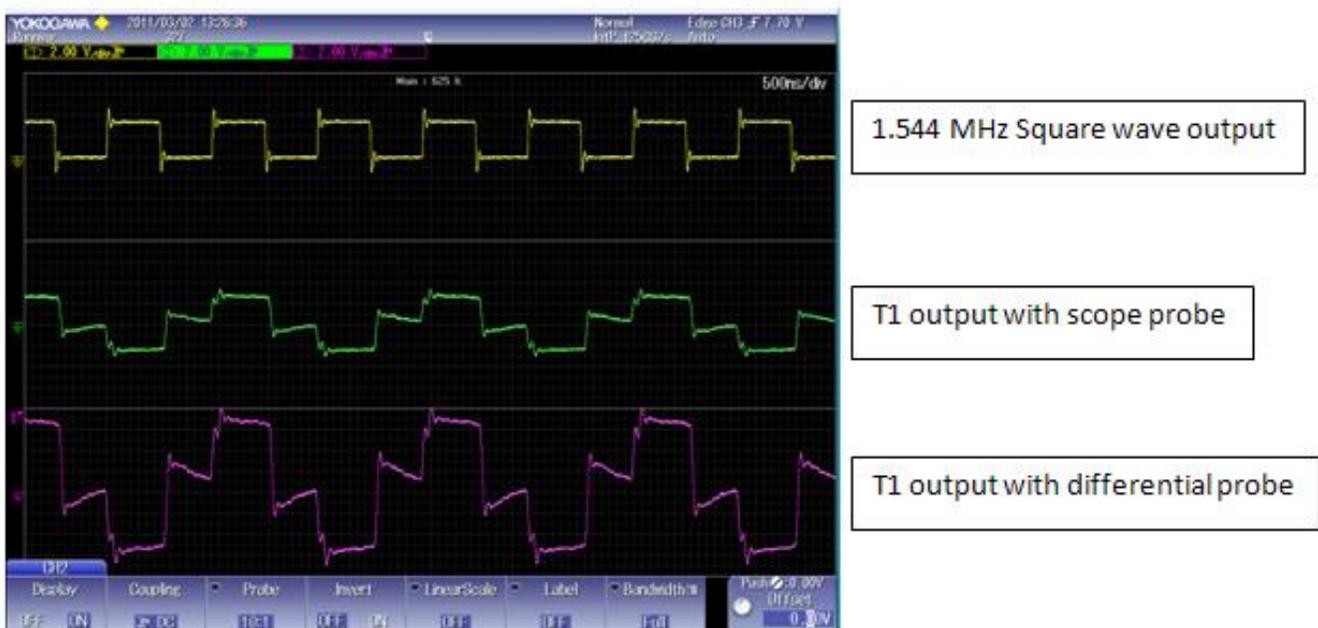
Screenshot of DS1 output from a SecureSync DS1 output Option card

DS1 Pulse Mask (for acceptable signal verification)

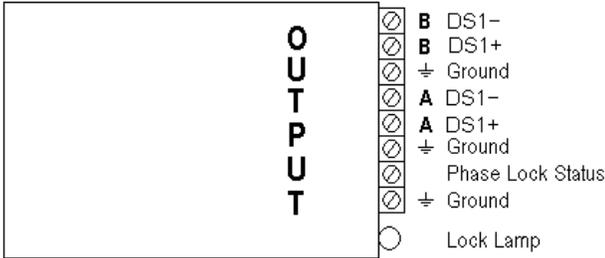
**Phase Lock Status:**

- TTL level high (1) whenever the VersaTap is phase locked to 10 MHz reference
- TTL level low (0) when not locked to 10MHz reference.

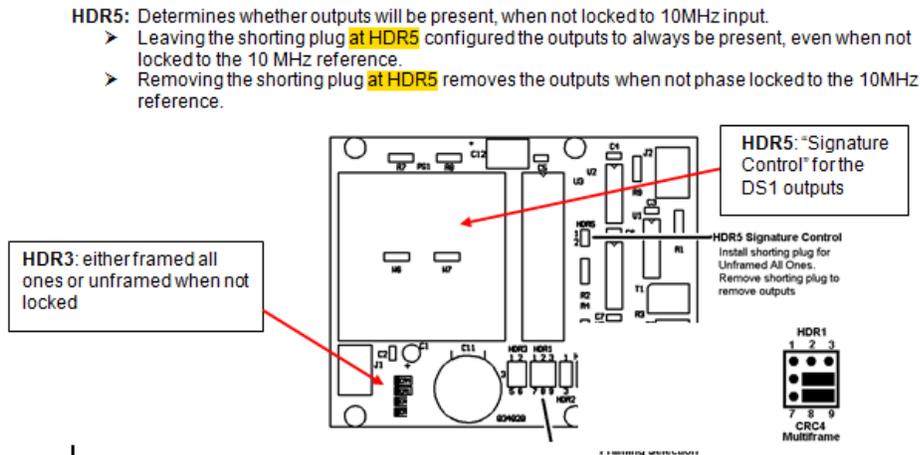
**HDR5:** Determines whether outputs will be present, when not locked to 10MHz input.

- Leaving the shorting plug at HDR5 configured the outputs to always be present, even when not locked to the 10 MHz reference.
- Removing the shorting plug at HDR5 removes the outputs when not phase locked to the 10MHz reference.

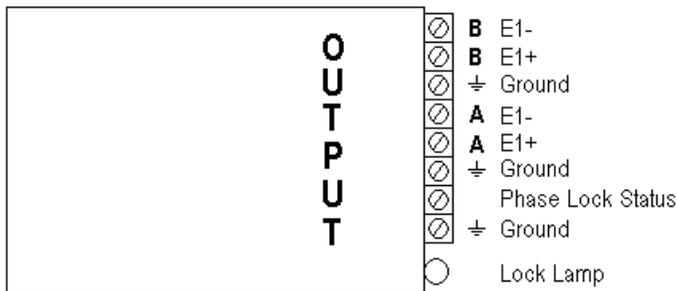
**Phase Lock Status:**

- TTL level high (1) whenever the VersaTap is phase locked to 10 MHz reference
- TTL level low (0) when not locked to 10MHz reference.

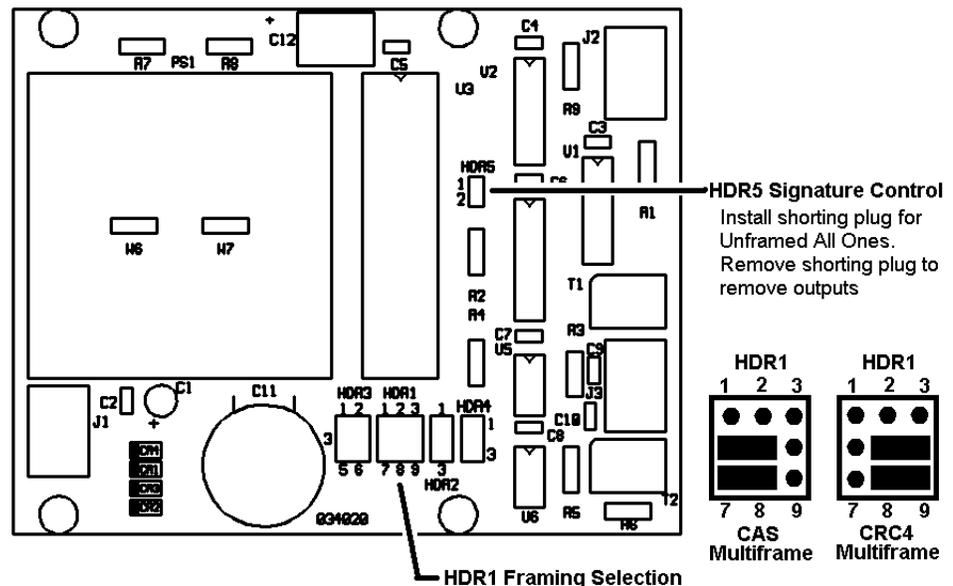
**Jumper configuration**

**HDR1: (E1 Framing)** Selects either CAS Multiframe or CRC4 Multiframe (Default setting is CRC4 Multiframe).  
(Refer to picture above for the two configurations of HDR1)

**HDR5:** Provides either an Unframed All Ones (even when not locked to the 10MHz input) or complete removal of the output signal whenever the VersaTap is not phase locked to the 10 MHz input reference.

- The unit is factory configured to provide an Unframed All Ones when unlocked (jumper installed).
- To program the E1 outputs for complete removal when unlocked, remove the shorting plug found on HDR5.

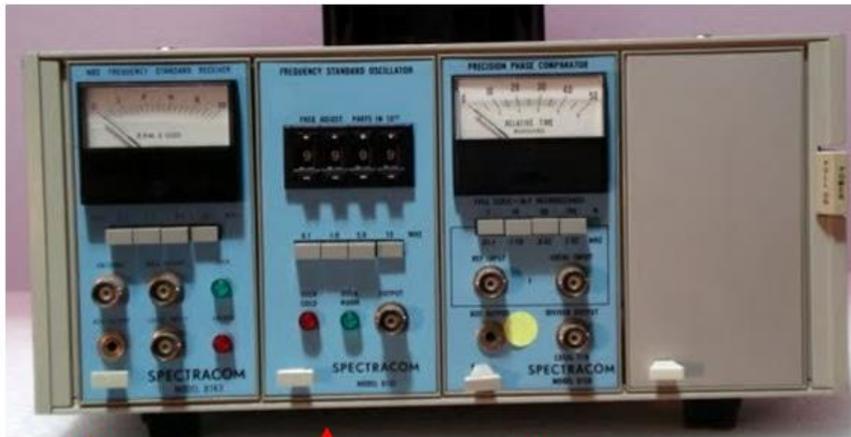
## Model 8131 (Frequency Standard Oscillator) (discontinued)

Model 8163  
WWVB  
Receiver/Comparator

Model 8131  
Frequency Standard  
Oscillator

**Email from Tom Richardson (13 March KW)** Found it. It's a battery pack. Good luck finding an 8131 manual. I think it was two 12 volt batteries wired as a 24 volt battery. I seem to remember them becoming rattles when we overcharged them.
