Software Version 1.7.0: Release Notes

Orolia released a software update for SecureSync 2400. Customers can download this software update at no charge from the Orolia website. This software update will upgrade the unit's system software to **Version 1.7.0**.

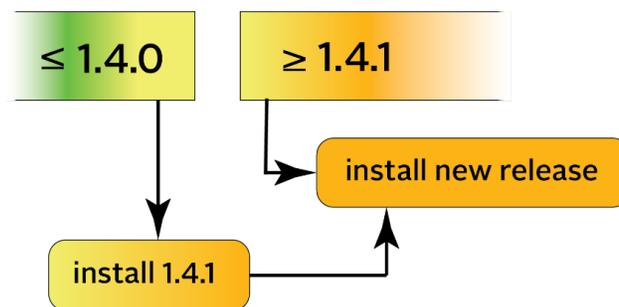
Note: if your unit is currently on a software version below 1.4.1, it is necessary to upgrade to 1.4.1 before proceeding further (see image below). The upgrade to 1.4.1 comes with significant system changes and does not allow downgrading to earlier versions. Refer to the upgrade warnings section of the 1.4.1 release notes in this document for specific information.

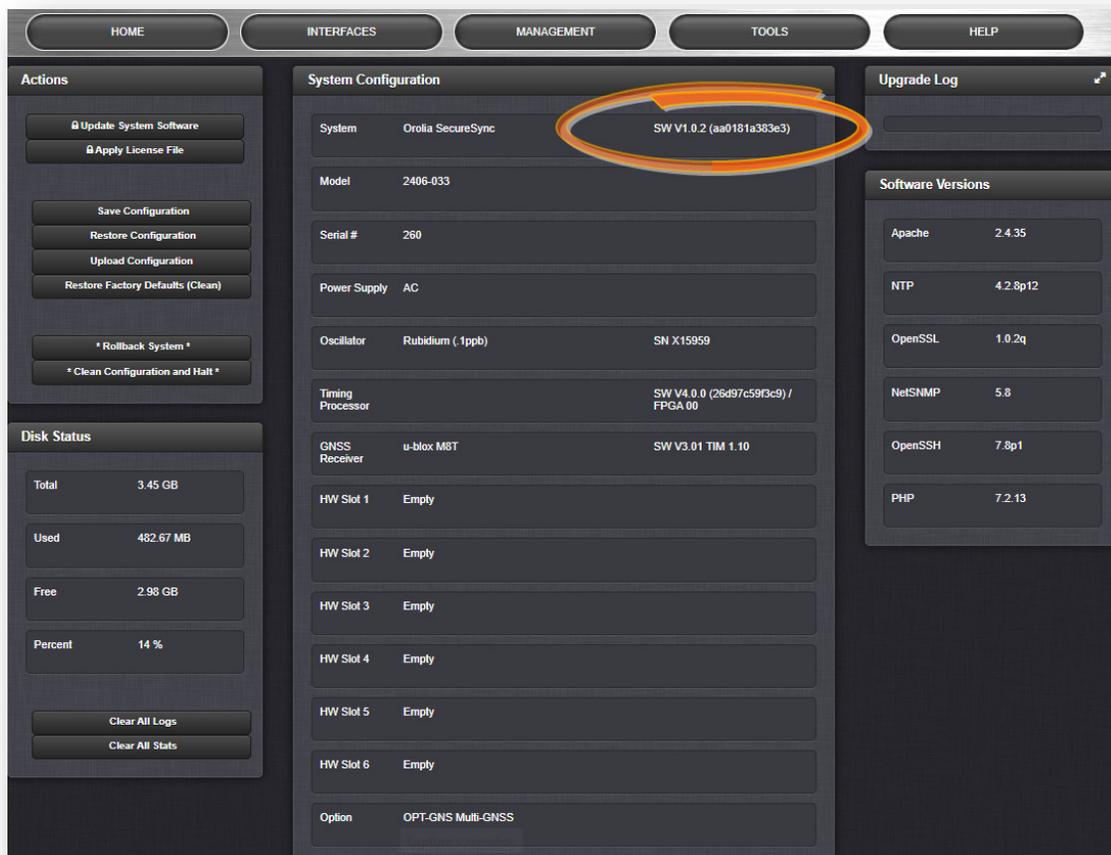
1. Login to the unit's Web UI
2. Navigate to **Tools > Upgrade/Backup**. The **System Configuration** panel in center of the screen displays the current version number under System:

Figure 1: Software revision reported under Tools > Upgrade/Backup.

To determine the software version currently installed on your unit:
