# SecureSync 2400

## Software Version 1.8.0: Release Notes

Safran Trusted 4D (Orolia/ Spectracom) released a software update for SecureSync 2400 model. Customers can download this software update at no charge from the Safran Trusted 4D website (see [Downloading the Software Update](#)). This software update will upgrade the unit's system software to **Version 1.8.0**.

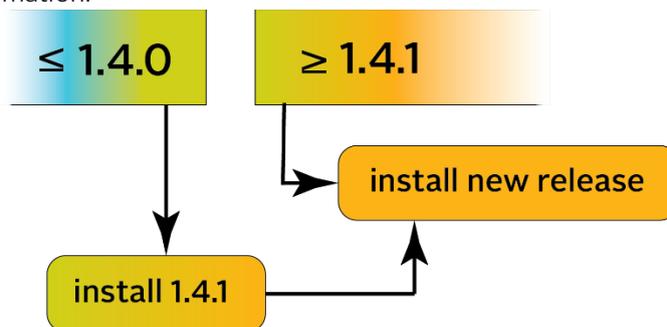
**Note:** if your unit is currently on a software version below 1.4.1, it is necessary to upgrade to 1.4.1 before proceeding further (see image below). The upgrade to 1.4.1 includes significant system changes and does not allow downgrading to earlier versions. Refer to the upgrade warnings section of the 1.4.1 release notes in this document for specific information.

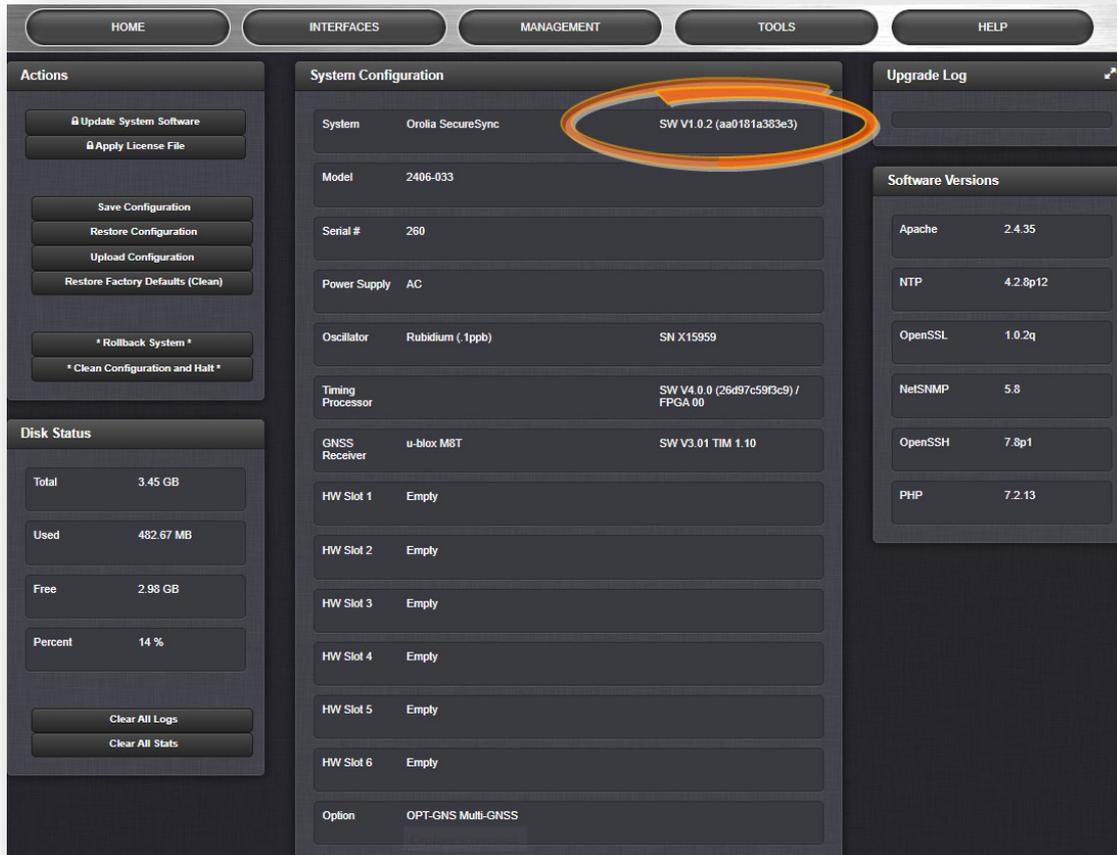
1. Login to the unit's Web UI
2. Navigate to Tools > Upgrade/Backup. The System Configuration panel in center of the screen displays the current version number under System:

Figure 1: Software revision reported under Tools > Upgrade/Backup.

*To determine the software version currently installed on your unit:*
