Model 1200 series SecureSync/9400 series

Lafayette (Model 1200 series SecureSync)

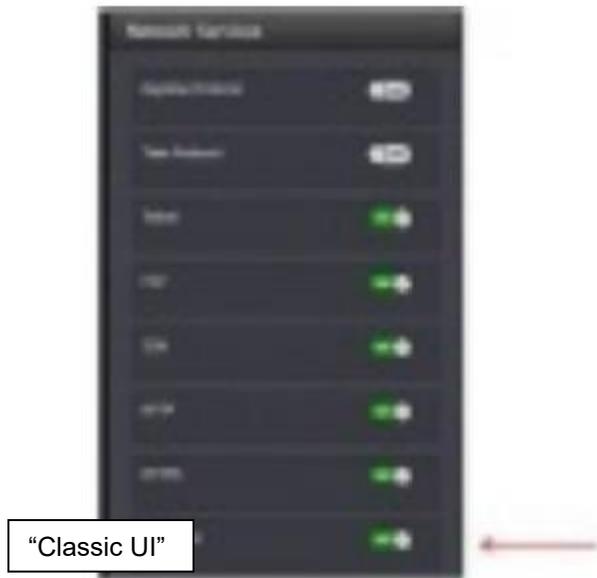
Email Keith sent to a customer: To disable the classic interface browser, navigate to the bottom of the Management -> Network page of the browser. At the bottom of the list of "Network Services" (left side of the page) is the "Classic UI" slider switch.

Simply slide this switch to the OFF position and the classic interface is no longer available!

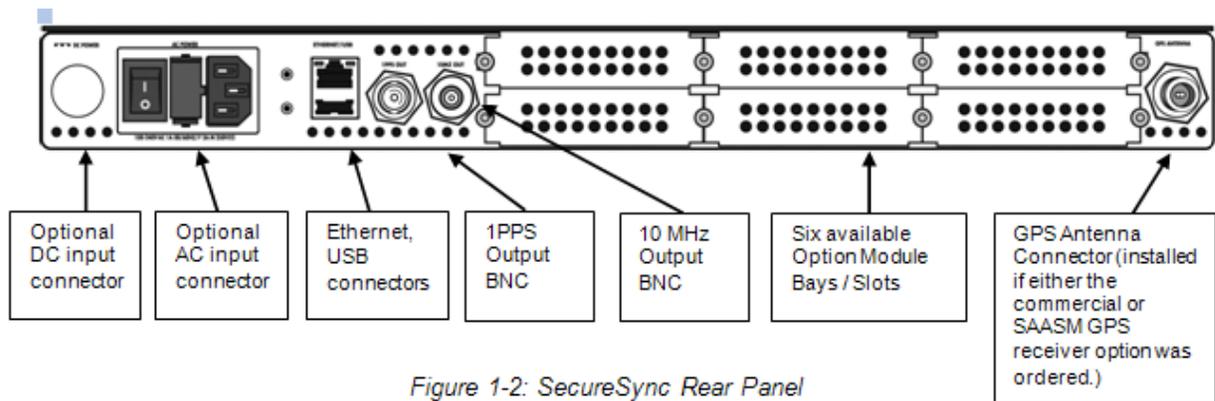
Figure 1-2: SecureSync Rear Panel

Rear panel/Slots-Slot Numbering

C) SecureSync rear panel

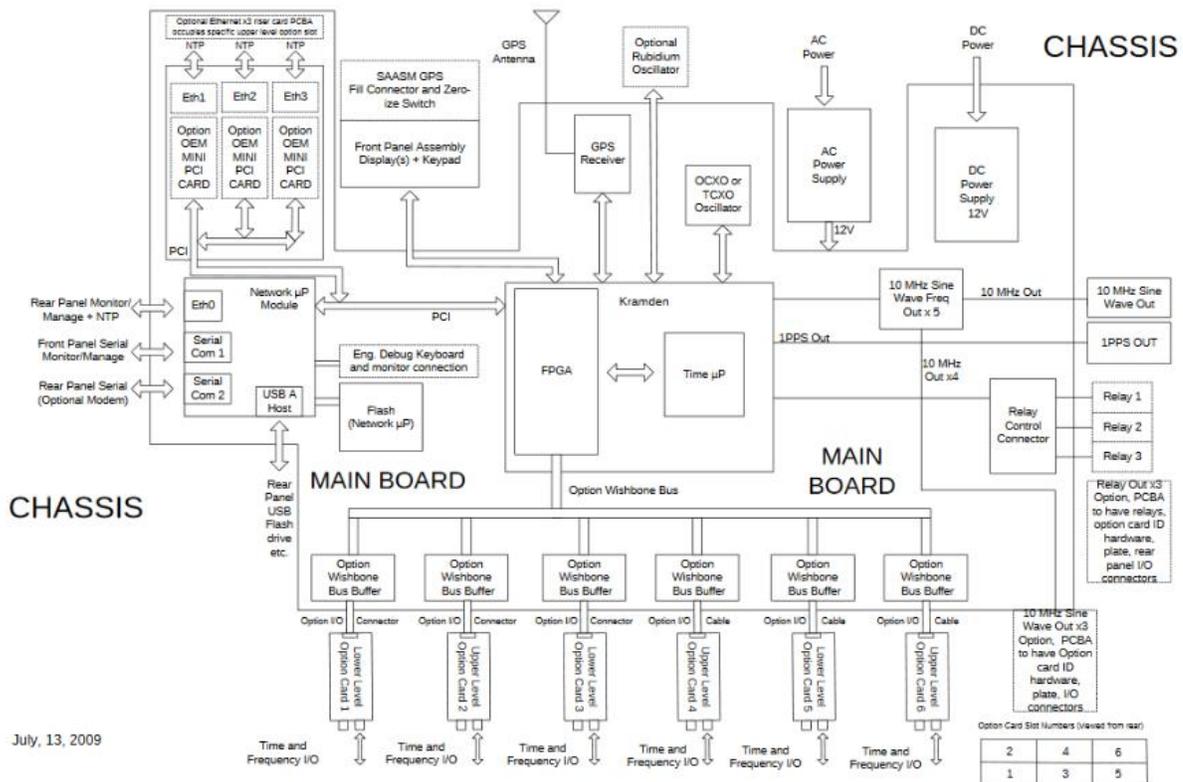
Figure 1 – Lafayette System diagram

Lafayette Main Board/Chassis HW Spec.
Security Level: SPECTRACOM PROPRIETARY
Audience: INTERNAL

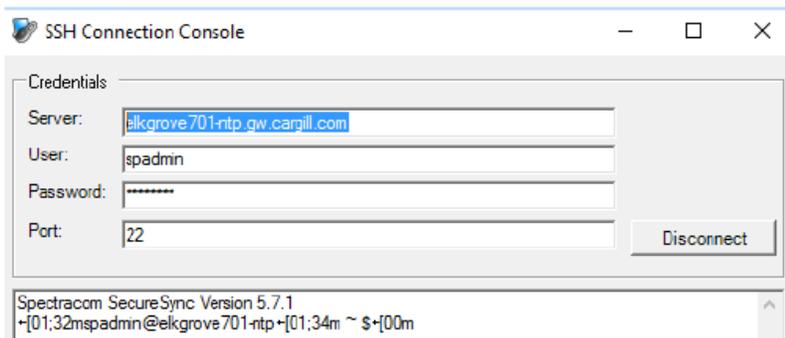
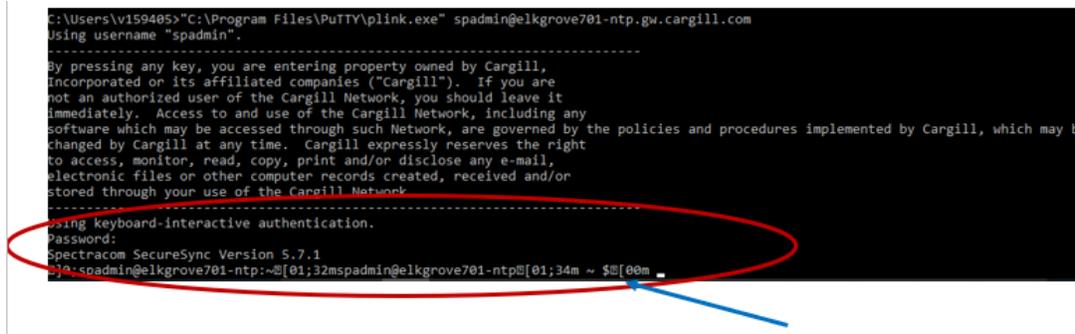
Customer Report (Aug 2018) We have SecureSync setup in our environment and we are integrating its local account password management to Lieberman tool. In pursuing doing this integration we are failing to change the password of the accounts and below is the update from the tools team. Please share your advice to get this integrated to Lieberman tool for its password management.

Post login, it prompts with weird characters. It may be due to color coding or character length limitation. Please check with vendor.

Email from Ron Dries (21 Aug 18) The software version is 5.7.1 and they are using ssh as spadmin. The issue appears to be due to terminal colors, and the terminal they are using is not able to handle them.

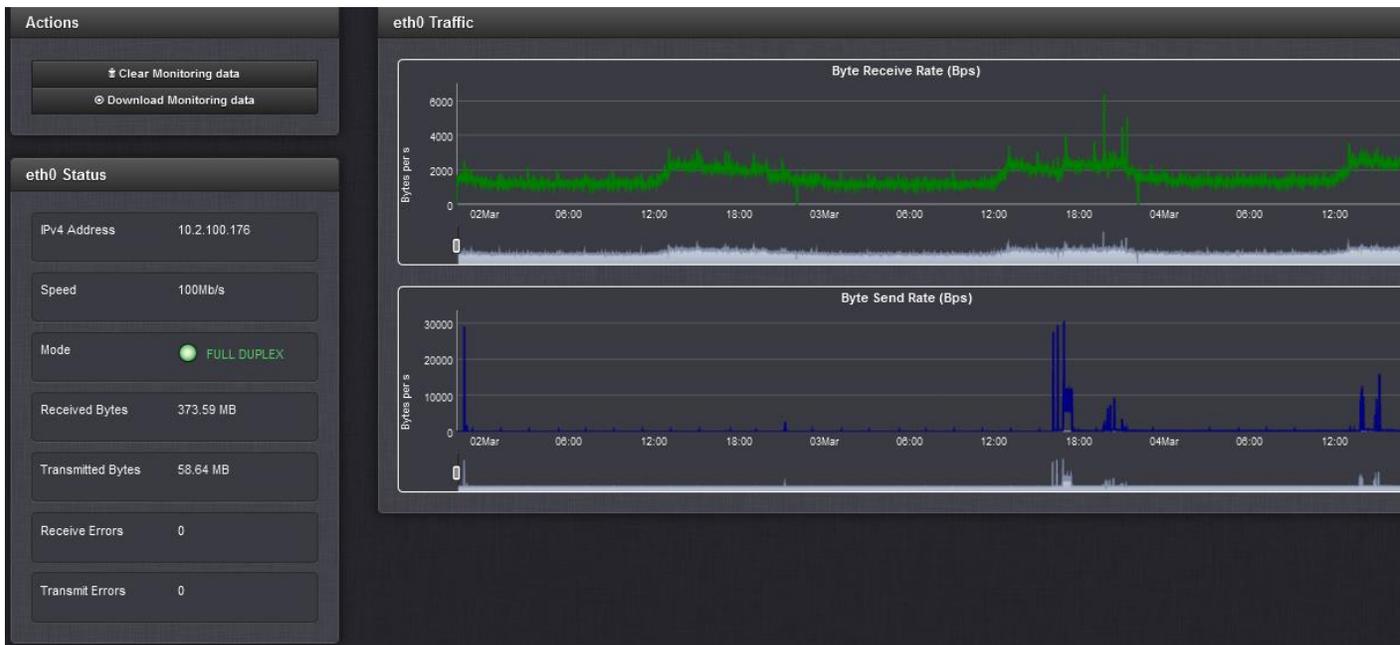
Tools -> Ethernet Monitor page (added in software update version 5.4.0)

- Eth0 transmit/receive graphs are in the Tools -> Ethernet Monitor page
- This new page was added in update v5.4.0

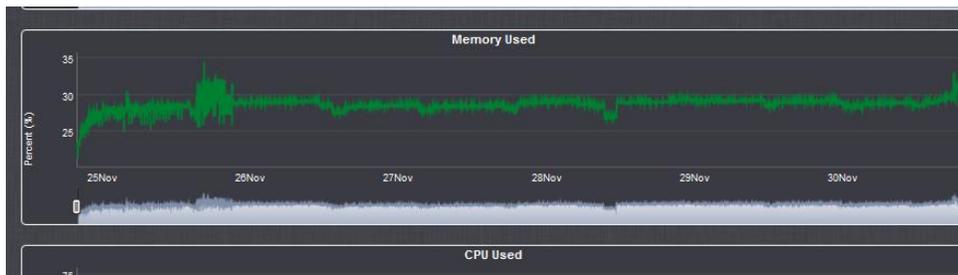
1. Memory Used” graph at the bottom of the Tools -> System Monitor page of the newer browser

- This graph available starting in software update version 5.3.1

Partial email from Tim Hammer (24 Sept 2021) Memory Used is determined using data obtained from the Linux kernel and represents the percentage of memory that is not available on demand.

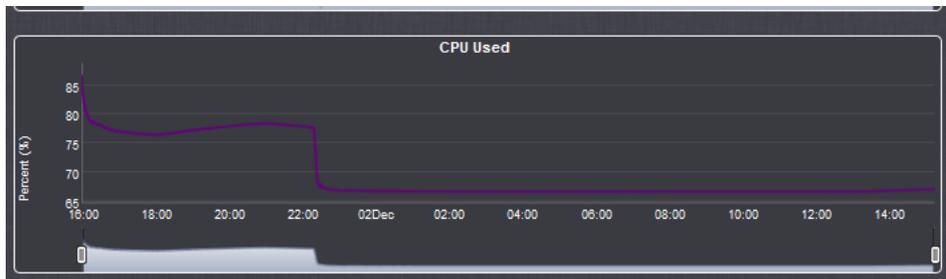
1. “CPU Used” graph towards the bottom of the Tools -> System Monitor page of the newer browser

- This graph available starting in update version 5.3.1

Partial email from Tim Hammer (24 Sept 2021) CPU Used is determined using data obtained from the Linux kernel and represents the percentage of time that the CPU is busy working (vs. being idle). Similar to memory usage, normal operations will result in fluctuations as applications and the kernel provide the unit's functionality.

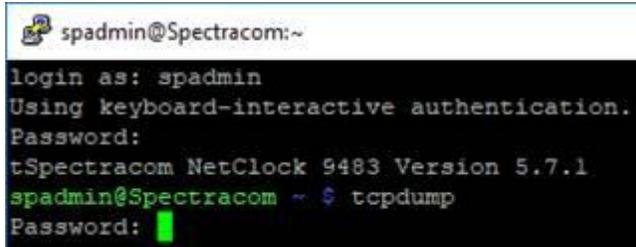
- 1) use **CTRL + C** to stop a capture in progress
- 2) If the tcpdump command responds with a password (as shown below) tcpdump has been disabled in the time sever (and can't be re-enabled without performing a full upgrade/restore to factory default):

```
spadmin@Spectracom:~  
login as: spadmin  
Using keyboard-interactive authentication.  
Password:  
tSpectracom NetClock 9483 Version 5.7.1  
spadmin@Spectracom ~ $ tcpdump  
Password: █
```

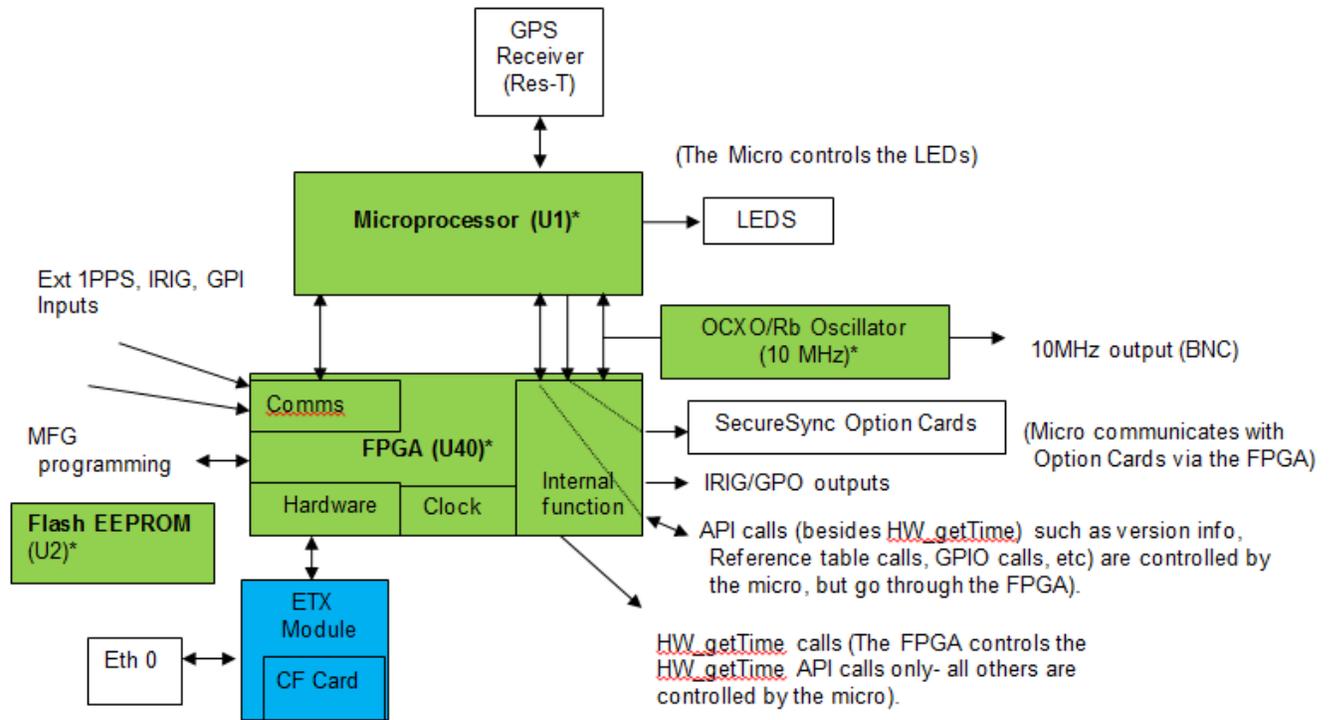
* denotes item is part of the Kramden Timing System (KTS) (Green fill items)

Network processor software (blue fill)

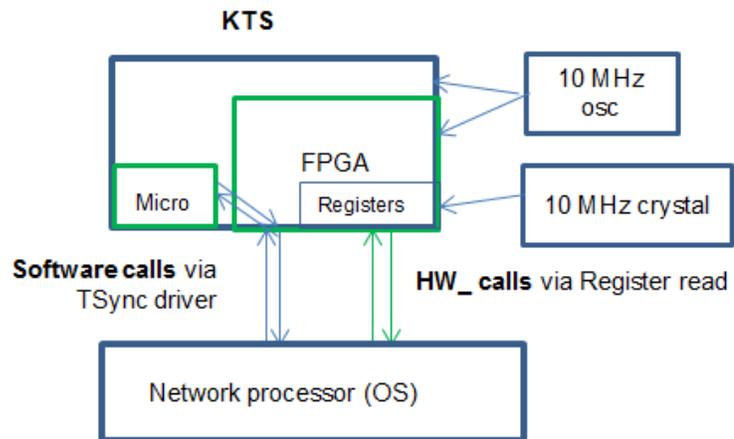
Kramden Timing System (KTS)

Function: “Brains” of system timing, input reference functionality , all of the TSync related calls (GetTime calls, oscillator control, GPIO, GPS)

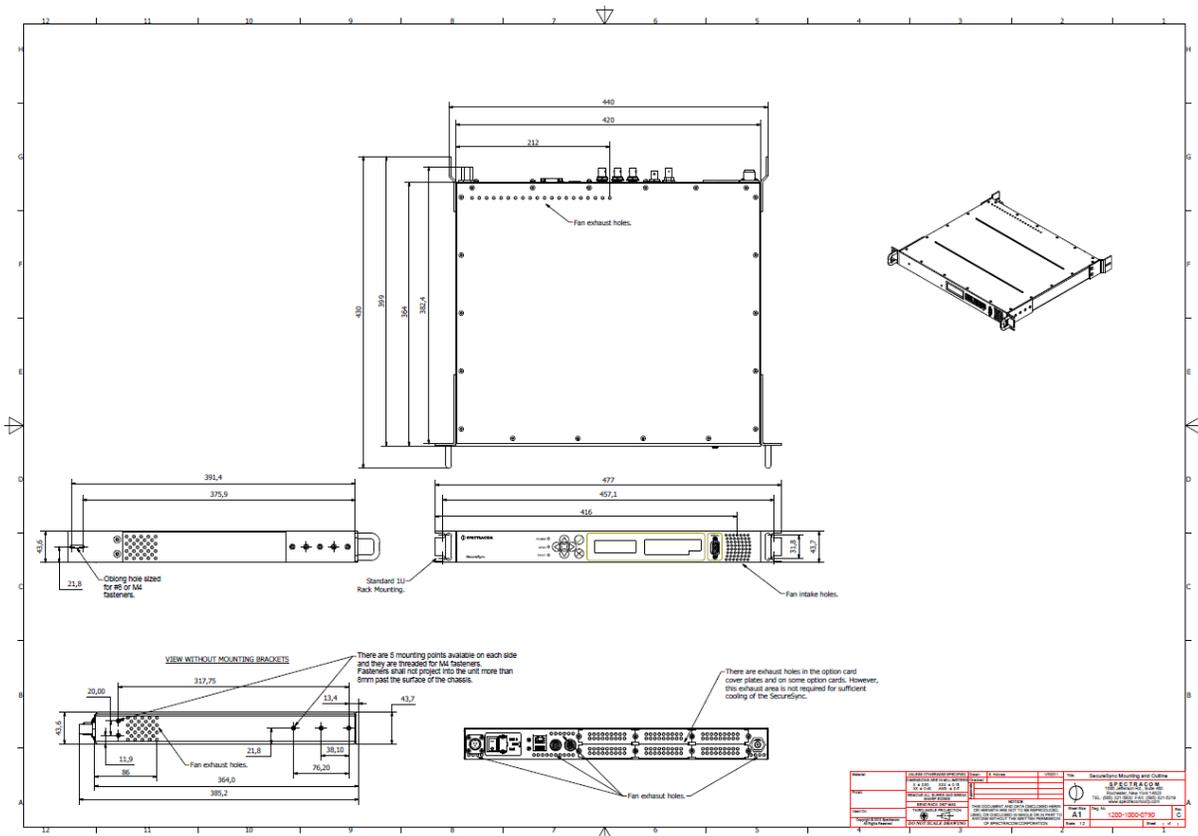
Mounting hardware

- Drawing below (1200-1000-0790rd) at [I:\Customer Service\EQUIPMENT\SPECTRACOM\EQUIPMENT\SecureSync\CAD - 3D drawings\SecureSync with Trimble or No GPS receiver\1200-1000-0790rd \(mtg and outline\).pdf](I:\Customer Service\EQUIPMENT\SPECTRACOM\EQUIPMENT\SecureSync\CAD - 3D drawings\SecureSync with Trimble or No GPS receiver\1200-1000-0790rd (mtg and outline).pdf)

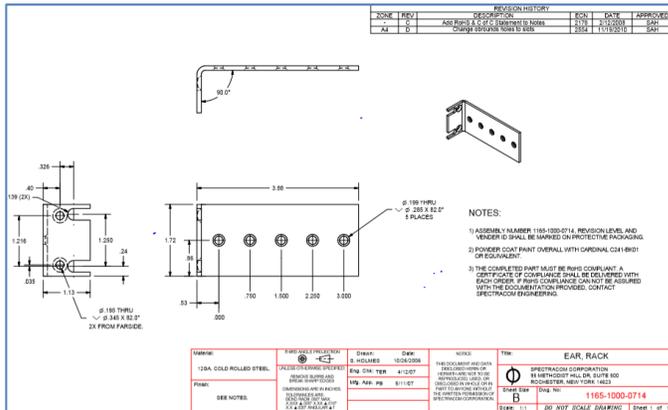
- SecureSync uses the same rack ear hardware as the Model 9300 series NTP time servers
- Mechanical drawing of rack ears: Refer to drawing “1165-1000-0714” (in Arena) at:
 - https://app.bom.com/items/detail-sourcing?item_id=1202841946&version_id=10221223518&orb_msg_single_search_p=1&redirect_segno=8126093994

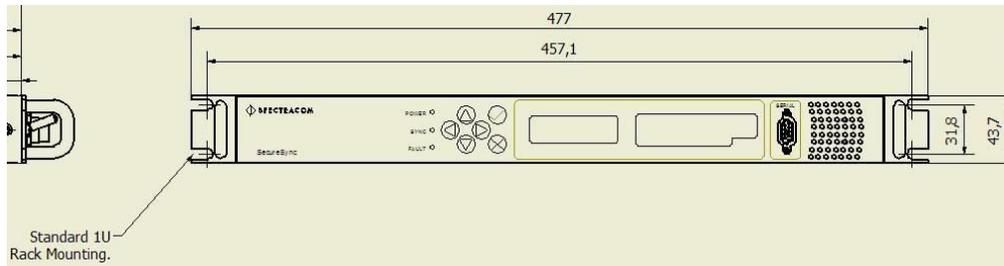
Below is a current drawing that shows the rack ear slots for the Spectracom SecureSync mounting. Our Hardware design engineer also mentioned that the slot size of 7.1 +/- 0.3 is per specification EIA-310-D.

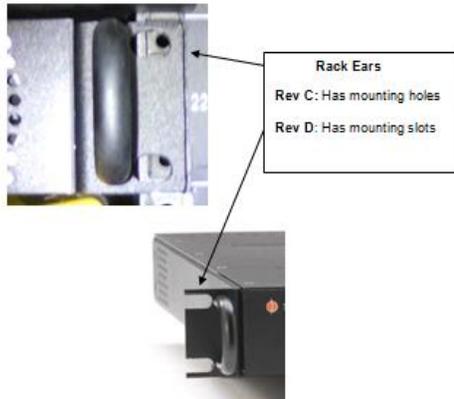
Rack ears are too short for 19 inch rack

- Refer to Case 6074 (Pavel May with Jane Street capital) for additional info
- Pavel reported the ears were too short, and sent us the following picture.

Note: The two rack ears are placed in a small static bag. The bag doesn't have a label on it indicating the P/N or Rev for the rack ears. The rev of the two ears is obtained by questioning if the ears have a mounting hole or mounting slots, as shown above.

(8/15/12) Scott Holmes responded to us with: They have the old 1165-1000-0714 Rev C rack ears. His rack is a bit out of tolerance or these ears would fit. We had one or two customers with this problem over the years so we submitted an ECN in November 2010 to open up the mounting holes in order to add more tolerance here. We now stock the Rev D part. If we send them a pair of the current 1165-1000-0714 Rev D rack ears, that will solve their problem

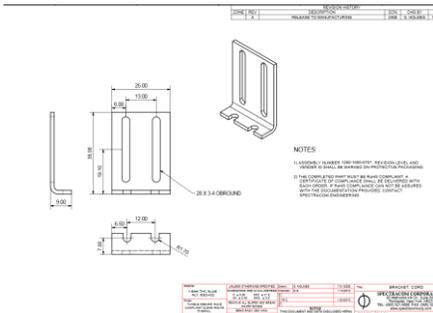
The 1200-1000-0707, 1200-1000-0708 are used to secure the AC power cord in the SecureSync using the two holes next to the power inlet module using (2) HM11R-03R5-0004 M3.5x4 screws and the HM72R-03R5-0002 nut.

- In addition to two rear support brackets, the AC support Bracket and hardware is included in the SecureSync Anc Kit, Rugged Installation" (1200-0000-0704)
- P/N for just the Power cord bracket 1200-1000-0707

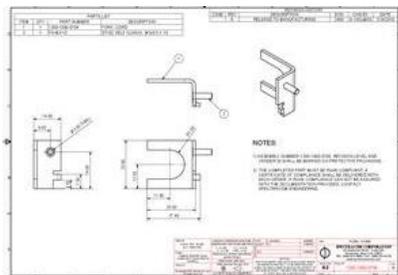
- P/N for just the Power cord fork: 1200-1000-0708

- This cord bracket attaches to the two vertical holes right next to the AC power connector (using the two **HM11R-03R5-0004 screws**)

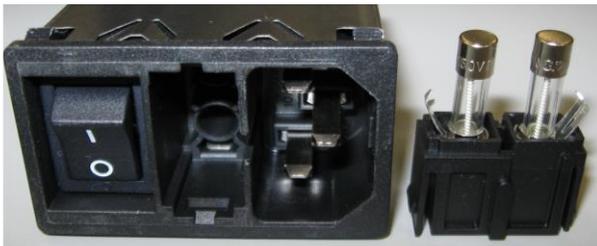
- F010R-0002-000E, FUSE, 2A,SB, IEC SURGE, GLASS, 250V, 5X20M, Fuses for AC power entry module
- MFG P/N Littelfuse 0213002.MXP

The AC fuses (Spectracom P/N F010R-0002-000E) used in the SecureSync are from a company called Littelfuse and their P/N is 0213002.MXP. They are available through Digikey. They can refer to <http://parts.digikey.com/1/parts/692754-fuse-250v-iec-slo-5x20mm-2a-0213002-mxp.html> for replacements.

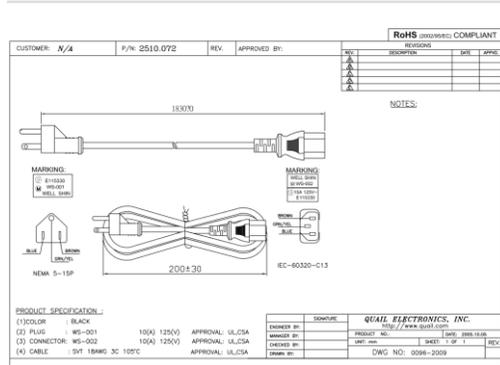
A) US version line cord (120VAC) (CA06R-1513-0001)

- Our P/N: CA06R-1513-0001
- Refer to: (ArenA) https://app.bom.com/items/detail-spec?item_id=1202841923&version_id=10257870238

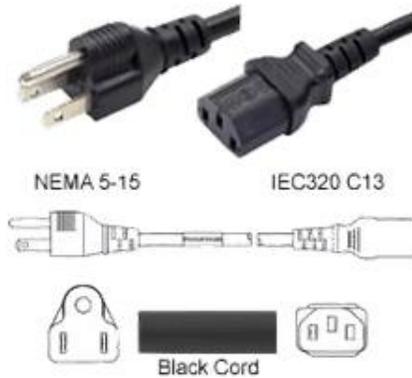
- **Cable length:** 6 ft 7 inches (2032 millimeters)

Standard (supplied) “detached” power cable is C13 to NEMA 5-15P (this cable is not attached to the back of the unit- it’s detachable from the power connector).

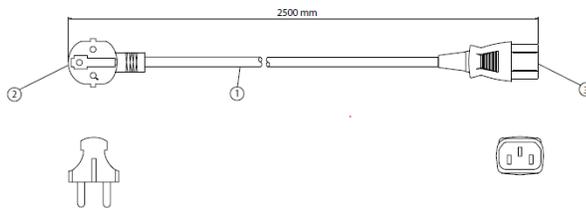
B) Euro version line cord (CA06R-EU13-0001)

- Our P/N: CA06R-EU13-0001 (in Arena) https://app.bom.com/items/detail-spec?item_id=1203165790&version_id=10257870248
- **Description:** AC CORD,EU to C13,18AWG,10A,250V, 70C
- **Cable length:** 8.2 feet (2500 millimeters)

PLUG: CONTINENTAL EUROPEAN CEE 7 RIGHT ANGLED **Connector:** IEC 60320 C13 (to SecureSync)

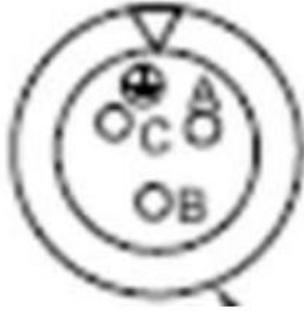
At the bottom of this page, click to expand the "**Pinout description, DC connector**" information. As also excerpted below, the NetClock can accept either + or - DC input voltage. The difference between the two is just which Pin (Pin A or Pin B) of the three pin connector the DC power is connected to:

Pin B goes to the most positive DC voltage of the DC source. For +12 V or +24/48 V this would be the positive output from the DC source. **For a -12 V or -24/48 VDC source this would be the ground or return of the DC source.**

Pin A goes to the most negative voltage of the DC source. For +12 V or +24/48 V this would be the ground or return output from the DC source. **For a -12 V or -24/48 VDC source this would be the negative output from the DC source.**

Pin A goes to the most negative voltage of the DC source. For +12V or +24/48V this would be the ground or return output from the DC source. For a -12V or -24/48V DC source this would be the negative output from the DC source.

Pin C goes to the Earth ground of the DC source.

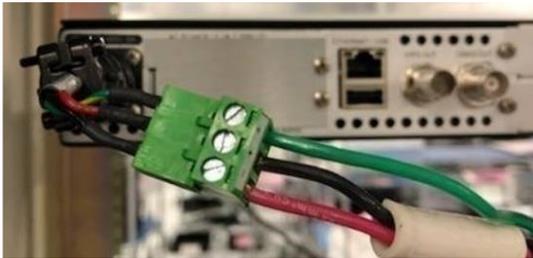
CA08R-PST3-0001 (DC connector to 3 position terminal block connector adapter cable)

- **Description:** CABLE,CIRC TO Terminal,3 Pos terminal block,18AWG,300VAC
- **in SAP:** https://app.bom.com/items/detail-spec?item_id=1223896303&version_id=10709212858
- **Process Detail (CA08R-PST3-0001-PD) in Arena:** https://app.bom.com/items/detail-spec?item_id=1248910025&version_id=11027259628
 - PD includes the drawing below

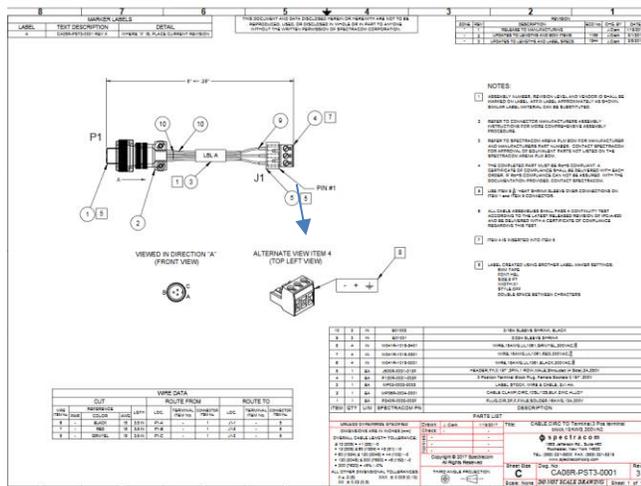
3 Pin Terminal block connector (plugs into J500R-0031-012F, which is soldered to the wires)

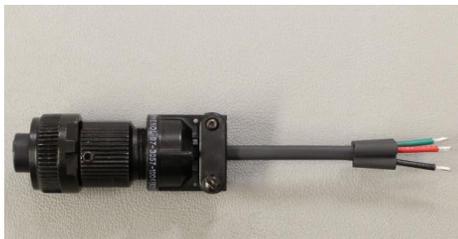
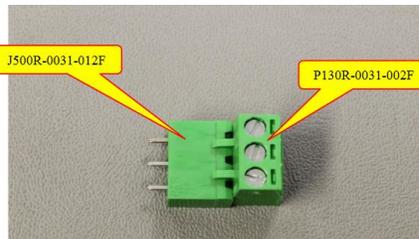
Our P/N: P130R-0031-002F

Note: The three Wires are soldered onto the small metal shafts and shrink-wrapped onto a separate Jack (there are two connectors, not just one).

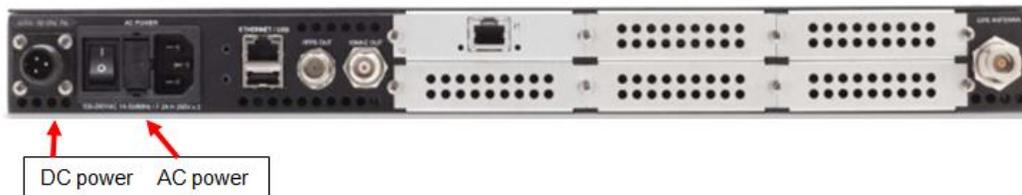
C) SecureSyncs with both AC and DC Input power

Note: AC input, when supplied, is selected over the DC input (AC input is primary. DC input is backup).

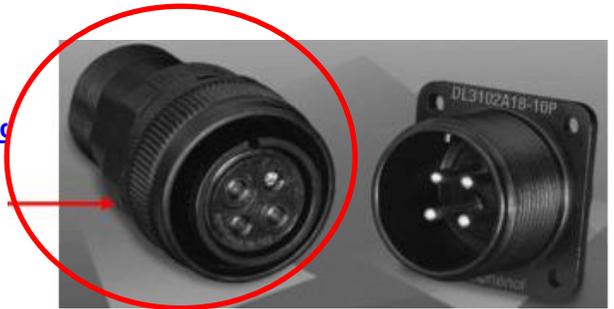
A) Mating connector

- Amphenol P/N: DL3106A10SL-3S
- Our P/N: P240R-0032-002F (in Arena) at: https://app.bom.com/spec?item_id=1202844982&version_id=10221223528

The DC mating connector is an “Amphenol” connector. Their Part Number is “DL3106A10SL-3S”. The Spectracom P/N is P240-0032-002F. The connector has solder cups for soldering wires to the connector pins.

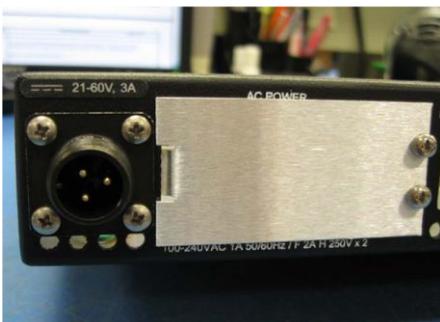
DC power only

Below are two pictures of the DC connector. It’s a little difficult to see from this picture, but the outer circle of the connector is threaded:

This comment is referring to the available DC input power connector for the SecureSync. The AC input is a standard IEC line cord. The DC connector is threaded so that the mating connector can be physically and positively attached with a metal threaded nut. Though not necessarily recommended, the SecureSync could theoretically be picked up by its mating DC power connector without the plug falling off the back of the SecureSync and thereby causing the unit to lose input DC power.

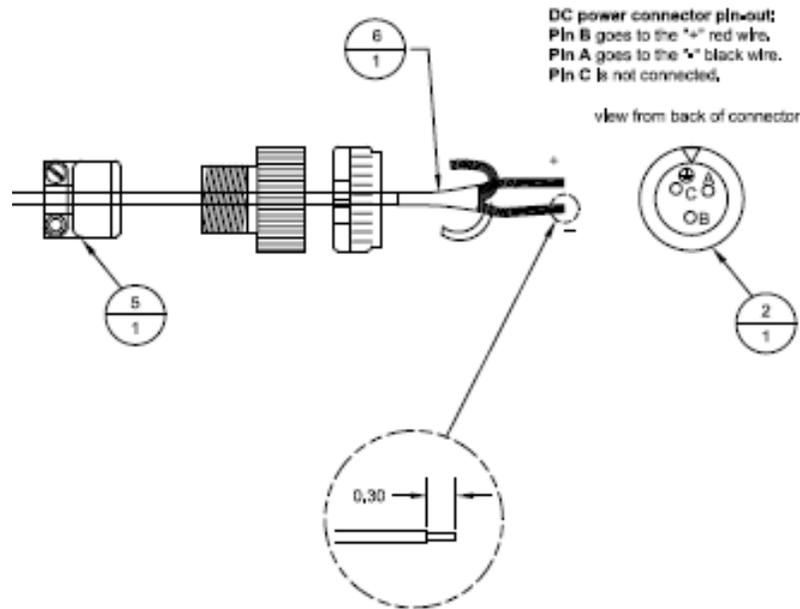
DC power wiring

- A cable of 6 feet or less, using 16AWG wire, with adequate insulation for the DC voltage source should be used with this connector.
- The 6 feet or less cable is due to inrush current causing voltage drop. Refer to email below.

Email from Sam Otto: I checked with design engineer ([Mark McGregor](#)) who recommends a 24VDC, 6.25 Amp, 150 watt power supply using 16 gauge wire less than 1 meter from out unit. The reason for this is the inrush current causes the voltage to drop which results in an under voltage lockout preventing your SecureSync from powering on.

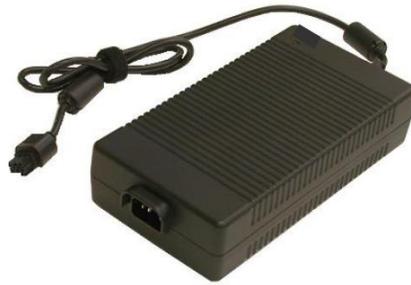
**** (PS06R-2Z1M-DT01) Available AC to 24VDC converter for Dual AC input power**

Shortcut to MFG data sheet (SL Power MENT1220.pdf): <I:\Engineering\Engineering Shared\Spectracom Parts ROHS\PS06R-xxxx-xxxx> (Note: we use power option 2)

Highly recommend considering to purchase and use the [Spectracom Model PS06R-2Z1M-DT01 \(Available AC to 24VDC converter for redundant AC input\)](#) instead of retrofitting the time server. This external AC to DC converter will alleviate the need for the equipment to be returned to us for hardware modifications.

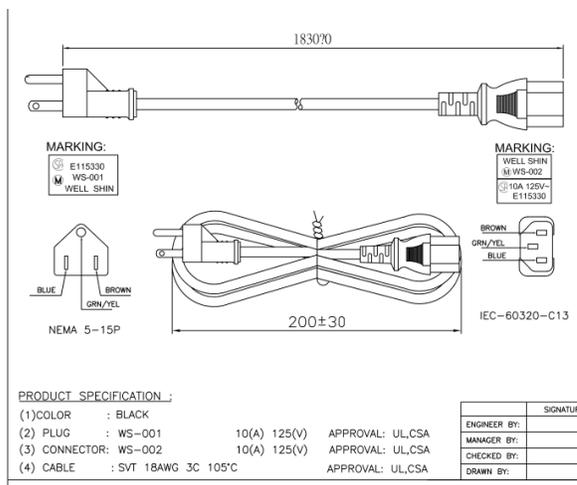
Provided AC Line cord (CA06R-1513-0001)

- Refer also to "**AC power cable included in ancillary kit**" (in this same document)
[CA06R-1513-0001](#) AC CORD,5-15P to **C13**,18AWG,10A,125V,105C
- The cable length of the 2nd AC power is 3 ft. or 0.9 Meters

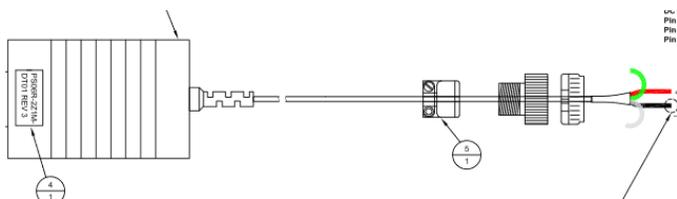
DC Output

- Length of cable ~38 inches
- **DC Connector** Our P/N P240R-0032-002F (Amphenol Pre-Earth/FMLB threaded connector DL3106A10SL-3S, for mating with the input DC connector on the back of the chassis)

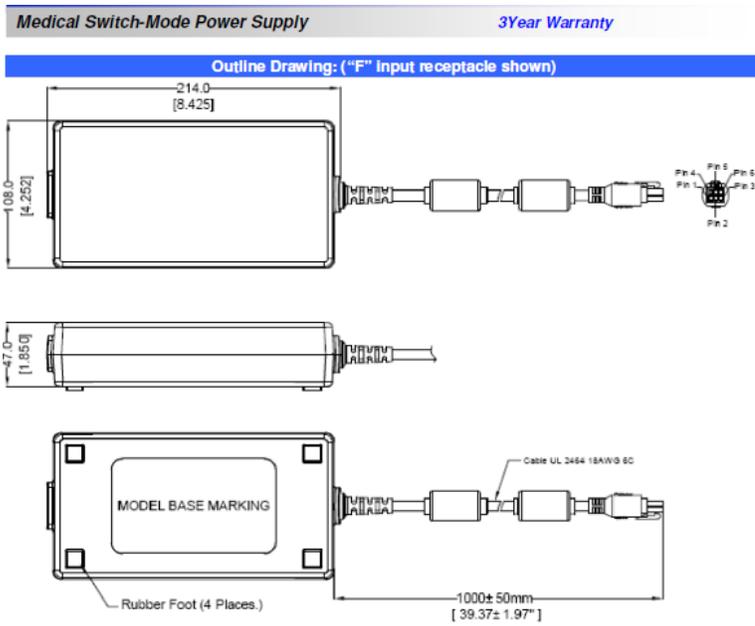
Mechanical mounting for the power supply

- No mounting is provided- any mounting needs to be custom
- Manufacturer's Data Sheet contains a mechanical drawing that can be provided as a reference for a customer to create some type of custom mount:

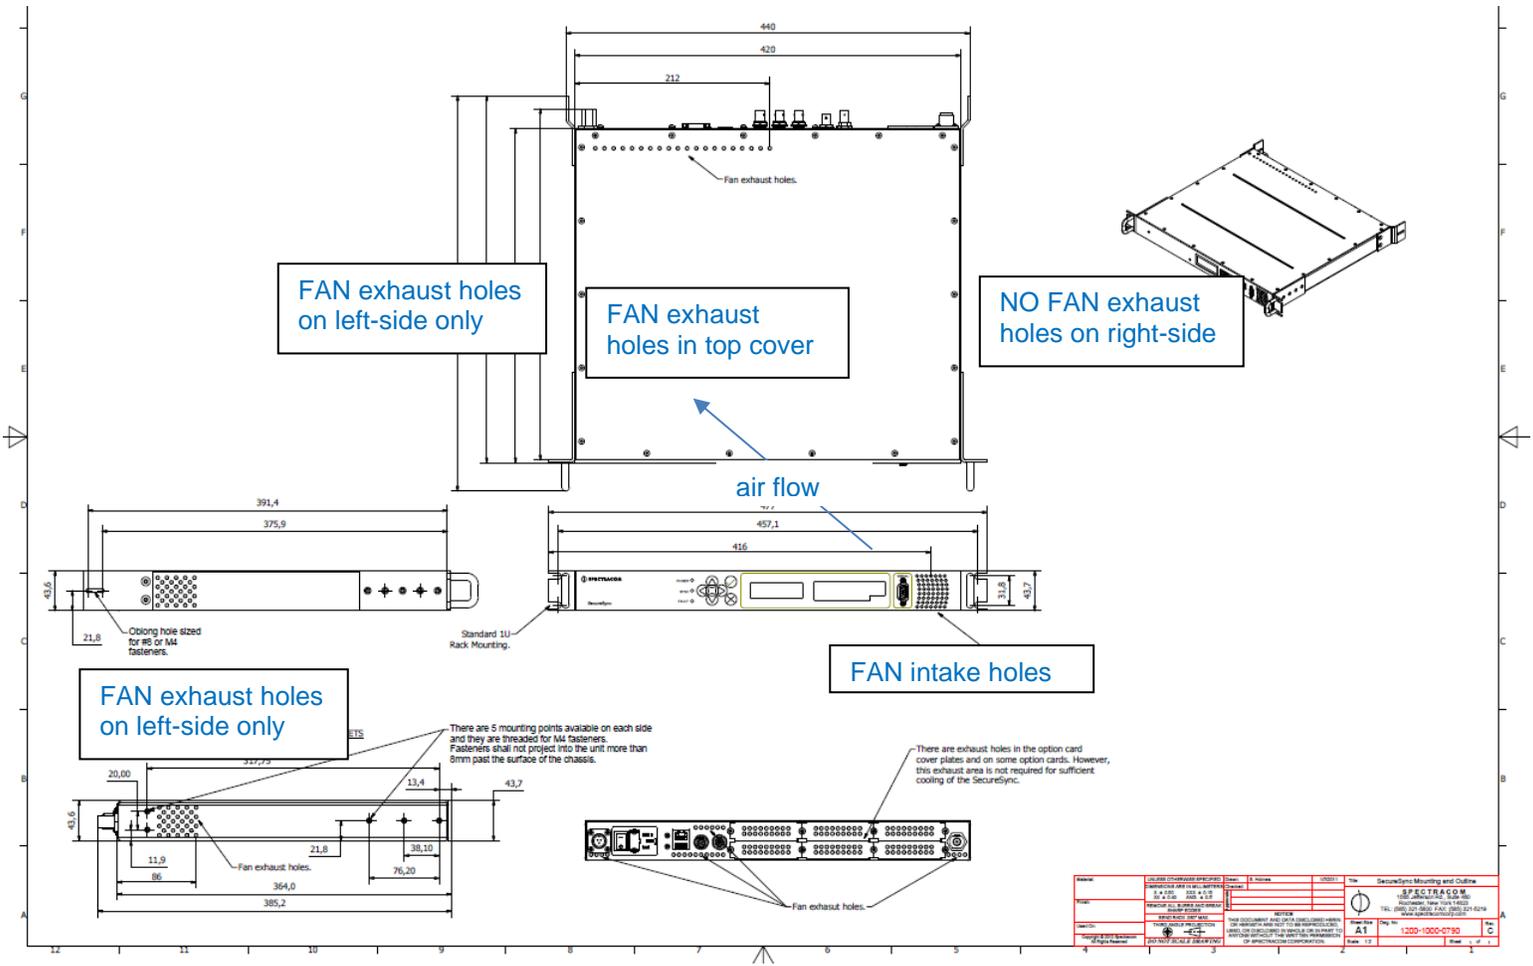
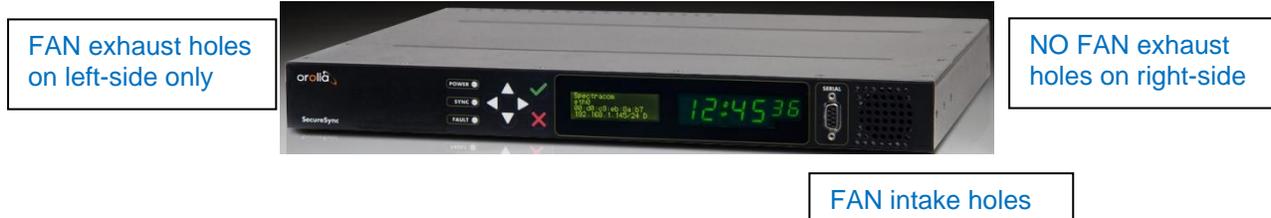
Airflow thru chassis/Airflow requirements

- Drawing below (1200-1000-0790rd) at [I:\Customer Service\EQUIPMENT\SPECTRACOM\EQUIPMENT\SecureSync\CAD - 3D drawings\SecureSync with Trimble or No GPS receiver\1200-1000-0790rd \(mtg and outline\).pdf](I:\Customer Service\EQUIPMENT\SPECTRACOM\EQUIPMENT\SecureSync\CAD - 3D drawings\SecureSync with Trimble or No GPS receiver\1200-1000-0790rd (mtg and outline).pdf)

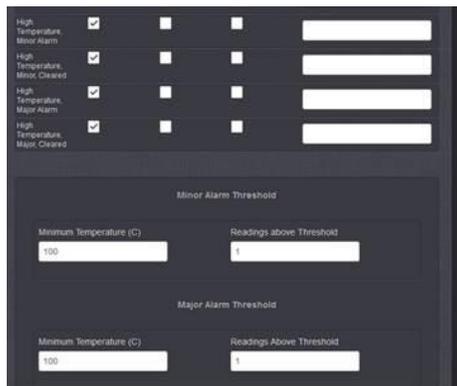
However, software version 5.3.1 also added SNMP traps and gets and Minor/Major alarms associated with the internal temperature. If the cooling fan was to fail and this resulted in the internal temperature exceeding a user-specified threshold, a Minor and/or Major alarm can be optionally asserted and an optional SNMP trap can be sent to an SNMP Manager. Alarms and SNMP Trap alerts for high/low temperatures are configured in the **Management -> Notifications** page of the browser (with version 5.3.1 or above installed), System tab (as shown below)

checkboxes in this tab allow the associated temperature traps to be enabled to be sent, and the user-configurable temperature thresholds are configured in the fields towards the bottom of this tab. “Readings above threshold” allows a delay (in seconds) between each insertion of this alarm (for instance, set it to “5” for a 5 second delay between each insertion of the condition, if the temperature remains above the specified value for a length of time. this prevents it from being continuously inserted as the temp remains above the threshold).

However, software version 5.3.1 also added SNMP traps and gets and Minor/Major alarms associated with the internal temperature. If the cooling fan was to fail and this resulted in the internal temperature exceeding a user-specified threshold, a Minor and/or Major alarm can be optionally asserted and an optional SNMP trap can be sent to an SNMP Manager.

Checkboxes in this tab allow the associated temperature traps to be enabled to be sent, and the user-configurable temperature thresholds are configured in the fields towards the bottom of this tab. "Readings above threshold" allows a delay (in seconds) between each insertion of this alarm (for instance, set it to "5" for a 5 second delay between each insertion of the condition, if the temperature remains above the specified value for a length of time. this prevents it from being continuously inserted as the temp remains above the threshold).

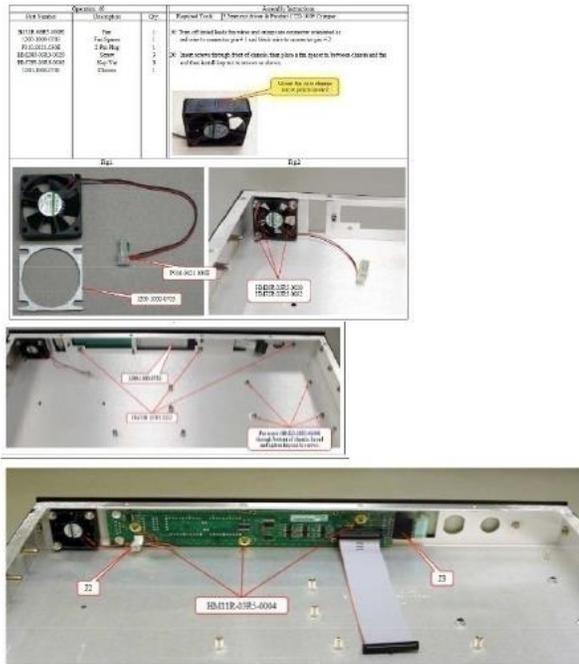
Email from Dave L (18 Apr 18) It is not impossible to replace the fan, just not really easy. You would need to disassemble the front panel a bit to prevent the fan screws from turning if they will not loosen or tighten. If they are manageable you would not need to remove the front panel.

Here is a view of the inside showing the screw locations, this should help.

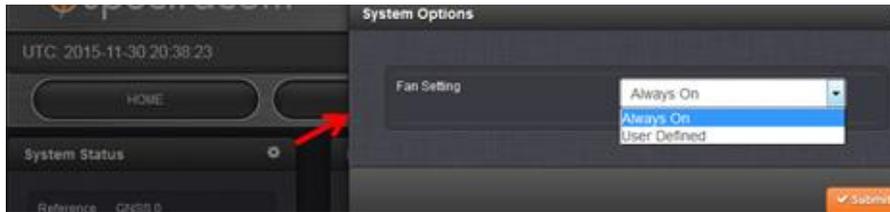
- **Home** page

- If the EEPROM has been reprogrammed, select the **gear** ICON next to “**System Status**” in the upper-left corner of the **Home** page (or the Gear ICON in the **Tools -> System Monitor** page). The pop-up window allows selection of fan “**Always On**” or “**User Defined**”. Selecting “User Defined” allows selection of fan turn-on temp (40c by default) and fan off temp (30c by default).

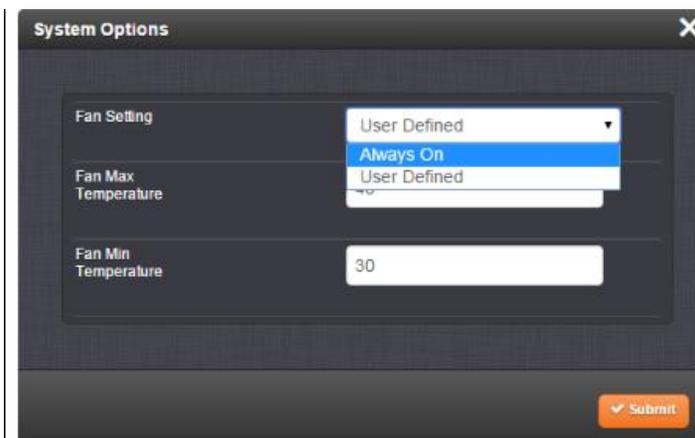
- **User Defined:**

After selecting “**User Defined**”, fan turn on/turn off temps are then displayed underneath (Based on CPU temp):

- **Fan Max Temperature:** The CPU temperature in °C at which the fan will turn ON. It is advisable to set this temperature no higher than 40°C.
- **Fan Min Temperature:** The CPU temperature in °C at which the fan will turn OFF (the default is 30°C).

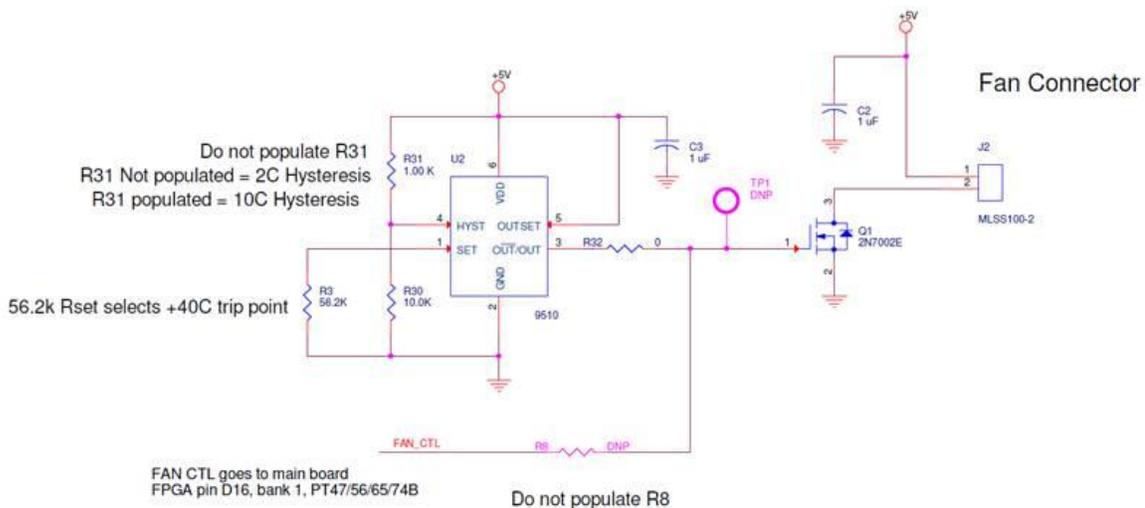
Email from Mark McGregor (12 Oct 2015) There was a period of time when the SecureSync fan control located on the front panel was changed from its original settings of fan turn on at 40C and 10C Hysteresis (for hysteresis, temperature must drop 10C to turn fan off once it is on). This will be present only on the newer front panels with bare PCB 1200-1000-0300 Rev. C. The 1200-1000-0300 Rev. C have an SMT connector to the front panel overlay, J3, rather than a through hole connector.

The 50C turn on, 2C hysteresis was done by making front panel resistor R3 to 48.7k and new resistor R31 not populated, DNP.

So, some time last year, the newer front panels fan control has been changed to be back to the original 40C turn on, with 10C hysteresis to try to keep the RB and ETX as cool as possible.

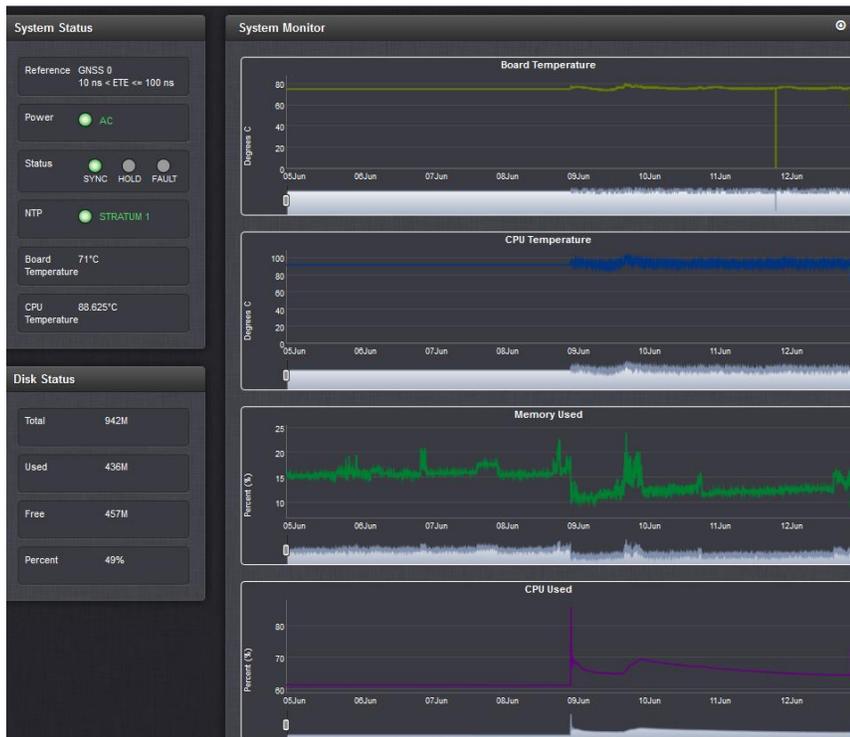
- Version 5.3.1 moved the temperature graphs to the Tools -> System Monitor page of the browser

NOTE: from talking with Dave Sohn (22 oct 15 KW). These reported temperatures (in Celsius) may initially appear to be very hot to some customers. They need to understand that these are not ambient temperatures inside the chassis. They are the actual die temperature for the processor (Processor temp and CPU temp) or very close to the ovenized oscillator (Oscillator temp). These higher temps are expected for the specific components they are monitoring.

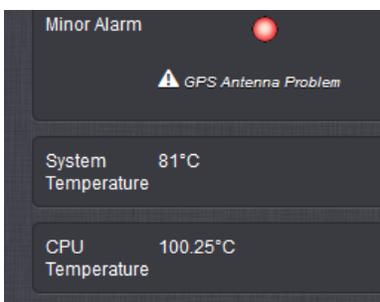
- Software version 5.3.0 (Sept 2015) also added Board (System) Temperature and CPU temperature (three different temperatures are now available, for newer units that have the temp sensor installed)
- The CPU and board temperatures are not stored in discstats. All three temperatures are stored in MySQL database and can be downloaded as part of a csv or json file. See the information further above about how to export this raw data that is used for graphing.
- **CPU Temperature** and **Board Temperature** readouts added on the left side of the **Management -> Disciplining** page:
 - **System/Board Temperature** and **CPU temperature** readouts were added on the left side of the **Home** page, as well as the left side of the **Management -> Disciplining** page
 - **Home** page of browser

- **With version 5.2.0, three different temperatures are now available, for newer units that have the temp sensor installed)**
 - **“Temperature” / “Oscillator Temperature”** = temperature sensor on PCB, near the oscillator (~ 50 deg c) (this was the first sensor reported - reported temperature was added in software versions 5.2.0/5.2.1, if the temp sensor is installed)
 - **“CPU Temperature”** = Processor temperature based on sensor near the KTS CPU processor (~100 deg C) (available in versions 5.3.0 and above)

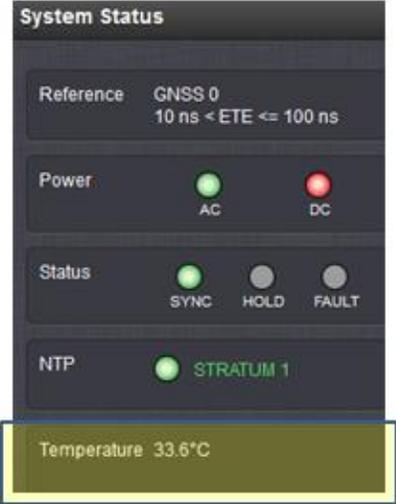
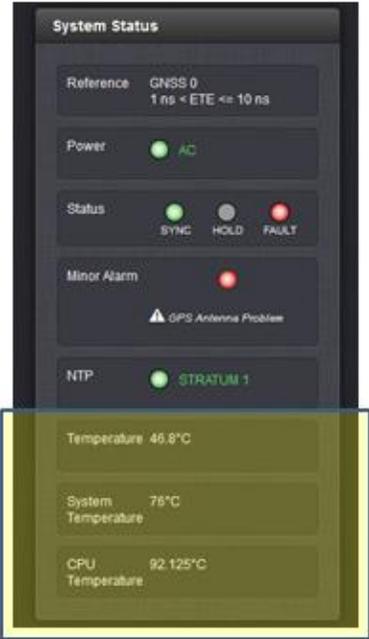
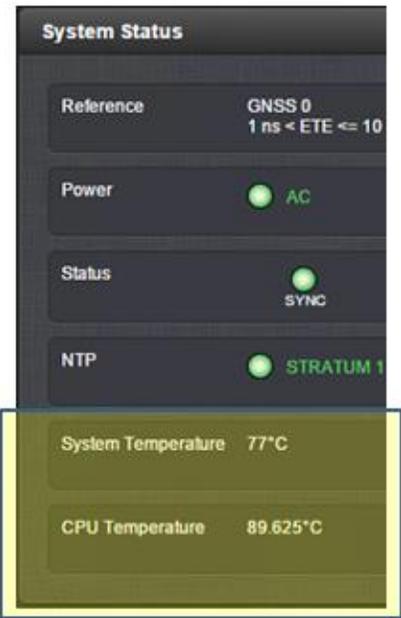
Versions 5.2.0 and 5.2.1 (if the temp sensor is installed)	Versions 5.3.0 and above (if the temp sensor is installed)	Software was updated to versions 5.3.0 and above (temp sensor was not installed)

<p>"Temperature" = temperature near the oscillator</p>	<p>"Temperature" = temperature near the oscillator</p> <p>"System Temperature" = ETX module temperature</p> <p>"CPU Temperature" = Processor temperature</p>	<p>Temperature near the oscillator not available without sensor installed</p> <p>"System temperature" = ETX module temperature</p> <p>"CPU Temperature" = Processor temperature</p>

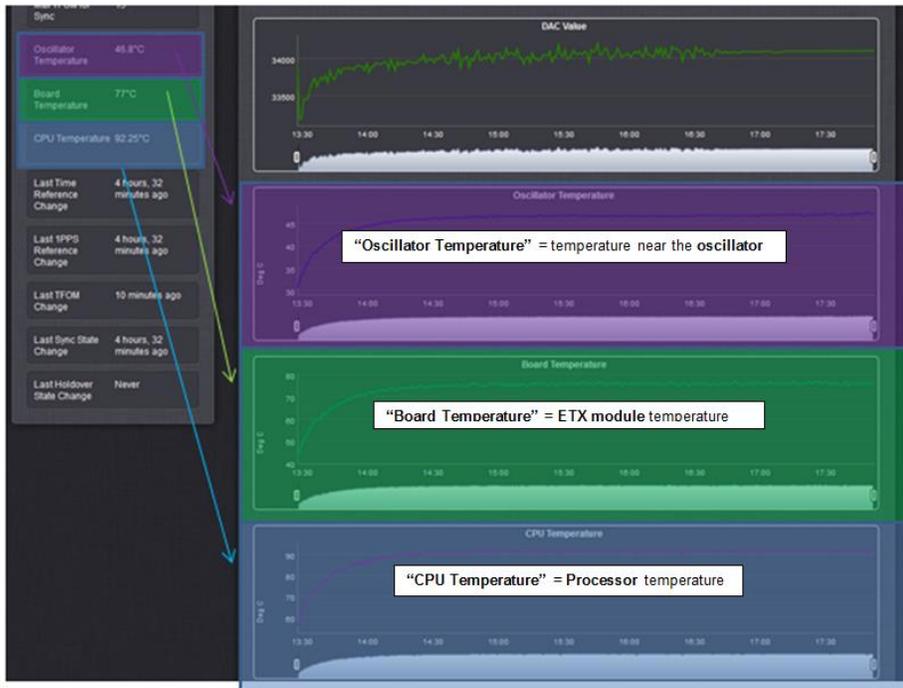
Temperature-over-time graph (Management -> Disciplining page)

- Versions 5.3.0 and above (temp sensor installed)
- Reports Oscillator, board (ETX Module) and CPU (Processor) temperatures

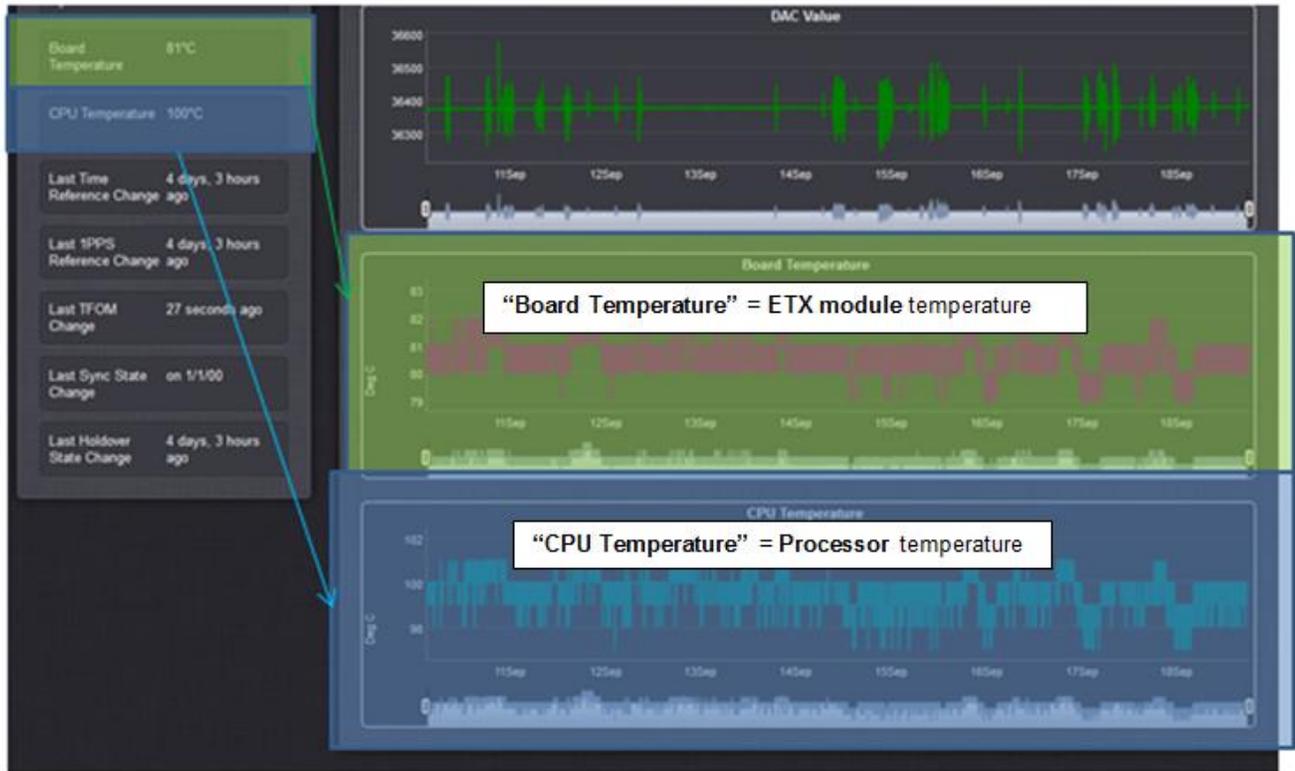
Software was updated to versions 5.3.0 and above (and temp sensor was not installed)

- Reports PCB and CPU temperatures (oscillator temp is not available without the sensor being installed and software versions prior to 5.1.7)
