Model 1200 series SecureSync/9400 series

Lafayette (Model 1200 series SecureSync)

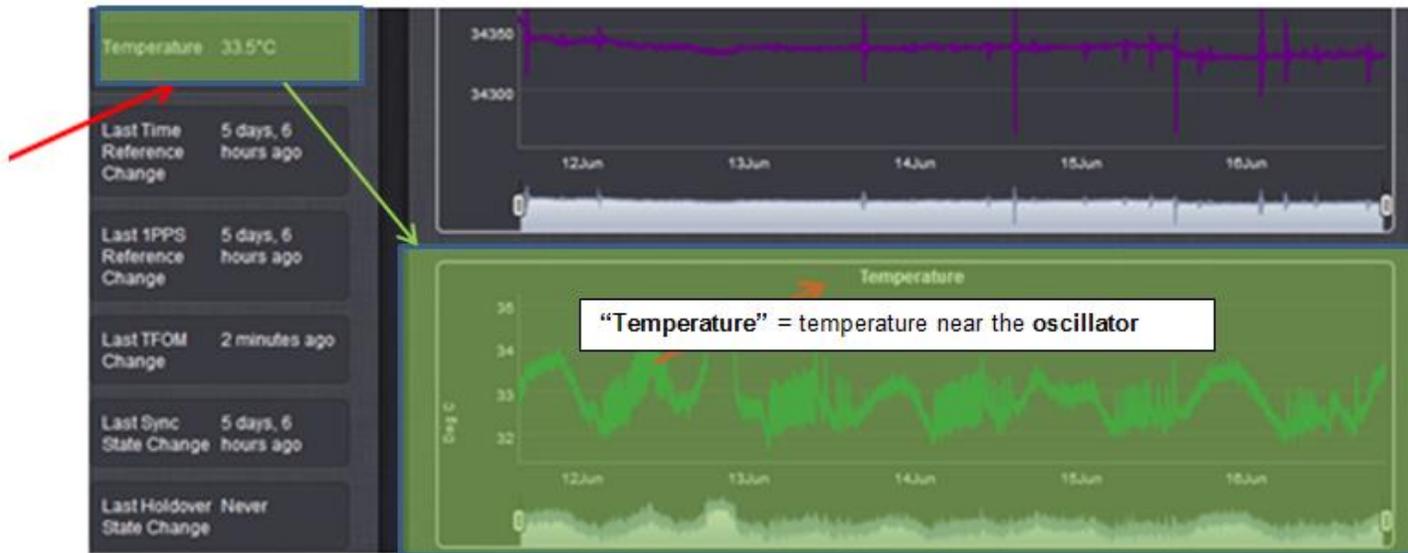
Temperature near oscillator not available without sensor installed

Versions 5.2.0 and 5.2.1 (if temp sensor is installed on the main board)

- Reports just oscillator temperature

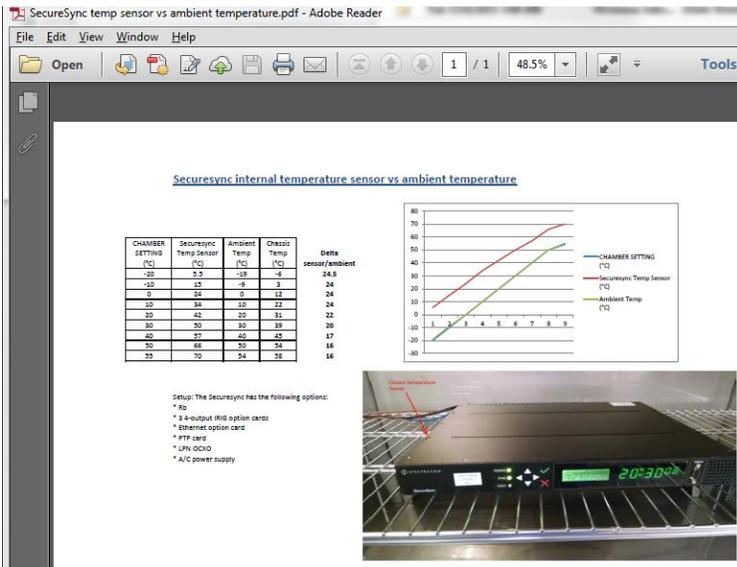
A Reply from Tim Tetreault (13 Jul 2015) Here is the test data on the internal temperature sensor of the SecureSync vs ambient temperature. The testing was done with a SecureSync that had the same configuration as the SecureSync's in the AMDR units.

Q (from Raytheon) "for the temperature, I noticed that the probe is for internal to the system. At what reading would the temperature be considered critical? How does the operating temperature range in the spec correlate to the temp reading on the system?"

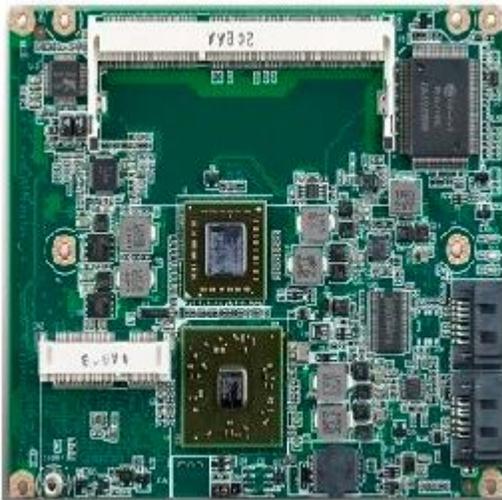
A) **SOM-4466TZ2-T01A1E** (2nd generation ETX for SecureSyncs and 9400s)

Email from Jodi to customer (28 Sept 17) The ETX module is located near the CF card. It has 4 screws and a black heat sink. Remove power from the Secure Sync first, of course. Once you remove the cover of this SecureSync, we recommend following best practice for ESD environments. Remove the screws from the ETX module, take the module out, then re-seat it and replace the screws. Once you’ve ensured that it’s fully seated, you can then put the cover back on and start the device up again.

- ECO 1330 (Aug 2017) is to incorporate the 2nd gen ETX in SecureSyncs): in Arena https://app.bom.com/changes/detail-summary?change_id=2389332675&
- ECO 1294 (Aug 2017) is to incorporate the 2nd gen ETX in 9400 series NetClocks): in Arena: https://app.bom.com/changes/detail-summary?change_id=2388757395&orb_msg_single_search_p=1

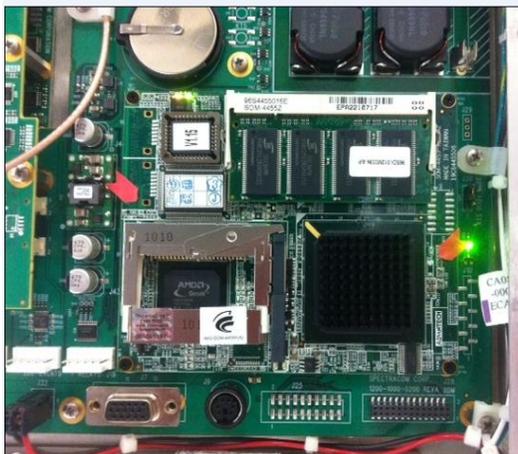
First generation ETX module

(Advantech P/N SOM-4455ZR-T01A2E)

Our P/N: MP20R-0003-0008

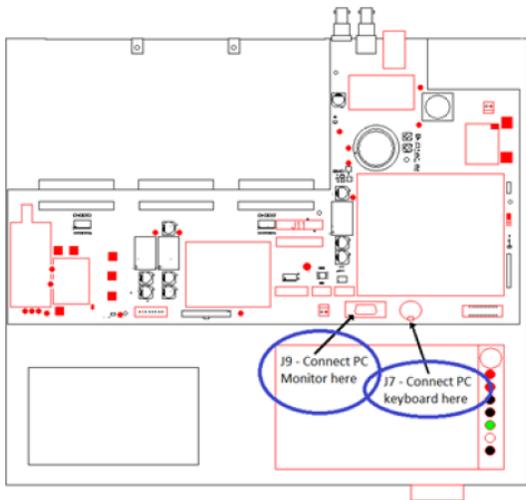
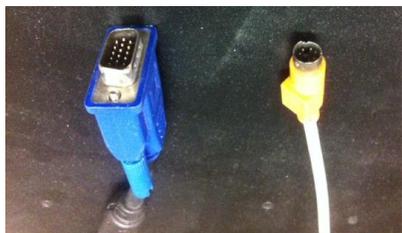
Email from /Dave Lorah- These items are you standard VGA cable and Keyboard cable, I have attached the jpegs for your review

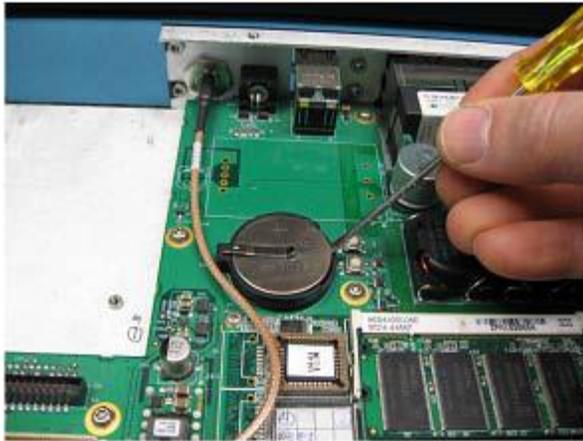
RTC coin cell lithium battery (BR3032)

- Info/Document for replacing the RTC battery in SecureSync (P/N 1200-5000-0055)
 - Refer to manuals in Released drive: [EQUIPMENT\SPECTRACOM EQUIPMENT\SecureSync\Battery replacement](#)

- There is one lithium battery installed on the main PCB in all SecureSyncs. This is for the BIOS/RTC clock (A 3vdc - 500mAh, Lithium coin cell battery)

A. reply from Keith (Oct 2014) To answer your question, there are really only two ways to tell if the Lithium coin cell RTC battery needs to be replaced. The first is the System Time will be incorrect at each power-up, with the amount of error being about the length of time it was powered-down for, until an external reference corrects the time and the SecureSync goes into Sync. The second way is to measure the voltage on the battery with the cover removed (there is also a test point on the main board for this voltage, TP69).

The battery has an expected life of about 5 years of cumulative unit power-down time (it only discharges when input power is removed from the SecureSync). As long as power is normally applied, I would recommend that the battery just be routinely replaced like every 5 years or so to prevent it from starting to become too low.

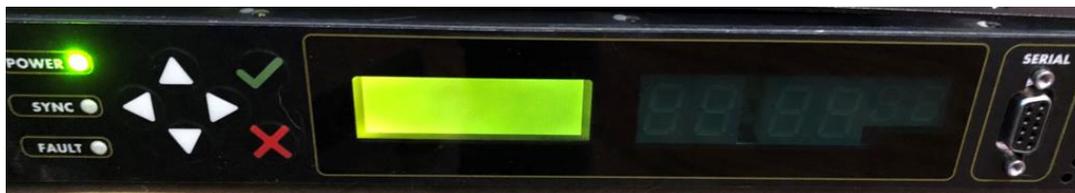
A) 2nd Gen ETX module installed (blank LCD and blank LED. Need to power cycle twice)

- ETX modules from Advantech (with a revised BIOS and a jumper in a different location), the unit will initially “hang”, if the battery is dead or removed. But if its them powered-down and then quickly powered-back up right away again, it will be able to power up again.
- ~~We are supposed to at some time start receiving the ETX modules with a different BIOS/jumper setting which alleviates this conditon. This issue applies the first unit shipped with the 2nd gen ETX module, through the first unit shipped with the bios/jumper modified ETX (sometime post Jan 2019).~~—Status update to this potential change/fix, Per Ron Dries (18 Nov 2021) We tried to use a ETX that had been modified by Advantech, but it hjust caused more problems. So we reverted back.

- Refer to Salesforce case 268696
- When the EX detects a bad or missing battery, the ETX halts its boot-up process (with a confirmation request to continue). The subsequent power cycle overrides the halt/confirmation and thus allows the ETX module to continue booting-up.
- To alleviate the requirement of the second/subsequent power cycle, change (or install) the coin cell battery.

Per discussion with Ron Dries (18 Nov 2021) when the ETX first powers-up and sees its battery is either dead or missing, it asks for a confirmation on whether or not to proceed with booting-up. If it doesn't receive the confirmation, it just sits there waiting for it. The second power cycle overrides the need to respond with the confirmation.

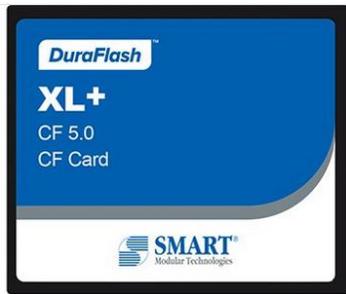
### Industrial grade Compact Flash card used in SecureSyncs/NetClock 9400s

- **MFG/Model:** SMART Modular Technologies/ DuraFlash™ XL+ CF 5.0 CF Card
  - **Our P/N:** MP20R-0004-1000 (in Arena): [https://app.bom.com/items/detail-sourcing?item\\_id=1202844920&version\\_id=10212771558](https://app.bom.com/items/detail-sourcing?item_id=1202844920&version_id=10212771558)

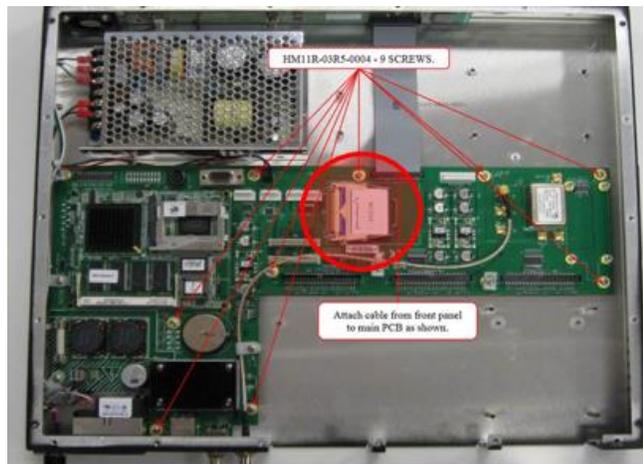
Here is a photo of the PC Board inside the chassis (Please ignore the red lines to the screws). The CF card is in the center.

When the CF card is installed and the unit returned to the rack, power it on and wait a few minutes until the front panel indicates the network parameters. This will show eth0 by defaults and will pick up a DHCP address if one is available.

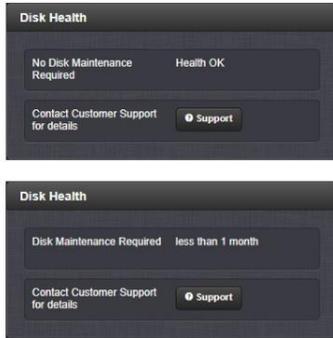
## 2.2. Results

To view your Disk Healthcheck results:

- After installing the software patch, refresh the Upgrade/Backup page.
- A new Disk Health panel will display (below Disk Status). This information will update daily.
- Your Disk Status will either be **Disk Maintenance Required** or **No Disk Maintenance Required**. A status of Disk Maintenance Required will include an approximate length of life in months.
- If your Disk Health is **more than approximately three months**, your unit will have enough disk life to upgrade to the latest version of the software. (Upgrade is strongly recommended to preserve your disk).
- If your Disk Healthcheck estimates **less than three months**, do not upgrade your unit. Contact Customer Support.
- See contact information below for additional information on your projected disk life.

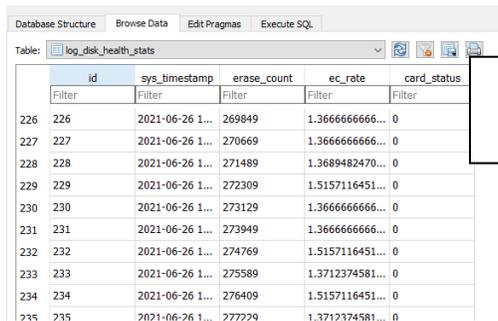
**Note:** Apparently, with newer versions such as 5.8.9 and above, diskhealth.log info is now in the sqlite database, instead of a separate diskhealth.logfile in the log bundle (see below):

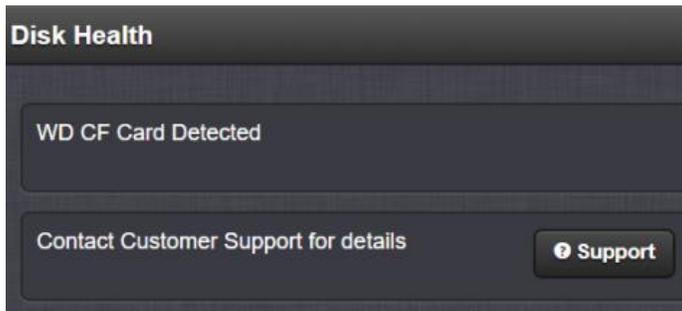
**example reply from Dave L (17 Jan 2020)** If you have a older Seuresync it may have a CF card from a different vendor (WD = Western Digital) and the card does not have the capability to read the number of read/write cycles. If you see any Seuresyncs with the WD cards, these are old and should be replaced.

But he also mentioned that original (VERY early) SecureSyncs shipped with a different type CF card (Western Digital card - not the “smart cards” we have been using since switching a long time ago).

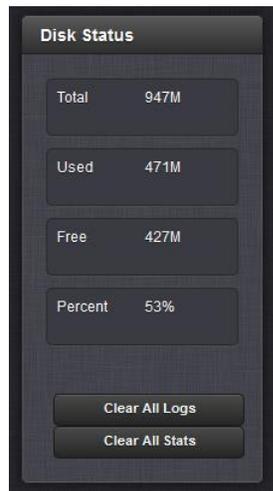
- Update version 5.2.0 added CF card memory status to the newer web browser (not available in classic interface). Also added ability to delete logs and Statistics from the same location

- **Tools -> Upgrade/Backup** page of the browser

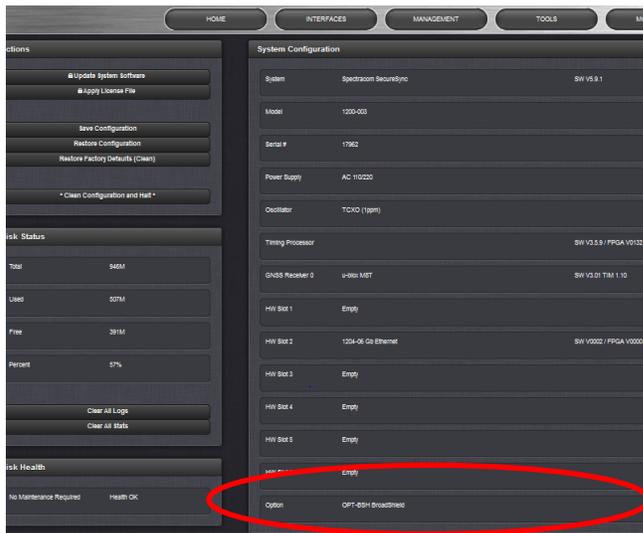
- 3. Once the Opt-BSH license file has been installed (even if the BSH software file hasn't been installed yet) the bottom of the [Tools-> Upgrade/Backup](#) page and the Manifest log indicate BSH is installed.

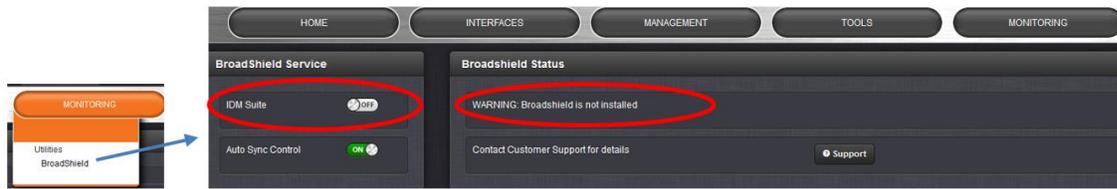
Symptoms of a software update being performed/patch needing to be applied ([Monitoring](#) -> [BroadShield](#) page)

Turning on IDM suite indicates BroadShield is enabled. But refreshing the page turns it back off again. HotPatch is applied similar to standard software update (only takes a couple minutes. Will report it failed. No reboot required)

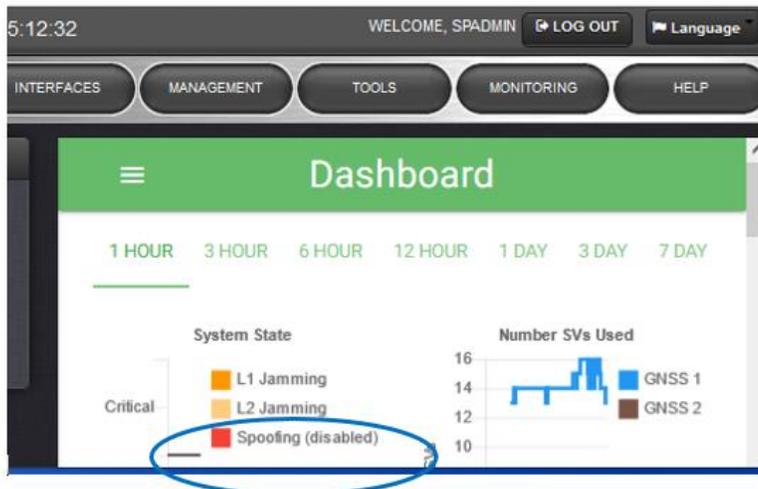
- Refer to “Deleting installed Option Licenses” further above
- Note the BroadShield software can be removed. But Option JADE (Jamming, but no Spoofing detection) will remain enabled.

- The license file for Broadshield will remain (the Monitoring tab, with BroadShield in the drop-down, will still be visible. Clicking on BroadShield will show that BroadShield is not installed and can't be enabled)

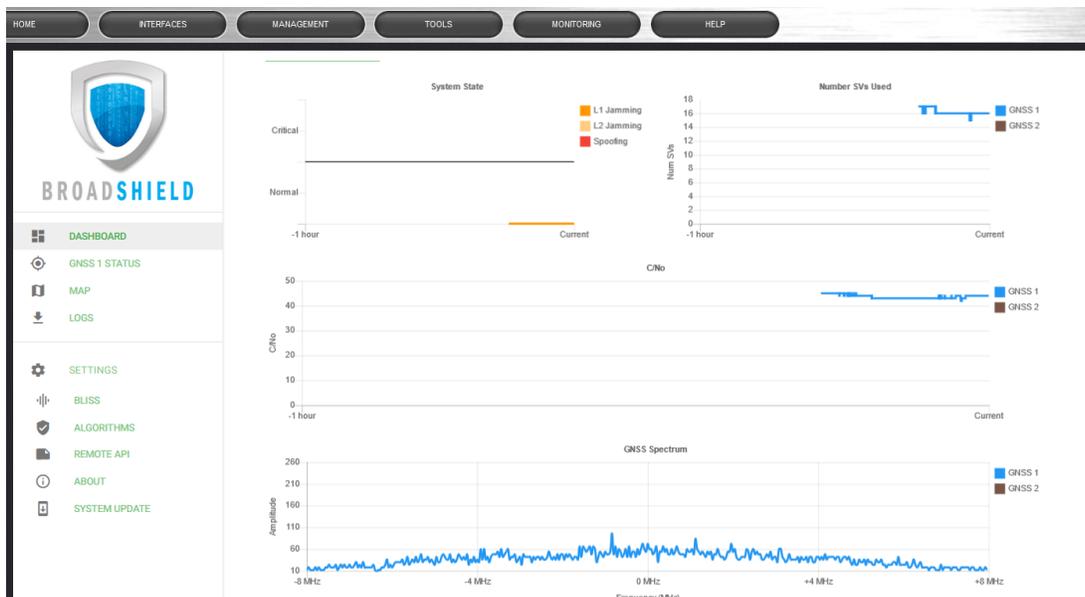
Main page below, with BSH v5.7.6 installed (and with "SETTINGS" on the left expanded down to see all selections)

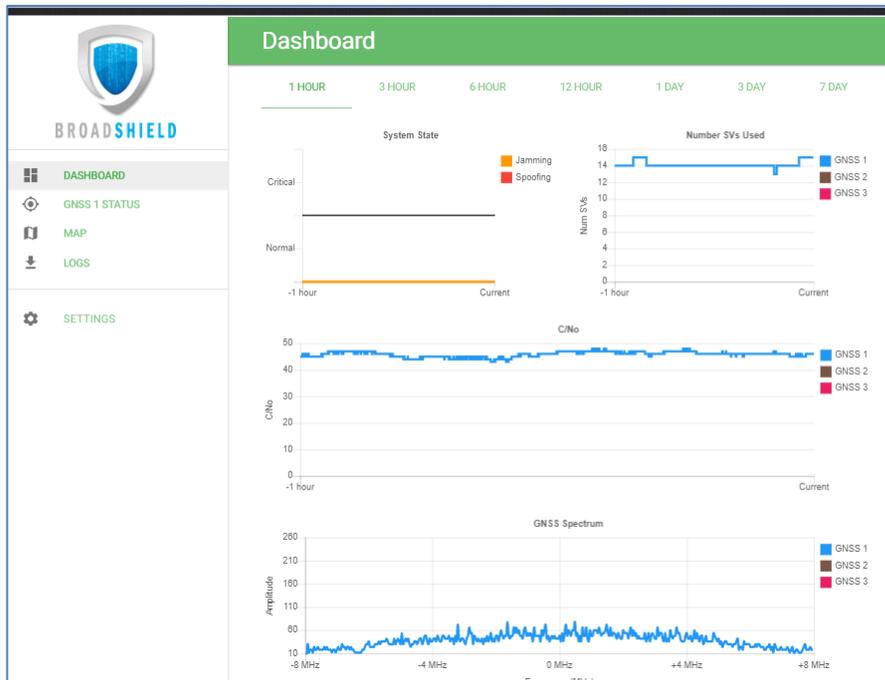
## B) Dashboard

The bottom graph labeled Spectrum visualizes the current signal over the GPS frequency band. Unusual amplitude spikes indicate a potential threat. If your system is equipped with more than one GNSS receivers, a green and an orange graph will indicate the signal level for additional receivers.

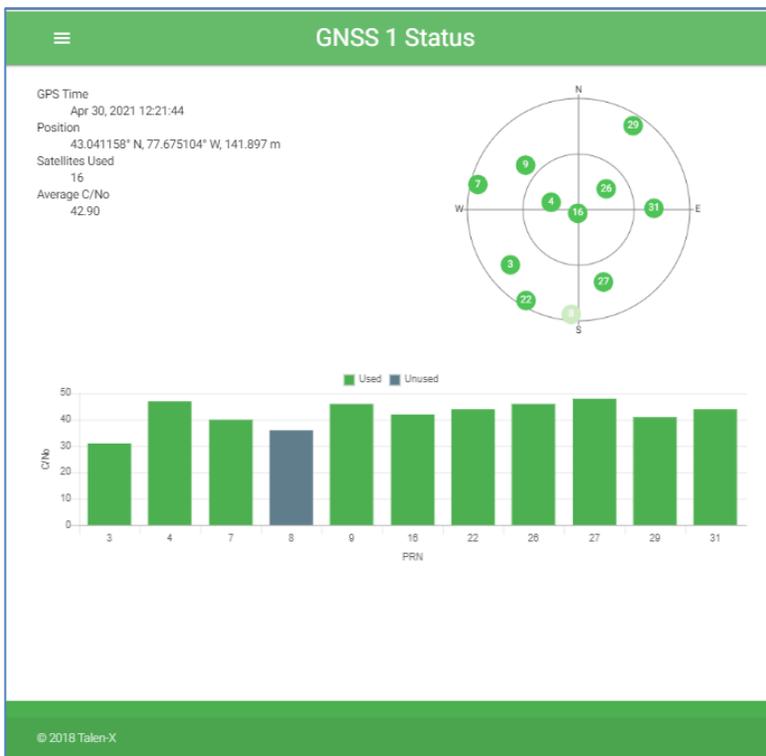
### C) GNSS 1 Status (Display only. No mouse-hovers)

- **GPS Time:** Time and Day as provided by SecureSync's GNSS receiver.
- **Position:** The position as determined by SecureSync's GNSS receiver.
- **Satellites Used:** The number of **GPS satellites** currently received by SecureSync. This number includes all satellites currently received for all enabled constellations (see [Selecting GNSS Constellations](#)). Note that BroadShield uses only GPS signals for jamming/spoofing detection.
- **Average C/No:** Average Signal to Noise (SNR) ratio. An average C/No value higher than 30 can be considered "good".

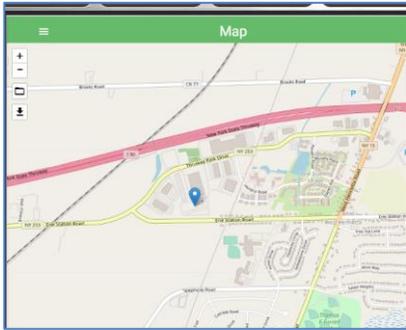
## D) Map (requires SecureSync to have Internet Access)

The map displays your current position, as reported by the GPS receiver. Should the displayed position differ from the actual antenna position, the GPS signal is likely spoofed.

Note that the map data is not part of the BroadShield software, but is downloaded from the Internet. Hence, this feature is only available if your SecureSync unit is connected to the Internet.

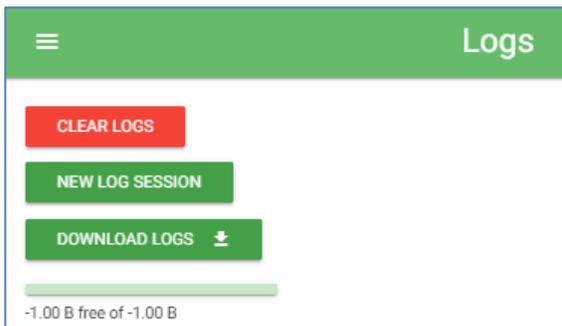
## E) Logs

- To **clear** all current logs stored on SecureSync, click CLEAR LOGS.
- To **start** a new log session, click NEW LOG SESSION.
- To **download** current logs, click DOWNLOAD LOGS.

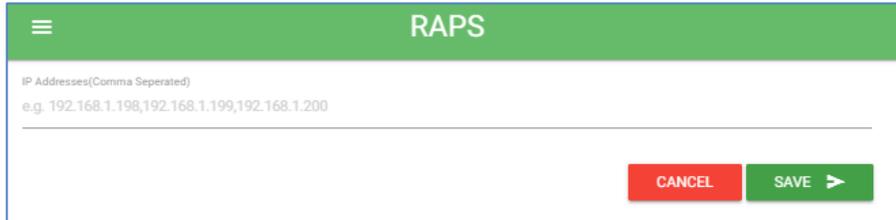
### 1. RAPS

- Not sure what this is for
- Not observed in BSH software version 5.7.6 (was in earlier versions), must have been removed,
- IP address field at top can be edited

The screenshot shows the RAPS settings menu. At the top, there is a green header with a hamburger menu icon and the text "RAPS". Below the header, there is a text input field labeled "IP Addresses(Comma Seperated)" with the example text "e.g. 192.168.1.198,192.168.1.199,192.168.1.200". At the bottom right of the menu, there are two buttons: a red "CANCEL" button and a green "SAVE" button with a right-pointing arrow.

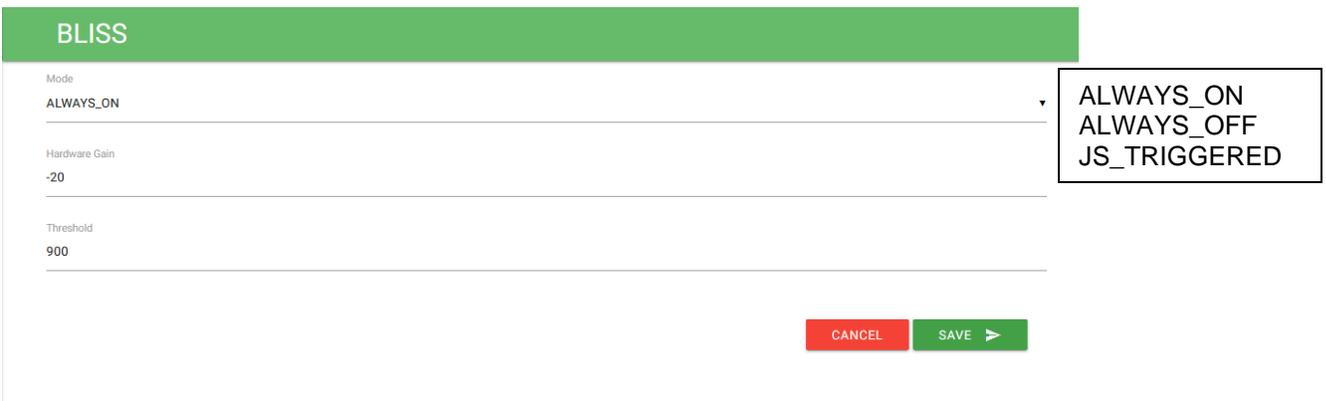
### 2. BLISS

- Not sure what this is for
- First noticed in BroadShield version 5.7.6 (don't believe it was present in earlier versions)

The screenshot shows the BLISS settings menu. At the top, there is a green header with the text "BLISS". Below the header, there are three settings: "Mode" with a dropdown menu showing "ALWAYS\_ON", "Hardware Gain" with a text input field showing "-20", and "Threshold" with a text input field showing "900". To the right of the "Mode" dropdown, there is a box containing the text "ALWAYS\_ON", "ALWAYS\_OFF", and "JS\_TRIGGERED". At the bottom right of the menu, there are two buttons: a red "CANCEL" button and a green "SAVE" button with a right-pointing arrow.

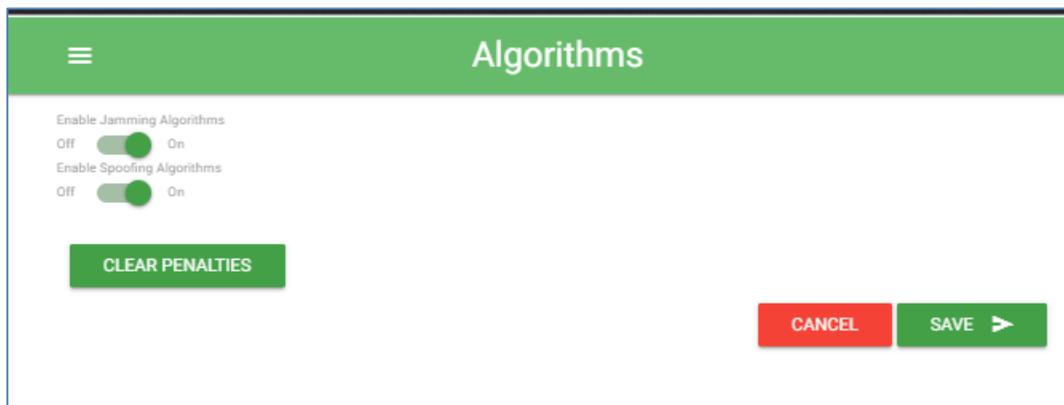
### 3. Algorithms (“Enable Jamming Algorithms” / “Enable Spoofing Algorithms”)

The screenshot shows the Algorithms settings menu. At the top, there is a green header with a hamburger menu icon and the text "Algorithms". Below the header, there are two toggle switches: "Enable Jamming Algorithms" and "Enable Spoofing Algorithms". Both switches are currently in the "On" position. Below the toggle switches, there is a green button labeled "CLEAR PENALTIES". At the bottom right of the menu, there are two buttons: a red "CANCEL" button and a green "SAVE" button with a right-pointing arrow.

This menu option allows you to disable/enable **Jamming** or **Spoofing**. Spoofing refers to impersonating the live-sky GNSS signal, thus "deceiving" the GNSS receiver, while Jamming refers to interference of the signal, i.e. making the live-sky GNSS signal unusable. Per default, both are Enabled.

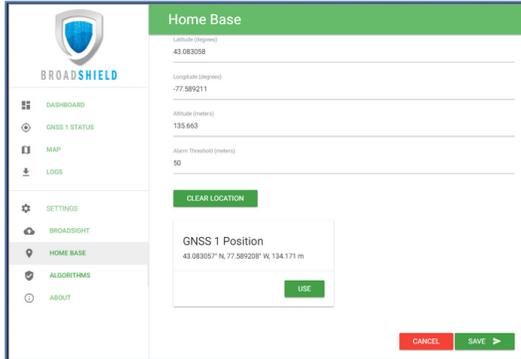
## B) “Home Base” position (optional) (Appears to have been removed in BroadShield v5.2.2)

- By setting the HOME BASE position you allow BroadShield to use this location as a reference position for spoofing detection:
  - Should BroadShield detect that the geographic position reported by SecureSync's GPS receiver seems to move beyond the set Alarm Threshold (even though SecureSync does not move), an alarm will be triggered.

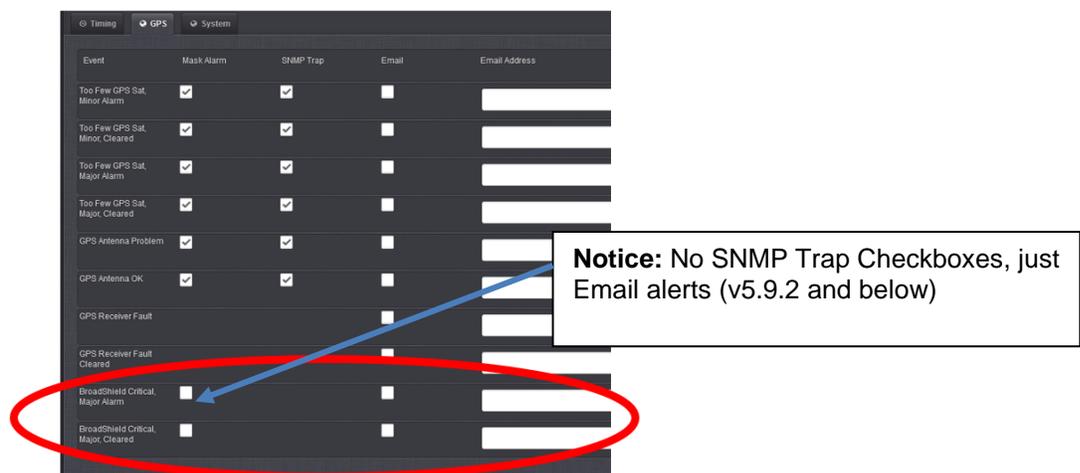
- BroadShield alerts Enabled or masked in the **Management -> Notifications** page of the browser, **GPS** tab (only displayed if “IDM Suite” is enabled)

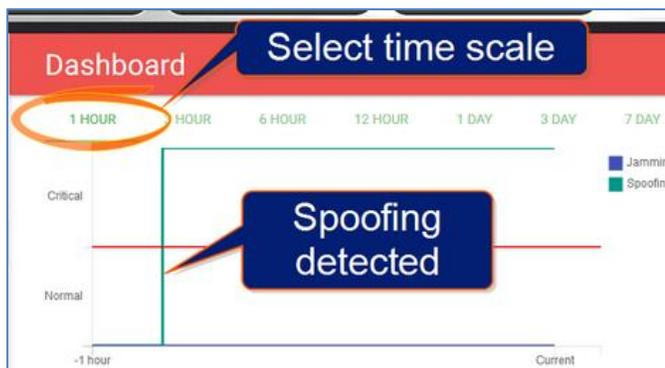
### A) Top graph of the dashboard (displays past signal level over time)

**Note:** You can **change the time scale** by clicking on any of the labels at the top (between “1 hour” and “7 days”)

- **Displays the past signal level over time**, divided into a Normal and a Critical signal level (separated by a red line).
  - A **blue** line in the Critical zone indicates a potential jamming incident, while
  - A **green** line indicates that SecureSync may be subject to a spoofing attack.
  - **Note:** A SecureSync reboot will reset all history data (it can still be retrieved via LOGS.)

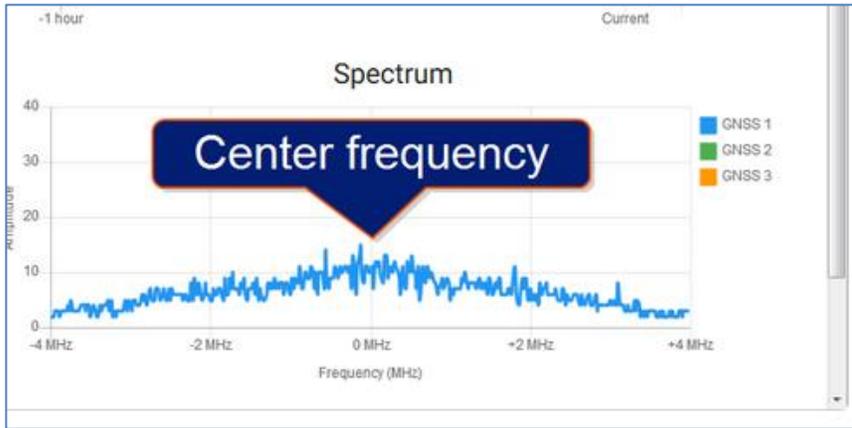
### B) Bottom graph of the dashboard (labeled “Spectrum”) (shows current signal over the GPS band)

- Visualizes the current signal over the GPS frequency band.
- Unusual amplitude spikes indicate a potential threat.
  - If your system is equipped with more than one GNSS receiver, a green and an orange graph will indicate the signal level for additional receivers.

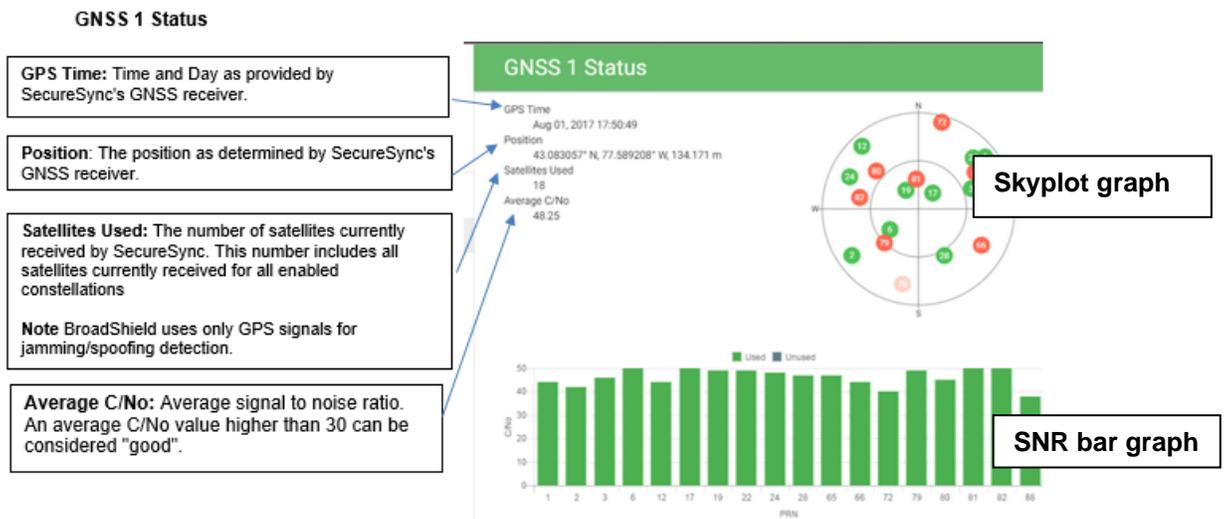
### GNSS 1 Status (Skyplot graph)

- This graph visualizes the signal-to-noise ratio for up to 20 received satellites in real time. The satellites are numbered by their NMEA ID's (as in the skyplot mentioned above).

The center of the skyplot represents the antenna position. The skyplot shows all GPS satellites currently being tracked and – if enabled (under INTERFACES: REFERENCES > GNSS Reference: GNSS 0 > Edit button > Selected Constellations) – will also display all GLONASS satellites (numbered 65 and higher). Note, however, that GLONASS satellites will not be used by BroadShield. Galileo and Beidou satellites will not be displayed.

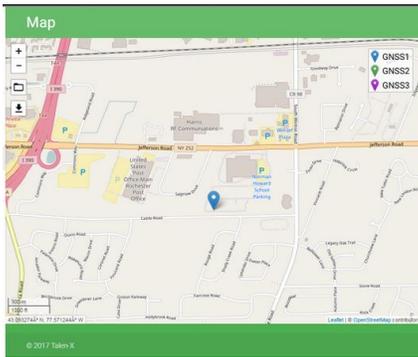
## MAP (requires SecureSync to have Internet Access)

**Note:** the map data is not part of the BroadShield software, but is downloaded from the Internet. Hence, this feature is only available if your SecureSync unit is connected to the Internet.

- The map displays your current position, as reported by the GPS receiver.
  - Should the displayed position differ from the actual antenna position, the GPS signal is likely spoofed.

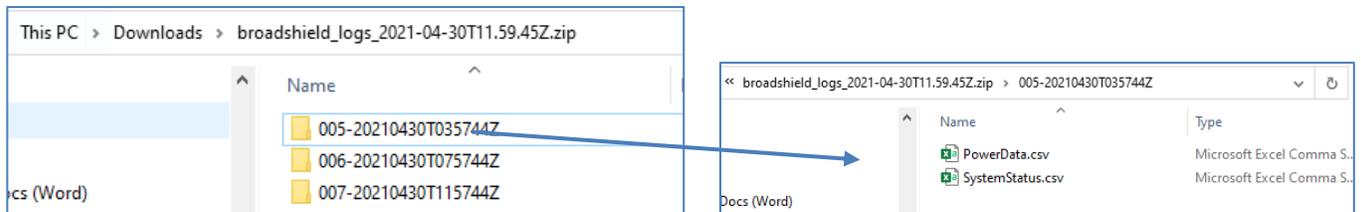
### Example of downloaded logs

Two csv log files in each folder

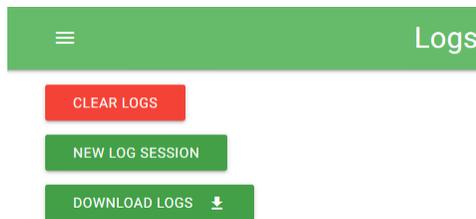
### Clear/download logs (SystemStatus.csv files)

- To clear all current logs (SystemStatus.csv files) stored on SecureSync, click CLEAR LOGS.
- To start a new log session, click NEW LOG SESSION.
- To download current logs, click DOWNLOAD LOGS.

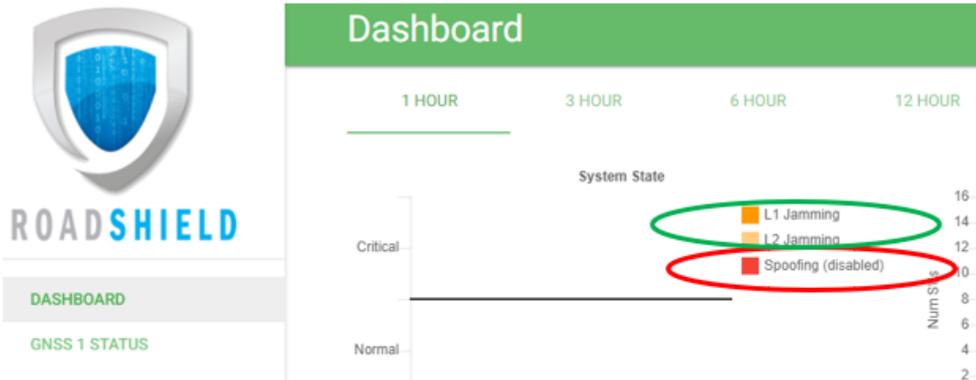
Per Keith (Nov 2021) the only report I could find to differentiate Opt-Jade (not Opt-BSH) being installed is in the Opt-BSH software itself:

As of at least versions 5.9.1 and below, it appears that the only indication that Opt-Jade (or Opt-BSH) is installed, is via the **Monitoring** button at the top of the browser page

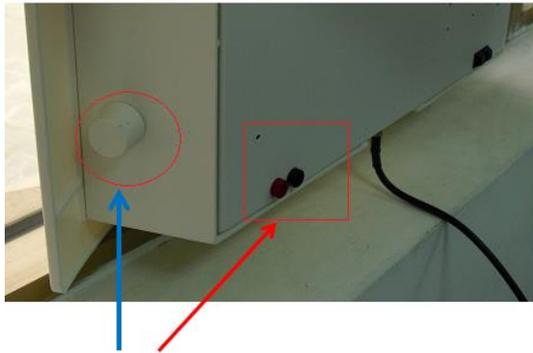
### Knob and red/black jacks

### Skylight phase 1 and phase 2 antenna P/N: 1213-0000-0600

- Rev A is the phase 1 antenna (GPS only)
- Rev B is the phase 2 antenna (GPS and Glonass)

- **Knob:** The Skylight antenna has decorative LEDs built into the faceplate and the knob is a brightness control for the LEDs.
- **Jacks:** The red and black jacks are so you can swap the internals 180 degrees to have the antenna face inwards or outwards.

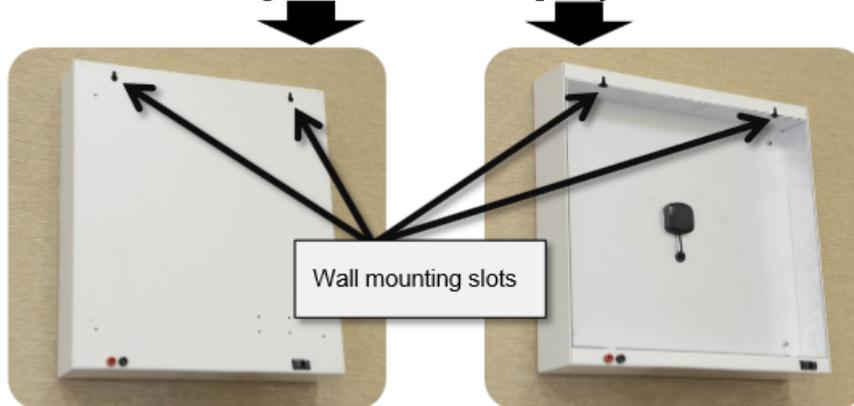
The antenna can be mounted **facing towards** or **facing away** from the wall:

Mounting the antenna facing towards an exterior wall often leads to the best reception.

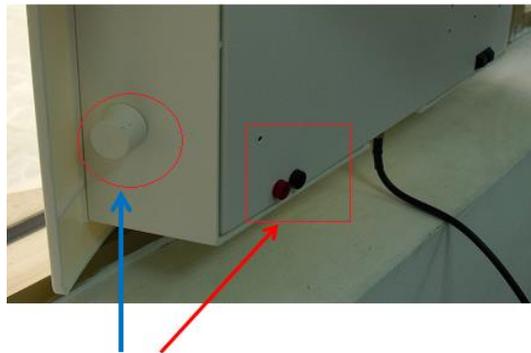
**Note: I believe the "option to reverse the antenna facing by switching the direction of the front plate" Dave mentions in his email below is referring to switching the red and black jacks on the back of the antenna:**

**Jacks:** The red and black jacks are so you can swap the internals 180 degrees to have the antenna face inwards or outwards.

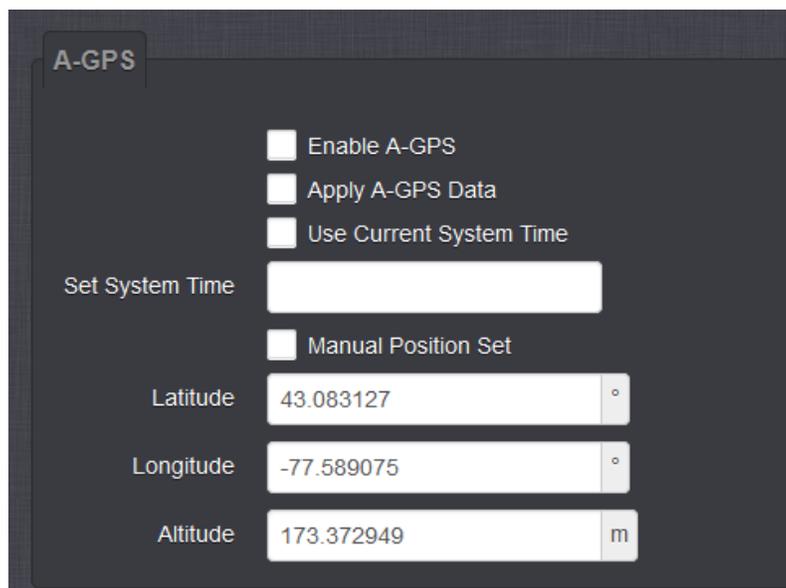
**A-GPS**

A-GPS is configured in the **Interfaces** -> **GNSS Reference** page of the browser.

Then click on the "Gear" box between "GNSS 0" and the indication of how many satellites are being tracked (below the photo)

- Enable A-GPS
- Apply A-GPS Data
- Use Current System Time

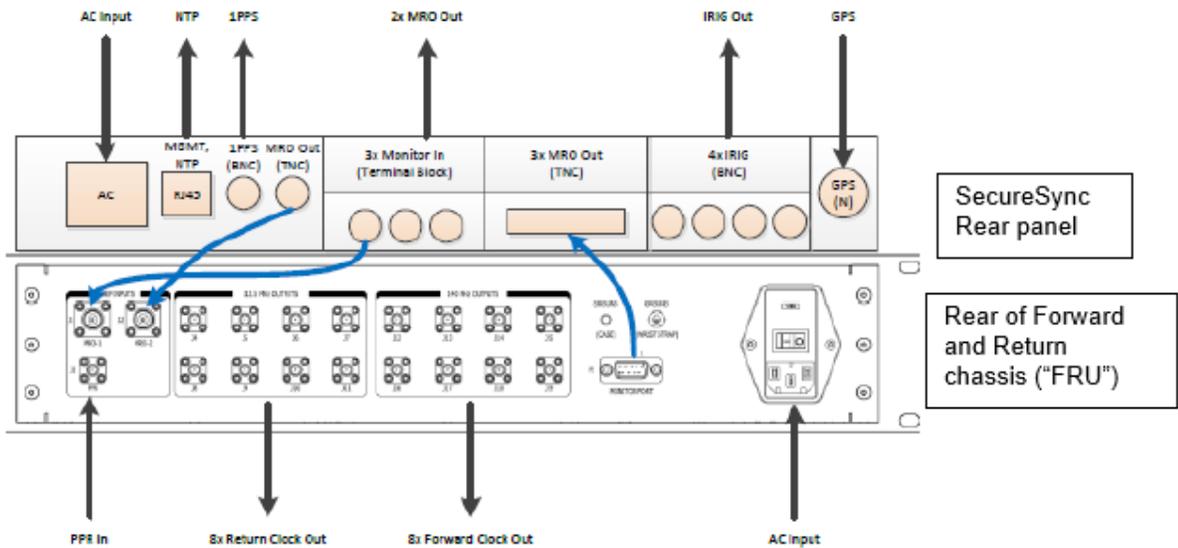
Figure 2 - Rear of System

Rear panels of SecureSync and Forward and Return (FRU) chassis

Note: the three blue lines are the interface cables (provided in the anc kit).

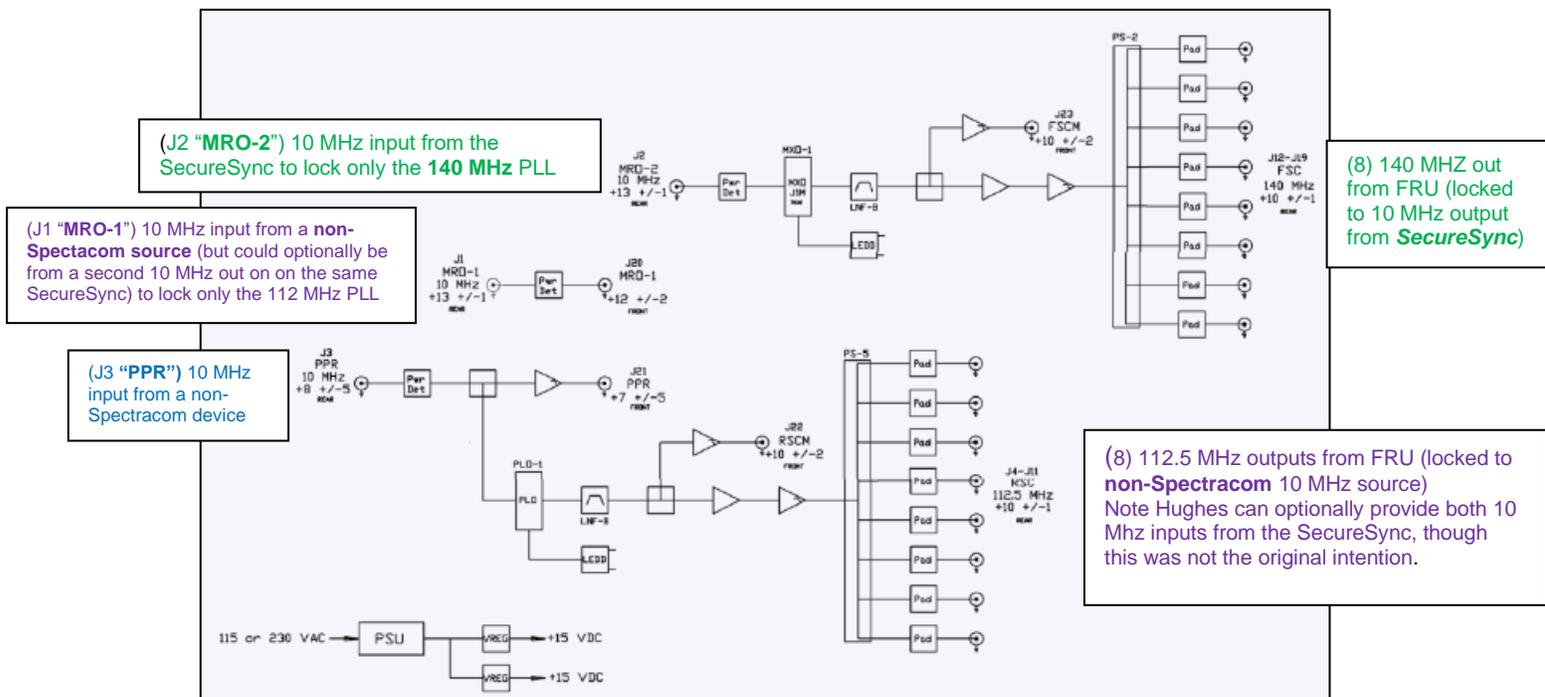
### Forward & Return Clock Distribution (FRU) Block diagram

- **Our P/N:** MP41R-0002-0001 (in Arena at: [https://app.bom.com/items/detail-spec?item\\_id=1211945230&version\\_id=10370633288](https://app.bom.com/items/detail-spec?item_id=1211945230&version_id=10370633288))
- **Hughes P/N:** 150449-0011
- This is a custom device co-created by both Spectracom and Wenzel for Hughes.
- Front panel has status LEDs and PLL signal monitor outputs
- Rear panel has input power and input/output connectors
- No “smarts” in this unit. It’s just PLLS and LED indicators.

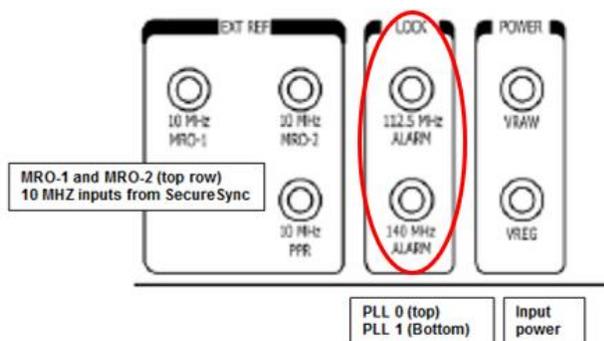
#### 1. PLL Lock Status LEDs the front panel of the Forward and Return chassis

- LEDs on the front of the Wenzel clock distribution chassis (refer to "1" further below)
- In the SecureSync's browser (left side of the **Management** -> **Disciplining** page) (refer to "2" further below)
  - In the SecureSync's **oscillator log** (osc.log) (refer to "3" further below)

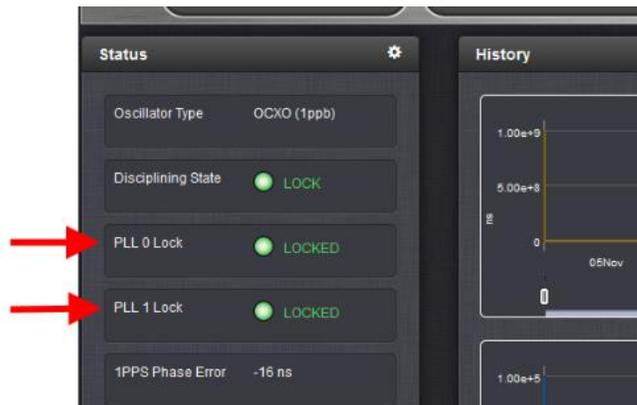
- 1) Look at the LED Lock indicators on the front panel of the Wenzel chassis (FRU)
- 2) Look at the two PLL lock status indicators (0 and 1) on the left side of SecureSync’s *Management -> Disciplining* page of browser:

- Lock status for the two PLL circuits is reported on the left side of the **Management** -> **Disciplining** page of the browser (and are logged in the Oscillator log- refer to the info further below)

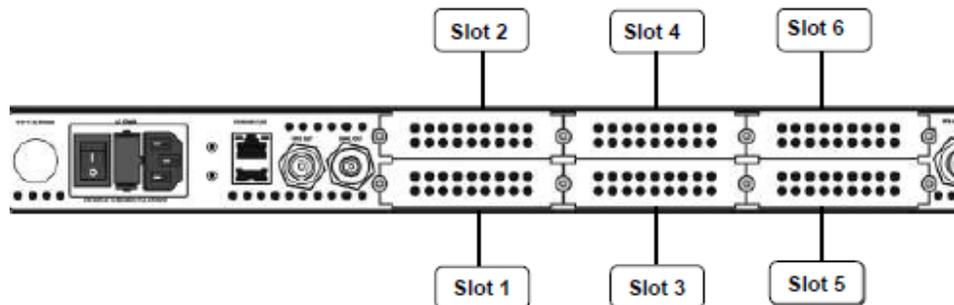
*SecureSync Rear Panel Option Module Bays*

The six option module card bay slots are designated as Slot 1 – Slot 6, as shown in the following figure:

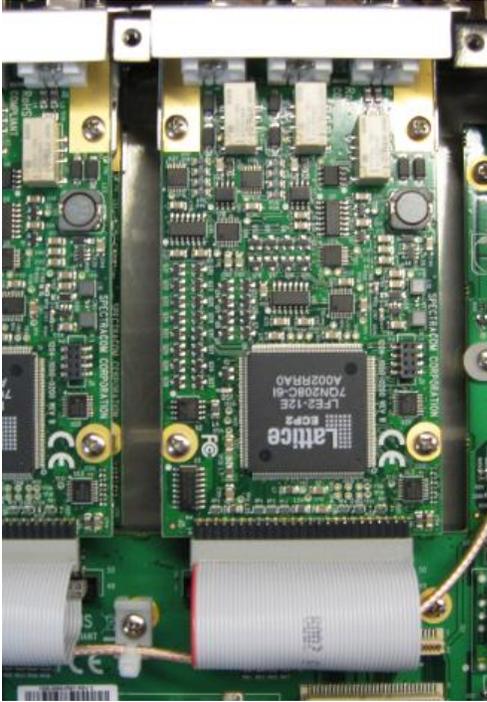
#### Ribbon cable should be “looped outward”

- When we send new Option Cards to be installed in the field, a kit that includes a 50 pin ribbon cable (ribbon cable is our P/N CA20R-R200-0R21) and the Install guide mentioned above, is provided with each card. This ribbon cable provided is only used when installing an Option card in the top row (Bays 2, 4 and 6). The ribbon cable is not used with the bottom row of Option Cards (Bays 1, 3 and 5).

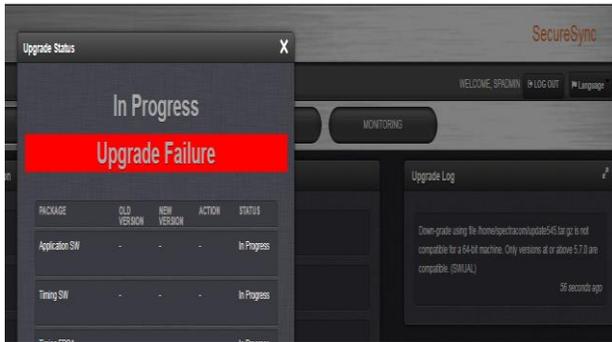
“Down-grade using the file /home/spectracom.update545/tar/gz is not compatible for a 64-bit machine. Only versions at or above 5.7.0 are compatible. (SWUAL)”

- Starting in software version 5.70 software, Paul M added a check to see if a newer ETX is installed, and if an earlier version of software is attempted to be applied, the updater will fail with an error message. The upper-right corner of the screenshot shows this error message!!

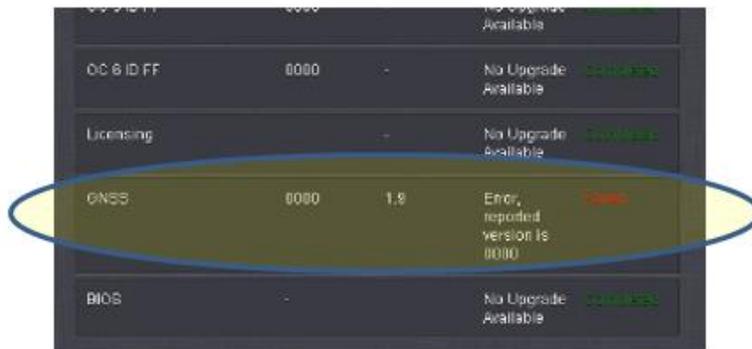
3. “Error, reported version is 0000, Status: Failed” appears “Upgrade Status” ‘In Progress’ window (for “GNSS”)

- This Error message is due to having a Res-T GPS receiver (first Model used in SecureSync/9400s) installed when the v5.6.0 and above updater checks to see if a Res-SMT-GG or ublox is installed.
- No further actions required. There are no available/expected updates for the Res-T receivers.
- Hendrik intends to add note starting in the v5.7.0 update instructions.

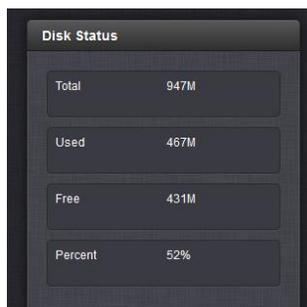
Tools -> Upgrade/Backup page of the browser (under “Disk Status”)

**Note:** Also added ability to delete logs and Statistics from the same location

**Note:** In general, disk usage should be **less than** around **70%** or so usage to prevent issues with the update process. Logs and previous update bundles may be taking up too much space.

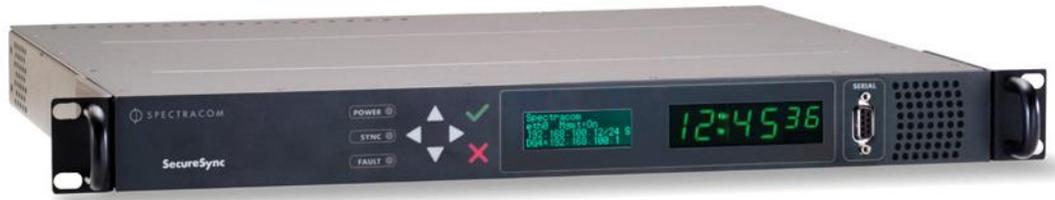
## **\*\*Front Panel LCD / LED time display / keypad**

During boot-up (power-up or reboot), or after a clean, the displays are initially all blank. After a few moments, the LED display goes to all 0's for several seconds. Then, it displays the time read from the RTC (which should be fairly accurate). Then later, the LCD will start displaying data, also (unless the front panel is configured for "None" in the front panel "Display Content" field).

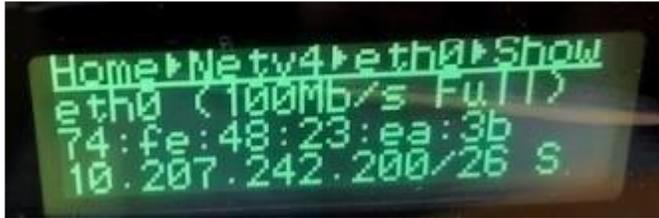
- 7) I then **just connected a network cable from eth0 to a small switch sitting on my desk**. Within just a couple moments of connecting this network cable, the screen automatically refreshed to display the same network settings I had configured before the unit was rebooted. (all I did was connect eth0 to another network device, to clear the built-in indication (all 0s) that lets a user know a cable is not connected to that network interface (such as eth0))

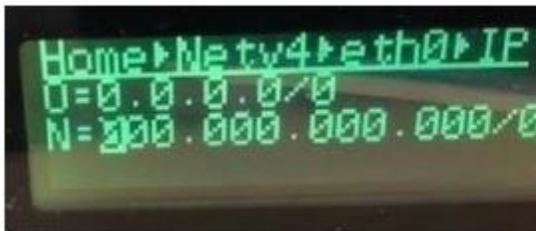
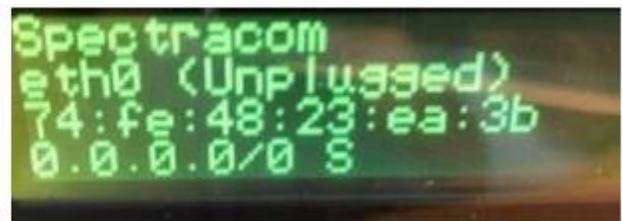
- 8) I then just disconnected the network cable connected to eth0 to show what is displayed every time the interface doesn't detect its connected to another network device (after boot-up or during routine operation without a reboot). Within just a couple moments of disconnecting the cable from eth0, the display automatically changed back to the built-in indication (all 0s displayed for the port not having a cable connected) to let me know there is no cable currently connected to eth0 again (note this is the same display which was present when I first booted-up with no cable connected)"

In summary, as long as there is an "S" displayed after initially configuring eth0 via the front panel, DHCP is disabled and the static IP address HAS been successfully configured (and these settings are not being lost after reboot). There is no need to connect a cable to configure eth0. But if you wish to see the settings did persist/save during the reboot, just optionally (not required for successful configuration) connect an ethernet cable to eth0 and another network device (PC/HUB/Switch), to temporarily clear the built-in indicator of eth0 sensing that there is no currently no cable connecting it to its hub/switch. This indicator clears just a couple moments after the network connection to eth0 is in place!

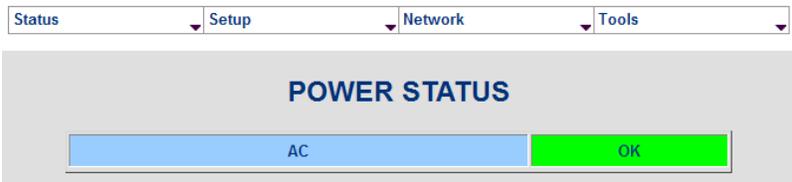
## Status/Power page of the classic interface browser

- Version 4.8.0 and below showed both AC and DC indications, whether or not both were installed (power option not installed was automatically displayed as red alarm state).
- Starting in version 4.8.2, this web page now only displays which power configurations are installed (if an AC or DC power configuration isn't installed, it's not displayed in the browser).

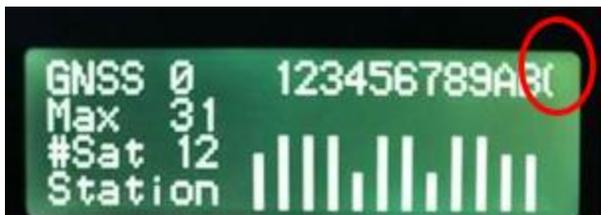
### D) (Jan 2019) The header letter "c" for the 12<sup>th</sup> satellite in the GNSS signal strength bar graph is partially cut off at the right edge of the LCD display

**Email from Jodi (17 Jan 2019)** We did some research on this. I spoke directly with one of our Repair Techs as well. After speaking with Tom, we can say that the observation that you've made is normal, and the last digit being cut off could be due to an older firmware version for the display.

The display showing in this manner does not affect functionality or cause problems. We have seen this before, especially with older displays, that have the older firmware, and our own devices in the Tech Support Lab show the last digit "C" as cut off as
