Model 1200 series SecureSync/9400 series

Lafayette (Model 1200 series SecureSync)

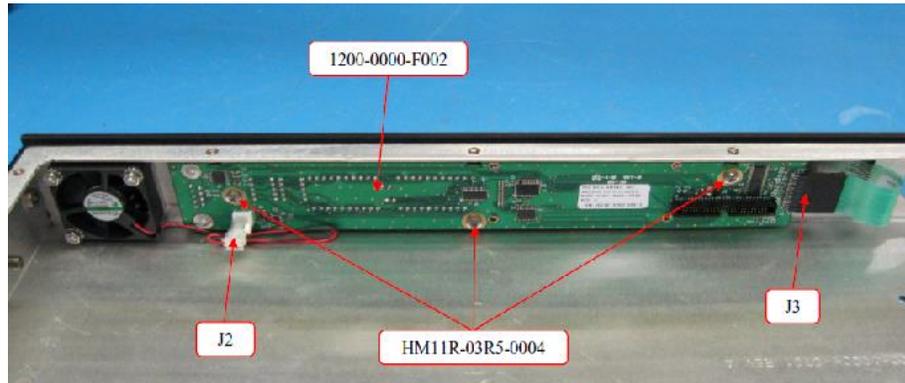
- 1) Remove the 20 screws from the top cover and remove the cover.
- 2) Remove the fan connection shown as (J2) below.
- 3) Remove the three screws attaching the front panel PCB to the chassis. You may not need to remove the J3 or ribbon cable to get to the film.
- 4) The protective film on the LCD Display will peel off easily.
- 5) Reassembly is the reverse of disassembly.

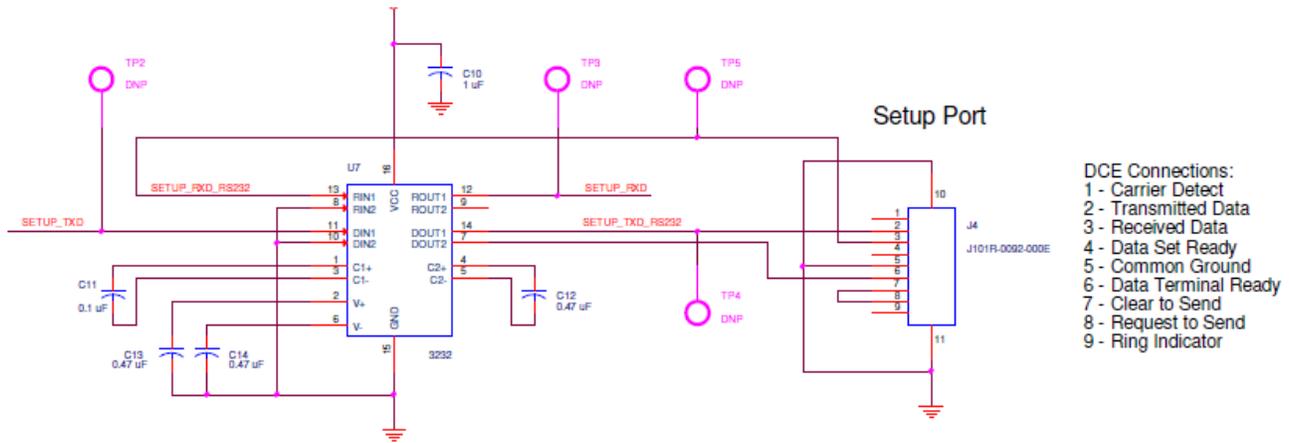
### **RS-232 signal levels/pin-out (DCE device)**

- RS-232 driver (U7 on Front panel PCB): U050R-3232-000P (Texas Instruments MAX323) in Arena: [https://app.bom.com/files/detail-summary?file\\_master\\_id=1237200855&file\\_id=1750108215](https://app.bom.com/files/detail-summary?file_master_id=1237200855&file_id=1750108215)
- 5v logic

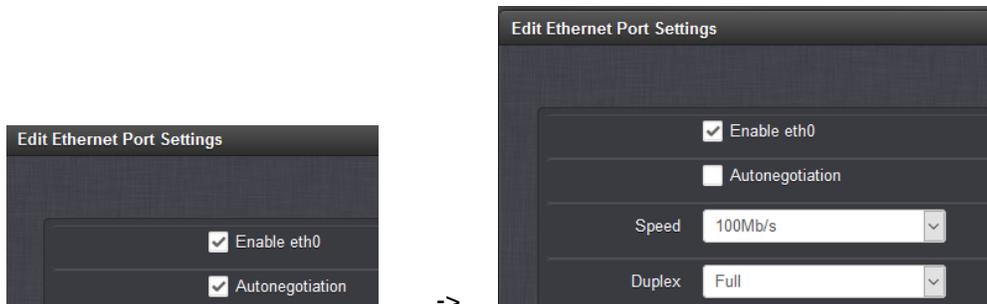
1. Navigate to the *Management* -> *Network Setup* page.
2. Unselect the “Autonegotiation” checkbox (selected on all interfaces by factory default)

3. Configure desired speed and duplex
4. Press Submit

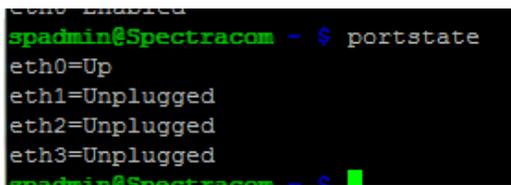
- CLI command is **portstate**
- Displays status of all installed Ethernet ports, including Eth0.

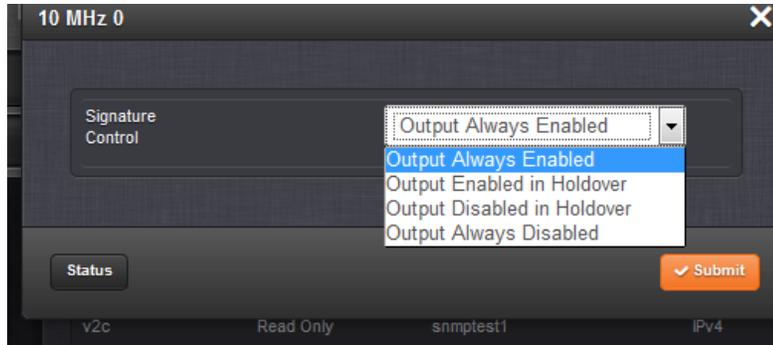
## Use of web browser to control 10 MHz

➤ As of at least v5.6.0, the 10 MHz output can only be disabled via the browser (set Signature Control to "Output Always Disabled" in the **Interfaces** -> **10 MHz 0** page of the browser):

Partial email from Keith (12 Apr 17 and added to on 17 May 17) ...Currently, the 10 MHz output can only be disabled by changing the configuration of the 10 MHz Signature Control in the web browser. Signature Control for just the 10MHz output can be set to "Output Always disabled" for as long as its desired to squelch this particular output (no effects on the other outputs/functions of the system) as shown below:

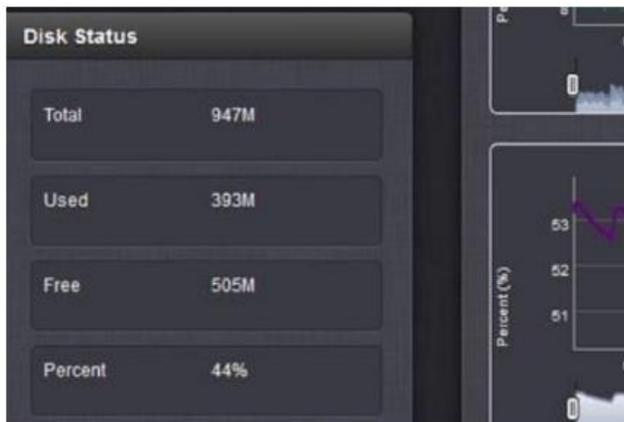
- **Tools** → **System Monitor** page of the web browser (versions **5.3.1 and above**)

Refer to the **"Percent"** field at the bottom of this section.

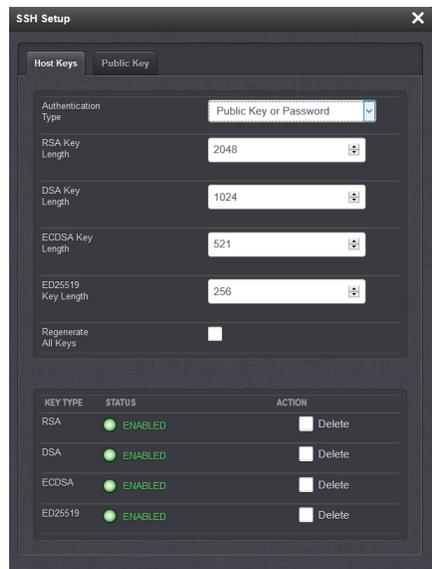
### A) SSH configuration via the newer (black/charcoal) interface browser.

- refer to online SecureSync user guide: [http://manuals.spectracom.com/SS/Content/NC\\_and\\_SS/Com/Topics/SETUP/SSH\\_Configuration.htm](http://manuals.spectracom.com/SS/Content/NC_and_SS/Com/Topics/SETUP/SSH_Configuration.htm)
- Configured in the **Management** -> **SSH Setup** page of the browser, **Host Keys** tab

- Can login using Public Key Only, Password only, or either Public Key or Password
- When using password to connect via SSH, account and password is either the spadmin account/password or a user account that has been created.

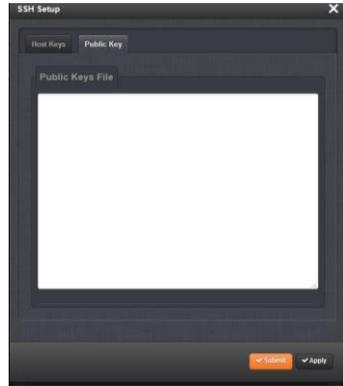
**“Public Key Tab:** Paste the public key from each computer that wishes to access the NTP server via SSH into this field (if there are four computers, paste four keys into the table and then change “View or Edit” to Enabled. Press

Submit). Each key goes into a new line in this field).

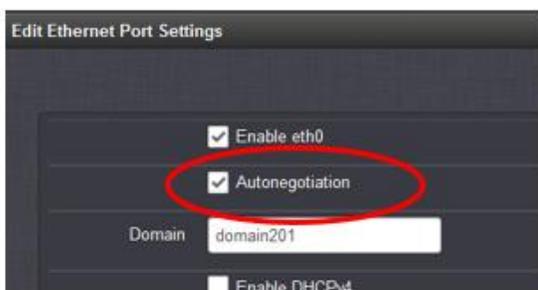
“Autonegotiation” enabled (default)

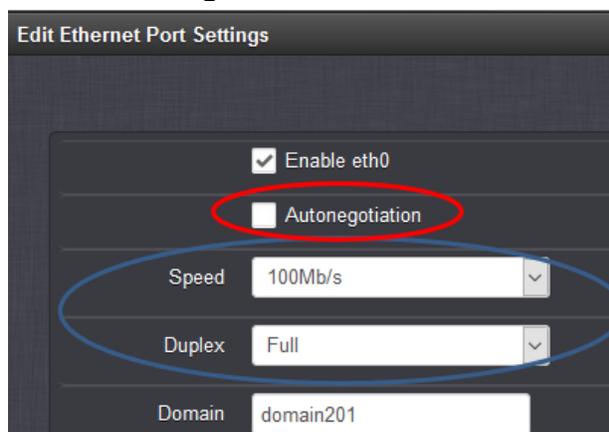
“Autonegotiation” disabled

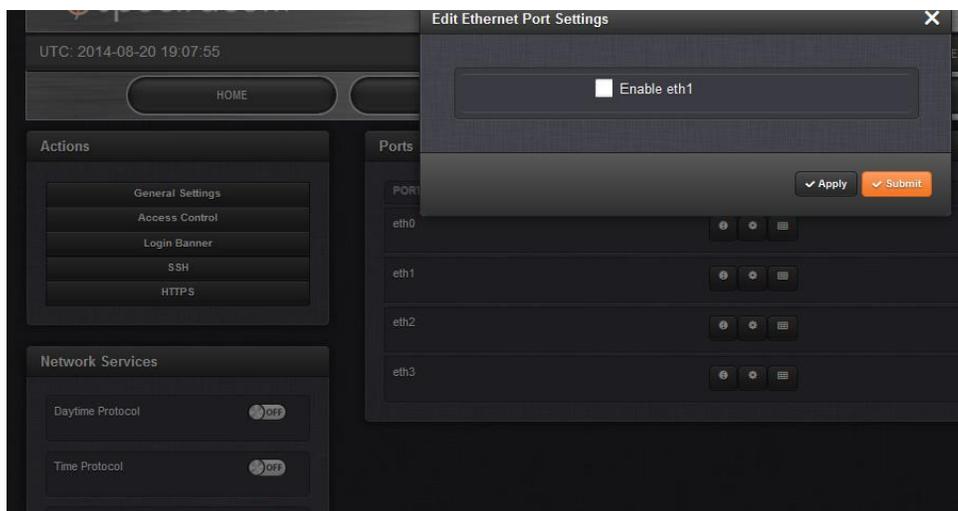
### A) Enable/disable the Ethernet interfaces via the web browser

- 1) **Management** -> **Network** page of the browser
- 2) Click on the center “**GEAR**” ICON (center of the three ICONS) to open the pop-up window.
- 3) Select the “**Enable eth**” checkbox to expand the pop-up window.
- 4) Configure the port settings as desired (unselect **DHCP** to configure a static address).

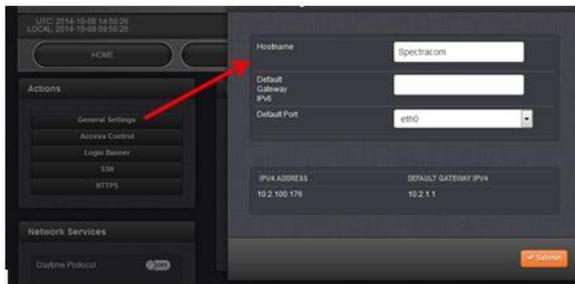
#### A) Newer web browser: *Management* -> *Network* page, General Settings button on the left

- To view the current value: click on the left of the three icons (i) for the particular port
- To change the current value: click on the middle of the three icons (gear icon) for the particular port. It's the "Domain" field.

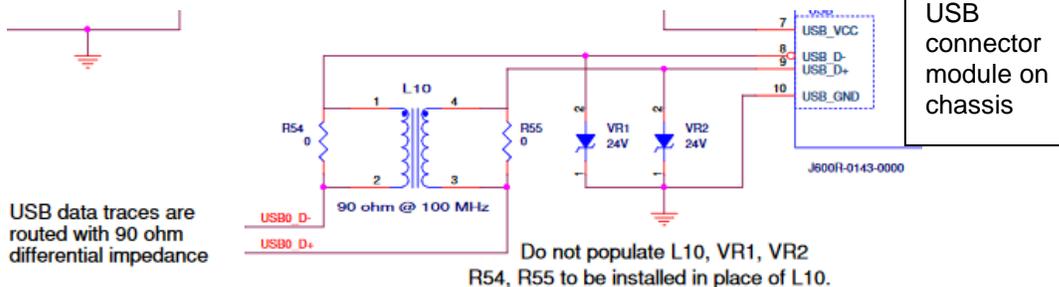
### Excerpt from main board PCB (1200-1001-0200). Do not release

**A Keith's response (input from Paul M, 11 Apr 18):** It is reserved for potential future use only. At this time, the Operating system does NOT include any USB drivers. The power is detectable only. There is no way to mount or use any USB storage or device.

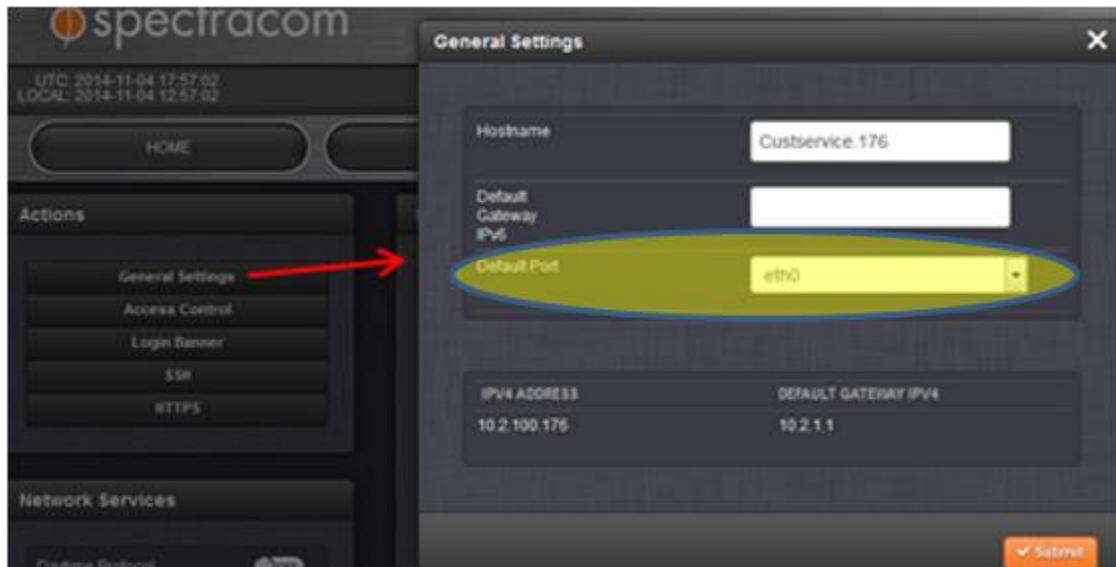
### B) Newer black/charcoal browser (v5.1.2 and above):

- Management -> Network page of the browser, "General Settings" button (on the left side of the screen):

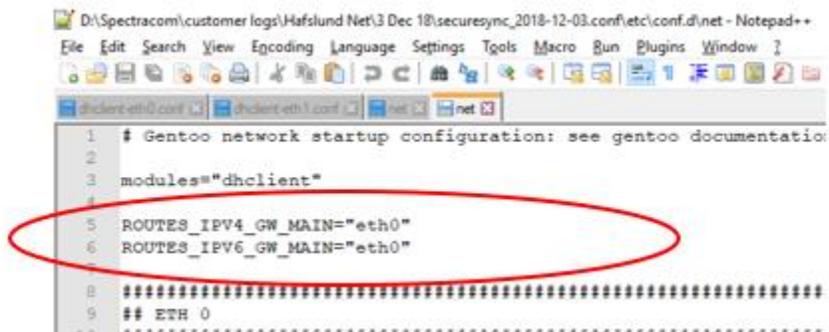
Main default port config is stored/located (at the very top of the file. as ROUTES\_IPV4\_GW\_MAIN and "ROUTES\_IPV6\_GW\_MAIN") in: `./etc/conf.d/net`

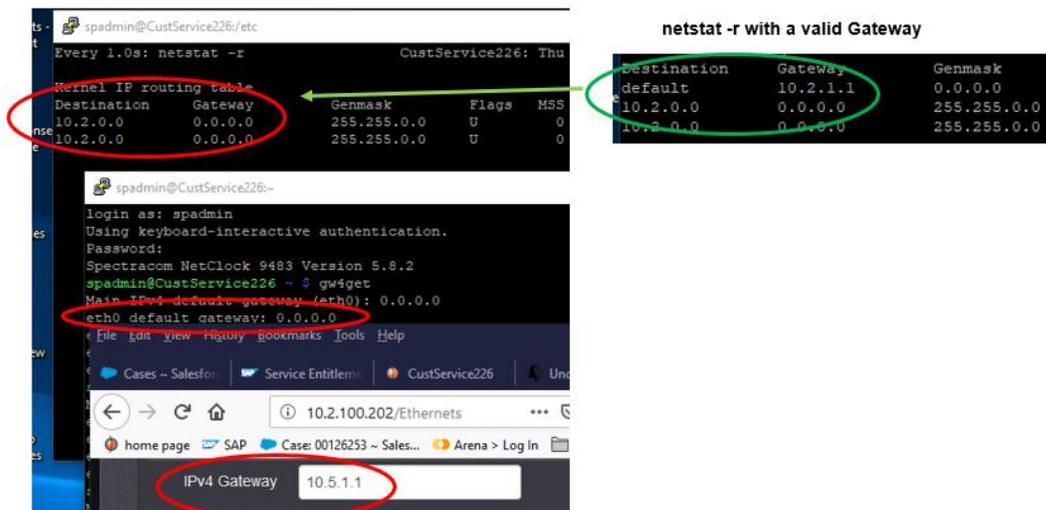
If the configured gateway address is not valid (example below is gateway entered "10.5.1.1" instead of "10.2.1.1")

- **Front panel:** LCD "Gateway" menu **displays all 0's** if its not a valid gateway address
- **gw4get** CLI command: displays all 0's if its not a valid gateway address
- **netstat -r** cli command: displays all 0's if its not a valid gateway address
- **web browser** displays the incorrect/invalid address which was entered

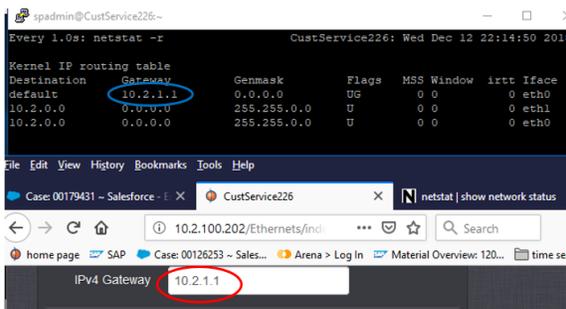
**E) With the correct Gateway address entered via eth1/browser (with eth0 not connected to network) = Works fine**

- **`netstat -r`** (and web browser) reports (and continues to report) the entered gateway address of 10.2.1.1
- Front panel LCD “gateway” (and IP address) displayed as all 0's just because cable is disconnected

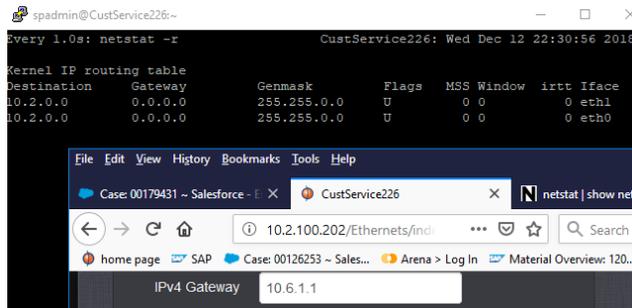
**F) Invalid gateway address (10.6.1.1) configured (not on same subnet as IP address) with eth0 still disconnected**

- “netstat -r” doesn’t report the invalid address
- web browser will continue to report the invalid address entered.

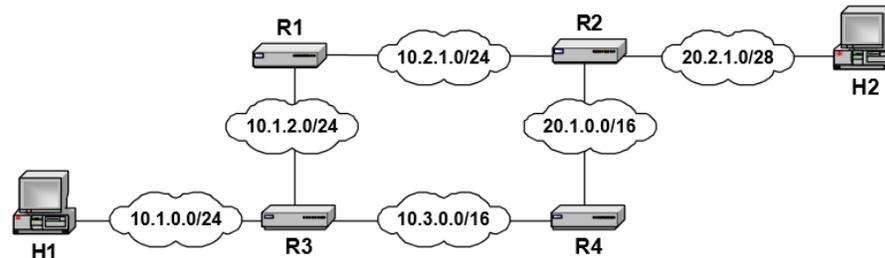
Figure 3.2. Collection of networks (View at the IP layer).

Routing tables, which are kept at both hosts and routers, play a crucial role in the delivery of IP datagrams. A routing table tells a host or router what to do with a datagram that must be transmitted. There is one routing table lookup for each IP datagram. For a given destination IP address, the routing table lookup may yield that the destination IP address is on the same IP network as an interface of the local host or router. In this case the datagram is said to be *directly deliverable*. Alternatively, the routing table lookup may yield the IP address of a *next hop router*, which is a router to which IP datagrams can be directly delivered. In Figure 3.2, host A and router R1 can directly deliver IP datagrams to each other. For host H1, the only next hop router is router R3. Router R1 has two possible next hop routers, routers R2 and R3.

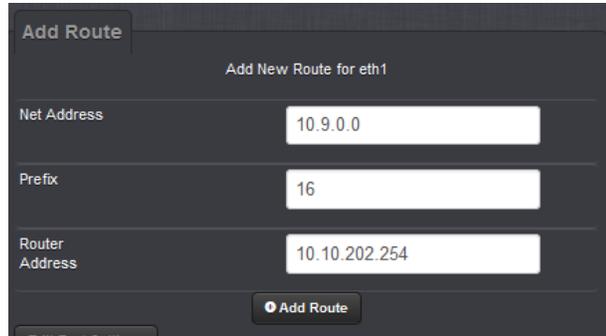
1. **Eth0** is the configured default port/gateway address (its gateway is 10.2.1.1)
2. But an internally generated packet (not responding to an incoming packet) needs to go out **eth1** instead of **eth0** (example- the address it needs to go to is **10.9.3.4 /16**, via eth1's gateway address of **10.10.202.254**)
3. Normally, the packets would go out eth0 (the default gateway). So a static route needs to be configured in eth1 that tells it to route this address/subnet (such as **10.9.0.0** via eth1's gateway address of **10.10.202.254** with a prefix of **16**

The screenshot shows a web interface for adding a static route. The title is "Add Route" and the subtitle is "Add New Route for eth1". There are three input fields: "Net Address" with the value "10.9.0.0", "Prefix" with the value "16", and "Router Address" with the value "10.10.202.254". Below the fields is a button labeled "Add Route".

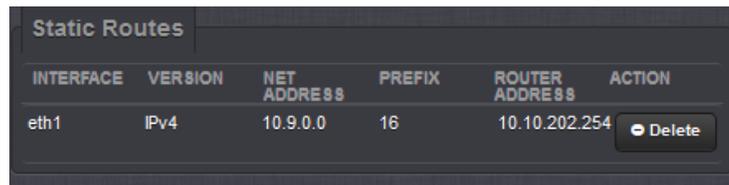
After pressing "Add Route"

| INTERFACE | VERSION | NET ADDRESS | PREFIX | ROUTER ADDRESS | ACTION |
| eth1 | IPv4 | 10.9.0.0 | 16 | 10.10.202.254 | Delete |

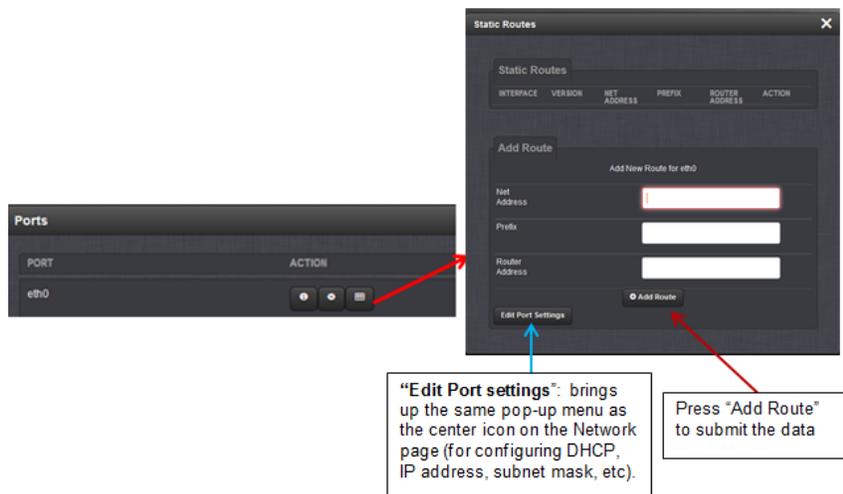
1. Navigate to the Management -> Network page of the browser
2. Click on the third (“table”) icon for the applicable eth0, eth1, eth2 or eth3 interface port that it’s desired to add the route.
3. In the “Add Route” pop-up window that opens, enter the **static route**
  - **Net Address**: This is the address/subnet to route to.
  - **Prefix**: This is the subnet mask in prefix form e.g., "24". See also [Subnet Mask Values](#).
  - **Router Address**: This is the gateway address the packet will initially go through to get there.
4. press “Add Route”.

- **Net Address**: (“This is the address/subnet to route to”, such as **10.2.0.0** for instance). For example, enter: “**10.10.1.101**” in this field). Note that the SecureSync doesn’t care how to get to this address after its sent to its gateway address
- **Prefix**: This is the subnet mask in prefix form (a two digit number for the subnet mask. Example: for a 255.255.255.0 subnet mask, enter “**24**” in this field). Refer to the table below to determine the applicable subnet mask’s two digit number:

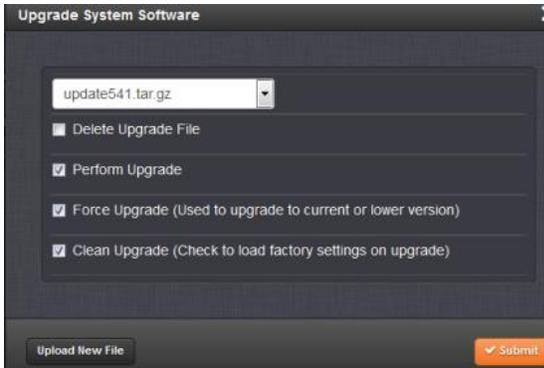
The start of this process is similar to performing a standard software update to the latest version. But after selecting/uploading the software update bundle into the SecureSync, instead of just selecting the **"Perform Upgrade"** checkbox, both the **"Force Update"** and **"Clean Upgrade"** checkboxes also need to be selected, as well (as shown below). Then press Submit.

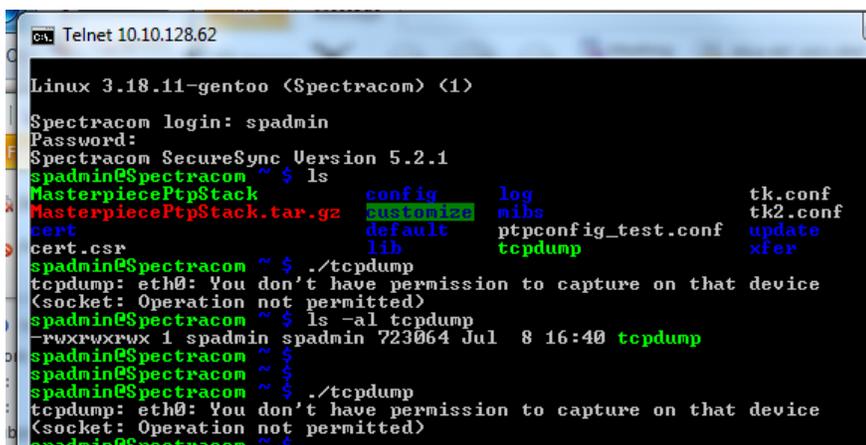
**Per Paul Myers (7 jul 15)** You can't get access to underlying features using spadmin owned tcpdump (note from Keith- Paul had a co-op remove TCPDump using the slider switch and then brought it back into the system using spadmin. This shows a user can't simply install tcpdump and start using it with just admin rights (must use the default tcpdump or be logged in as a root to use a different tcpdump.

```
ca. Telnet 10.10.128.62
Linux 3.18.11-gentoo <Spectracom> <1>
Spectracom login: spadmin
Password:
Spectracom SecureSync Version 5.2.1
spadmin@Spectracom ~ $ ls
MasterpiecePtpStack  config          log             tk.conf
MasterpiecePtpStack.tar.gz  default        mibs           tk2.conf
cert                 lib            ptpconfig_test.conf  update
cert.csr             tcpdump       xfer
spadmin@Spectracom ~ $ ./tcpdump
tcpdump: eth0: You don't have permission to capture on that device
(socket: Operation not permitted)
spadmin@Spectracom ~ $ ls -al tcpdump
-rwxrwxrwx 1 spadmin spadmin 723064 Jul  8 16:40 tcpdump
spadmin@Spectracom ~ $ ./tcpdump
tcpdump: eth0: You don't have permission to capture on that device
(socket: Operation not permitted)
spadmin@Spectracom ~ $
```

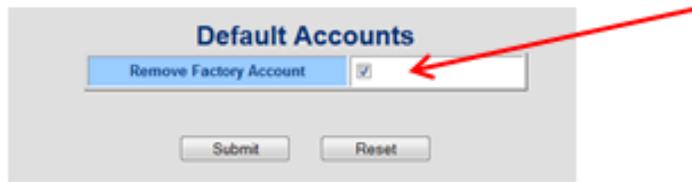
- 1) Login as spadmin or other custom account in the Admin group (custom accounts in the User group don't have permissions to delete the spfactory account)
- 2) Navigate to the **Tools** -> **Users** page of the browser, **Security** tab
- 3) At the bottom of this tab (under "**Default Accounts**"), select the checkbox next to "Remove Factory Account" and press Submit.

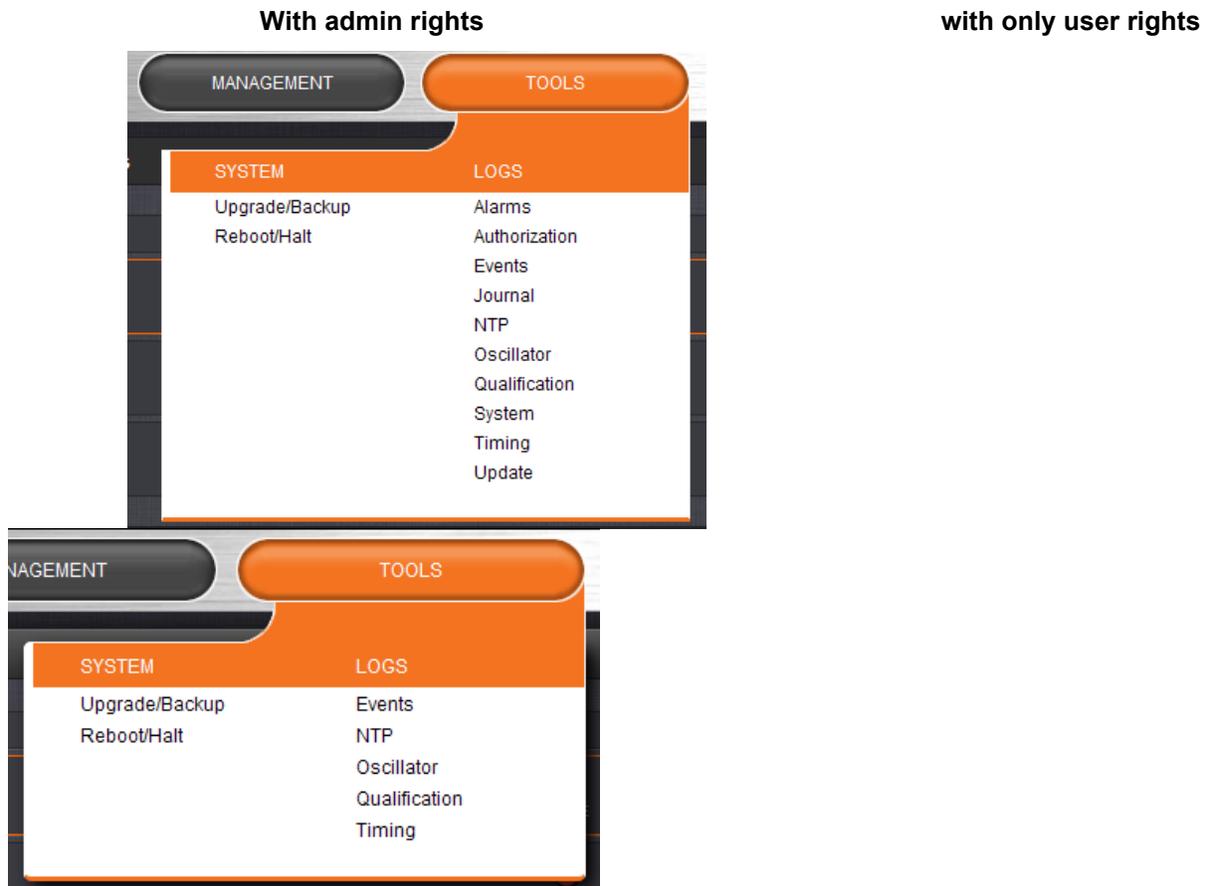
**1. Tools menu**

**Logs:** Limited logs can be viewed by user (only the listed logs can be viewed)

**Upgrade/Backup:** User cannot access this page (Goes to the Home page). Can't perform any updates.

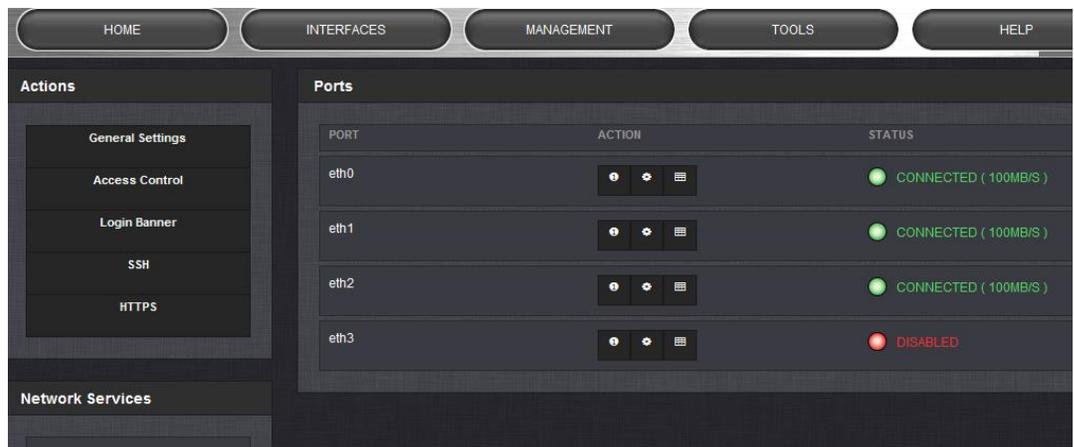
**admin account:**

As shown below, when logged in as user and “Network is selected, the “Actions” buttons (for General Settings, Access Control, login banner, SSH and HTTPS) normally located on the left-side of the screen is not available. Also, when logged in as a user, the only one of the three normally available boxes for the ports is the status box (users can’t make changes to the network settings or disable Ethernet ports).

These selections are only available as spadmin

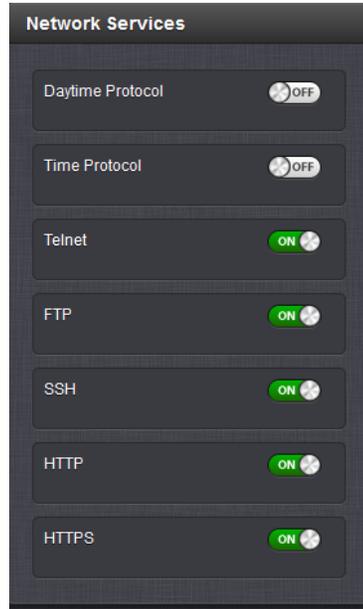
**Network Services (such as telnet, FTP, SSH and HTTP/HTTPS):** Can move the switches, but they won't do anything. So a user cannot enable or disable any Services. Browser will report "Setting FTP Failed" if a switch is moved.

"Network Services" Switches do not allow a "user" to be able to enable or disable any Services (must be an admin to enable/disable)

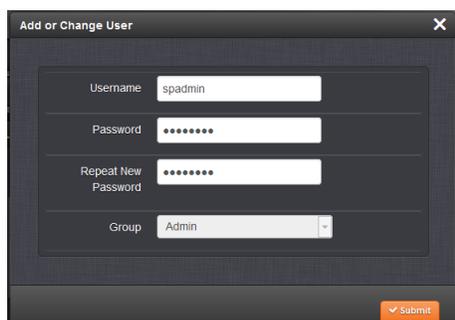
- 4) This will open a pop-up window. Enter the desired new password and press Submit.

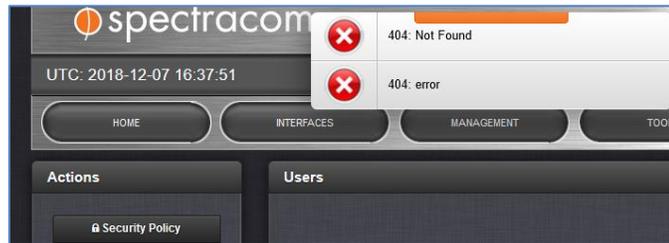
## Displayed Error messages of both 404: Not Found and 404: error displayed after pressing “Change my password” button

This Error message is displayed after pressing the “Change my Pasword” button while currently logged in using remote authentication

**Note** This error message is displayed instead of opening the pop-up window which allows the password to be changed.

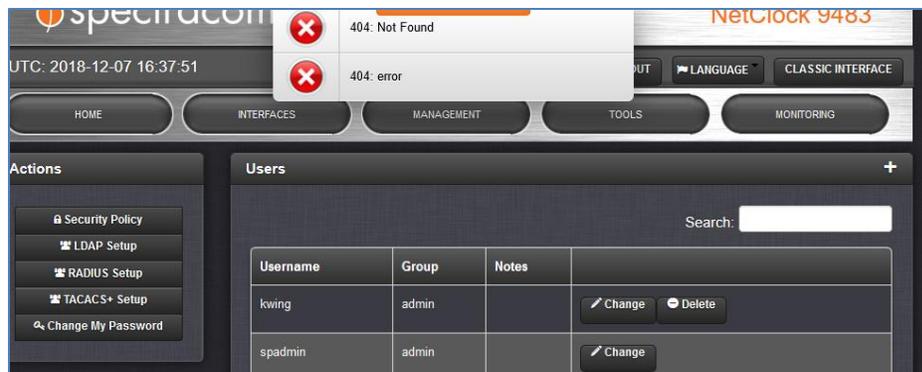
### When logged in using remote authentication (Radius, LDAP or TACACS):

This event is expected, since the account resides in the Remote auth server – not in the SecureSync. Remote authentication passwords need to be managed directly on the remote auth server

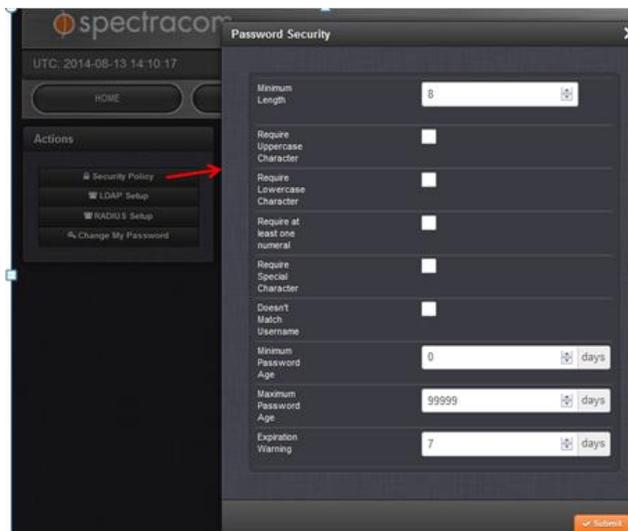
- Consists of: password aging, password length, complex passwords and delete the default spfactory account
  - **Software Versions 5.1.2 and above:** in the **Management -> Authentication** page of the browser. Click on **Security policy** on the left side of the page
- There are several other minimum password requirements which can be enabled as desired, via “Security Policy” (**Management -> Authentication** page of the browser. Click on “**Security Policy**” on the left side of the page) as shown below. These minimum password requirements include the following:

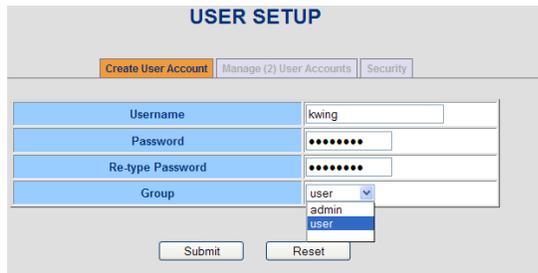
Below is a screenshot for the **Tools-> Users** page of the browser, showing how to initially assign (or change thereafter) permissions for each User account that is created:

The screenshot shows a web browser interface titled "USER SETUP". At the top, there are three tabs: "Create User Account" (highlighted in orange), "Manage (2) User Accounts", and "Security". Below the tabs is a form with the following fields:

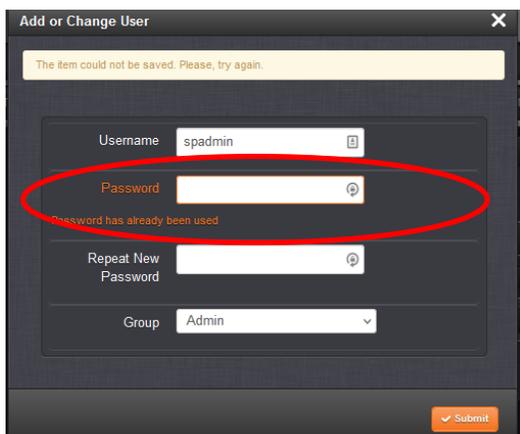
*Test below from v5.9.4 (shown after entering an earlier password and then pressing Submit)*

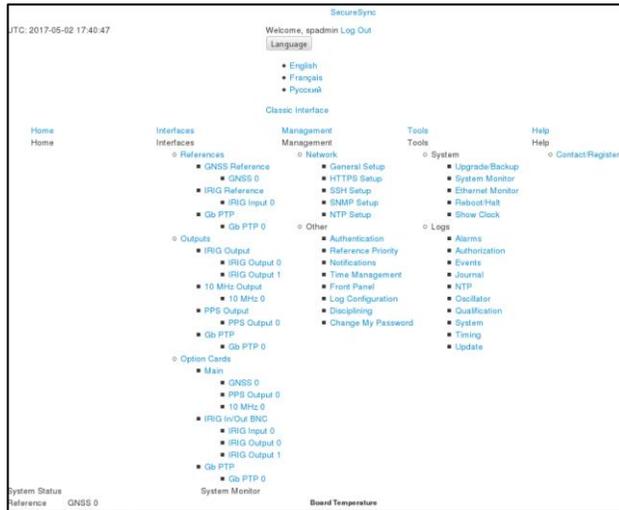
- Can successfully login to the newer browser in 5.1.2 and above, but the display just shows words and categories
- Refer to Salesforce cases such as 25213

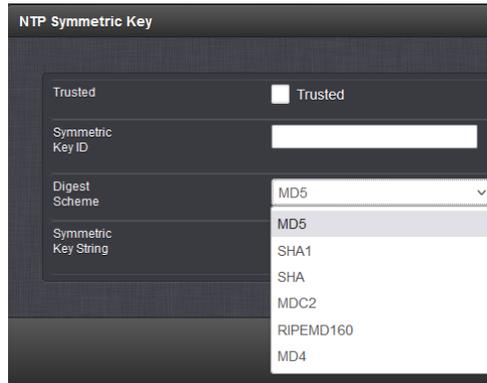
- **NTP symmetric Key:** NTP supports SHA2, but SHA2 is **not** listed/available in the drop-down field as a selection (refer to work-around further below)

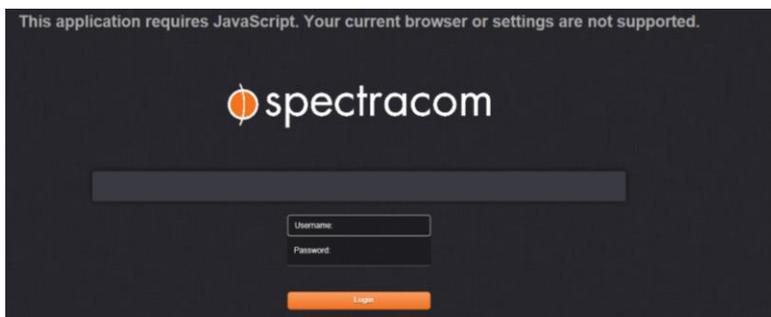
**A) No successful login occurs and the following error message is displayed at the top of the window: "This application requires JavaScript. Your current browser or settings Are not supported." (as shown below)**

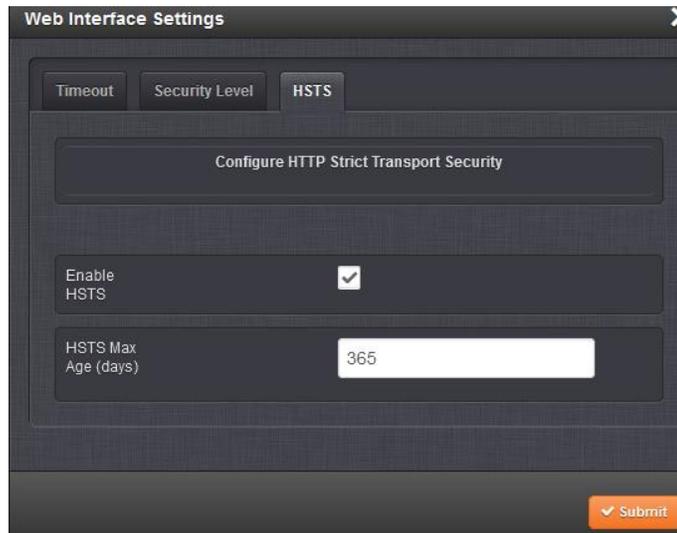
- 1) Navigate to **MANAGEMENT** > **Network Setup**.
- 2) Select **Web Interface Settings** (button on left)
- 3) Select the **HSTS** tab to Enable/Disable HSTS, or to configure the Max Age of the functionality (default is set to 1 year).

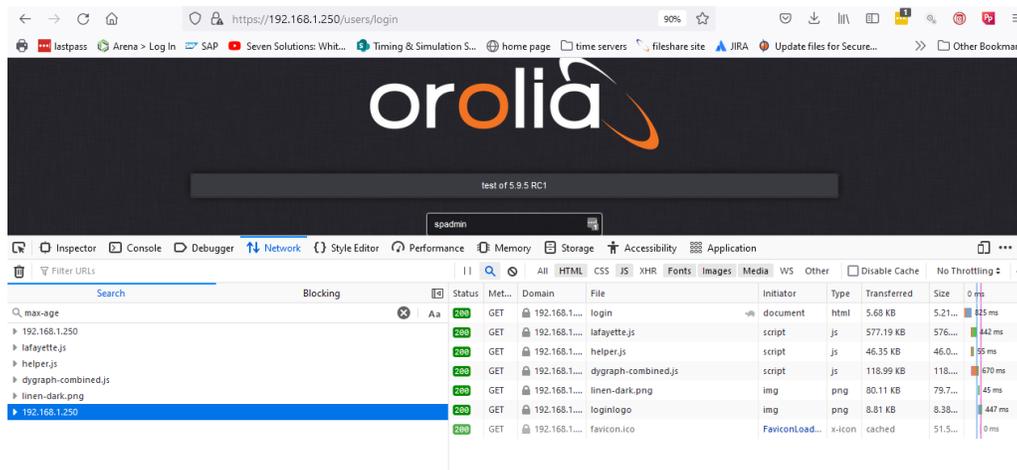
1. Open a browser connection to the SecureSync
2. In Google, click the “three dots” and select More Tools -> Developer Tools  
In Firefox, go to Tools -> Browser Tools -> Web Developer Tools
3. Select the “**Network**” tab
4. Click the magnifying glass and search for “**max-age**”
5. Reload the page
6. The list on the left is/are all the locations max-age (a parameter for HSTS) was found.

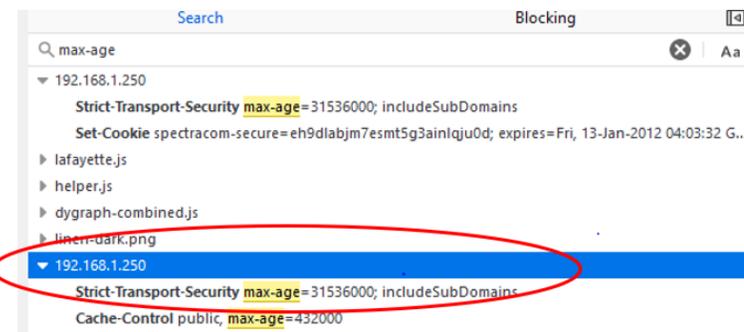
7. Click on the item(s) listed on the left to see the HSTS parameters (**Strict-Transport-Security max age**) drop-down below it.

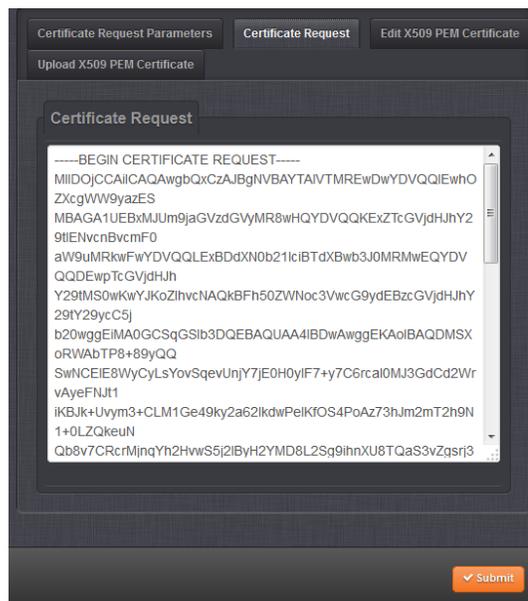
1. Navigate to the **Management -> HTTPS Setup** page of the browser
2. (Optional Step to be able to confirm a new certificate has been created at the end of this process): Go to the **Certificate Request** tab to view the current certificate. Either screenshot it, as shown below or copy/paste the contents to a Word document.

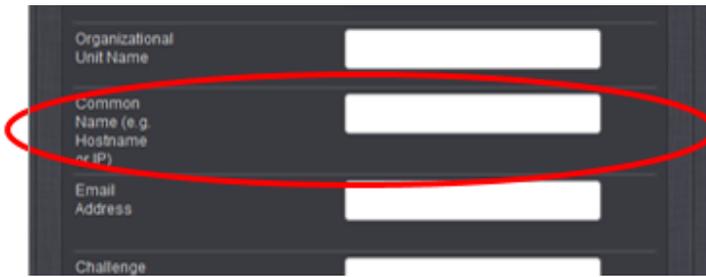
A screenshot of a certificate configuration form. The form has several input fields. The 'Common Name (e.g. Hostname or IP)' field is circled in red. Other fields include 'Organizational Unit Name', 'Email Address', and 'Challenge'.

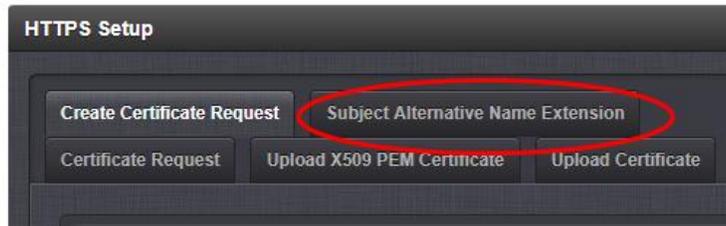
- Refer to [https://www.openssl.org/docs/apps/x509v3\\_config.html](https://www.openssl.org/docs/apps/x509v3_config.html)
- Refer to sites such as <https://tools.ietf.org/html/rfc2818>
  - the Common name must be DNS SAN
- Ability to create SAN certificates was added in update version 5.8.0
- SAN certificates essentially allow adding more than one Common Name for the time server (standard certificate only supports one Common Name)
- Creating a SAN certificate involves configuring a second tab (“**Subject Alternative Name Extension**”) in the HTTPS Setup page

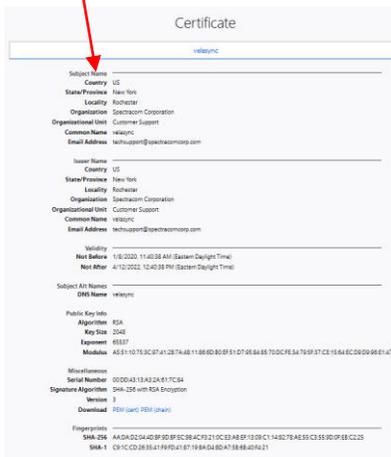
Websites prove their identity via certificates. Firefox does not trust this site because it uses a certificate that is not valid for 10.10.162.20. The certificate is only valid for velasync.

Error code: MOZILLA\_PKIX\_ERROR\_SELF\_SIGNED\_CERT

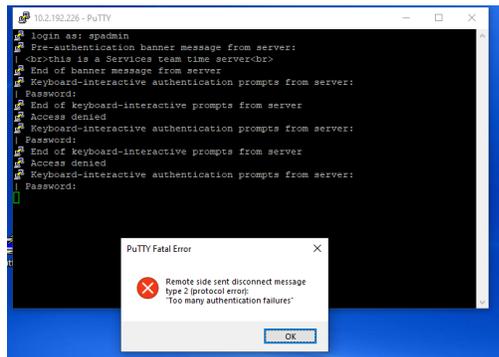
- The number of failed login attempts for ssh is hard-set to **(3) three, with a 60 second lock thereafter**. This value is not user-configurable.

- After waiting a full **60 seconds**, users are provided just **one** attempt thereafter to login successfully (instead of the normal **three** attempts) or the 60 second lock counter starts again (trying to login before 60 seconds has elapsed counts as that **one** attempt, and so user has to wait an additional 60 seconds before trying to login again).

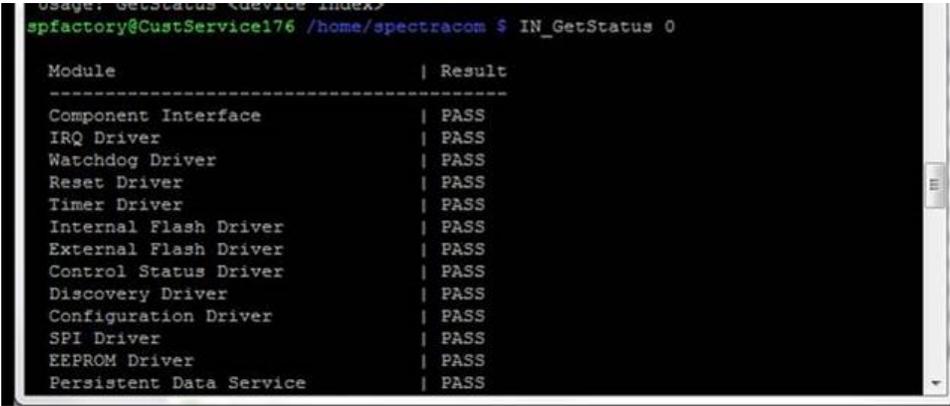
**Note:** Refer to the **IN\_GetStatus 0** CLI command in the CLI section of this document to display a list of pass/fail state for KTS initialization (Example below). See if any items report FAIL. This command is available in the spadadmin account.

Module | Result
-----|-----
Component Interface | PASS
IRQ Driver | PASS
Watchdog Driver | PASS
Reset Driver | PASS
Timer Driver | PASS
Internal Flash Driver | PASS
External Flash Driver | PASS
Control Status Driver | PASS
Discovery Driver | PASS
Configuration Driver | PASS
SPI Driver | PASS
EEPROM Driver | PASS
Persistent Data Service | PASS
```

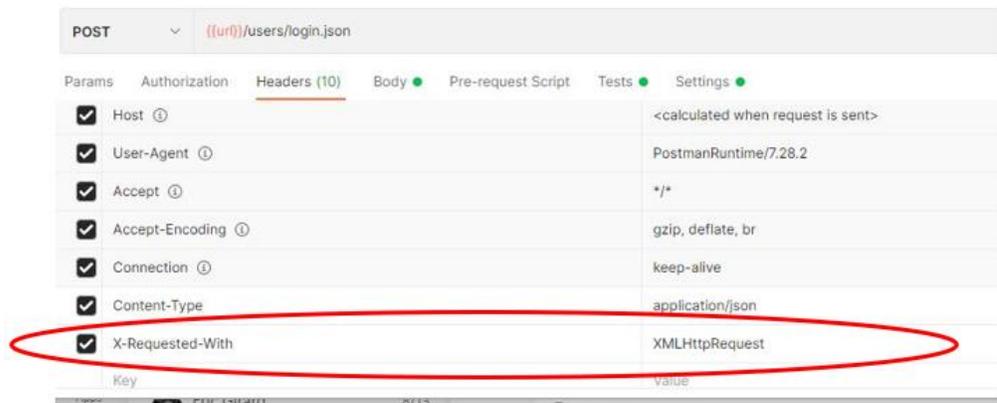
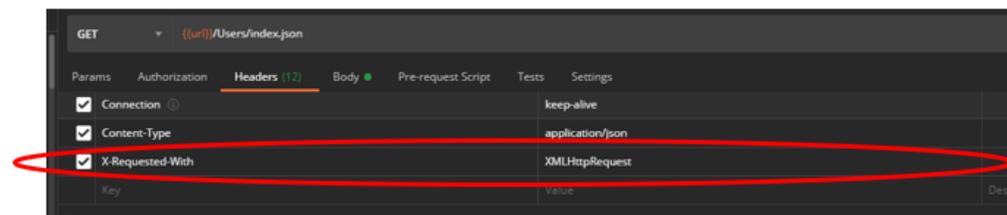
### **X-Requested-With: XMLHttpRequest**

In postman it can be added like the below example:

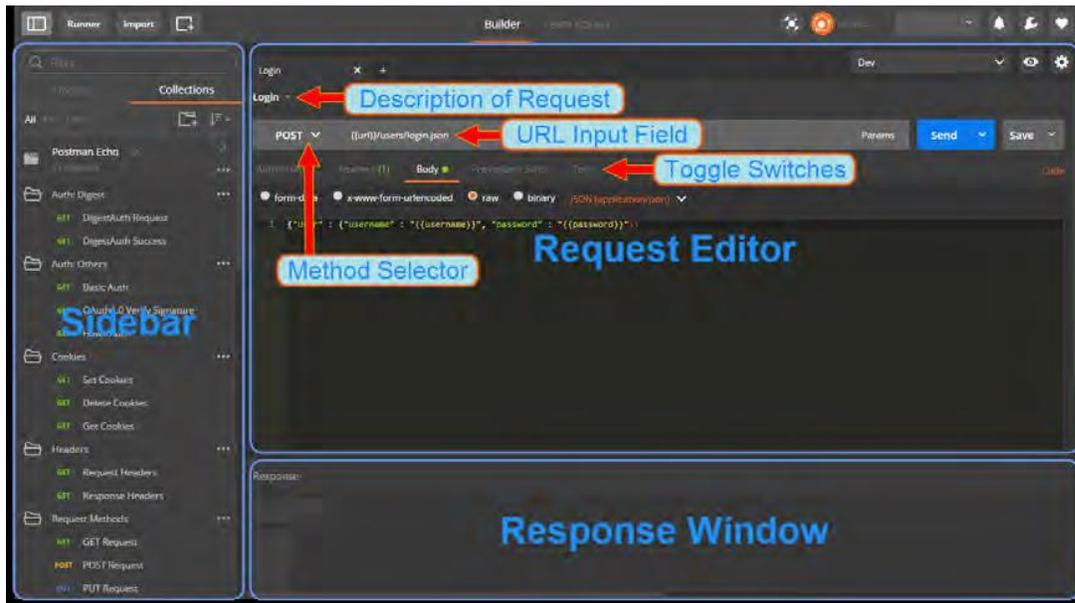
The following is a brief overview of the Postman UI. More comprehensive assistance can be found under <https://www.getpostman.com/docs>.

The Sidebar lists the requests stored in the loaded Collections (see "Spectracom REST API Developer Guide" on the previous page), and – under the History tab – a list of recently submitted requests.

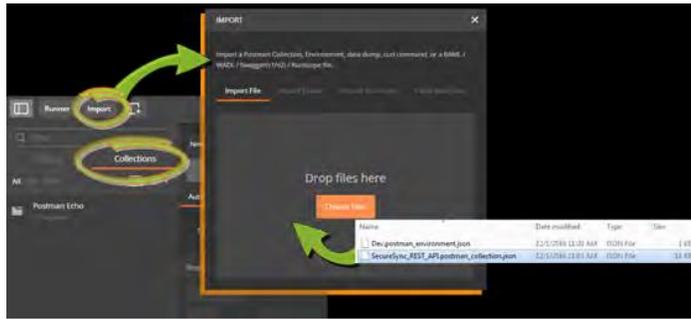
➤ Navigate to Collections > Import: Choose File.

c. From the zip folder created in step 2, select the file `SecureSync_REST_API-postman_collection.json`, and open it. Under the Collections tab in the Sidebar on the left, `SecureSync REST API` will be displayed. Click on it to display the Collection's folders which reflects the menu structure of the `SecureSync Web UI` e.g., `Networking`, `Log Configuration`, `NTP`, etc. Each folder contains requests. Click on any request to display it in the Request Editor.

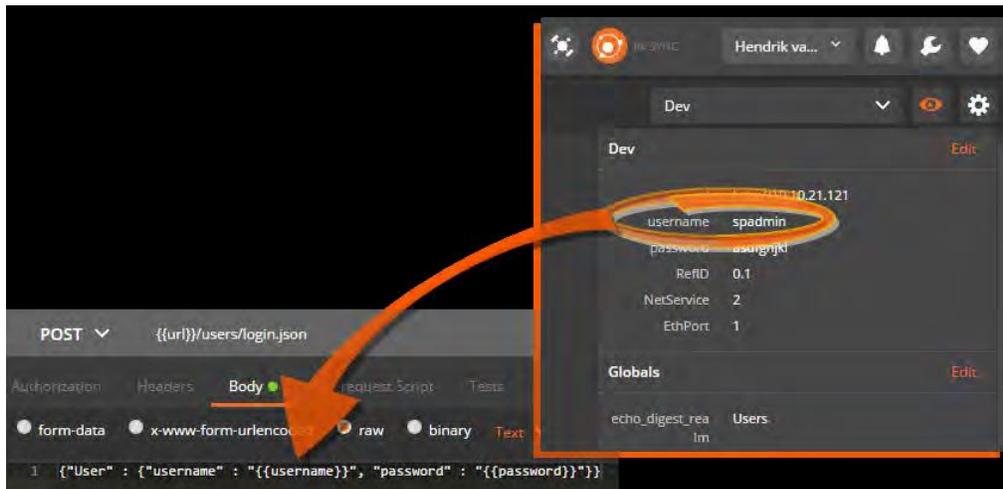
To use a development variable, apply two curly brackets in the body code:

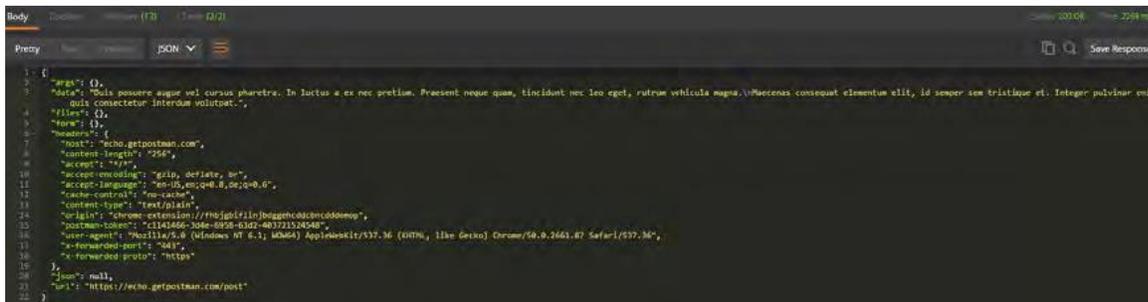
To test, click the blue `Send` button. The coding window will display the requested code:

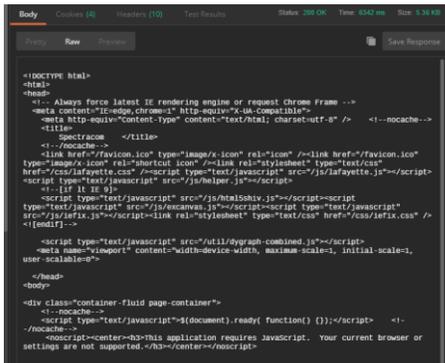
## Raw tab

<meta name="viewport" content="width=device-width, maximum-scale=1, initial-scale=1,
user-scalable=no">
</head>
<body>
<div class="Container-Fluid page-container">
<!--no-cache-->
<script type="text/javascript">(document).ready(function() {})</script> <!--
--no-cache-->
<script><center><h3>this application requires JavaScript. Your current browser or
settings are not supported.</h3></center></script>
```

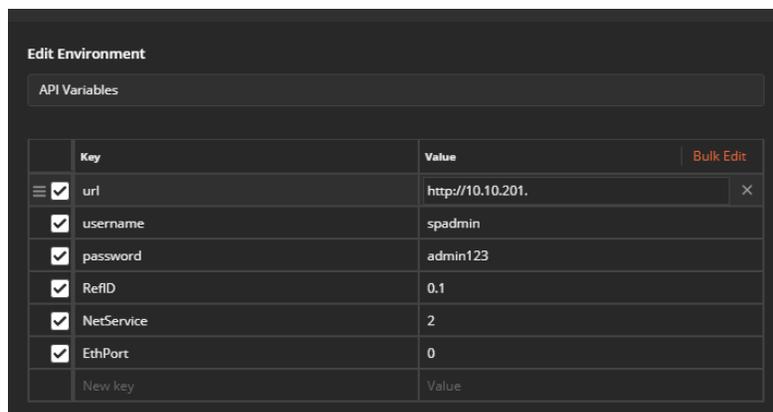
4. Click the **EYE** button to see which environment variables have been loaded with this environment file: One variable is called **url**, another one is **spadmin**, etc.

Click edit to change any/all the values (such as the URL of the desired SecureSync). Then click **“Update”**.

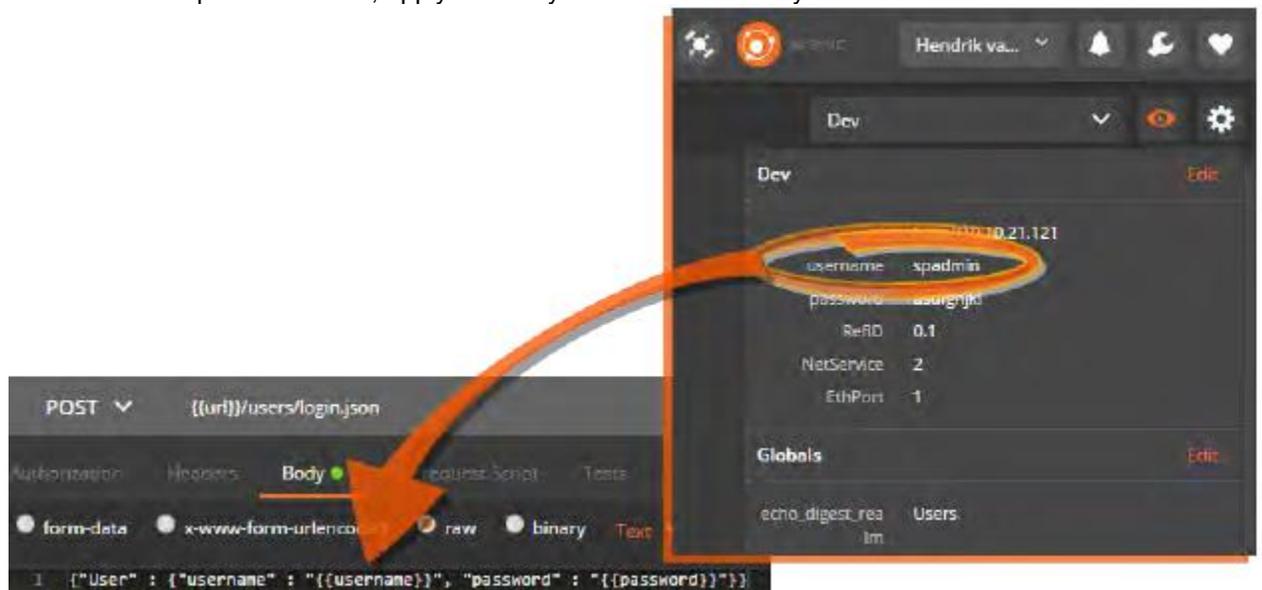
To use a development variable, apply two curly brackets in the body code:

To test, click the blue **Send** button (top-right corner of the page). The coding window will display the requested code:

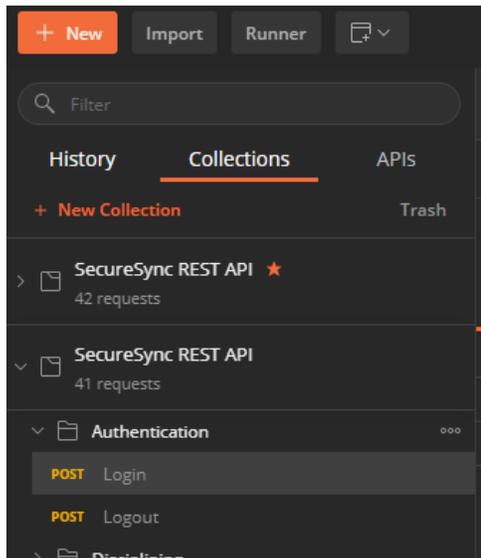
2. Expand **“SecureSync REST API”**, and perform **Authentication** -> **“Login”** to the desired SecureSync (highlight **“Login”** and press the **Send** button (in blue))

3. Scroll down about 56 lines and verify it indicates (in white text) **“Welcome, spadmin</spa”**
