Model 1200 series SecureSync/9400 series

Lafayette (Model 1200 series SecureSync)

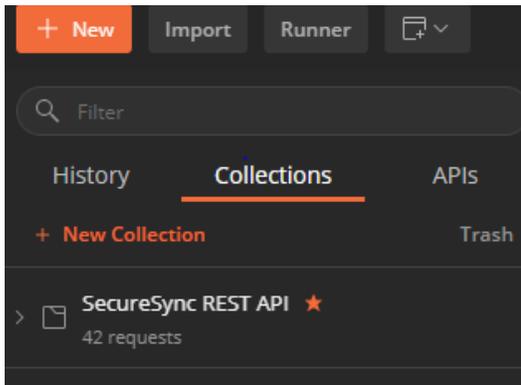
3. On the left-side of the page expand “**SecureSync REST API**”,

4. Expand and perform **Authentication** -> “**Logout**” to the desired SecureSync

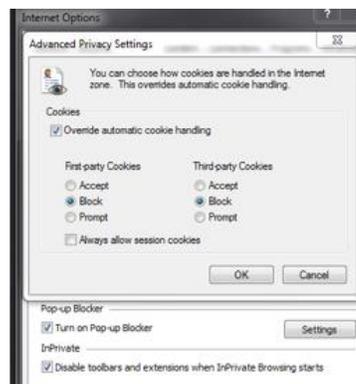
In IE, go to **Tools -> Internet Options**. Select the **Privacy** tab, and press **Advanced**

The **Advanced Privacy Settings** window which opens, make sure both the **First party** and **Third party** cookies are not “**blocked**”. If I recall correctly, I think it's only the first party cookies which matter (but configure them both the same, just in case). If the cookies are blocked, you won't be able to login, there won't be an error message displayed, and the username goes away each time.

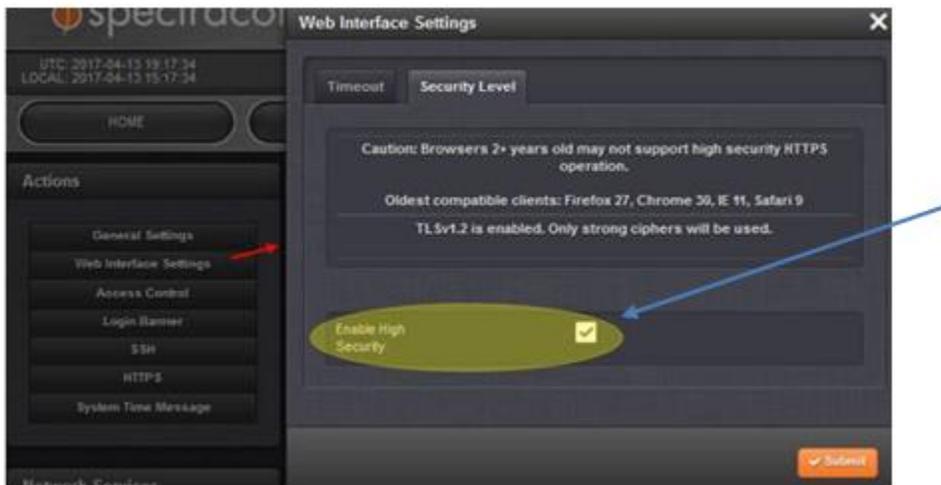
- If **HISEC** (the “**Enable High Security**” checkbox) is enabled in the time server, make sure “**TLS 1.2**” is enabled.

- the “**Enable High Security**” checkbox: is in the *Management* -> *Network Setup* page of the browser (press the “**web interface settings**” button on the left). Then select the “**Enable High Security**” checkbox in the “**Security Level**” tab (as shown below):

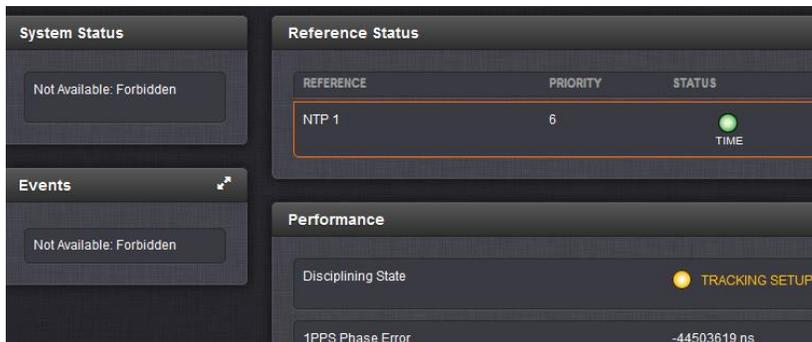
**Symptom:** “*Not Available: Forbidden*” error message is being displayed while trying to login to the newer (black/charcoal) web browser (login fails with “*Not Available: Forbidden*” displayed). But can still successfully login to the classic interface browser.

**This message indicates not currently logged into the browser (earlier login may have since timed-out)**

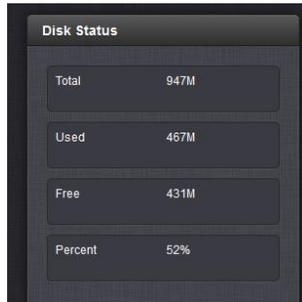
Note: Update version 5.2.0 added CF card memory status to the newer web browser (not available in classic interface). Note: Also added ability to delete logs and Statistics from the same location

Tools -> Upgrade/Backup page of the browser (under “Disk Status”)

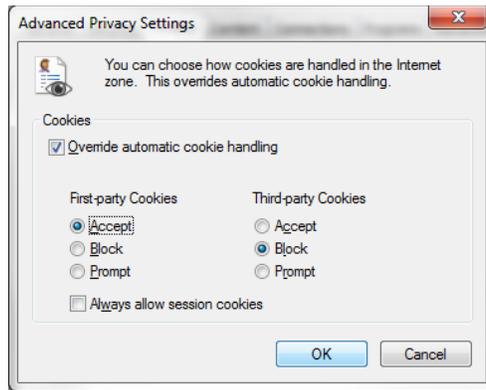
1. **Internet Explorer: Enable “First party Cookies” in Tools -> Internet Options, Privacy tab, Advanced button:**

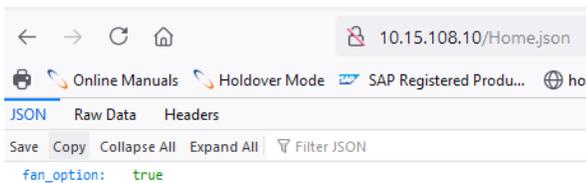
- Normally, the url for the Home page just reports the IP address.
- From Ron's email futher above: "For your point about the **Home** page to see the JSON data it provides you need to use the Endpoint: **/Home.json**"

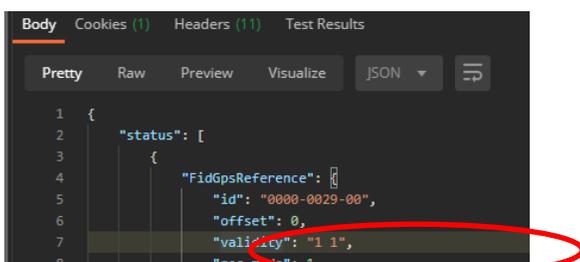
### "validity" variable

The variable “validity” is the Time and 1PPS validity.

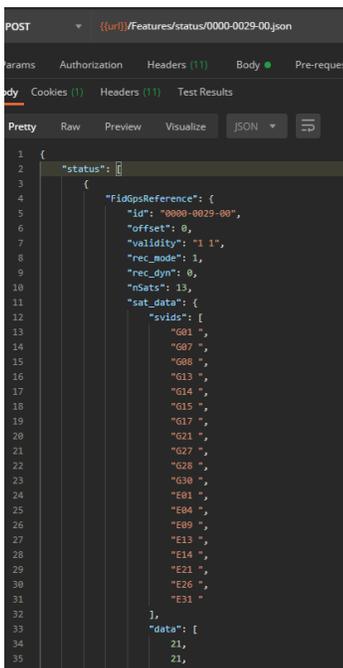
**Email from Ron D (7 June 2021)** To get GNSS Status a GET request can be sent to the Endpoint: [/Features/status/0000-0029-00.json](#)

```
POST {{url}}/Features/status/0000-0029-00.json

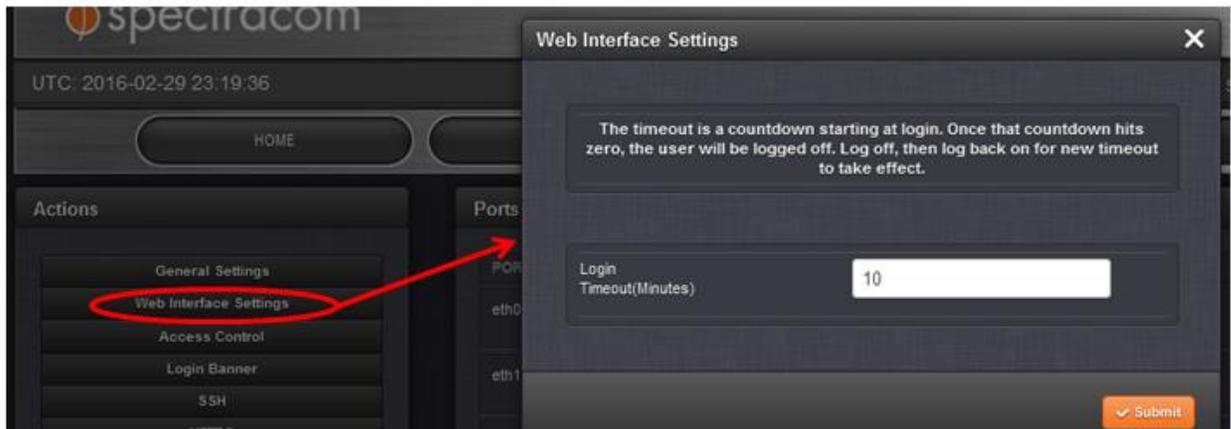
| Send for: | Secure connections only |

- Update **version 5.4.0** added configurable time-out (and consistent timeout of the browser)
- Click “Web interface Settings” on the left side of the **Management** -> **Network** page
- Configured in “**Minutes**”
- Available timeout range is from **10 minutes** to **1440 minutes (24 hours)**
- A change to the time-out period doesn’t take effect until the NEXT login (not while already logged-in)

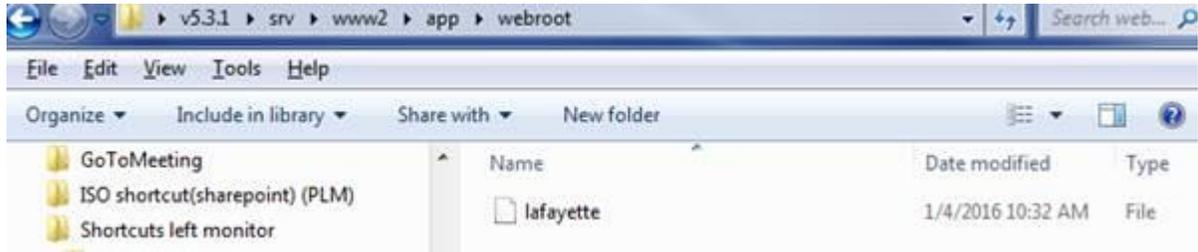
- 1) **Sqlite Database (“Lafayette”)** is located in the “**SRV**” folder of the logs bundle (available after untarring the log bundle).

Note this file is a few folders into the srv folder (**srv/www2/app/webroot**). Just keep clicking each folder inside the srv folder, until you see this single file (as shown below):

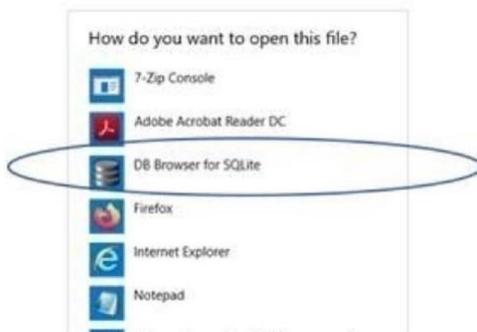
- 2) Double-click the “Lafayette” fi; and select to open it using the “DB Browser for SQLite” program.

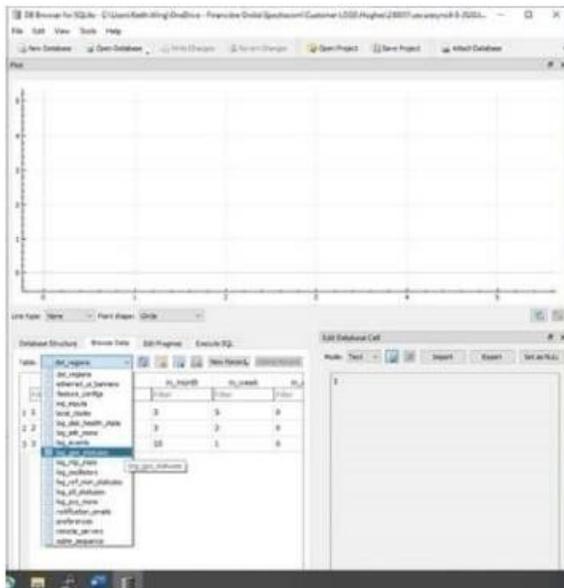
- 3) Under the graph area, select the “Browse data” tab

- 4) Change the “table” to the desired type of data to graph:

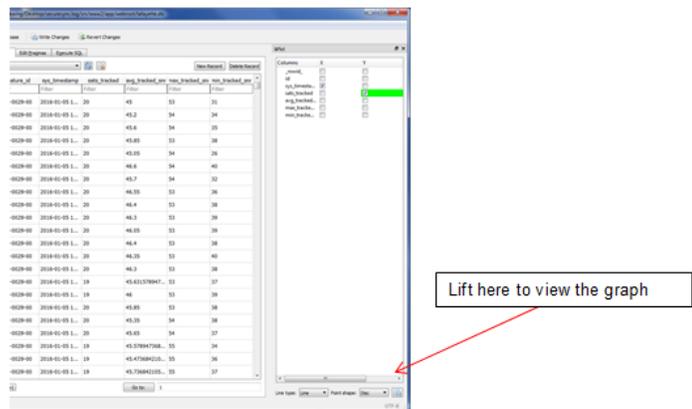
**Note:** Select “**sys\_timestamp**” for the X column and desired value(s) to graph in Y column. Graph updates automatically.

**Note:** if the graph can’t be found in the screen (and if **View -> Plot** has been selected) move the Plot table to the right side of the screen and use the mouse to pull up on the bottom bar.

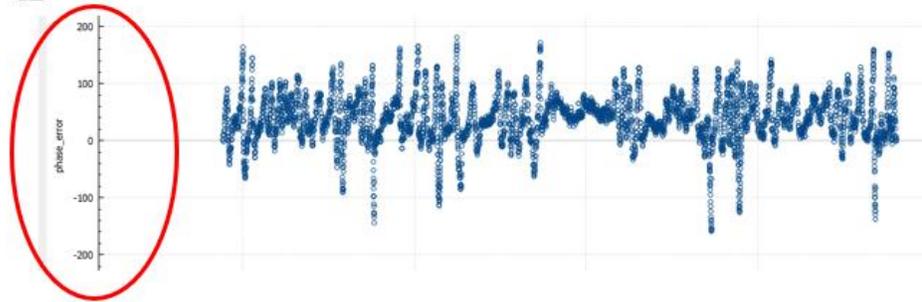
**A) log\_oscillators Phase Errors**

The reference monitor is a measurement taken before that offset gets applied

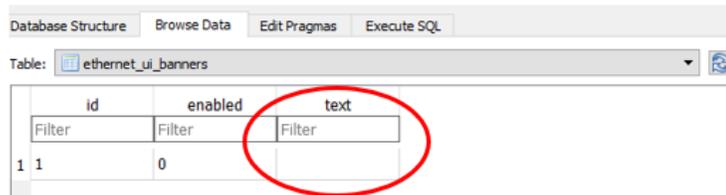
1. With no web browser log banner created/stored (notice the "text" field is null/empty)

The screenshot shows a database browser interface with tabs for 'Database Structure', 'Browse Data', 'Edit Pragmas', and 'Execute SQL'. The 'Browse Data' tab is active, showing a table named 'ethernet\_ui\_banners'. The table has three columns: 'id', 'enabled', and 'text'. The 'text' column is circled in red, indicating it is empty.

To view the browser's login banner, open the sqlite database, select the "**Browse Data**" tab and select the "**ethernet\_ui\_banners**" tables

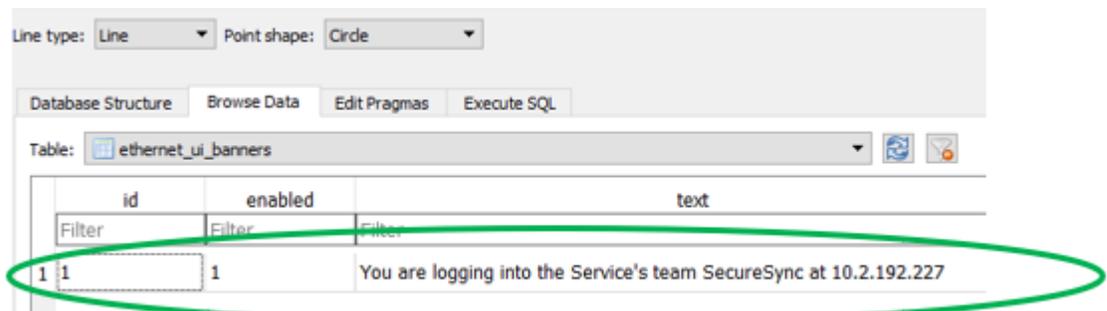
2. With web browser banner created/stored (placed in the "text" field)

*Sample web browser login banner was created*

The screenshot shows the same database browser interface as above, but now the 'text' field in the 'ethernet\_ui\_banners' table contains the banner text. The entire table row is circled in green.

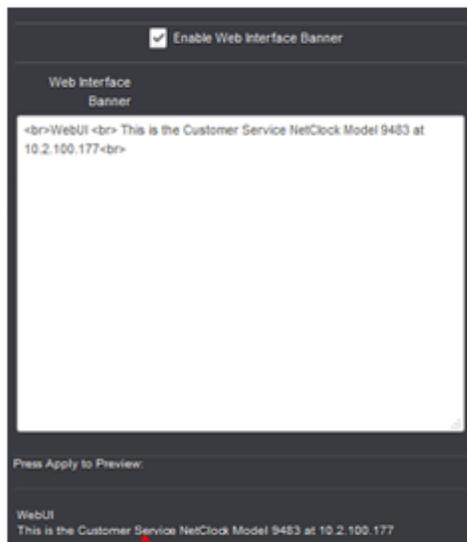
### Bottom banner (web browser login)

Sample Banner displays at bottom after pressing “Apply”

**Note:** “<br>” is to start a new line.

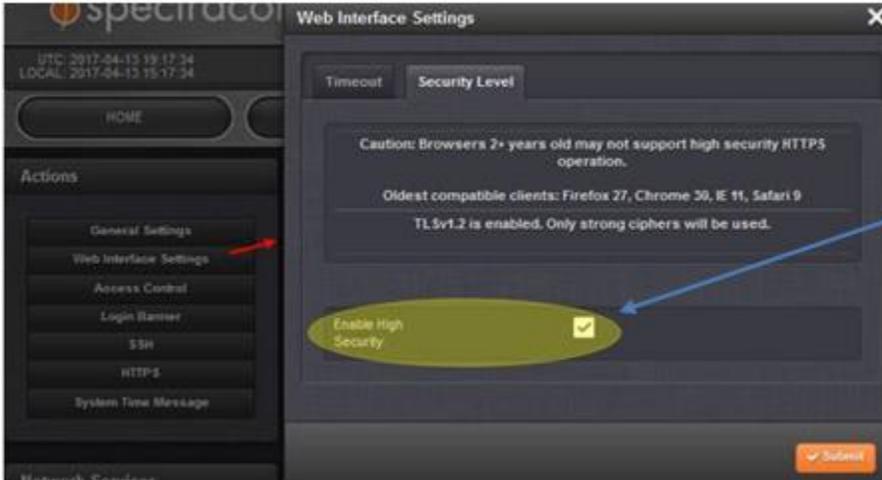
- Selection is in the **Management -> Network Setup** page of the browser (press the “**web interface settings**” button on the left). Then select the “Enable High Security” checkbox in the “Security Level” tab (as shown below):

- Ability to enable either ‘*both high and medium level ciphers*’, or ‘*high level ciphers only*’ was added in software version 5.4.5.
- Selecting the “Enable High Security” checkbox limits the ciphers list on the time server to only those algorithms considered most secure (preventing earlier browsers such as IE11 from being able to login)
- Factory default state is the “Enable High Security” checkbox NOT selected (providing both strong and medium ciphers for earlier browsers such as IE11 )

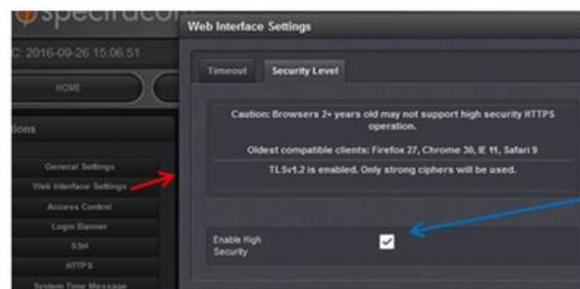
- Ability to select either high and medium level ciphers or just high level ciphers was added in software version 5.4.5.
- Update version 5.4.5 added the ability to either limit the newer black browser to use only strong security ciphers or to allow it to use both medium and strong ciphers (As determined by the requirements of the browsers desiring to connect to the SecureSync)
  - In v5.4.5 and above, there are now two different cipher lists. This checkbox determines which of the two is used).
  - TLSv1.2 is enabled when high Security is selected.
- Selecting “**Enable High Security**” limits the ciphers list to only those algorithms considered most secure.
- Selection is in the **Management** -> **Network Setup** page of the browser (press “**web interface settings**” button on the left). Then select the “**Enable High Security**” checkbox in the “Security Level” tab \*as shown below):

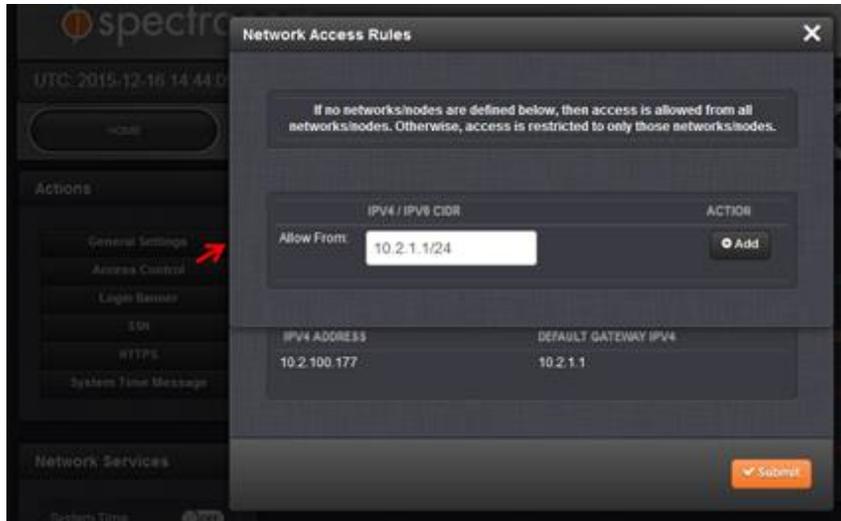
### C) Newer black/Charcoal web browser:

*Management* -> *Network* page. Then click on “Access Control” (on the left side of the page)

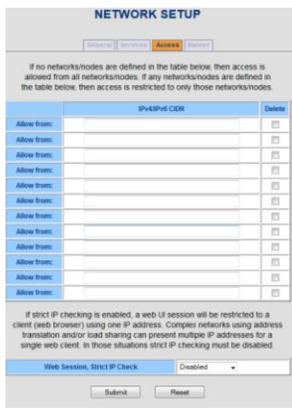
### D) “classic interface” web browser

Network -> General Setup page, Access tab (as shown below)

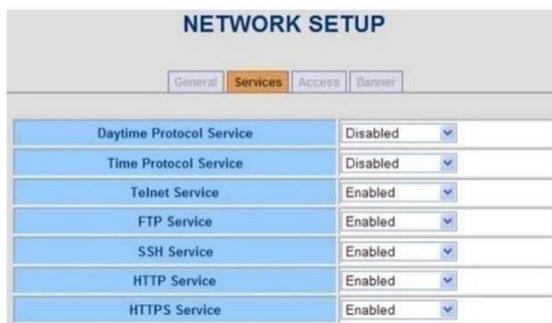
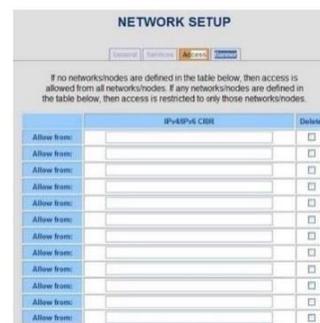
As shown in the left screenshot below, all of the "management services" are enabled (Daytime and Time protocols are not management protocols) and no clients or subnets have been configured to "allow" access via any of the management services (as shown in the right screenshot below), this indicates that any computer that can see this SecureSync can utilize any of the enabled services (assuming they know the login password, of course).

The Ethernet ports themselves ("Eth0", "Eth1", "Eth2" and "Eth3") are not directly configured to restrict access by the port name/number. Instead, each port is indirectly restricted by its applicable IP addresses. For example, if the network connector "Eth1" is connected to a network with IP addresses of 192.168.1.x, if the 192.168.1.x network is not listed in the Access table (and if the Access table has any other values entered), the PCs that are connected to port "Eth1" will not have access to the management functions of SecureSync.

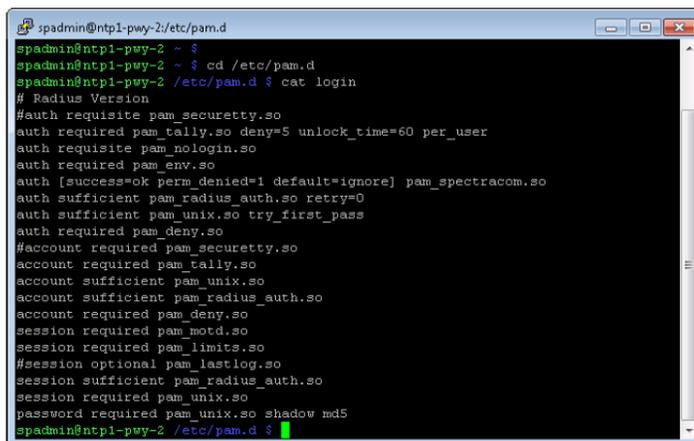
As indicated: (internal use only) Spectracom/etc/pam.d/radius and type: **cat login**

```
spadmin@ntp1-pwy-2:/etc/pam.d
spadmin@ntp1-pwy-2 ~ $
spadmin@ntp1-pwy-2 ~ $ cd /etc/pam.d
spadmin@ntp1-pwy-2 /etc/pam.d $ cat login
# Radius Version
#auth requisite pam_securetty.so
auth required pam_tally.so deny=5 unlock_time=60 per_user
auth requisite pam_nologin.so
auth required pam_env.so
auth [success=ok perm_denied=1 default=ignore] pam_spectracom.so
auth sufficient pam_radius_auth.so retry=0
auth sufficient pam_unix.so try_first_pass
auth required pam_deny.so
#account required pam_securetty.so
account required pam_tally.so
account sufficient pam_unix.so
account sufficient pam_radius_auth.so
account required pam_deny.so
session required pam_motd.so
session required pam_limits.so
#session optional pam_lastlog.so
session sufficient pam_radius_auth.so
session required pam_unix.so
password required pam_unix.so shadow md5
spadmin@ntp1-pwy-2 /etc/pam.d $
```

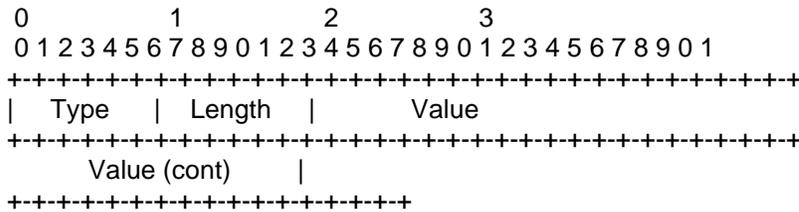
A summary of the Service-Type Attribute format is shown below. The fields are transmitted from left to right.

Type 6 for Service-Type.

Length 6

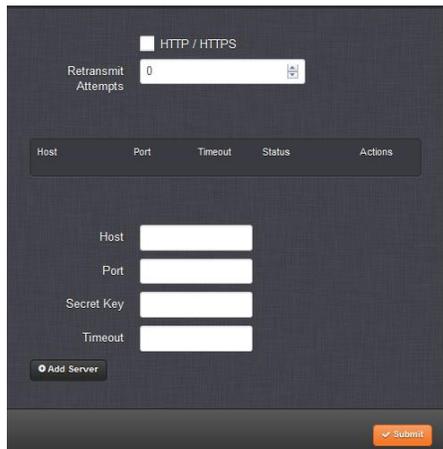
#### B) Configuration via web browser

**Management** -> **Authentication** page of the browser. Click “**Radius Setup**” button on left side of page

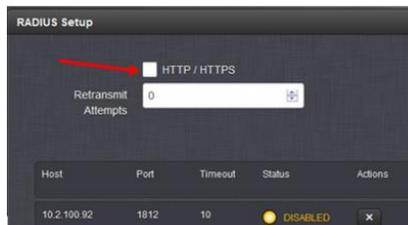
**HTTP/HTTPS checkbox not selected**

indicates the **HTTP/HTTPS** checkbox at the top of the Radius Setup menu isn’t currently selected. Press the “Radius Setup” button the left side of the page and select the **HTTPS/HTTPS** checkbox at the top of the “Radius Setup” menu. Then press Submit.

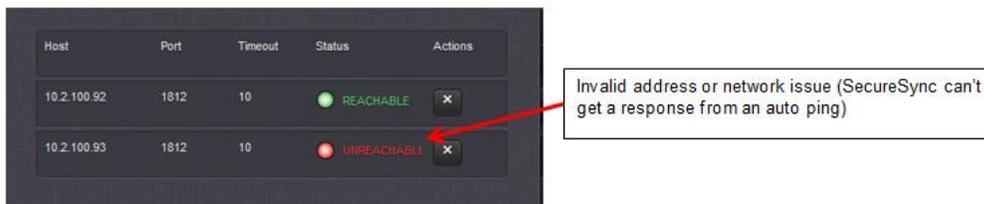
**Radius Server unreachable**

indicates a Radius server that the SecureSync is not able to communicate with. The Host address may not be correct or the Radius server may not be on the same network as the SecureSync.

**Note:** See Radius troubleshooting on diagnosing this condition.

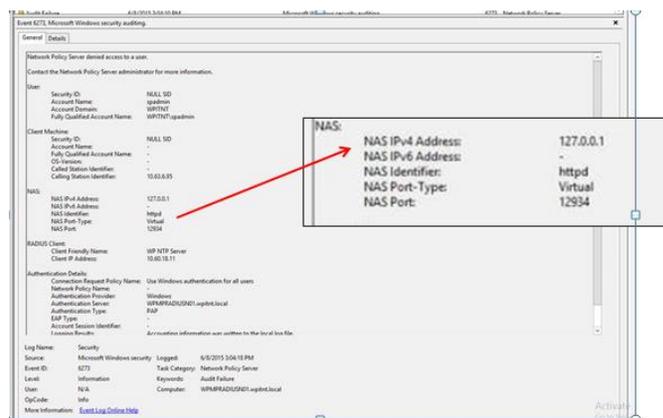
**Example screenshot showing SecureSync reporting its NAS address as its loop back address instead:**

2) **NAS address:** Are they possibly using the NAS address as a second layer of authentication (allowing only certain devices to be able to even contact the Radius server). Microsoft found our NAS address was being outputted in v5.2.0 and below as 127.0.0.1 which was blocking the SecureSync from even trying to authenticate (instead of it being the IP address of the SecureSync). This is expected to be addressed in 5.2.1. Refer to Mantis case 3017 and Salesforce case

- Refer to Salesforce cases 17439 and 18482.
- In versions 5.2.0 and below, the NAS address is always the loopback address of 127.0.0.1
- Starting in version 5.2.1:
  - If the SecureSync can't find a DNS server, its NAS address will remain its loopback address of "127.0.0.1"
  - If the SecureSync finds a DNS server, the SecureSync will then change its NAS address to the IP address it receives from the DNS server (which is the IP address that has been mapped to its hostname within the DNS server).

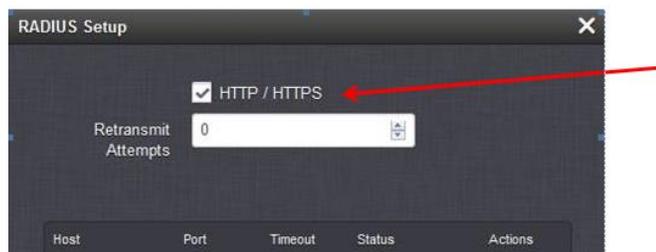
- C) To verify Radius is configured correctly should initially be able to login to the classic interface using Radius.
- D) Once radius has been verified with classic interface, disable and then re-enable Radius (Management -> Authentication page, click on the Radius Setup button on the left side of the page). Unselect the "HTTP/HTTPS" checkbox and press Submit. Then select this same checkbox and press Submit again.

Radius login should now be setup to work with the new browser, instead of the classic interface. Try logging in with the Radius account/password.

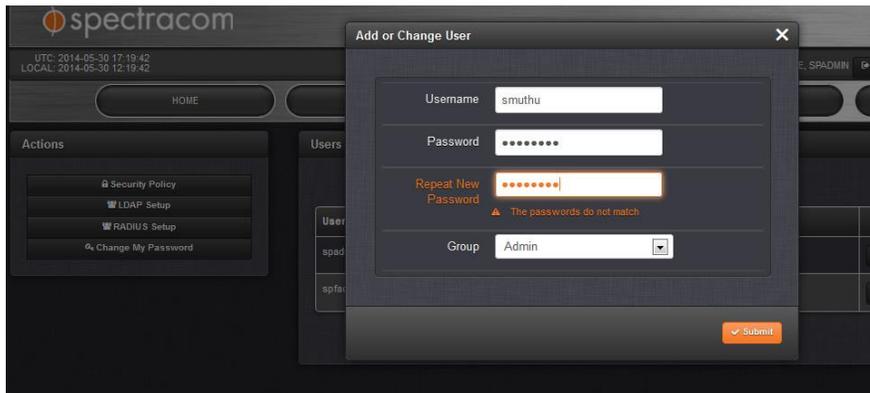
If you haven't already created a user account with the name of "smuthu" for example, go to the **Management -> Authentication** page of the new browser. Then click on the "+" sign in the upper-right corner (just above the "search" field). Enter the desired Radius Username and any desired password (doesn't have to be the same as the Radius account password). Then select the "Admin" Group and press Submit.

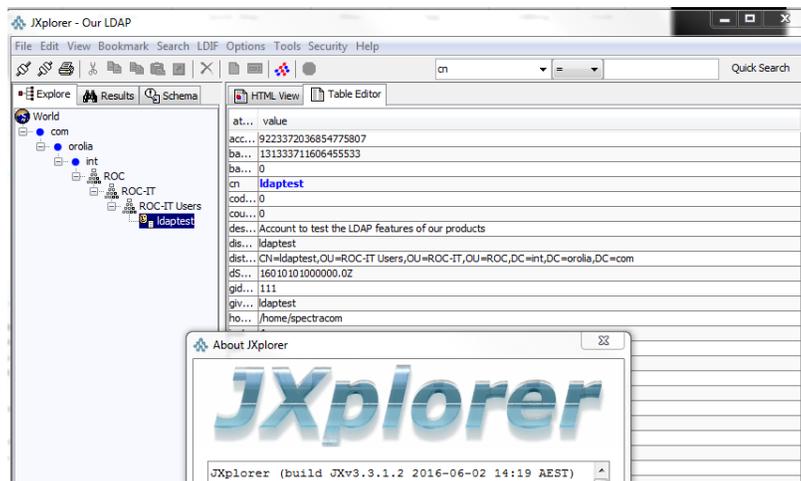
### Active Directory/schema viewer to see the directory structure of the IT's AD server

- Example of a freeware/opensource viewer: JXplorer

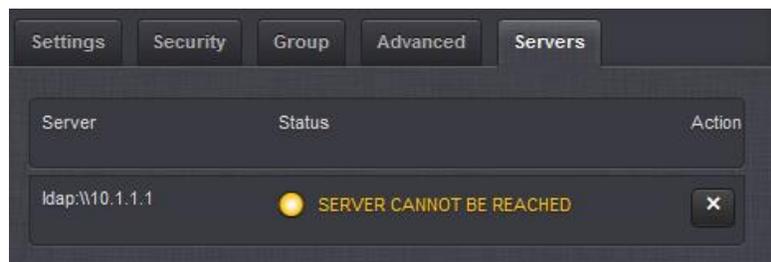
**Note:** After entering the LDAP server address, if the “Servers” tab reports “server cannot be reached” (instead of “LDAP Configuration valid”)

- 1) Whether using the LDAP server's IP addresss or hostname, the Server line must begi with **ldap://** (and **not "ldap:\\"**)
  - Example above shows the wack/wack going in the wrong direction (instead of \\, it should be //)
- 2) (if using a hostname instead of IP address) DNS is configured correctly and working (try temporarily using its IP address to see if it then connects. If it does, there is a DNS-related issue.
- 3) make sure all the LDAP settings (in the Settings tab) are correct. these do affect the adding of a server.

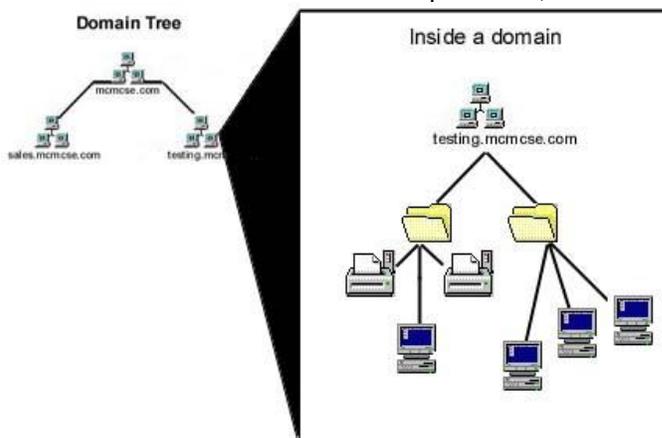
The folder symbols represent Organizational Unit (OU) containers and within each of these we find objects such as printers, [servers](#), computers, users, etc. Instead of objects directly located inside these OUs, there could be more OU containers.

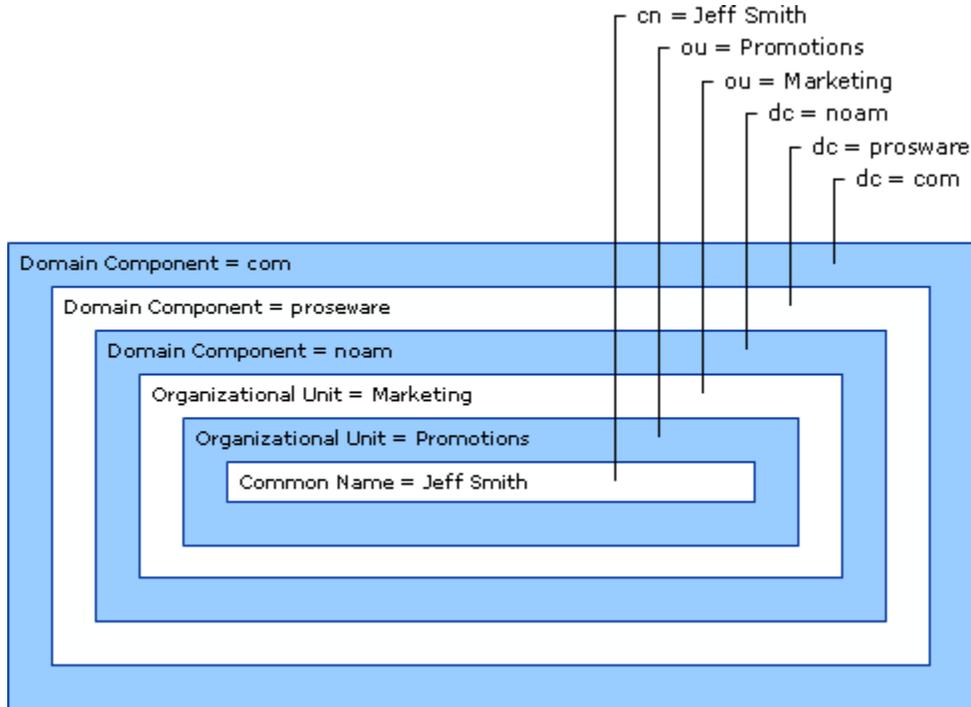
## Relative Distinguished Names That Make Up a Distinguished Name

The following figure illustrates the relative distinguished names that make up the distinguished name of the user object Jeff Smith.

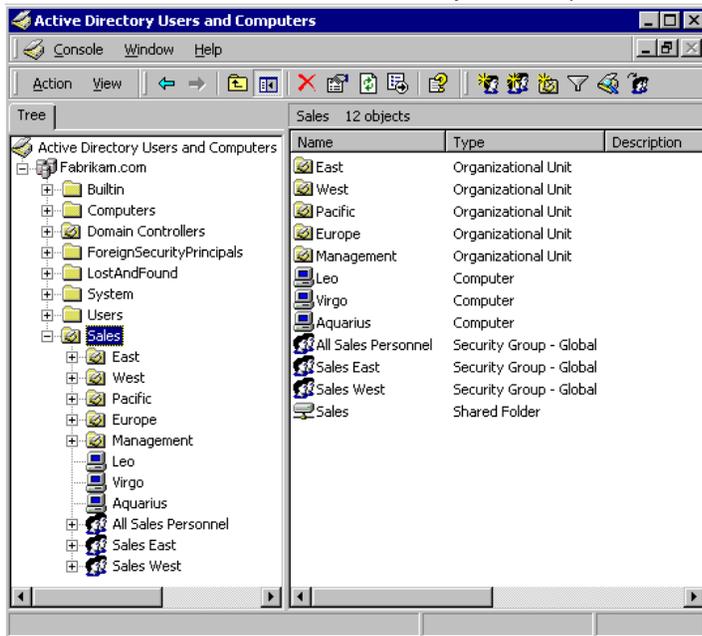
The following screen shot shows the Active Directory domain partition.

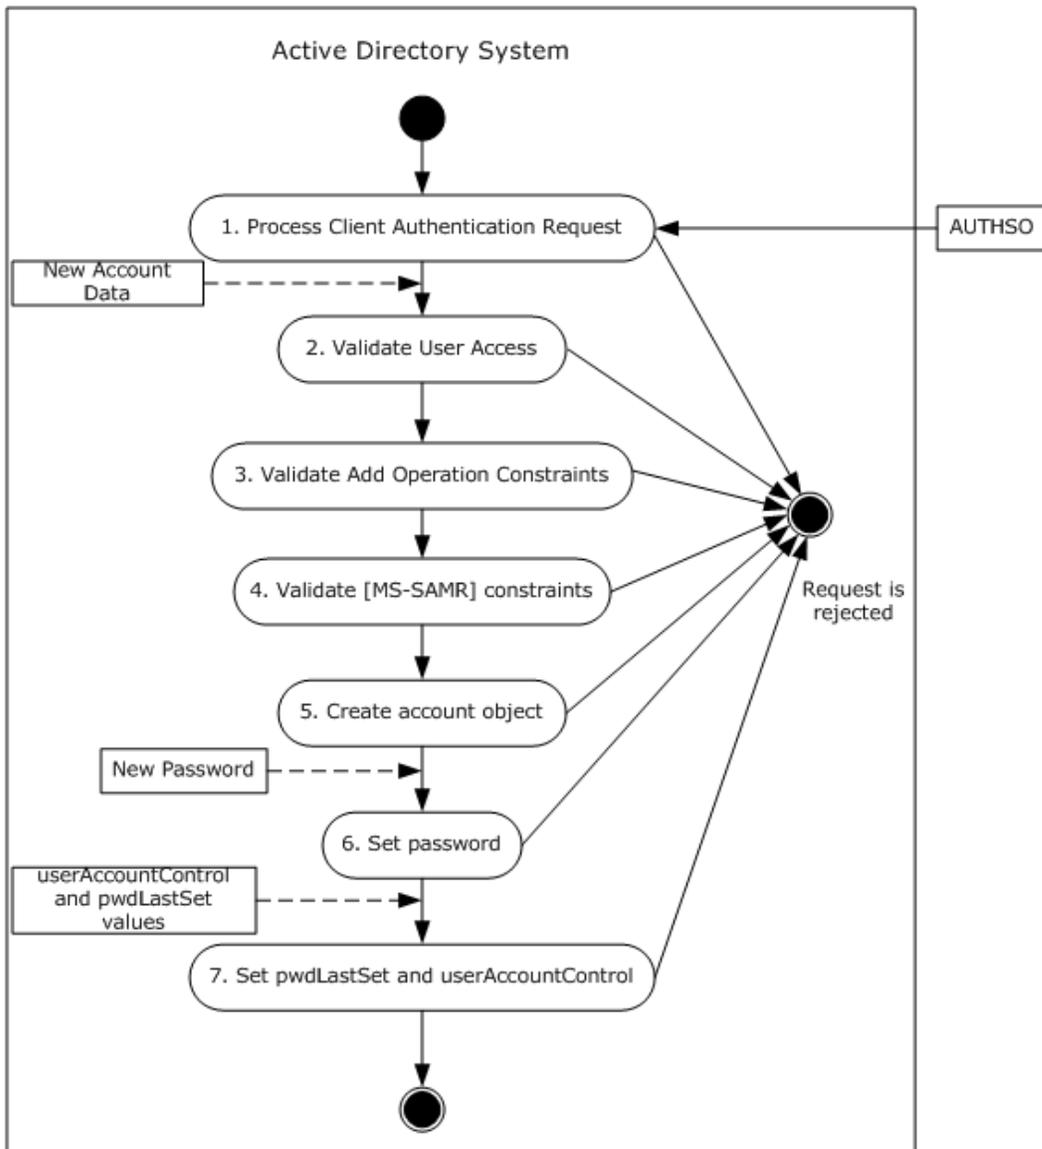
Figure 23: Server activity diagram for provisioning a user account using the LDAP protocol

- The directory server receives password information from the KDC. The password is set to the supplied value.
- The directory server receives LDAP modify requests containing new values for the userAccountControl and pwdLastSet attributes. The attributes are updated with the supplied values.

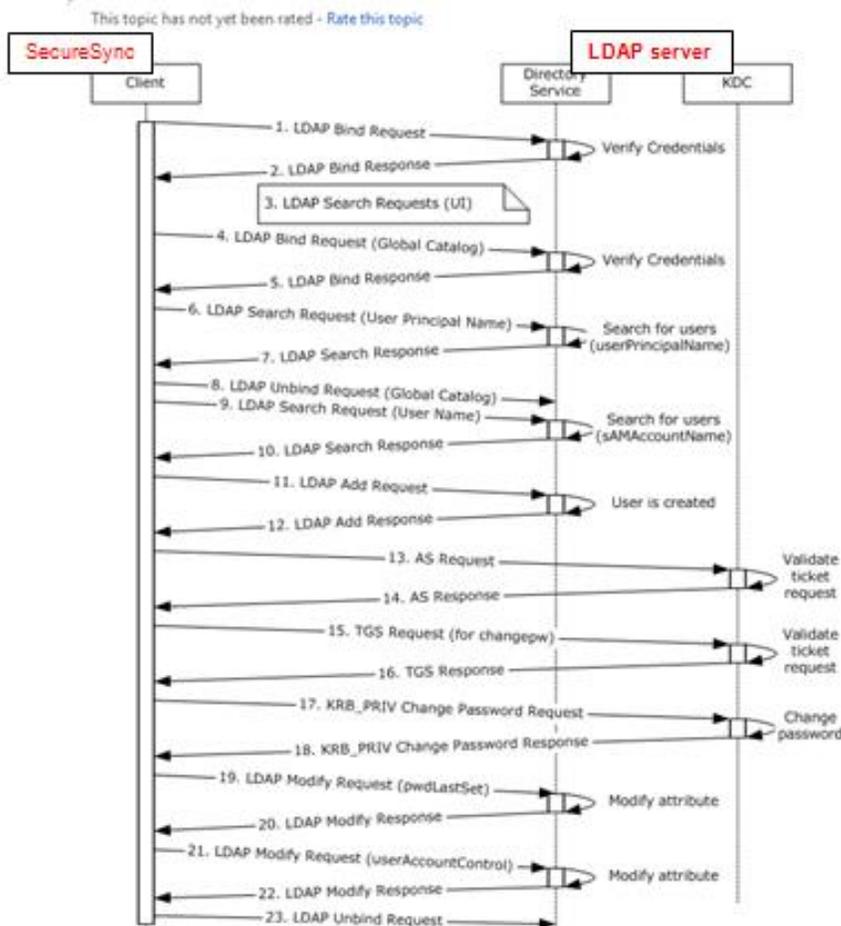
## 6.1.1.3 Sequence of Events

1. The program (see section 6.1.1) establishes an [LDAP](#) connection to the [directory](#) server. An **LDAP bind request** ([RFC2251](#) section 4.2, Bind Operation) is sent to the directory server with the credentials of an administrator.

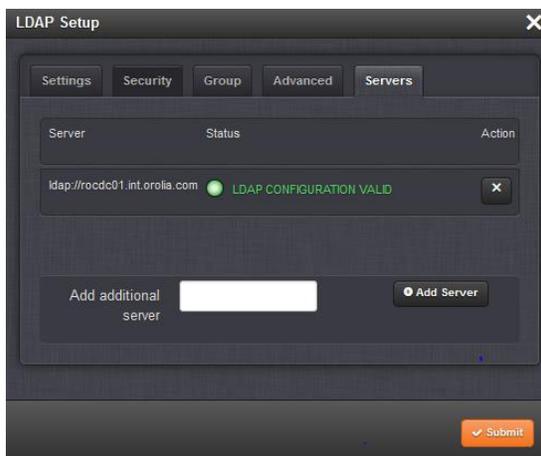
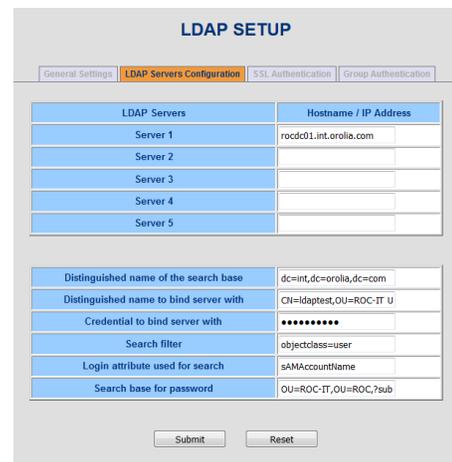
## 2. Servers tab

classic interface (5.4.1 software installed)

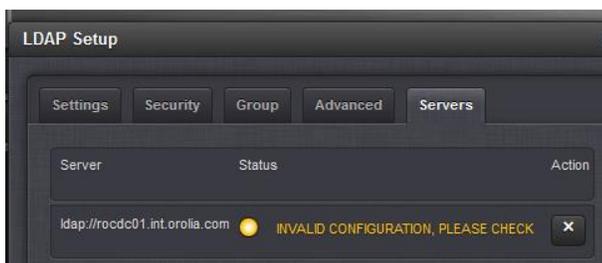
**“Invalid configuration, please check”** displayed, after entering LDAP server’s address

- 1) Make sure the Primary DNS /Secondary DNS server addresses are correct in the Ethernet interface settings. If DNS settings are missing or incorrect, this will occur.
- 2) Must use URI format for the LDAP address (“LDAP://” in front of the address- not LDAP:\)

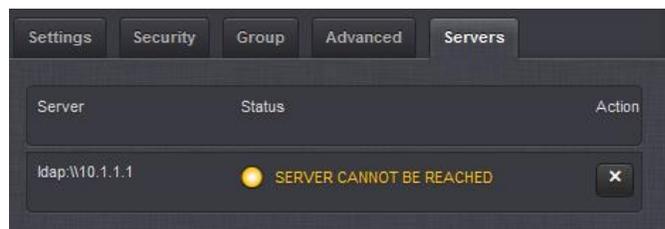
- **PASS (green):** indicates LDAP configuration is valid, An LDAP server that has been set up is available and is able to pass data. The configured LDAP server is responding to ping (reachable on the network)
- **Server cannot be reached (orange/yellow)**

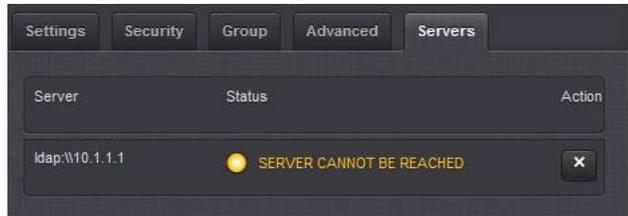
**Note:** After entering the LDAP server address, if the “**Servers**” tab reports “**server cannot be reached**”

- 1) Whether using the LDAP server's IP address or hostname, the Server line must begin with **ldap://** (and **not** “ldap:\\”)
  - Example above shows the wack/wack going in the wrong direction (instead of \\, it should be //)
- 2) (if using a hostname instead of IP address) DNS is configured correctly and working (try temporarily using its IP address to see if it then connects. If it does, there is a DNS-related issue.
- 3) make sure all the LDAP settings (in the Settings tab) are correct. these do affect the adding of a server.

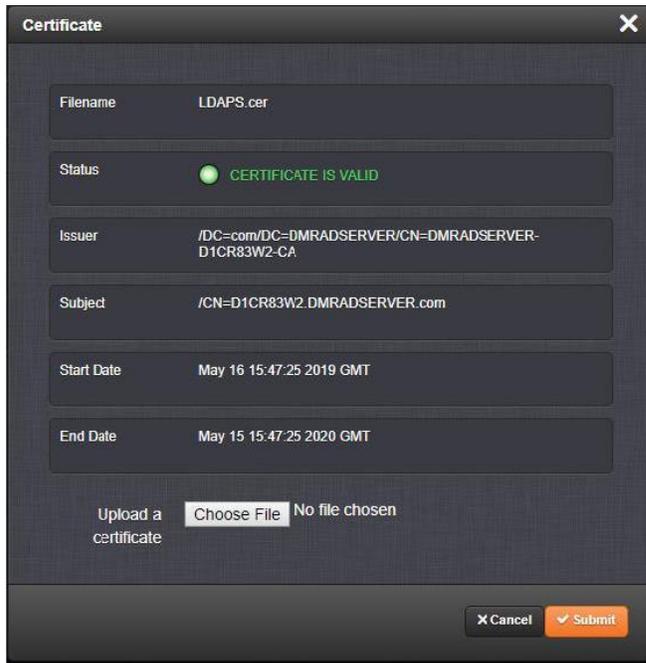
The certificate needs to be renamed for it to work. He renamed it to LDAPS.cer and it is now readable. He had the same error as you reported when it is named LDAS certificate.cer

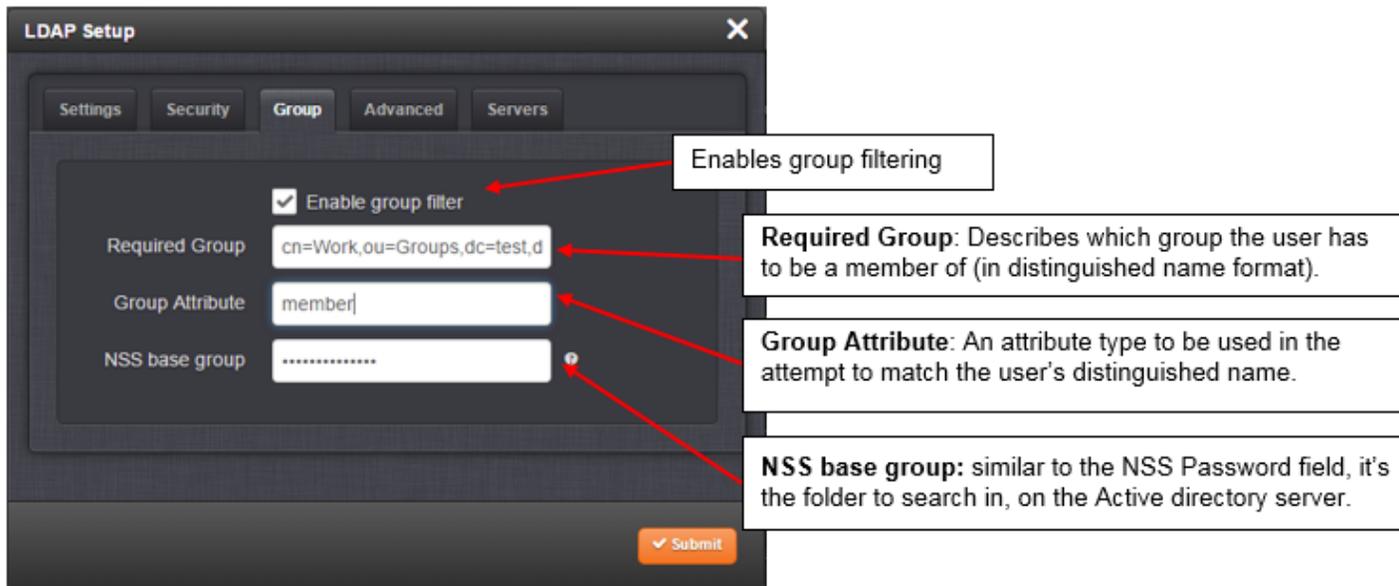
The above image is the group filter configuration tab for LDAP.

- The “**Enable Group filter**” checkbox enables group filtering

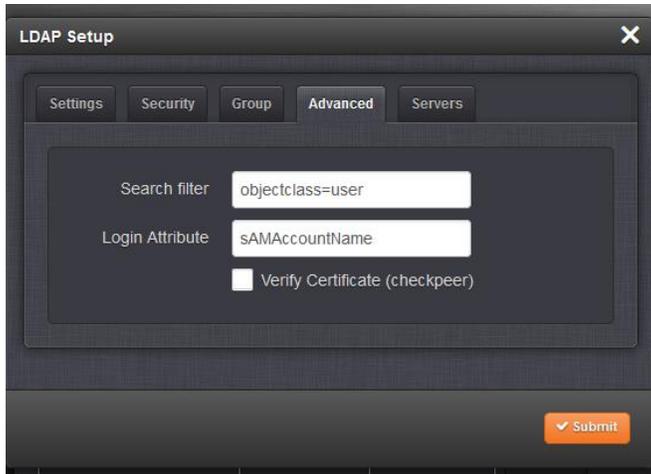
### 3. Advanced Tab (“Search filter” and “Login Attribute”)

The image shows a screenshot of the 'LDAP Setup' dialog box, specifically the 'Advanced' tab. The dialog has a dark grey background and a title bar with a close button. At the top, there are five tabs: 'Settings', 'Security', 'Group', 'Advanced', and 'Servers'. The 'Advanced' tab is selected. Below the tabs, there are two text input fields. The first is labeled 'Search filter' and contains the text 'objectclass=user'. The second is labeled 'Login Attribute' and contains the text 'sAMAccountName'. Below these fields, there is a checkbox labeled 'Verify Certificate (checkpeer)' which is currently unchecked. At the bottom right of the dialog, there is an orange button with a checkmark icon and the text 'Submit'.

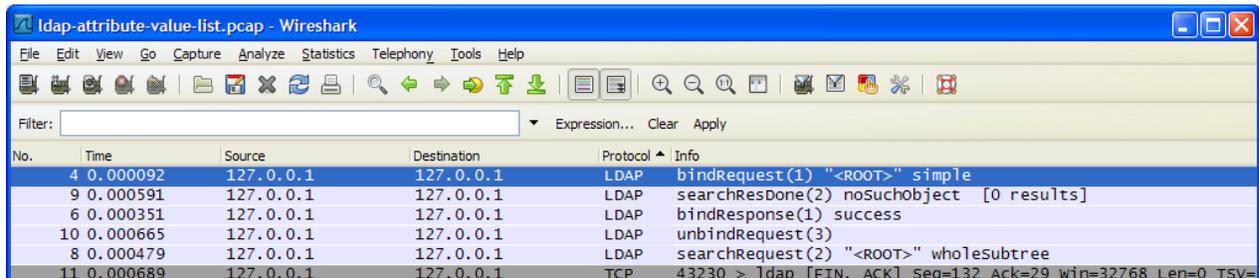
- **Sample LDAP Packet captures:** Refer to <http://wiki.wireshark.org/SampleCaptures>
- **Sample LDAP packet capture** (showing only LDAP protocol messages)

The screenshot shows a Wireshark window titled 'ldap-attribute-value-list.pcap - Wireshark'. The packet list pane displays the following entries:

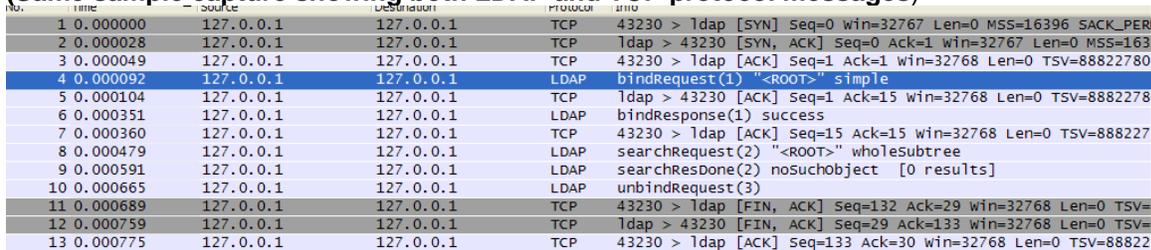
### (Same sample capture showing both LDAP and TCP protocol messages)

The screenshot shows a Wireshark window displaying a mix of LDAP and TCP messages:

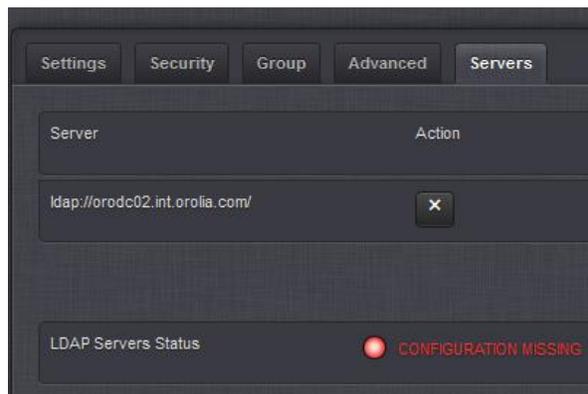
- 12) **“NSS password” field left blank:** login will take a long time but will still result in a successful login.
- 13) **“LDAP Servers Status” (Servers tab )** always reports **“configuration missing”** in at least versions 5.1.5 and below (as shown below)

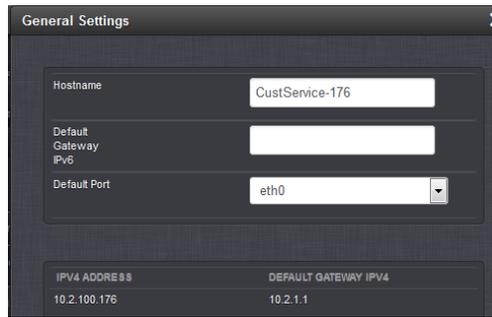
- Cause: can’t reach the LDAP server on the network
- I saw it here when there was an error in the default gateway address for Eth0. So it wasn’t able to reach the LDAP server. Management -> General Setup page of the browser a

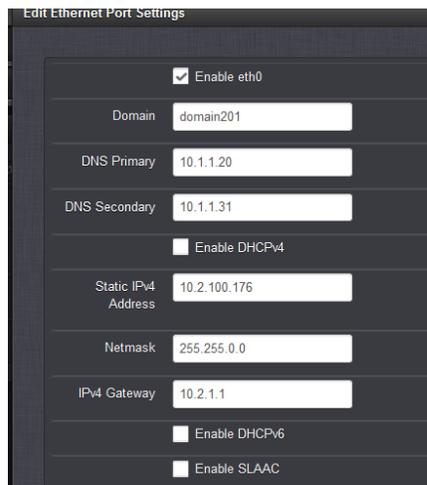
- DNS- Also saw it here when the DNS server values were deleted. DNS has to be setup correctly if using the DNS hostname for the LDAP server (instead of configuring its IP address). DNS is configured in the Management -> Network page of the browser and edit the particular port that goes to the DNS server.

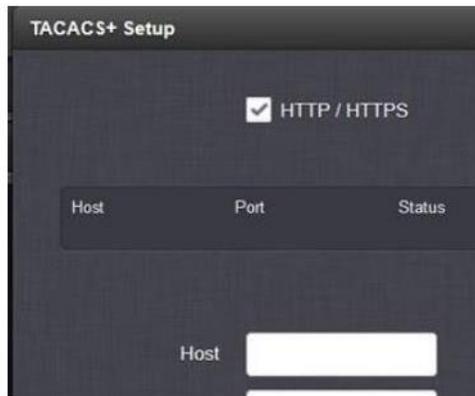
- fix is to disable/re-enable TACACS (make sure to press Submit after unchecking the box, and then press it again after selecting the box again- pressing submit a total of two times and no just once.
  - toggle the current state of TACACS (toggle it off and then back on again, using the “HTTP/HTTPS” checkbox at the top of the pop-up window for TACACS setup (**Management** -> **Authentication** page, **TACACS Setup** button on the left side) as shown below:

- Toggling TACACS off and back on switches the order of the two lines, if they are currently reversed
- Per SF Case 158734, if these two lines are reversed in the file, not able access the device through CLI while browser login works fine.

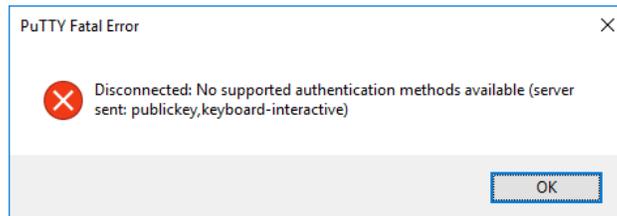
3. SSH login fails with a Fatal Error “**Disconnected: No supported authentication methods available (server sent publickey, keyboard-interactive)**”

The SSH “Authentication Type” field (*Management* -> *SSH Setup* page of the browser) is likely configured as “Only Public Key”. When using TACACS, it needs to be set to either “Only Password” or “Public Key or Password”

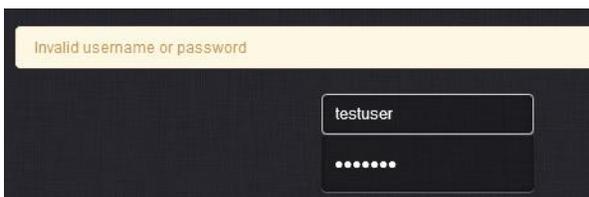
(v5.8.0 and 5.8.1) TACACS login to **browser** fails (“invalid username or password”), **unless TACACS login to ssh is first performed**, and connection remains open- then login to browser. **SSH login with TACACS is fine.**

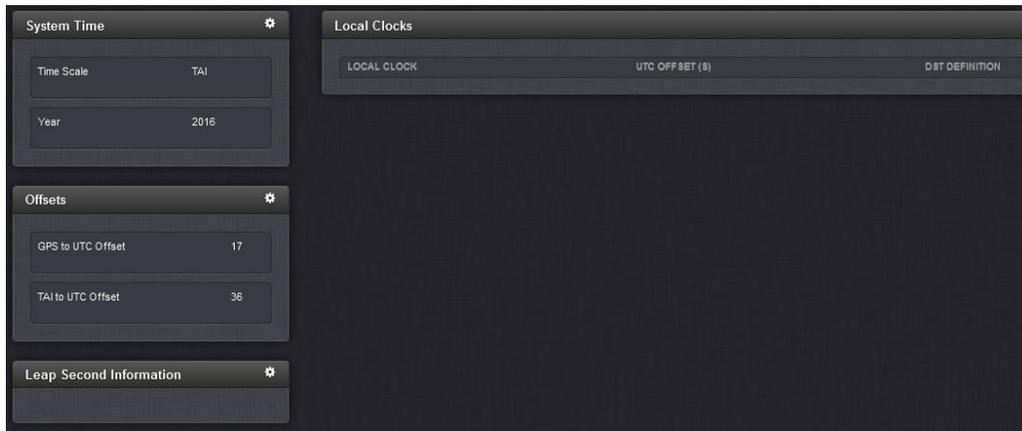
#### A) Newer browser: Management -> Time Management page of the browser

System Time is configured in the:

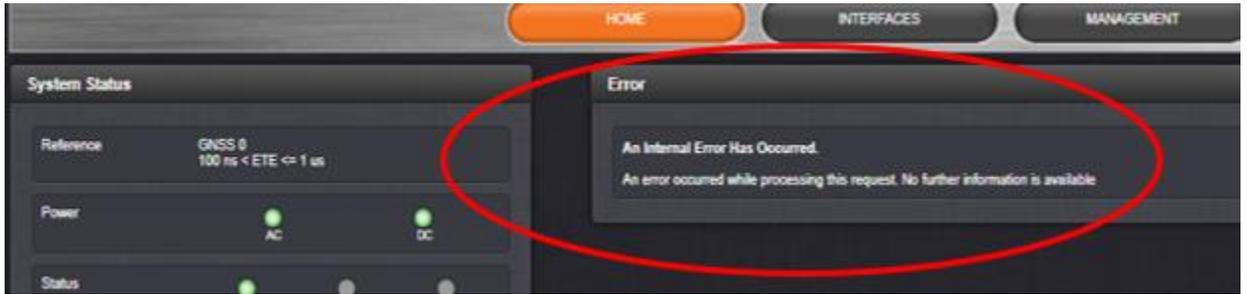
**Error message: “An internal error has occurred...”** is displayed **ONLY** while navigating to **JUST** the **Time Management** page of browser (all other pages of the browser navigate without an error message)

- Full error message displayed: “An internal error has occurred. An error occurred while processing this request. No further information is available”
- On at least one occurrence (18 Dec 2018, with v5.5.1 installed), this error message (An internal error has occurred...) was displayed **ONLY** when trying to navigate to **JUST** the **Management -> Time Management** page of the browser. All other pages were navigating just fine, with no errors displayed (recommended they reboot it-see the “software crash” email below).

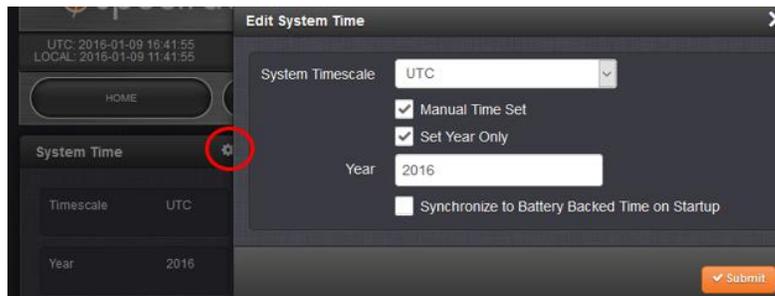
- With the exception of IRIG input having no year (such as B000), the year is normally set by the input reference.
- “Set year only” Checkbox/field is used when an IRIG input reference doesn’t contain present Year.
- Based on testing, the “**Set Year Only**” year value does persist during system reboots/power cycles (in case of power cycles, as long as the year is set at least 10 minutes before power cycle, so that the RTC has a chance to be updated). Reboots and Halts update the RTC automatically, at the time they are performed.

1. **Management** -> **Time Management** page and press the gear icon to the right of “**System Time**”
2. Select “**Manual Time Set**”
3. Select “**Set Year Only**”
4. Change the Year, as desired, and then press Submit (don’t need to also select “synchronize to battery backed...”)
5. With the system synced via IRIG input, can either perform a reboot command (via the browser, CLI or front panel) or wait at least 10 minutes after changing the year for the RTC to be updated, before power cycling.
  - If the unit doesn’t run long enough (up to 10 minutes) after setting the year before its power cycled, the year will be set to the earlier configured year once its boots-up. The RTC is only periodically set (every 10 minutes or when a reboot is commanded). RTC is set on commanded reboot, so no delay is necessary when rebooting.
  - See additional info further below
