Model 1200 series SecureSync/9400 series

Lafayette (Model 1200 series SecureSync)

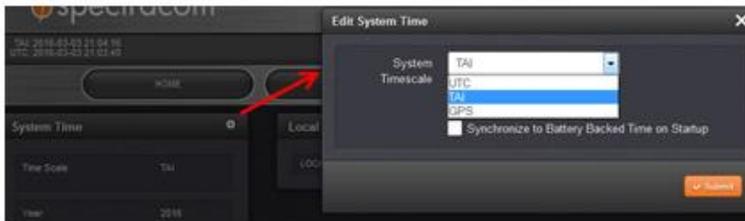
- System Time is UTC timescale by default
- Can be changed to either TAI or GPS timescale as desired (press the gear icon next to “System Time”):

- Changing the System Timescale value changes the “System Time”. So all references to time with the exception of PTP output (outputs such as the front panel, browser, NTP, logs, etc) use the new timescale offset.
- As of at least software version 5.4.1, NTP (and the unit’s logs) doesn’t have its own individual timescale configuration, so it will always follow the System’s timescale.

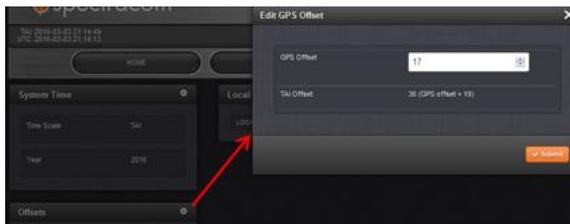
- **Management** -> **Time Management** page of the browser
- Click on the “gear” icon next to “Offsets” (left side of the page)

From the SecureSync user manual, cable delay can be set to a max of + /- 50 milliseconds (entered as 50,000,000 nanoseconds).

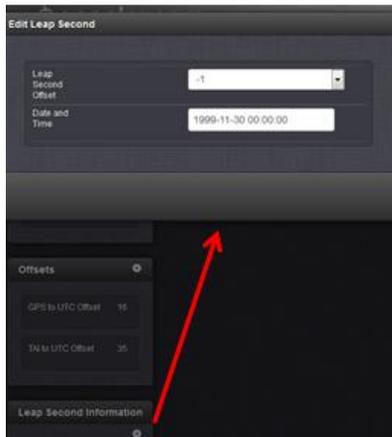
### **I) Newer web browser (versions 5.1.2 and above)**

**Management -> Time Management** page (bottom-left corner)

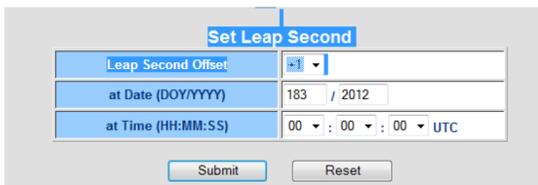
I ran the GSG Leap Second test and observed what was 'scheduled' in KTS.

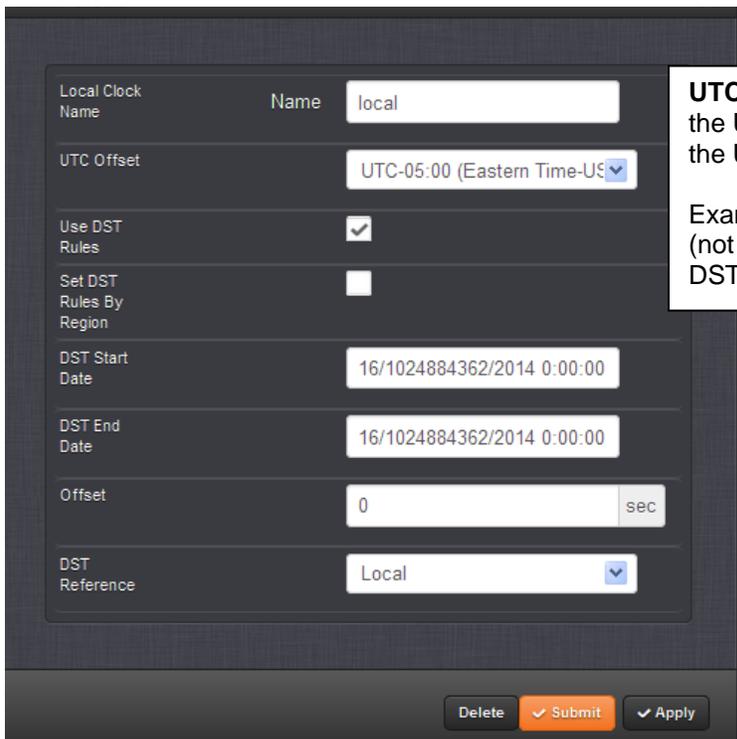
If “Use DST rules” is selected, bottom of page expands.

**UTC Offset:** Always set this drop-down to the UTC offset during **STANDARD** time (not the UTC offset during **DST** time)

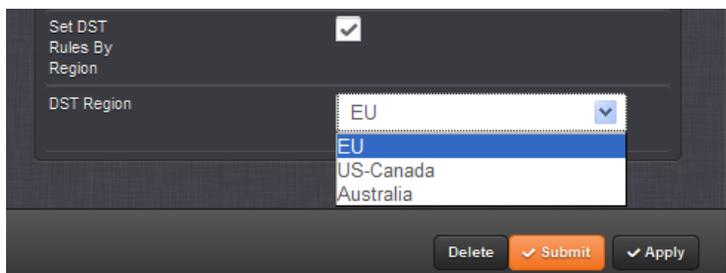
Select “Set DST Rules by Region” select region, and then Submit or Apply.

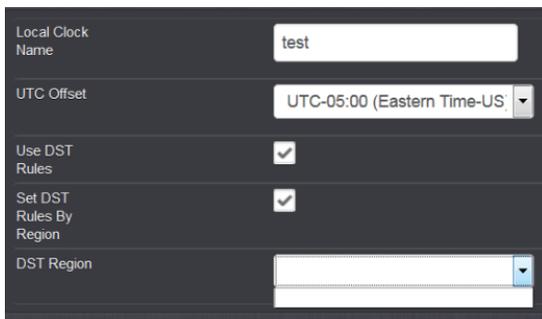
### C) Empty "DST Region" field drop-down list in the newer (black/charcoal) browser (DST Start and End dates also have erroneous info in them).

The screenshot shows a configuration panel for a local clock. It has a dark background with white text and input fields. The fields are: 'Local Clock Name' with the value 'test'; 'UTC Offset' with a dropdown menu showing 'UTC-05:00 (Eastern Time-US)'; 'Use DST Rules' with a checked checkbox; 'Set DST Rules By Region' with a checked checkbox; and 'DST Region' with an empty dropdown menu.

- Refer to Salesforce case 18044
- Engineering suspected issue with MySQL database.

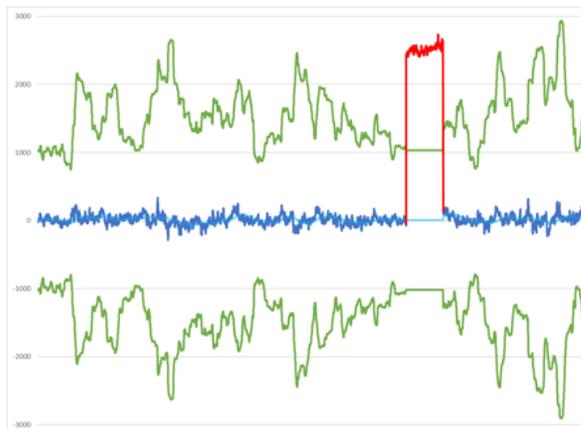
## SINGLE REFERENCE QUALIFICATION

Phase and frequency validation is done per reference against the internal oscillator

- Phase Validity Monitoring
- Running long term averages and standard deviations are calculated to generate validity thresholds
- Live phase measurements are checked against these thresholds to catch short term phase drift and jumps
- Jan 2016 13 usec GPS glitch
- Frequency Validity Monitoring
- Oscillator characteristics (aging, temperature stability) are used to generate frequency thresholds taking into account oscillator temperature measurements
- Frequency measurements of monitored references are validated against these thresholds
- Oscillator control history is also validated using these thresholds

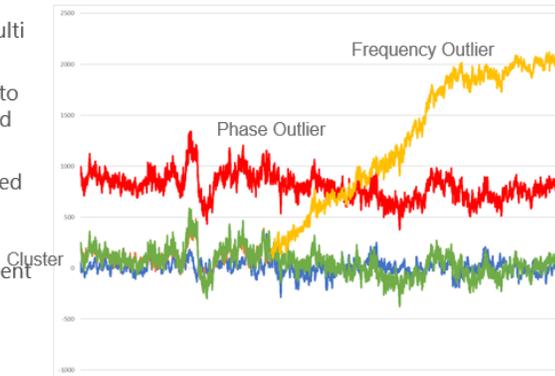
## MULTI REFERENCE QUALIFICATION

References validated by single reference checks are utilized in multi reference qualification checks

- Clustering techniques are used to group references together based on phase/frequency statistics
- Outliers can be determined based on phase biases or frequency drifts

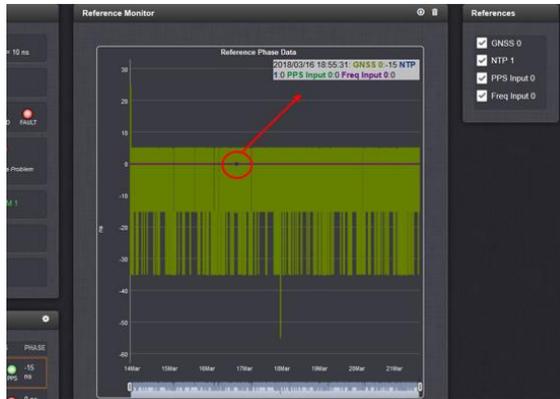
## Tools -> Reference Monitor page of the browser

**Email from Keith (21 Mar 18)** The table on the right of the plot lists all available 1PPS input references, allowing the ability to enable/disable the display of each one in the graph. Mouse-hovering over the graph plot (shown with the red circle I added to the plot) opens a gray display window (upper-right corner of the plot window) displaying the details of each reference at that particular date/time (in UTC timescale) and also indicates the corresponding line color of each reference being displayed in the plot area. The 1PPS phase error on the left side of the plot area, for the actual values of the 1PPS phase error for each input reference, is in "Nanoseconds"

The phase in the Reference Status location is the difference between the Reference and the On-time point (1PPS). So, all the references compare themselves to the System's on-time point.

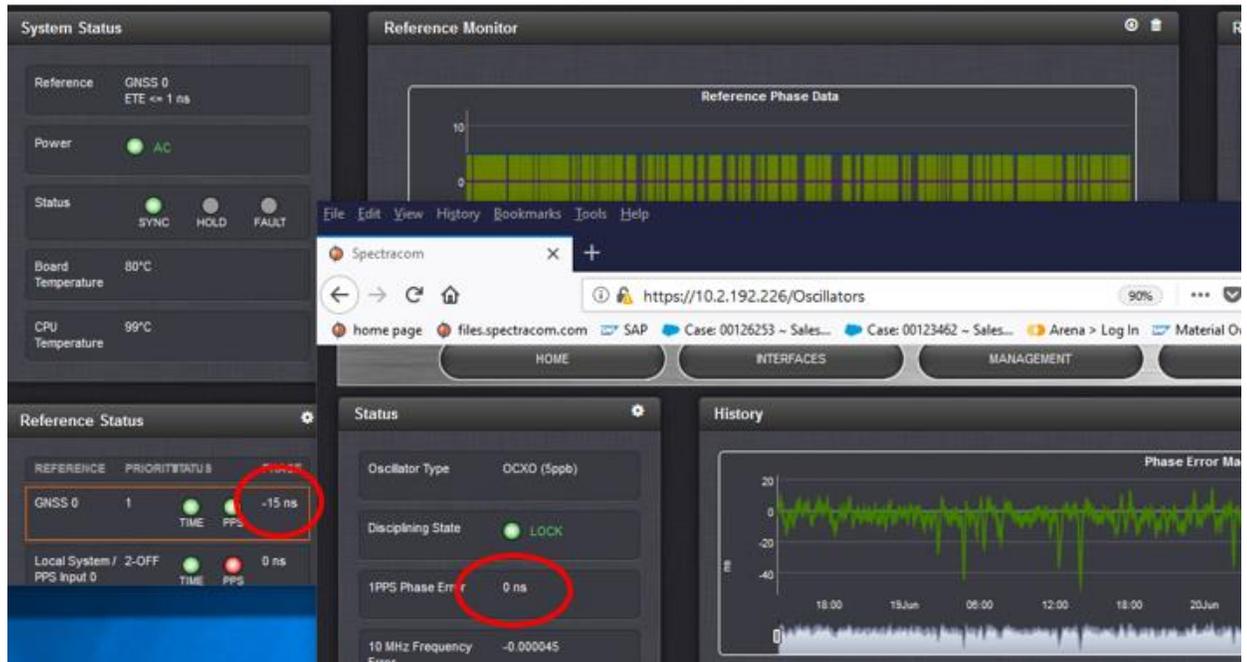
- Due to differences in granularity in the *Disciplining / Reference Priority* pages, versus the *Reference Monitor* page, the phase error values for the same reference may be reported as two different values.
  - As shown below, the phase error is reported as **0 ns** in the Disciplining page, while the GPS phase error is being reported as **-15 ns** in the Reference Monitor page.

**Per Dave S (19 Jun 2018)** I don't remember the direction of the offset (negative vs positive), but as far as the differences, the disciplining phase error is a filtered error, that has higher resolution. The reference monitor phase errors are raw offset values with a 20ns resolution. They should absolutely track each other in terms of trends, but due to the filtering and differences in resolution/granularity there will be differences in the reported offsets.

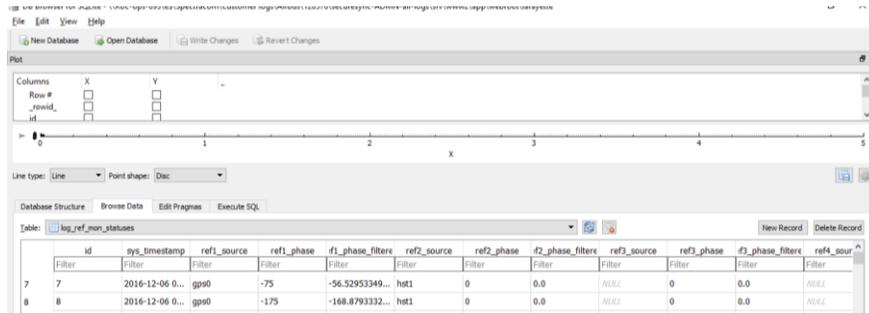
A. View the **Lafayette** (sqlite) database using the “**DB browser for SQLite.exe**” freeware.

B. In the “**Browse Data**” tab, select the “**log\_red\_mon\_statuses**” table:

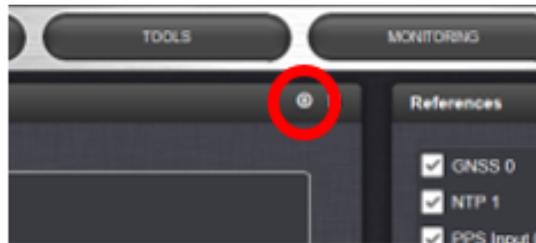
**2. Or as a .csv file, by clicking the “down arrow” (download) icon (next to the garbage can icon) in the *Tools -> Reference Monitor* page of the browser.**

**Note the amount of data in the Reference Monitor table may be too large to be able to use the “download to csv file” button in the browser**

➤ The csv file download button uses the web browser differently than the log bundle download function to download and convert the sqlite data to a csv file. this download button may not be able to download/convert larger amounts of data.

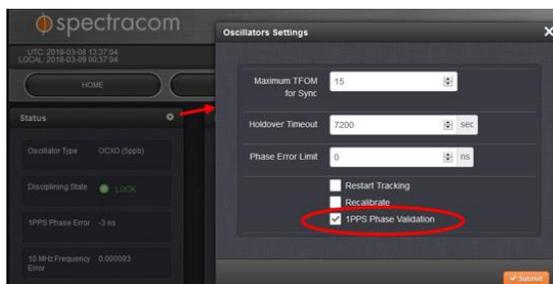
- **Disabled** by factory default (upgraded units / units which are cleaned and newly shipped units)
  - “Enabled in the **Management** -> **Disciplining** page.
    1. Press the gear icon to the right of “STATUS” (on the left side of the page).
    2. Select “**1PPS Phase Validation**” checkbox and press Submit

- **Once this function has been enabled:** “Phase measurements and thresholds are dynamically calculated based on the input references statistics”

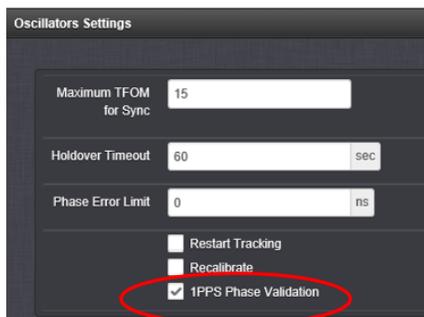
- **ENABLE Smart Reference Monitor: RS\_SetPhaseThreshold 0 all 2 5 999999 999999**<enter>

```
Max Threshold: 9999999.000000
spfactory@Spectracom /home/spectracom $ RS_SetPhaseThreshold 0 all 2 5 9999999 9999999

RS (all) Threshold:
Mode:      2
N:         5
Min Threshold: 9999999.000000
Max Threshold: 9999999.000000
spfactory@Spectracom /home/spectracom $ █
```

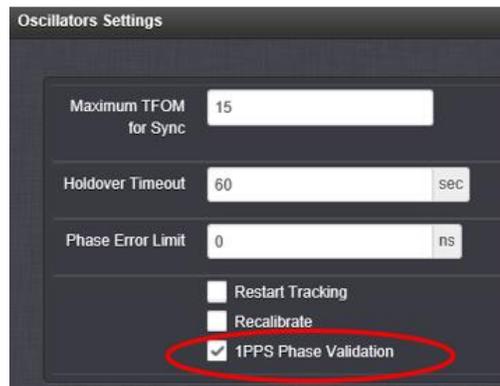
- **Disable Smart Reference Monitor: RS\_SetPhaseThreshold 0 all 0 0 999999 999999**<enter>

```
spfactory@Spectracom /home/spectracom $ RS_SetPhaseThreshold 0 all 0 0 9999999 9999999

RS (all) Threshold:
Mode:      0
N:         0
Min Threshold: 9999999.000000
Max Threshold: 9999999.000000
spfactory@Spectracom /home/spectracom $ █
```

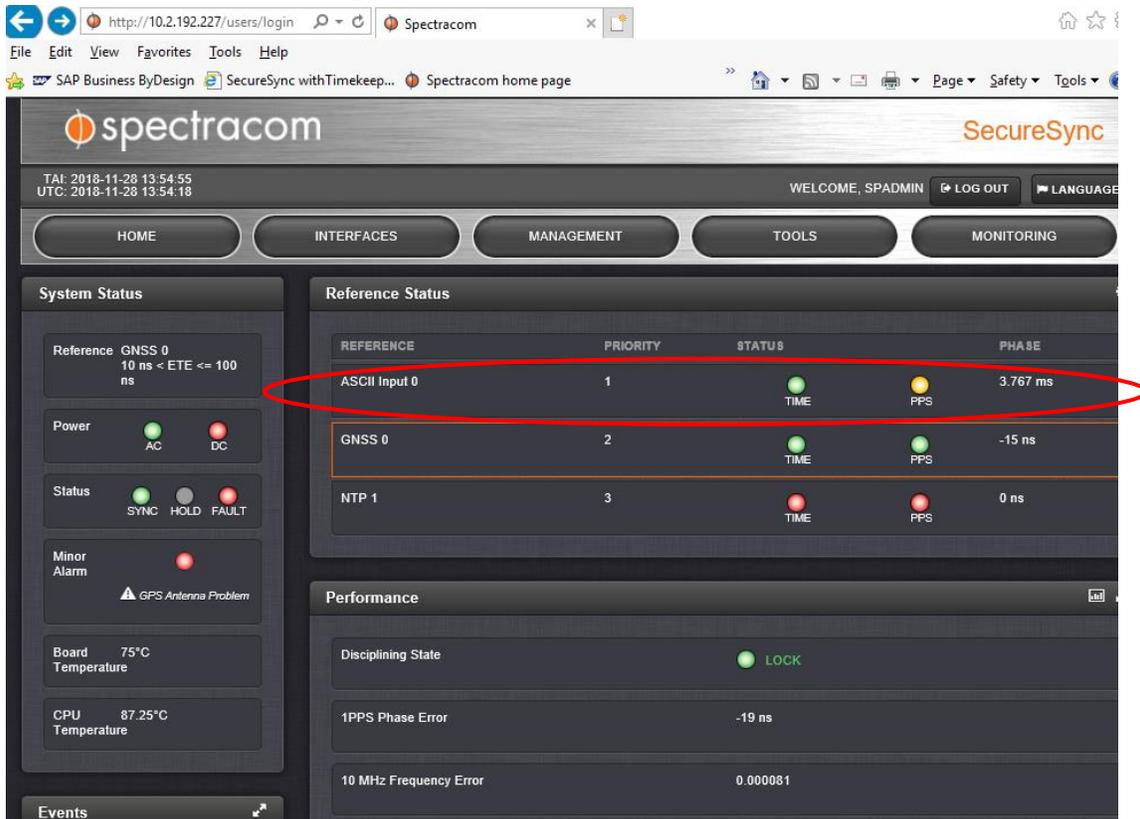
- Either *Home* or *Management* -> *Reference Priority* pages
- The Reference PPS indicator turns **YELLOW** when declared not valid by smart phase reference monitor.

When the “1PPS Phase Verification” checkbox (*Management* -> *Disciplining* page) is selected/enabled and a reference is declared “not valid”, its PPS indicator will turn **yellow** (not green or red) as shown below in the example of ASCII input being declared not valid (even though it wasn't the selected reference):

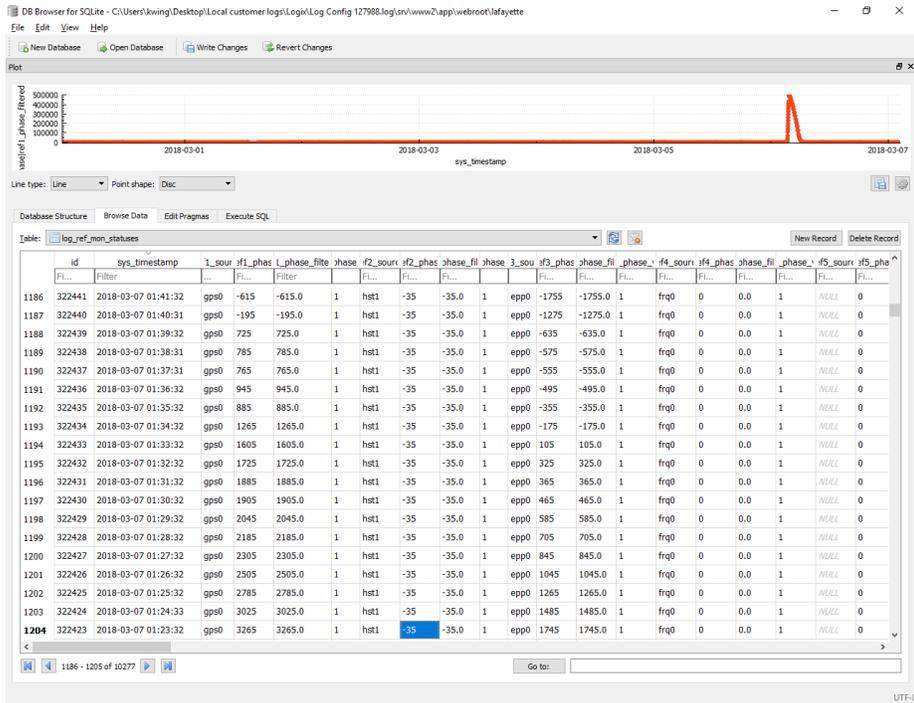
### Three associated fields for each timestamp

- **Refx\_source:** name/number for each input reference
- **Ref phase:** coarse phase error measurement from FPGA (don't use this value)
- **Ref phase\_filter:** accurate phase error measurement (use this value)

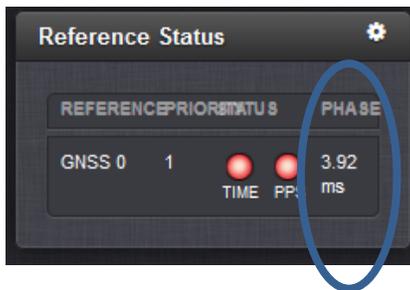
Left-side of the [Management](#) -> [Reference Priority](#) page

- Version 5.4.5 enhanced Reference Status with the current 1PPS phase error (to the right of each listed reference)

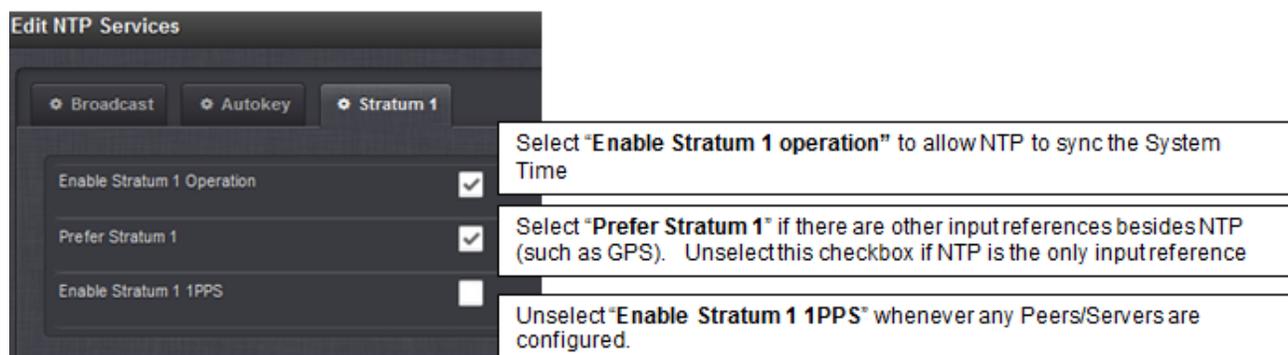
## 1PPS synchronization with NTP input - configuration notes

**Management** -> **NTP Setup** page, click on the “Gear” ICON (next to “NTP Services”) and Select the “**Stratum 1**” tab

**Important Notice:** Using NTP and external PPS input as the selected references requires **NTP Expert mode be enabled** so the ntp.conf file can be manually edited. Failure to edit the ntp.conf file in Expert mode degrades the performance of the SecureSyncs outputs (including PTP) and the system does not take advantage of the external PPS accuracies.

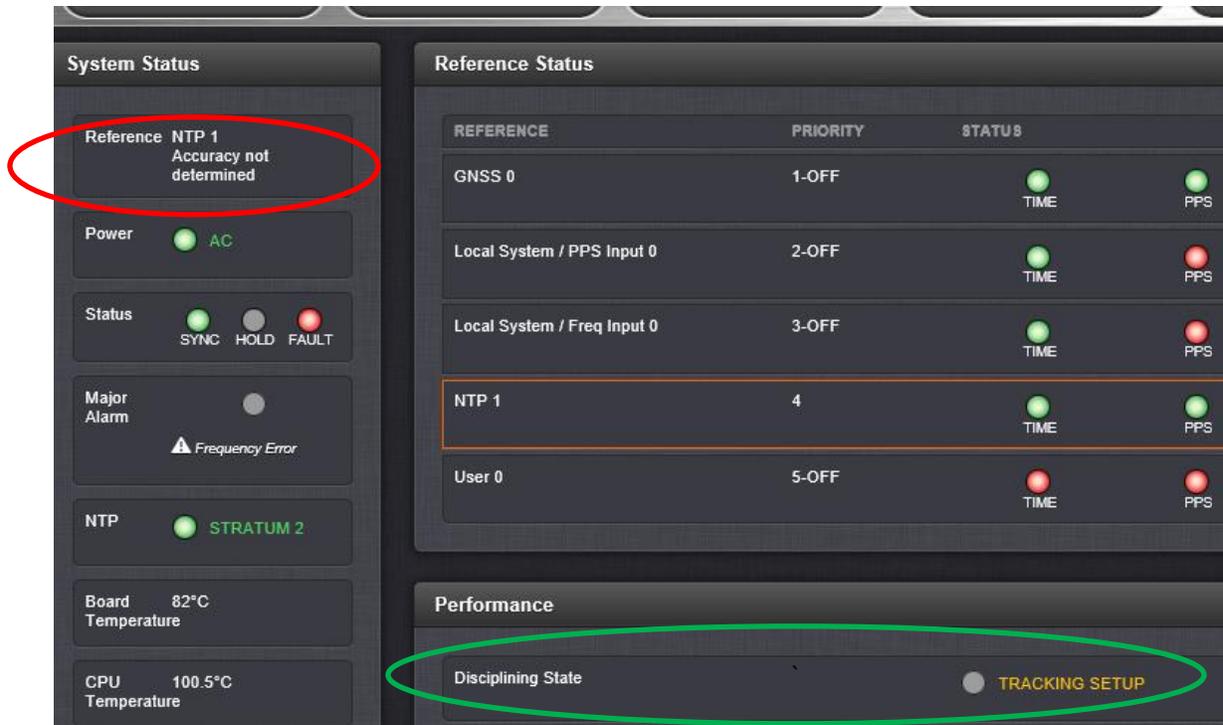
“Accuracy Not determined” (reported top-left corner of *Home* page, under “Reference” field)

The Oscillator “**Disciplining State**” remains in “**Tracking Setup**” mode (as shown above in green circle)

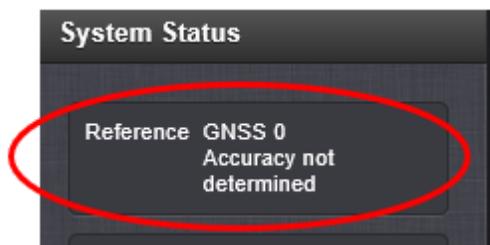
“**Accuracy not determined**” will remain reported for a short time, while showing a selected reference (such as GNSS 0, for instance)

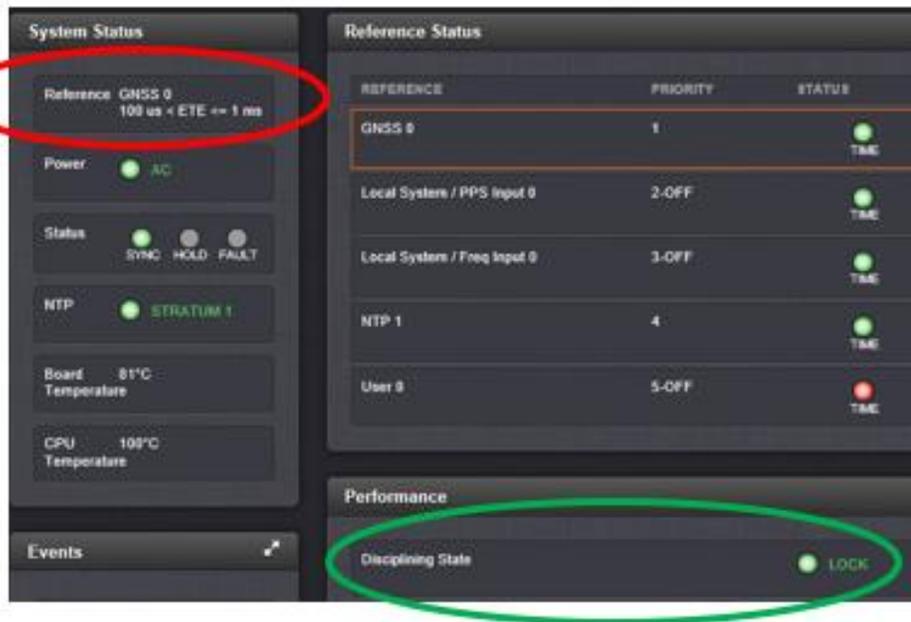
Once the oscillator has switched to “**LOCK**” to an external PPS reference (such as GNSS 0) for the first time, it

will then switch to reporting an “ETE value” (no longer reporting “Accuracy not determined”)

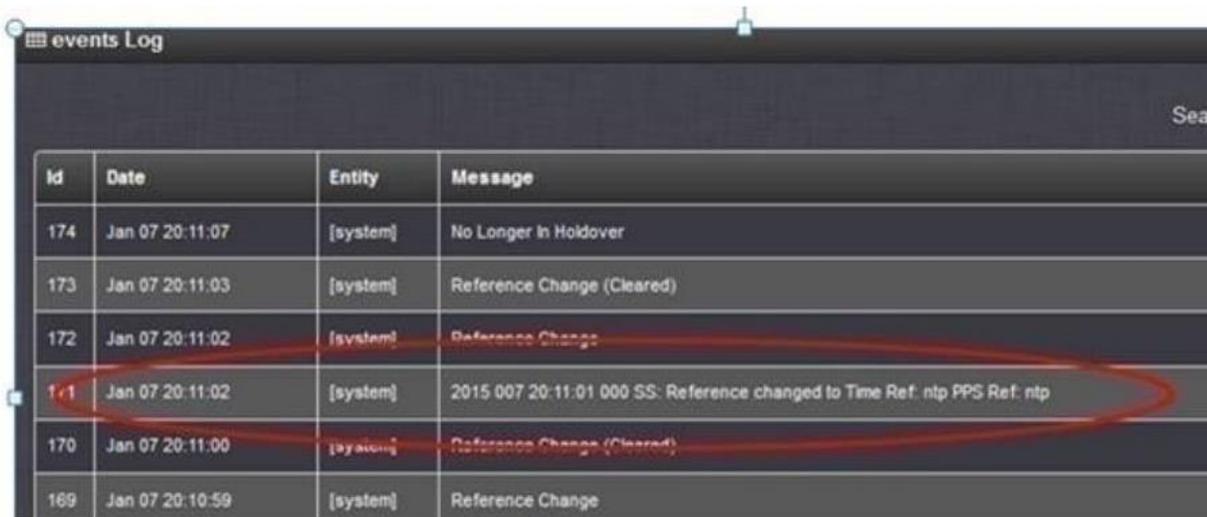
**A Reply from Keith (6 JAN 15)** Regarding the unit's logs indicating that it's synced with the Model 9383, the only available entry for indication that it's in sync with another NTP server is in the "Events" log which will report "**Reference Changed to Time Ref: ntp PPS Ref: ntp**" (as shown below). But it doesn't log the specific IP address of the time server it's synced with.

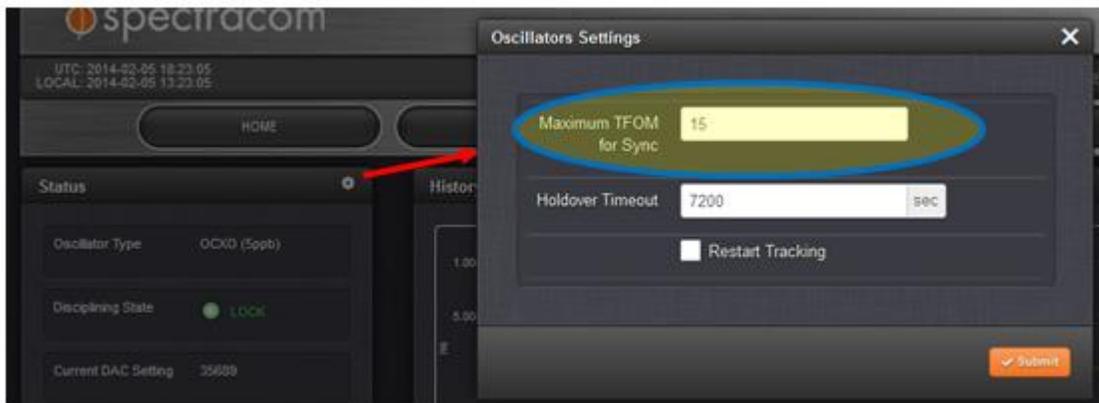
- Configured in the Management -> Disciplining page and then clicking on the “gear” next to “Status”
- Make sure Max TFOM is set to 15

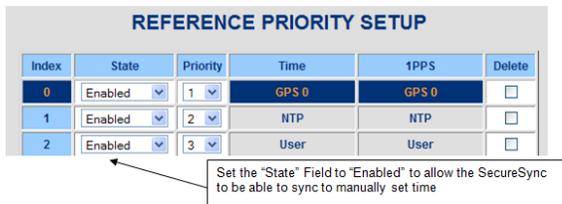
- 1) The "State" field User/User entry (row) of the Reference Priority table needs to be enabled (by default, its set to disabled). This table is configured in the **Setup -> Reference Priority** page of the browser (this table can also be configured using SNMP Sets).

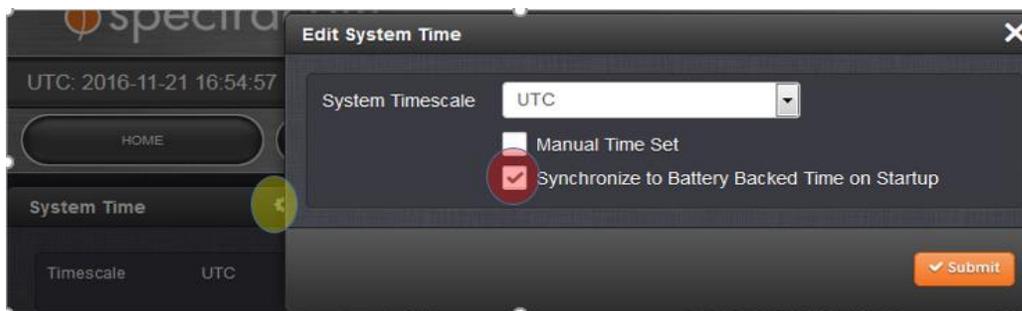
The “**Synchronize to Battery Backed time on Start-up**” checkbox can be selected as desired (as shown below) in the **Management** -> **Time Management** page of the browser (first press the “**gear**” icon to the right of “**System Time**” in the upper-left corner of the page to open the pop-up window)

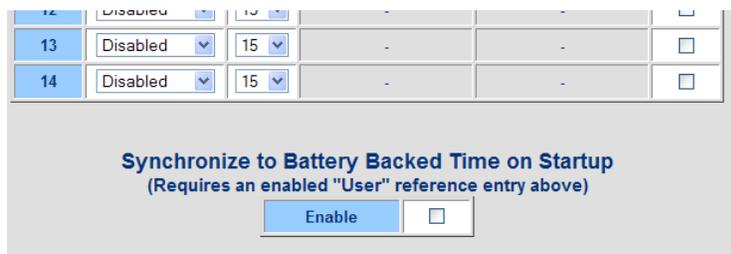
Checkbox to enable this feature (default is not selected) is located on the Setup /Reference Priority page of the browser:

Starting in version 4.8.0, customers will have the ability to have SecureSync sync to itself upon each reboot. For those customers that don't care about accurate time, this new feature prevents the user from needing to manually set the time, each time SecureSync reboots. It will now happen automatically, if they select the box under the Reference Priority table.

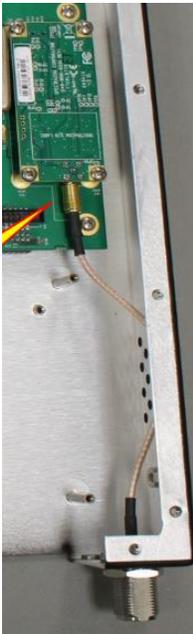
#### Antenna jack/coax cable connection to the GNSS receiver

- GPS coax cable assembly P/N: CA01R-0NSB-80R6

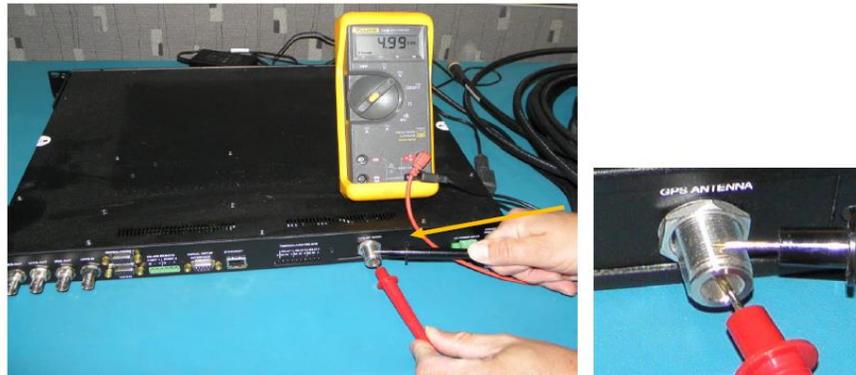
Figure 19: Verify 5vdc is present on the GPS antenna jack

As shown in Figure 19, measure the 5VDC voltage (the GPS receiver provides a nominal +5vdc to power the GPS antenna) across the rear panel antenna jack. Place the red probe of the meter on the center pin of the connector and place the black probe touching the threaded portion of the connector. There should be a nominal 4.8VDC to 4.9VDC present on this jack. If this voltage is NOT present, stop here and contact Spectracom Technical Support for additional assistance. If this 5VDC is not present, a problem internal to the SecureSync exists (the GPS receiver is not providing the +5VDC needed to power the GPS antenna). However, if the 5VDC is present, proceed to the next step.

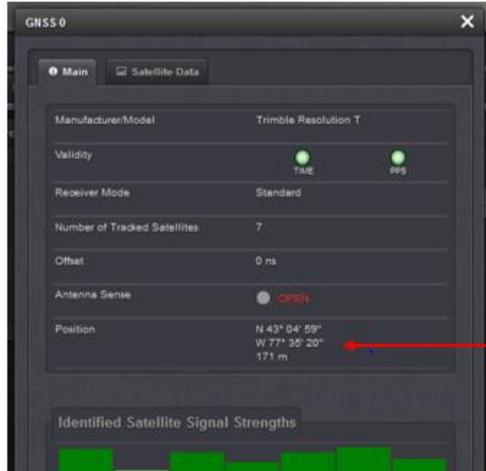
New web browser: Interfaces -> GNSS 0, Main tab

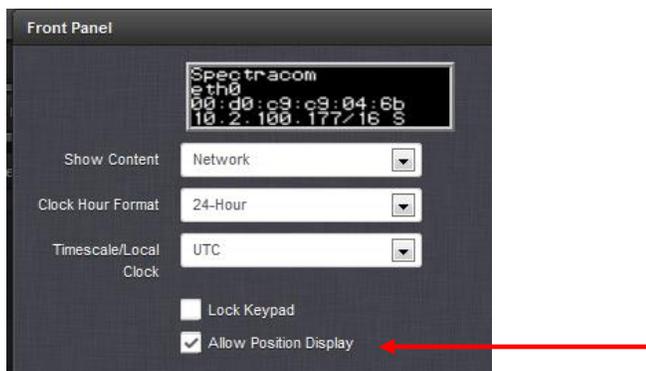
- Though it's not "over Ethernet", it can also be displayed on the front panel LCD (unless it's been disabled in the web browser- for security concerns, the position display can be disabled via the web browser so that it can't be selected to be displayed using the front panel keypad)

**New web browser: Management -> Front panel page**

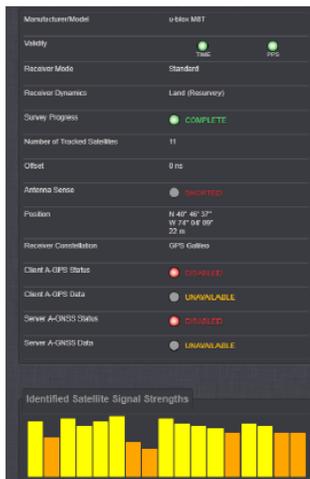
Water leaking into cable

- Refer to Salesforce Case 230174
- GPS signal strengths may be much lower than normal
- Check for water/condensation inside the cabling (such as from the antenna to the surge suppressor)

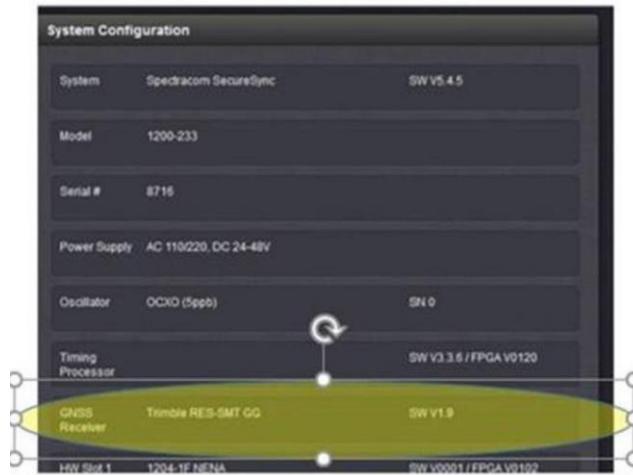
Email from Keith The Model of the GNSS receiver and its installed version is reported about half way down, in the **Tools -> Upgrade/Backup** page of the browser (under System Configuration), as shown below

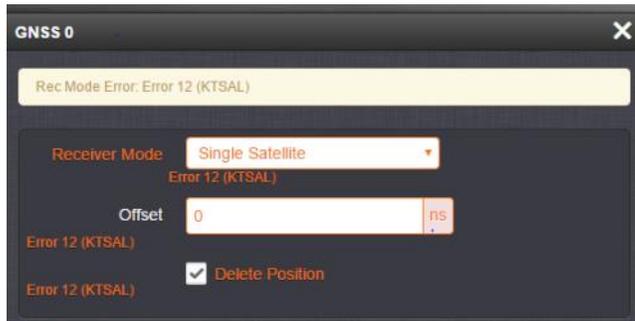
**“Rec Mode Error: Error 12 (KTSAL) message displayed with a ublox receiver installed (S/Ns 11719 and above)**

- Make sure main software has not been downgraded to any software version earlier than version 5.4.0 (version 5.4.0 is the minimum version that supports communications with a ublox receiver)

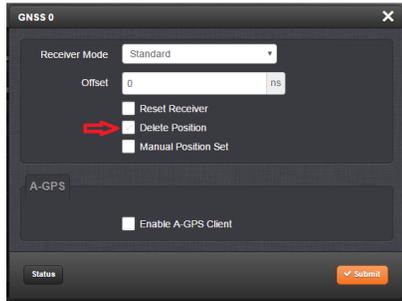
1. Launch a web browser and load the web user interface of the unit
2. Navigate to the GNSS status page (Interfaces -> REFERENCES -> GNSS Reference -> GNSS 0)
3. On the “Main” tab, click the “Edit” button
4. Check the “Delete Position” selection and click the “Submit” button
5. The survey will automatically restart
6. Shut down the unit prior to survey completion (~33 minutes)

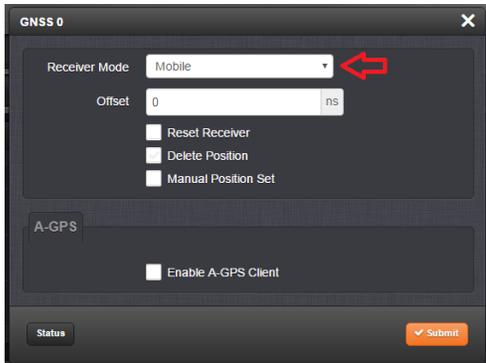
1. Launch a web browser and load the web user interface of the unit
2. Navigate to the GNSS status page (Interfaces -> REFERENCES -> GNSS Reference -> GNSS 0)
3. On the “Main” tab, click the “Edit” button
4. Change the “Receiver Mode” selection to “Mobile” and click the “Submit” button

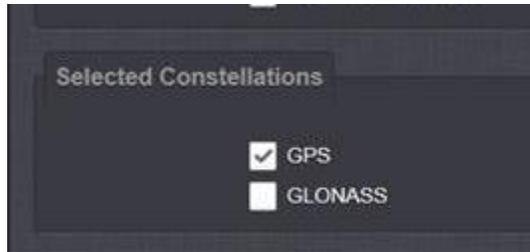
- Temporary work-around until firmware version 1.08 ("1.8") can be applied is to disable Glonass satellites and leave just GPS enabled.

- Glonass can be disabled in the **Interfaces** -> **GNSS 0** page of the newer browser (as shown below):

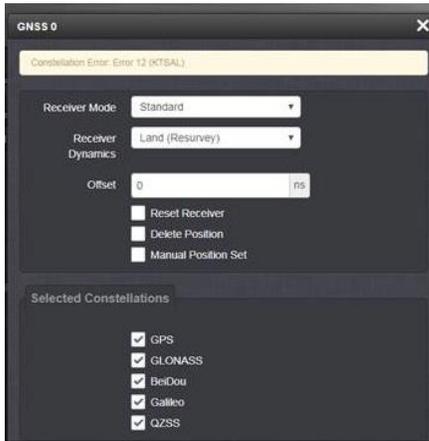
(Versions 5.7.0 and above?- GPS, Glonass, Beidou, Galileo and QZSS)

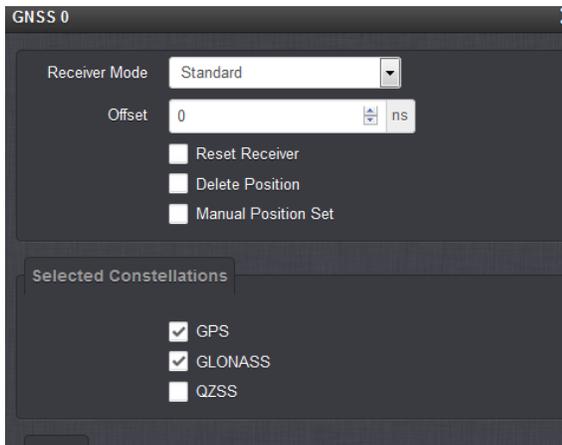
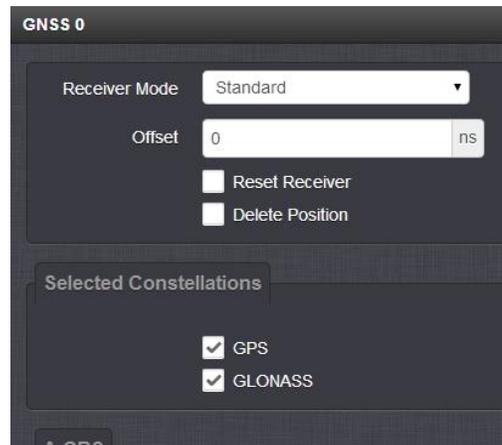
(Versions 5.3.0 and above- GPS, Glonass and QZSS)

(Versions 5.2.1 and below- GPS and Glonass)

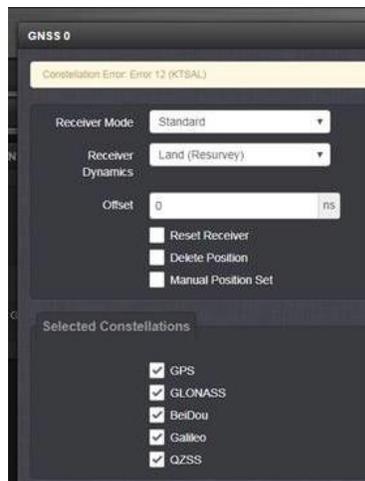
Error message displayed at top of window: **“Constellation Error: Error 12 (KTSAL)”**

**Valid Constellation combinations/Error message displayed: “Constellation Error: Error 12 (KTSAL)”**

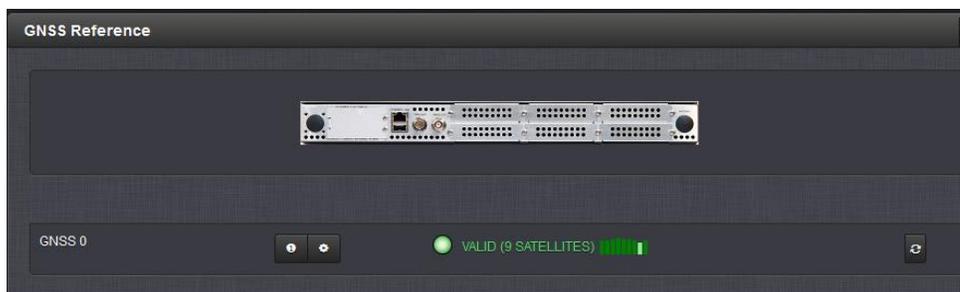
To determine the number of satellites currently being tracked, log in to the SecureSync's Web UI. The **Interfaces -> GNSS** page of the browser reports the number of satellites being tracked.

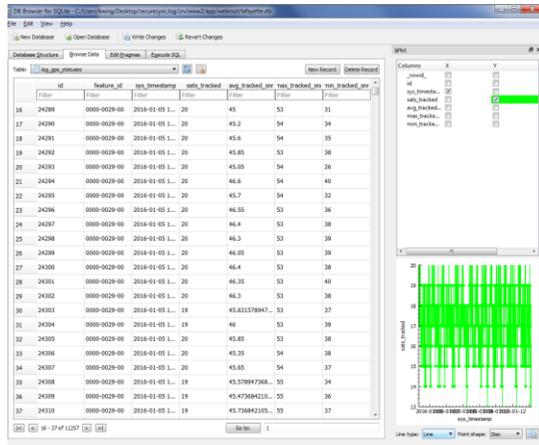
### 1. View the raw data and graph in the freeware “Sqlite DB browser” program (requires software versions 5.3.1 or above be installed in the time server)

- If the current software version is 5.3.0 or below, upgrade the software to versions 5.3.1 or above to change the MySQL database to SQLite database.
- With software versions 5.3.1 or above installed, “Save and download logs” (**Management -> Log Configuration** page of the browser)
- Use the Sqlite DB Browser program to view the database (database file is named “lafayette” and is located in the `/srv/www2/app/webroot` directory of the saved log file. Rename this file as “lafayette.db”)
- In the DB browser, open the database and then select the “**Browse Data**” tab. In the “Table” drop-down, select “**log\_gps\_statuses**” in the Plot table, select desired fields to be graphed.
- Data can be saved (as .png, .jpg, PDF or .bmp file) by pressing to “Save” ICON in the upper-right corner.

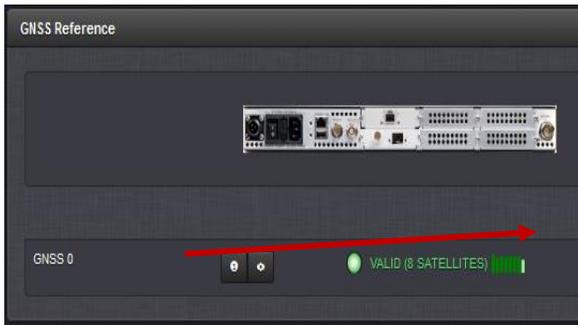
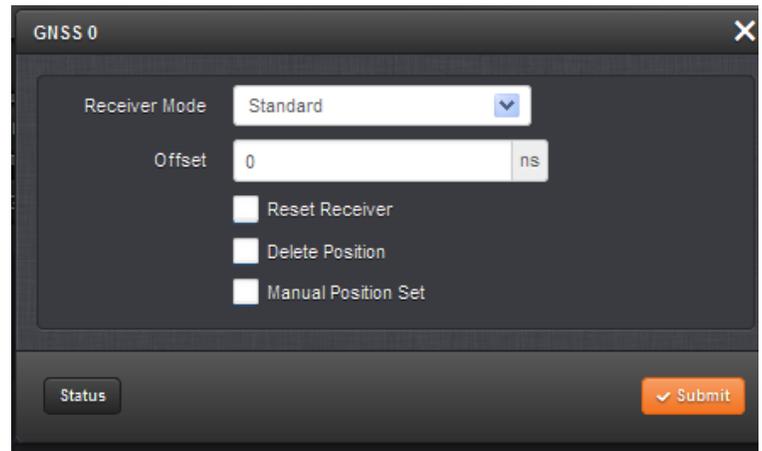
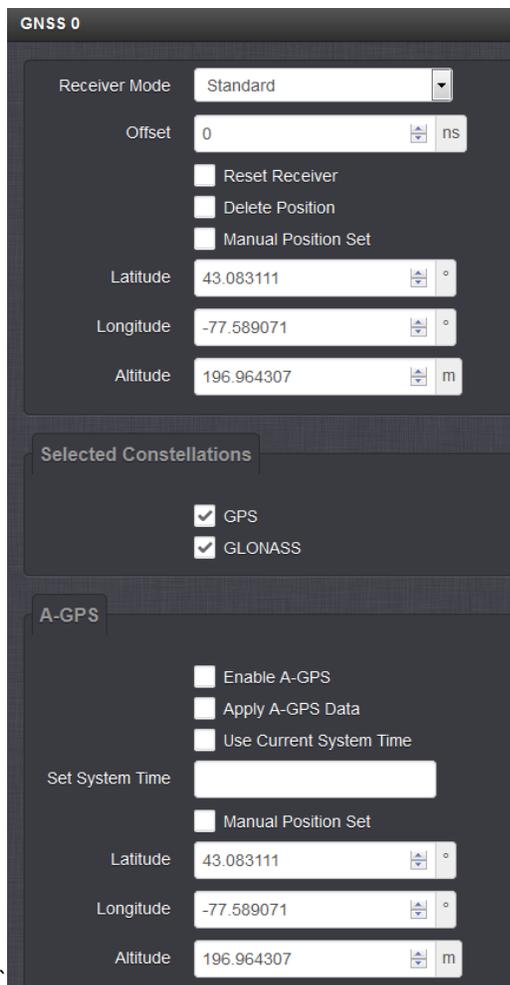
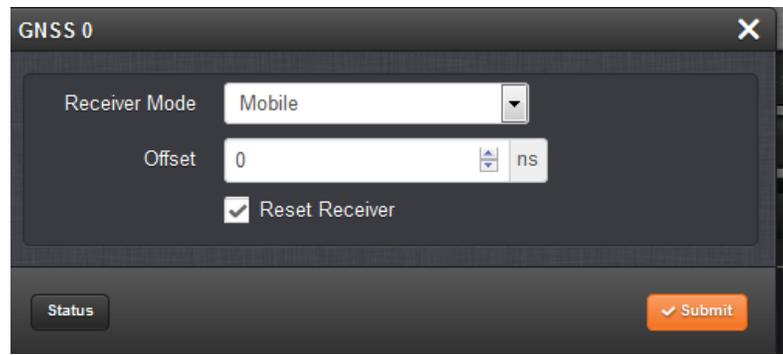
- 1) Go to **Interfaces** -> **GNSS 0**
- 2) Click the “gear” near “**GNSS 0**”

Interfaces -> GNSS 0, Edit (Glonass Option enabled)

Interfaces -> GNSS 0, Edit (Glonass Option not enabled)

### Change the GNSS Receiver Mode (Standard, Mobile or Single Satellite) in Archive versions 5.1.2 and above)

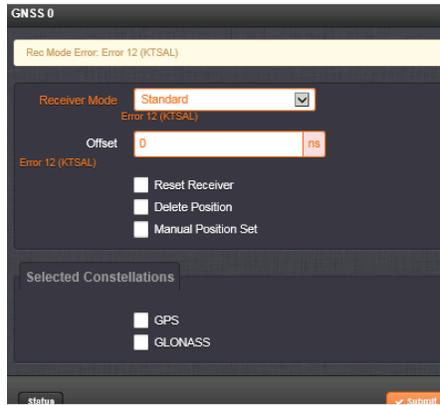
- Refer to SR4597 in SAP (see screenshot further below)
- Reported by Wells Fargo in two SecureSyncs with v5.2.0 software installed
- They reported the GNSS receiver changed on its own from Standard to Single Satellite mode.
- They have Glonass Option enabled.
- They weren’t making any changes to the GNSS receiver configs when this condition was observed.
- Fixed with reboot.

**“Constellation Error: Error 12 (KTSAL)”**: Error message displayed and “[webui] ERROR (7) - ERROR in KTSAL\_Set:

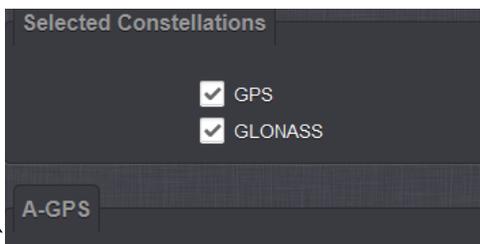
**For internal FYI info only**: When the Glonass option isn’t enabled and a Res-SMT-GG receiver is installed in software versions 5.1.7 and below, the GPS and/or Glonass selection (shown in the screenshot below) isn’t displayed on the web page- So neither constellation can be selected by a user. The “default setting” results in an “invalid” combination, so this error message is displayed. But the user config changes that were being made when the error was displayed are still applied, even though this condition occurred. So it’s just an error message display issue.

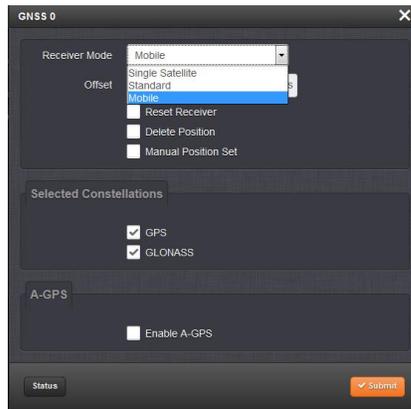
- Mobile mode is enabled/disabled in the Interfaces -> GNSS 0 page of the browser. Then click on the “Edit” box. Select Mobile and then Submit:

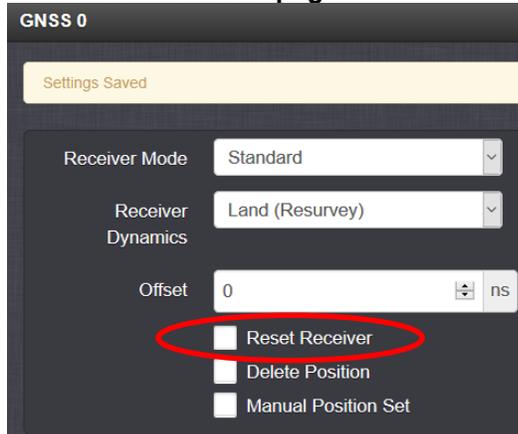
*Interfaces* -> *GNSS 0* page

The Reset Receiver command causes the GNSS receiver to execute a cold start: All data will be erased from the volatile receiver memory. Only non-volatile memory is preserved.

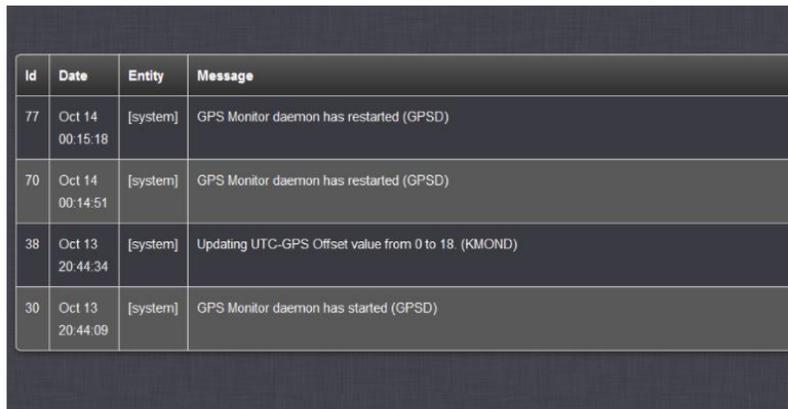
Thanks for the information. I did notice in the system log it referenced GPSD, but when I login to the shell I see gpsmond running...

| Id | Date | Entity | Message |
|---|---|---|---|
| 77 | Oct 14 00:15:18 | [system] | GPS Monitor daemon has restarted (GPSD) |

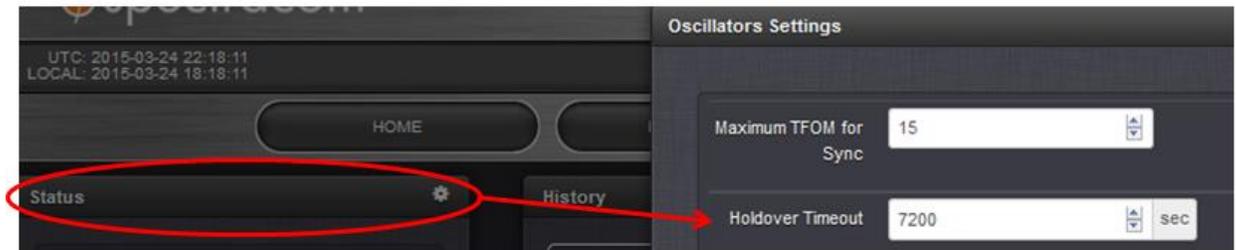
The length of Holdover is configured in the **Management -> Disciplining** page and then clicking on the “gear” next to “**Status**” (in seconds)

The value is configured in seconds with a valid range of 1 second up to 5 years. The default holdover period is 2 hours (7200 seconds).

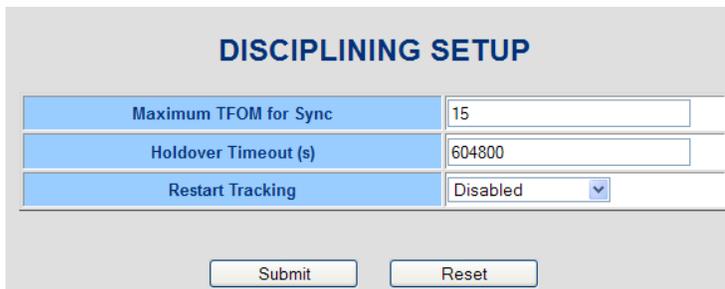
The length of holdover is set in the **Setup/Disciplining** page of the web browser.

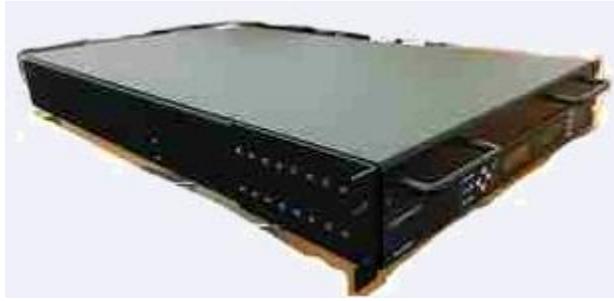
7) Raytheon AMDR special 1200 LPN, Wenzel g-Compensated Oscillator SecureSync (SecureSync-R563)

**Note:** Raytheon also refers to this product as the “Frequency Time Server” (or the “FTS 1200”)

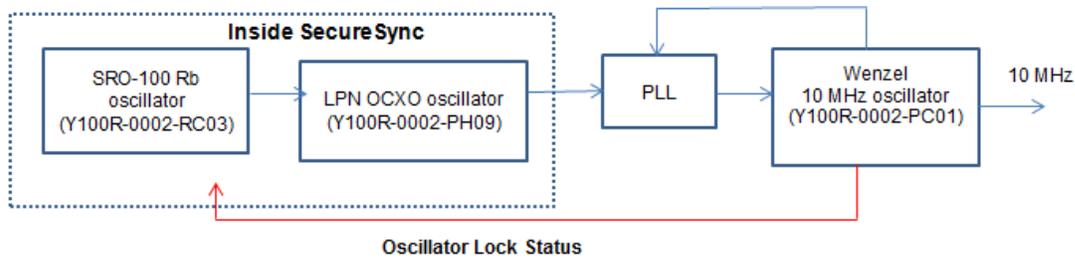
➤ **Our P/N for this external 10 MHz oscillator from Wenzel:** Y100R-0002-PC01

- **In Arena at:** [https://app.bom.com/items/detail-attach?item\\_id=1204722998&version\\_id=10245567288&orb\\_msg\\_single\\_search\\_p=1&redirect\\_seqno=7327495950](https://app.bom.com/items/detail-attach?item_id=1204722998&version_id=10245567288&orb_msg_single_search_p=1&redirect_seqno=7327495950)
  - VCOCXO,CM,10MHz,12V,5x10-10,5x6x2.75",20C to 35C
  - **MFG. P/N** 28056d

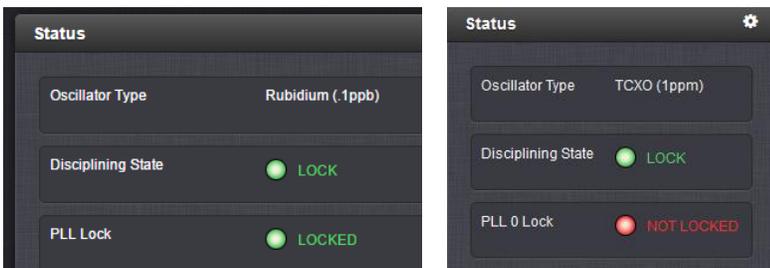
**Email from Tim Tetreault (~13 July 2015)** PLL status is available visibly within the web UI on the MANAGEMENT -> Disciplining page under the “Status” section like below.

The PLL status is also rolled up into our frequency error condition, which triggers notifications through our standard mechanisms (UI, logs, SNMP, email, etc.)

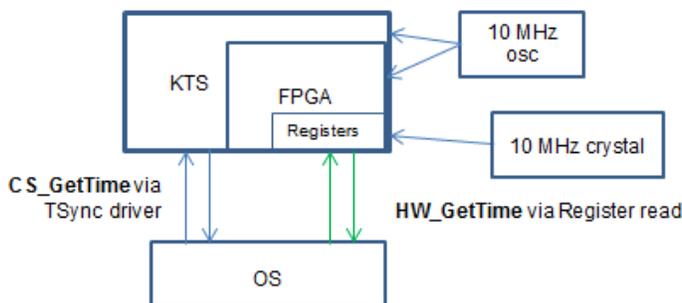
- Starting in version 5.2.0, System Log entries will be asserted if the 10 MHz input to the FPGA is lost.
1. Look for the following entries in the System Log
    - Timing System Hardware error
    - Failed CS\_GetTime (KAD)
  2. Then look for either:
    - Passed HW\_GetTime (possible oscillator error) (KAD) OR
    - Failed HW\_GetTime (probably FPGA failure)

1. If there are at least five (5) “Failed to read alarm info from KTS (KAD)...” entries in the System log, a “CS\_GetTime” call is sent to KTS to see if KTS is still communicating via the TSync driver.

- If there are less than 5 entries, nothing happens and the counter is reset
  - If there are at least 5 entries, the Tsync driver **will** be unloaded (reboot will be necessary to restore operation)

- If this call fails, the registers are not able to provide any data whatsoever. This means either bad FPGA or Tsync driver not running.
3. If both time calls fails, the issue could be with the TSync driver, so it’s unloaded (and remains unloaded) to allow the Network Processor to continue working. Reloading the Tsync driver requires the unit be rebooted.

4. If both calls fail, the oscillator likely glitched, causing both FPGA and KTS to stop responding.
5. If CS\_GetTime fails but HW\_GetTime passes, FPGA is still working.

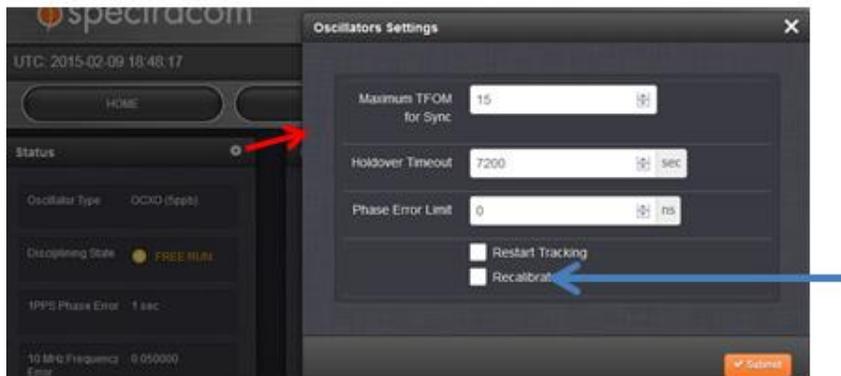
- For TCXO/OCXO oscillators only
- Update version 5.2.0 added a “Recalibrate” checkbox to the newer browser (not available in classic interface). Refer to Mantis case 1731.
- This checkbox (**Management** -> **Disciplining** page of the browser) allows the oscillator to be recalibrated by a customer without the need to run a patch or login as spfactory mode.
  - **Note:** This checkbox sends the following newer CLI command: **XO\_SetMode 0 3** to recal the oscillator.
