Model 1200 series SecureSync/9400 series

Lafayette (Model 1200 series SecureSync)

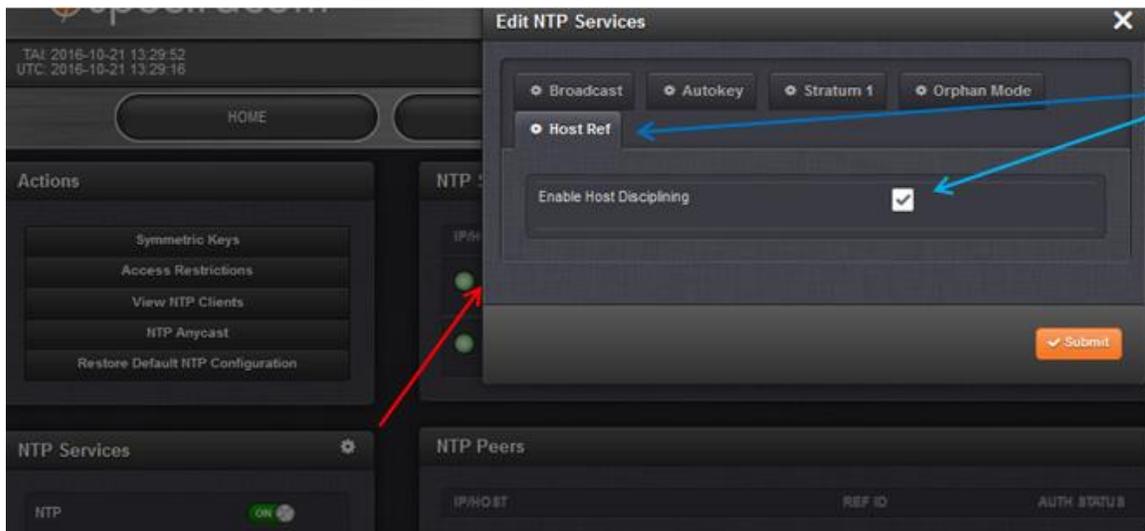
- Software update version 5.4.5 now defaults Host disciplining to OFF by factory default. But a user can enable it in the **Management** -> **NTP Setup** page of the newer browser. Press the gear icon to the right of "NTP Services" and in the pop-up window that opens, select the "Host Ref" tab. Then select the "Enable Host Disciplining" checkbox.

**(email from Keith, 21 Oct 16)** FYI: Due to some customers preferring the oscillator not be steered by NTP input, update version 5.4.5 added a new checkbox to be able to either enable this function, or to leave it disabled so that NTP doesn't discipline the oscillator.

The factory default setting is this checkbox being disabled (not selected), so that the oscillator is not disciplined by NTP. Since this is a brand new configuration in the software, this checkbox goes to the factory default state after the first update which added it to the software (once selected, updating it again to a newer version of software will return it to the state it was in before updating it). So after updating to version 5.4.5, this checkbox needs to be selected once, if its desired to discipline the oscillator to NTP (thereby clearing the Frequency Error alarm, instead of having to mask this alarm).

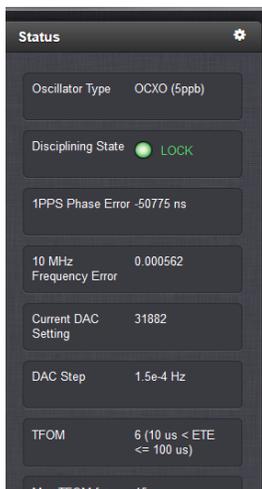
1. With one of our units (v5.8.3 installed) synced to another unit of ours (**both time servers in the same building**) and with Host Disciplining enabled, we typically see TFOMs of 5 and 6 (phase errors around 50usecs or so) with our time servers (OCXO installed)

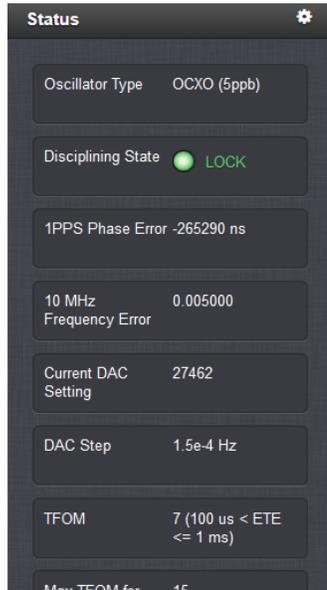
2. With our same unit (v5.8.3 installed) used for the test above synced instead to a **NIST INTERNET Time server (129.6.15.28)**, and with Host Disciplining enabled. I am seeing **similar results as above**- TFOMs of 5 to 7 (phase errors around 2-3 usecs to around 300us) with our time servers (OCXO installed) 10 MHz frequency error around 0.000258 Hz to 0.005000 Hz

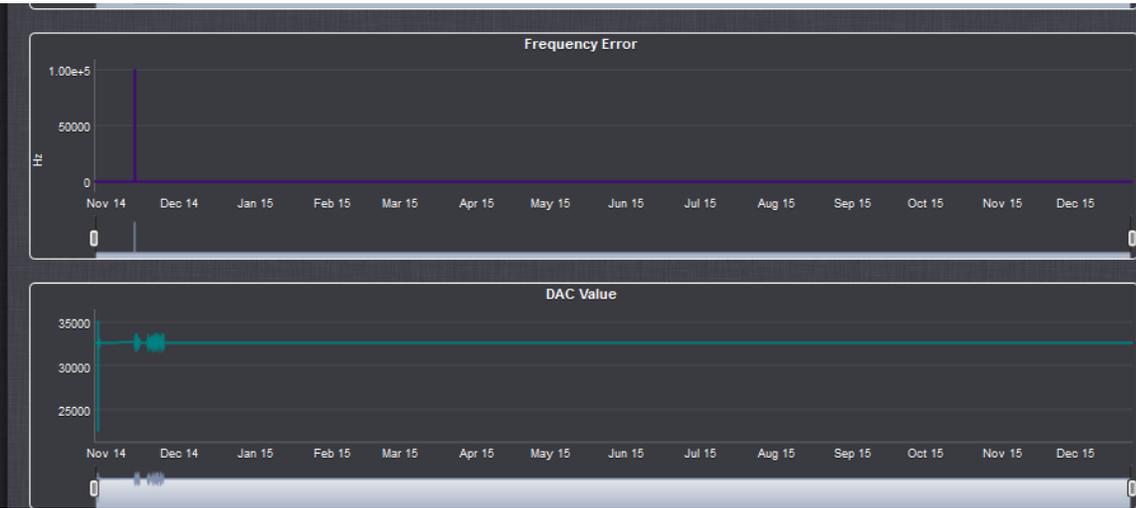
*Management* -> *Disciplining* page of the browser:

**A) New web browser (versions 5.1.2 and above)**

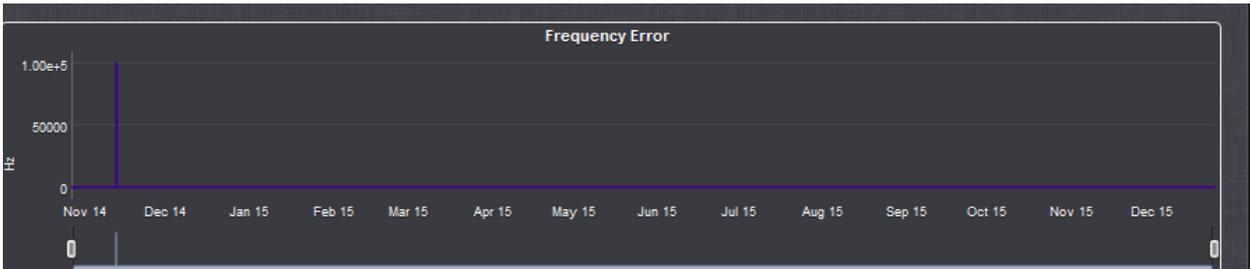
## 1. Frequency Error Graph

### Vertical scale (Hertz)

- Vertical scale is dynamic
- Vertical scale is the “RAW Frequency error” value in Hertz) (its not a Fractional Frequency Error value, like values reported in the Oscillator log)
- Typical values for the “raw” frequency error are like  $1 \times 10^{+/- 4}$ , or  $1 \times 10^{+/- 5}$ , (not like the fractional frequency error values such  $\times 10^{-11}$ , or  $\times 10^{-12}$  like we are used to seeing in the Osc log)

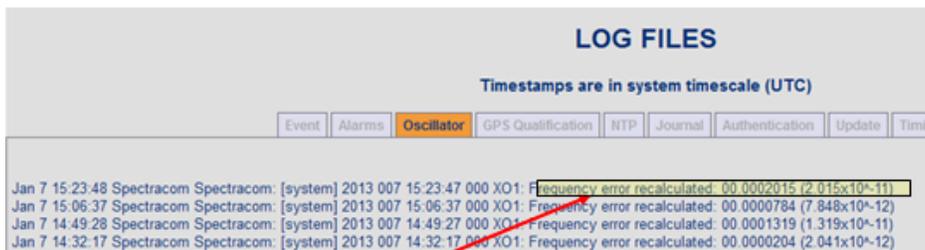
The “frequency error recalculated” messages in this log indicate the accuracy of the oscillator output, in comparison to a perfect 10 MHz signal (known as the “fractional frequency error”). The 10 MHz oscillator output is measured against the 1PPS generated by the selected 1PPS input reference.

The phrase “FREQUENCY ERROR RECALCULATED” designates the value to follow is reporting how close the oscillator’s actual 10 MHz output signal is to the desired frequency of 10.0000000 MHz (reported in scientific notation). This phrase is not an indication that there is a problem with the oscillator.

The “Oscillator” log provides an indication of the frequency counts of the oscillator’s 10 MHz output, as measured using the selected 1PPS Input Reference (Such as a GPS receiver’s 1PPS output signal) as a reference.

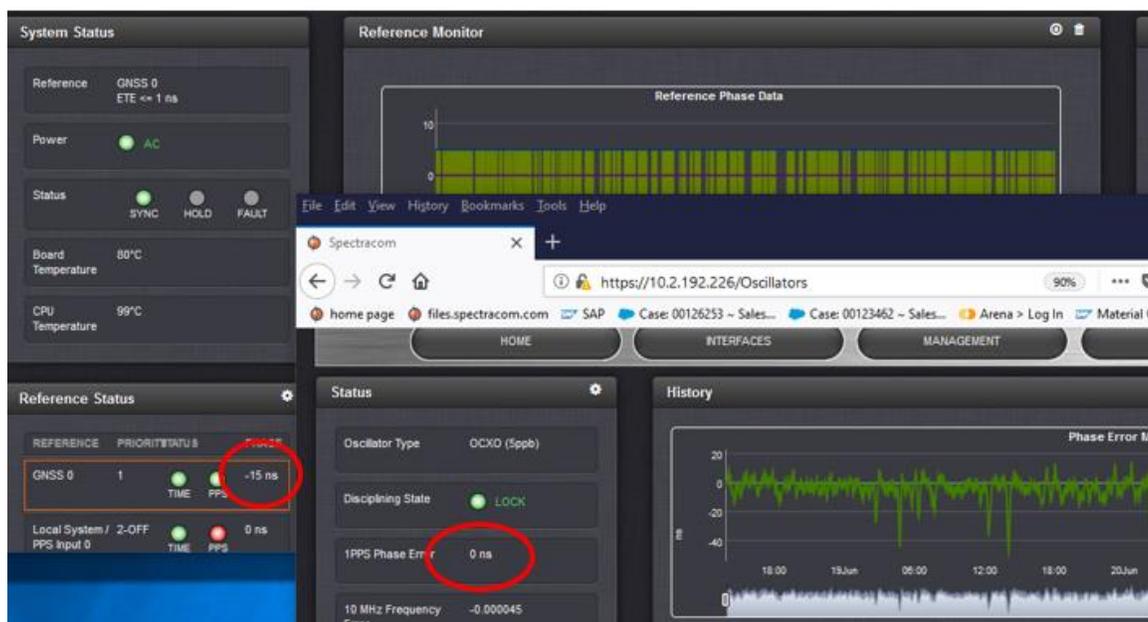
- Due to differences in granularity in the *Disciplining* -> *Reference Priority* pages, versus the *Reference Monitor* page, the phase error values for the same reference may be reported as two different values.
- As shown below, the phase error is reported as **0ns** in the *Disciplining* page, while the GPS phase error is being reported as **-15 ns** in the *Reference Monitor* page

**Per Dave S (19 Jun 2018)** I don't remember the direction of the offset (negative vs positive), but as far as the differences, the disciplining phase error is a filtered error, that has higher resolution. The reference monitor phase errors are raw offset values with a 20ns resolution. They should absolutely track each other in terms of trends, but due to the filtering and differences in resolution/granularity there will be differences in the reported offsets.

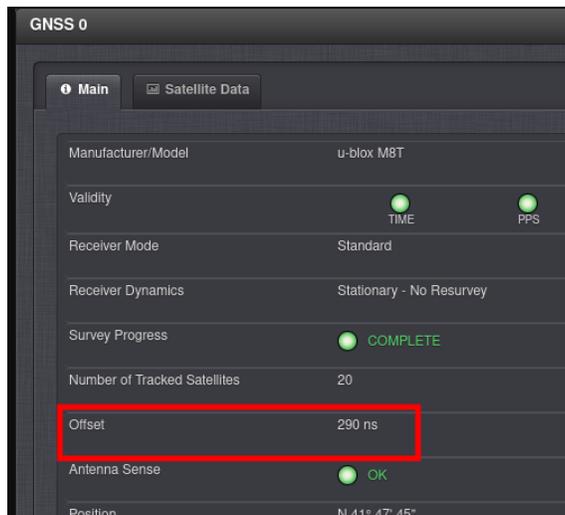
- Customer configured a **290ns** GPS cable delay/offset

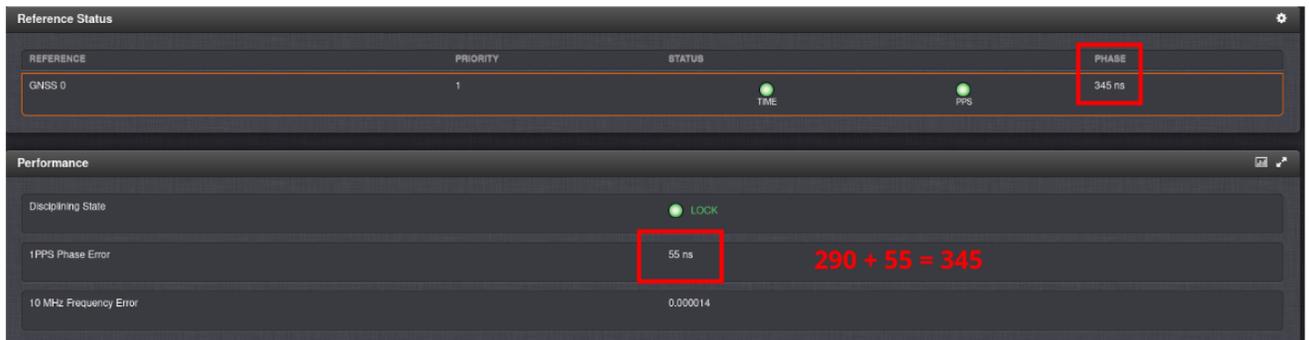
Also, just to make sure I 100% understand what you're saying. You're referring to this:

Is that right? In essence, the antenna delay offset is a fixed offset and not accounted for with displaying the GNSS 0 phase of 345 ns. So the sum of the fixed offset and the actual 1PPS phase error of 55 is what we're seeing for the reference phase of 345 ns.

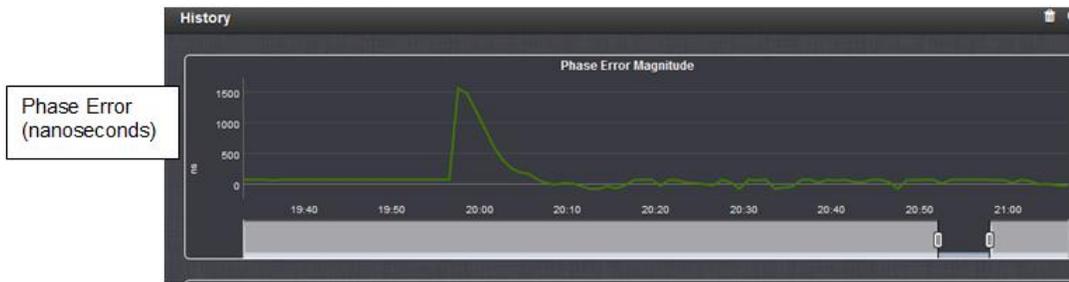
[Management](#) -> [Disciplining](#) page (top graph)

- Vertical scale is dynamic
- Vertical scale (nanoseconds) is in either decimal dot or scientific notation depending on the amount of error.

The vertical scales vary depending upon the actual error values so pay close attention to the labeling. Above a certain value, a decimal notation is used (such as 0.01 seconds). Once the error value decreases, the values change to scientific notation (such as 2e-06).

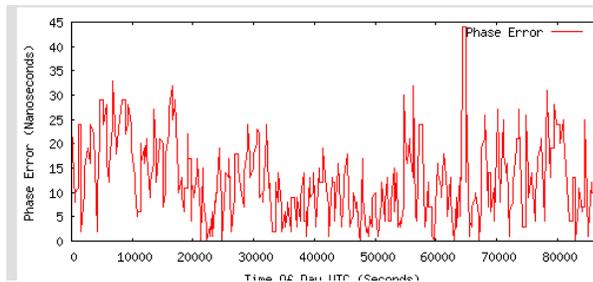
Archive Version 4.8.8 (Dec 2012, ECN 3099) added these three graphs to the **Status** -> **Disciplining** page of the browser

**Email from Dave Sohn (12/12/12)** Version 4.8.8 added phase and frequency error graphing on the unit. We generate files that include the phase and frequency errors as they are updated. Those could be pulled from the unit. We only keep the last 5 days on the box. As far as the actual logs go, we record the frequency error in the oscillator log as well.

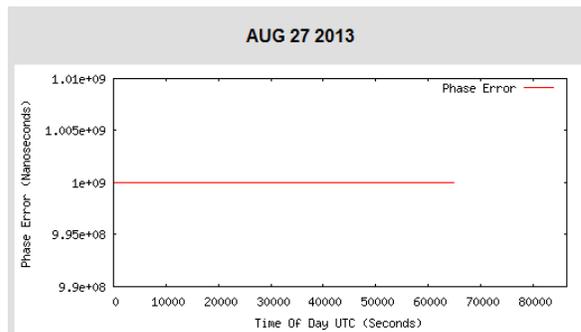
#### 1) 10 MHz Phase Error graph showing straight line

**Can be due to:**

- SecureSync synced via USER/USER mode.
- SecureSync synced via NTP.
- SecureSync not synced to any reference (oscillator in free Run mode).

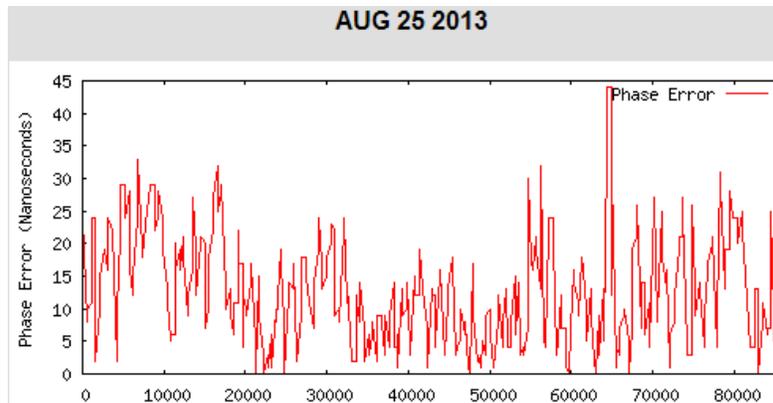
## B. Phase Error graph showing large intermittent spikes

### Can be due to:

- Ambient temperature changes
- Mechanical shock/vibration
- Intermittent GPS reception issues

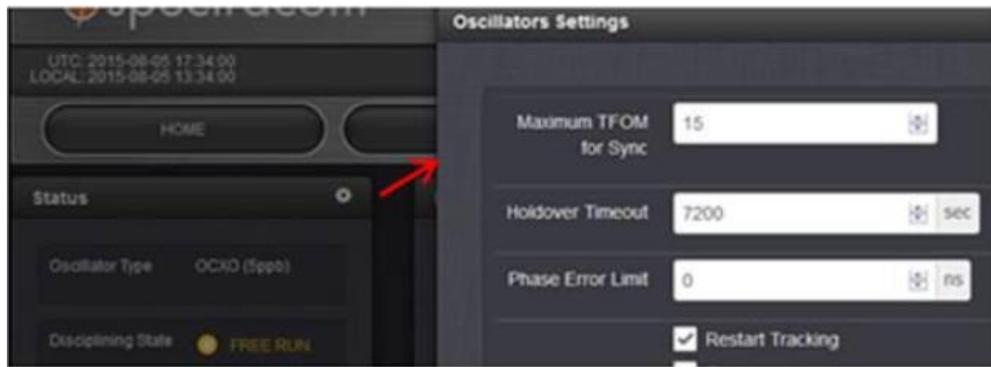
To perform a restart tracking, navigate to the **Management** -> **Disciplining** page of the browser. On the left-side of the page, click on the “gear” icon to the right of “Status”. In the pop-up window, select **Restart Tracking** and then press Submit.

The oscillator will now be realigned much faster to the GPS signal. The Frequency Error alarm should typically clear within about 15 to 30 minutes after performing this step.

In lieu of power cycling the unit, you can also manually perform a “restart tracking” which speeds up this alignment (it is similar to a reboot as far as the oscillator is concerned with the oscillator once-again coarse adjusted to the 1PPS reference even though no reboot was actually performed).

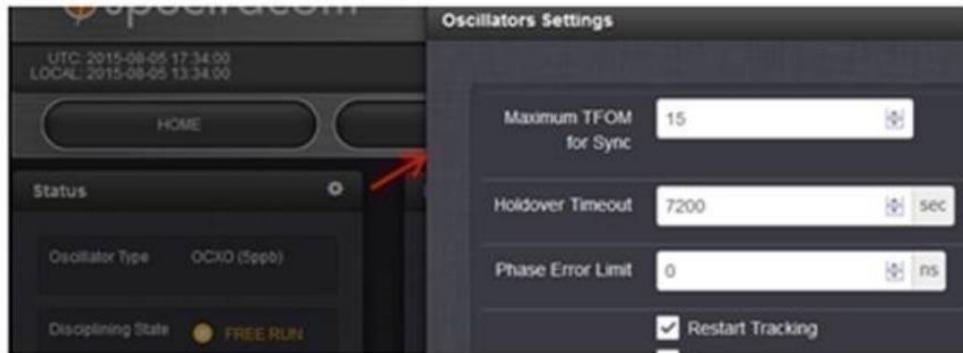
**Management** -> **Disciplining** page, Status gear icon pop-up window

**Phase Error Limit field** was added to the Edit window of the Disciplining page allowing for an automatic disciplining tracking restart, once the phase error limit is exceeded, thus avoiding manual intervention.

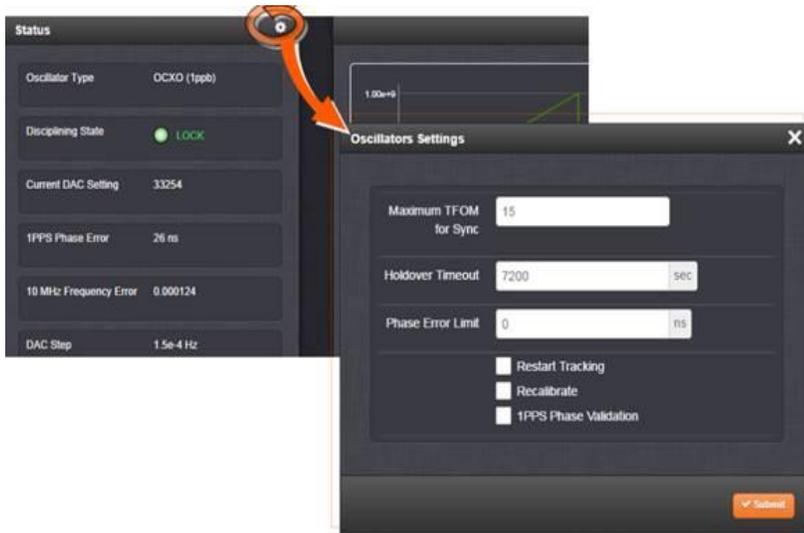
To either manually or automatically expedite the oscillator lock/relock, navigate to the **Management** -> **Disciplining** page of the browser. On the left side of the page, click on the Gear icon to the right of “Status”. This will open a pop-up window (as shown below). Selecting the “Restart Tracking” checkbox at the bottom will start a “one-time” oscillator relocking (the same process as occurs the first time after each reboot that an external reference is applied). This process is only performed when a user selects this checkbox (it can be applied multiple times/whenever desired as long as there is an external reference available for it to lock to).

To alleviate manual intervention, the “Phase Error Limit field” in this same window is used to perform an “automatic Restart Tracking” whenever the 1PPS phase error (the offset between the internal 1PPS and the external input’s 1PPS) exceeds a user-specified value. For instance, if the Phase Error limit is set to 1000ns, if the internal 1PPS is more than 1000ns different than the external 1PPS input, a “restart tracking” is performed at that time. Instead of slowly slewing 1000ns, the oscillator is hardware re-aligned to the reference, just like when a user manual initiates a “Restart Tracking”.

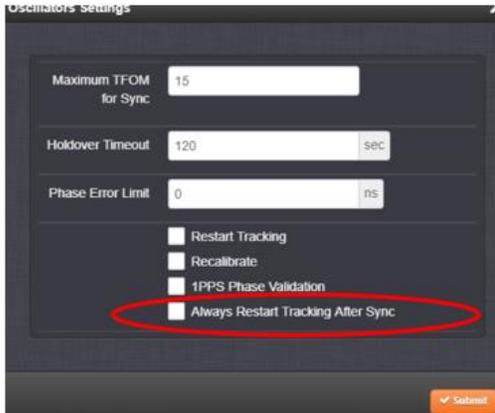
*Management* -> *Disciplining* page, Status gear icon pop-up window

**Always Restart Tracking After Sync:** When selected, this option will ensure that every time the unit exits holdover, the discipline tracking is restarted. It should be noted that this setting will only restart the tracking once when using the Phase Error Limit, unless the unit re-enters holdover.

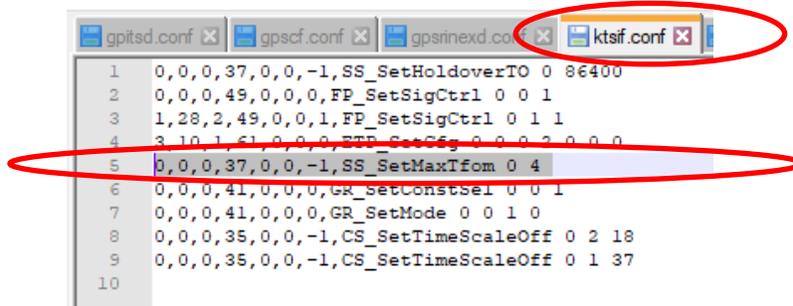
MaxTOM value for the black/charcoal web browser is stored in the ktsif file.

```
1 0,0,0,37,0,0,-1,SS_SetHoldoverTO 0 86400
2 0,0,0,49,0,0,0,FP_SetSigCtrl 0 0 1
3 1,28,2,49,0,0,1,FP_SetSigCtrl 0 1 1
4 3,10,1,61,0,0,0,FP_SetSigCtrl 0 0 0 2 0 0 0
5 0,0,0,37,0,0,-1,SS_SetMaxTfom 0 4
6 0,0,0,41,0,0,0,GR_SetConstSel 0 0 1
7 0,0,0,41,0,0,0,GR_SetMode 0 0 1 0
8 0,0,0,35,0,0,-1,CS_SetTimeScaleOff 0 2 18
9 0,0,0,35,0,0,-1,CS_SetTimeScaleOff 0 1 37
10
```

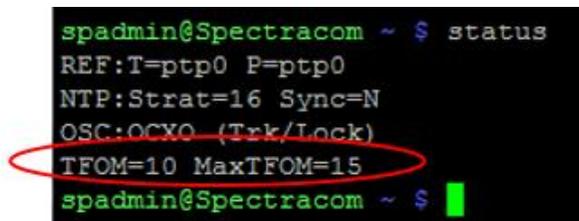
- MaxTFOM should be able to both read/set via REST API
- MaxTFOM cannot be **set** (configured) via the CLI (must be configured via the browser)
- Configured MaxTFOM value can be **reported** (not set, due to CLI permissions) via CLI using either the **SS\_GetMaxTfom 0** command or with the **status** command (which reports both the MaxTfom value as well as the current TFom value, as shown below):

```
spadmin@Spectracom ~ $ status
REF:T=ptp0 P=ptp0
NTP:Strat=16 Sync=N
OSC:OCYO (Trk/Lock)
TFOM=10 MaxTFOM=15
spadmin@Spectracom ~ $
```

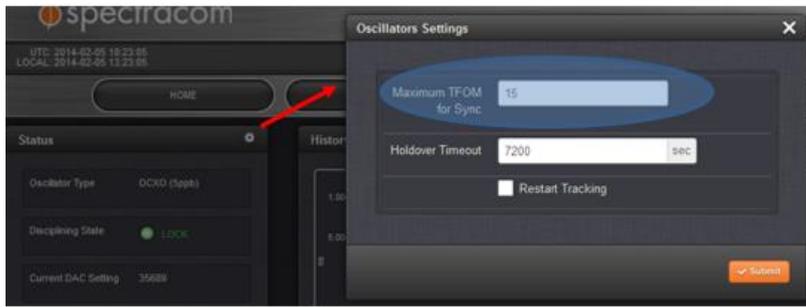
Note the “MaxTFOM” field is configured in the **Management -> Disciplining** page of the newer (black/charcoal) web browser. As shown below, click on the gear icon to the right of “status” (on the left side of the page). The MaxTFOM field can be configured in the pop-up window that opens. Press Submit after changing this value.

- The MaxTFOM (Maximum TFOM for Sync”) value is configured in the **Management -> Disciplining** page of the browser, and then clickon the “gear” next to “Status”

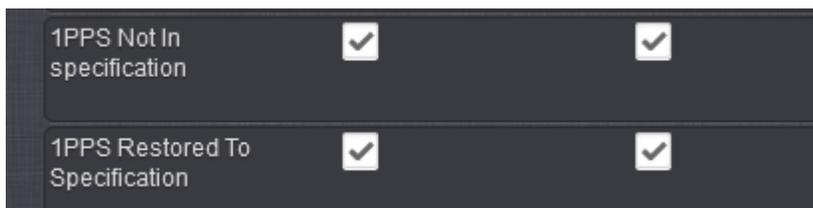
- Forced Holdover mode/Holdover alerts are asserted
- “1PPS not in Specification” alarms asserted. (SNMP alerts sent, if enabled)

- TCXO and OCXO disciplining rates are altered to help expedite the lowering of TFOM.

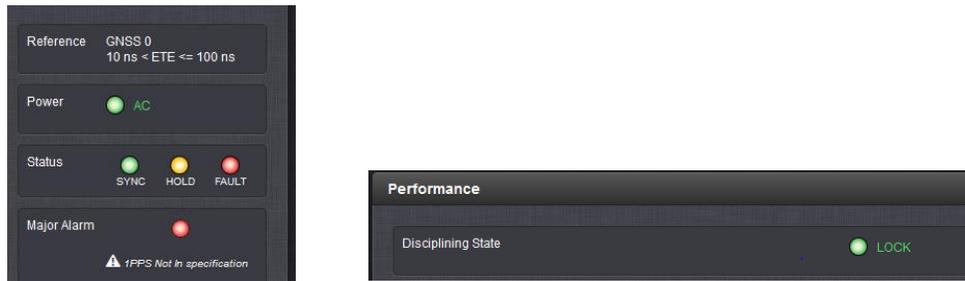
**B) RB oscillator. MaxTFOM changed to “1”. TFOM is 2 (TFOM 2 is now exceeding MaxTFOM 1)**

These are events that occur and alarm entries that are asserted. **“1PPS not in Specification”** occurs if the current TFOM values exceed the user-configurable max TFOM value. When the TFOM falls below Max TFOM, the Restored to Specification event/alarm entry is asserted.

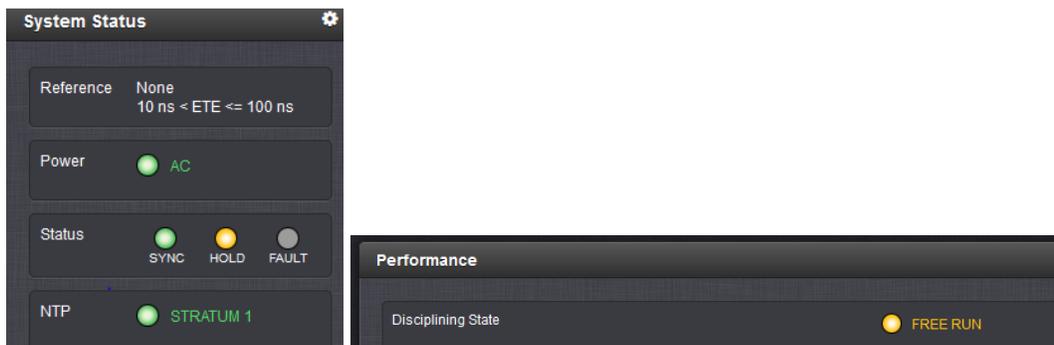
- A) RB oscillator. No valid input references. MaxTFOM set to default “15”. TFOM is 2 (TFOM 2 not exceeding MaxTFOM 15)**

**If SecureSync is already in Holdover mode, when TFOM starts to exceed MaxTFOM (due to estimated osc drift)  
Holdover mode (Holdover indicator is already yellow)**

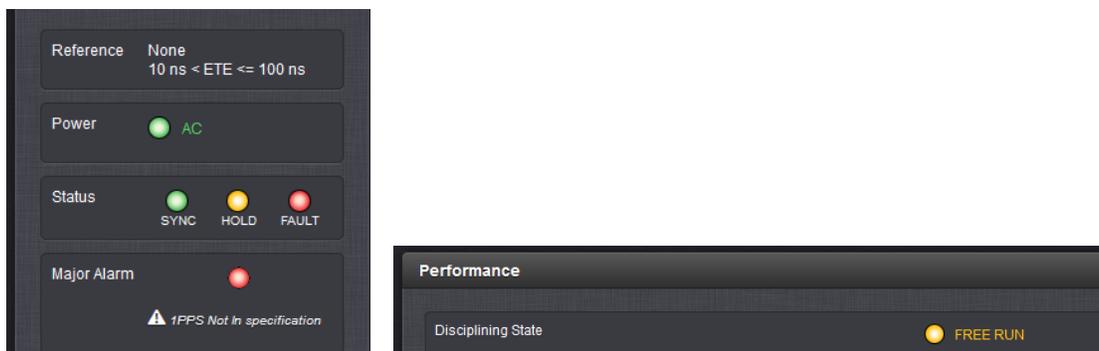
- B) RB oscillator. MaxTFOM changed to “1”. TFOM is 2 (TFOM 2 is now exceeding MaxTFOM 1)**

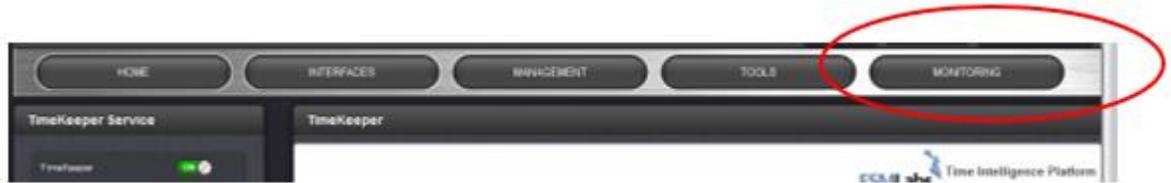
- For instructions on installing a license file, refer to: I:\Customer Service\EQUIPMENT\SPECTRACOM EQUIPMENT\SecureSync\License Files Updates
- License files are purchased/generated for a specific Serial Number. It can only activate this option on the specified Serial Number.
  - Installed license files are displayed in the Tools -> Upgrade/Backup page of the browser
    - An additional “**Monitoring**” button will be displayed in top-right of the browser, once timekeeper license has been installed

If you do not see the Monitoring tab on the upper right corner of the SecureSync you need to install a license file to enable it. Please see the attached document on how to install a license file if needed. Please note each license file is custom and only works on one particular SecureSync Serial number.

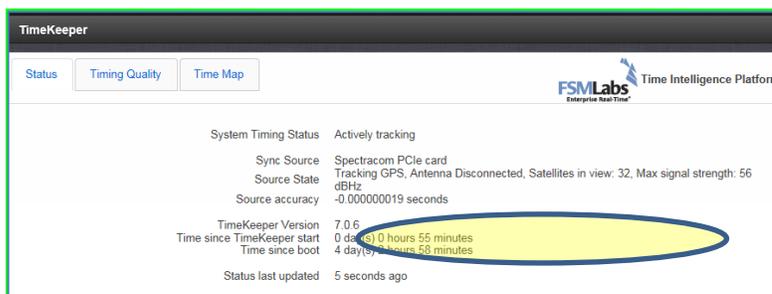
#### A) “**Status**” tab

- The Status tab provides information on the source currently tracked, as well as TimeKeeper system data, and system tracking information
- Similar to, but not identical to timekeeper in VelaSync:

- Will indicate Spectracom PCI Card, NTP or PTP, depending on the selected Source
- “Spectracom PCI Card”: indicates Timekeeper software is synced via Source 0 (GPS/GNSS, via the TSync driver)
- If it indicates “NTP” or “PTP” input (instead of Spectracom PCI Card”, Source 0 (GNSS/GPS) is not currently the selected reference. This means either:
- The GNSS receiver is not currently tracking any satellites (GNSS 0 is not a valid input) OR
- **The GNSS 0/GNSS 0** reference is not listed and enabled in the **Management-> Reference Priority** page of the

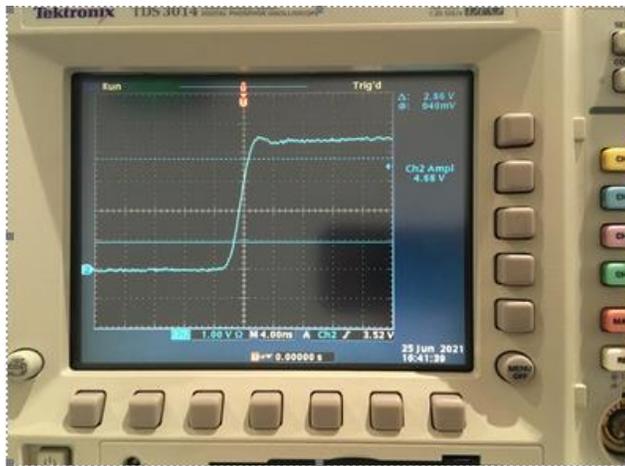
4.7 vdc amplitude(100%)  
3.8 vdc @(80%) dashed blue line  
0.94 vdc @(20%) solid blue line  
4ns scale per/div

**Answer ~ 2ns 20/80% rise time**

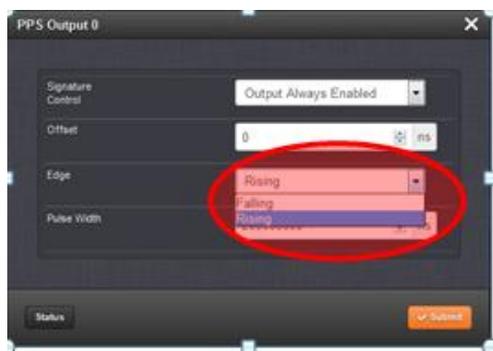
### To configure the active (ontime) edge to be either the "Rising" edge (factory default) or "Falling" edge

- 1) Navigate to the **Interfaces** -> **PPS Output** page of the browser (PPS output 0 for the base output)
- 2) Press **Edit**
- 3) In the "**Edge**" field, select the desired edge (such as "Falling")

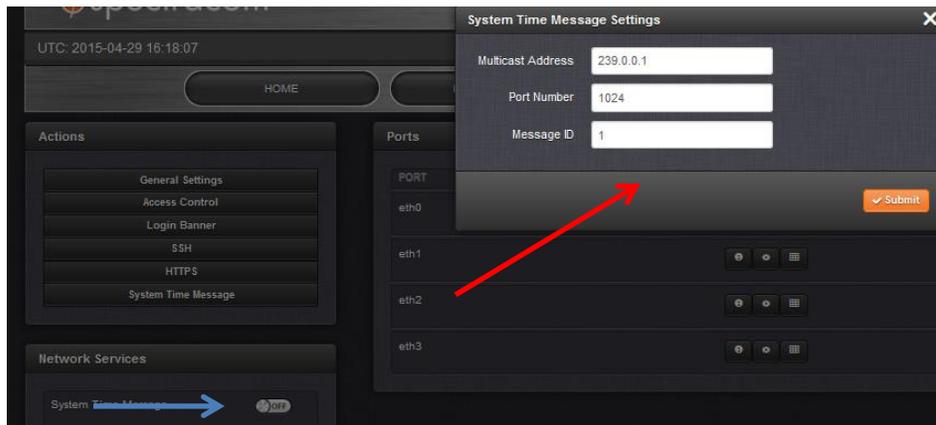
**Management** -> **Network** page of the browser

- Enable/Disable this service using the slider switch in the bottom left corner under “**Network services**”
- Configure this service by selecting the “**System Time Message**” button in the upper-left corner.

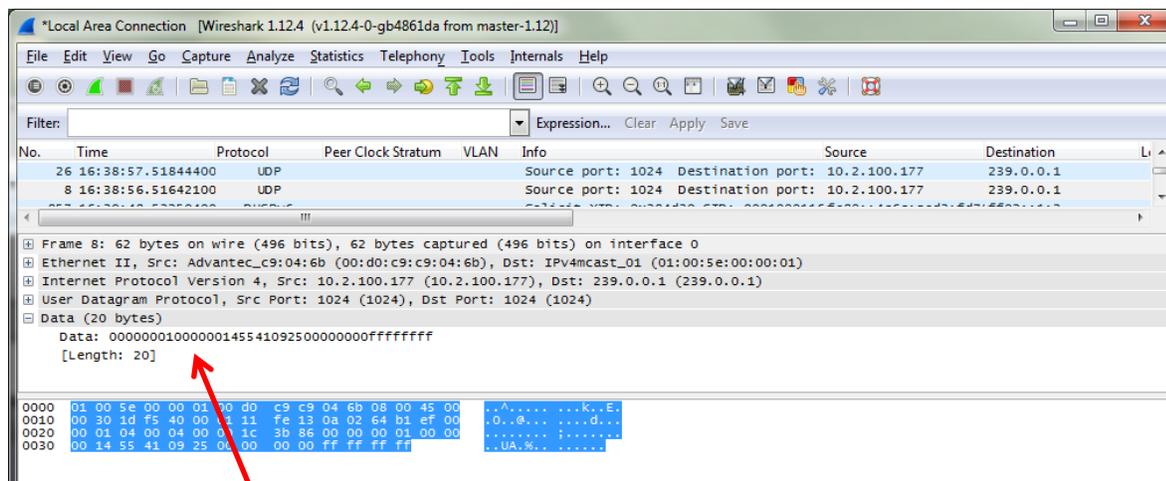
**Message ID 1**

Configured "Message ID" number ("1")

- This message contains the time when the next 1 PPS discrete will occur. It is sent once per second prior to the 1 PPS discrete.

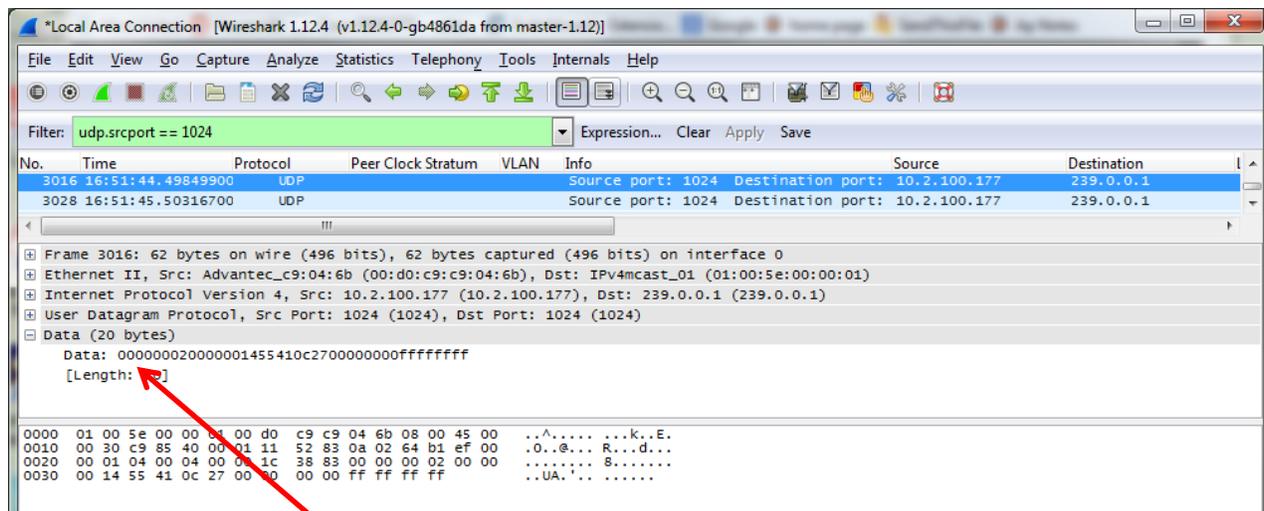
**Message ID 2**

Configured "Message ID" number ("2")

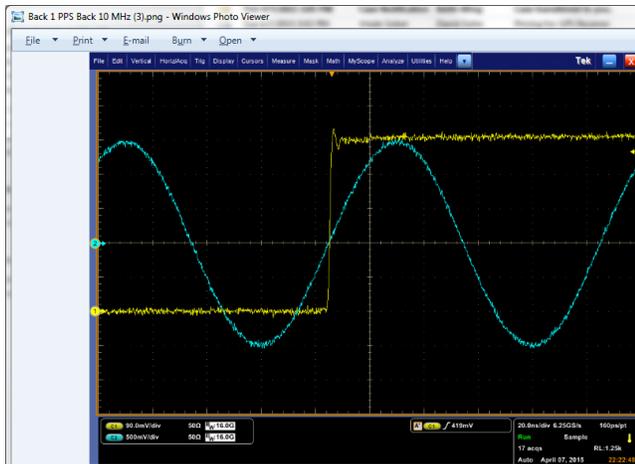
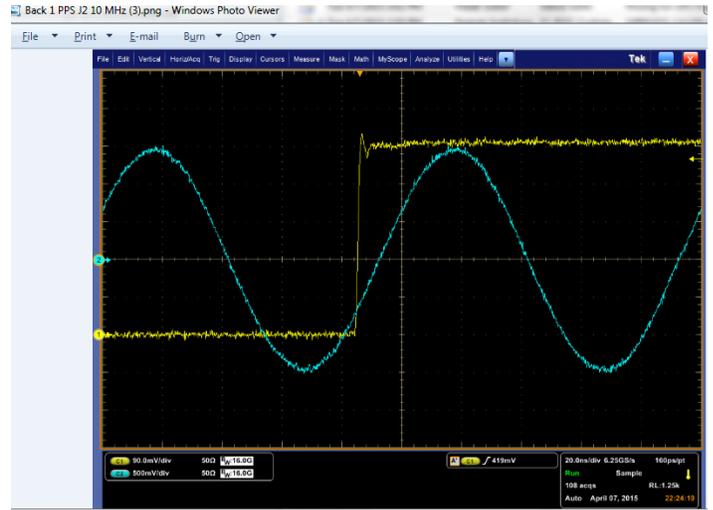
**1PPS/10MHz alignment for base output (and 1204-0C 10 MHz Option Cards)**

**1PPS/10MHz alignment for all 1204-1C option Card outputs**

**Per Dave Sohn (7 Apr 2015)** This is what I would expect from the system. There is no HW issue. The phase relationship on a 10MHz output is fixed with the 1PPS, but there is a difference between the outputs on the option card versus the main unit. If they need multiple outputs that have the same phase relationship, then they can just use the 1C option card outputs.

**Dave Sohn responded with:** This specification is held once HW adjustments are disabled after first sync (or if restart tracking is sent). At this point, the 1PPS is generated directly from the 200Hz clock, which is generated through a PLL from the 10MHz. However, when going into holdover, the 10MHz frequency will change from the current correction frequency to our best estimate of the correct frequency without any corrections for phase errors. It's possible that with that change, the 1PPS may appear to have one extra cycle if an edge transitioned later because of the frequency change and how their counter is tracking it and the 1PPS.

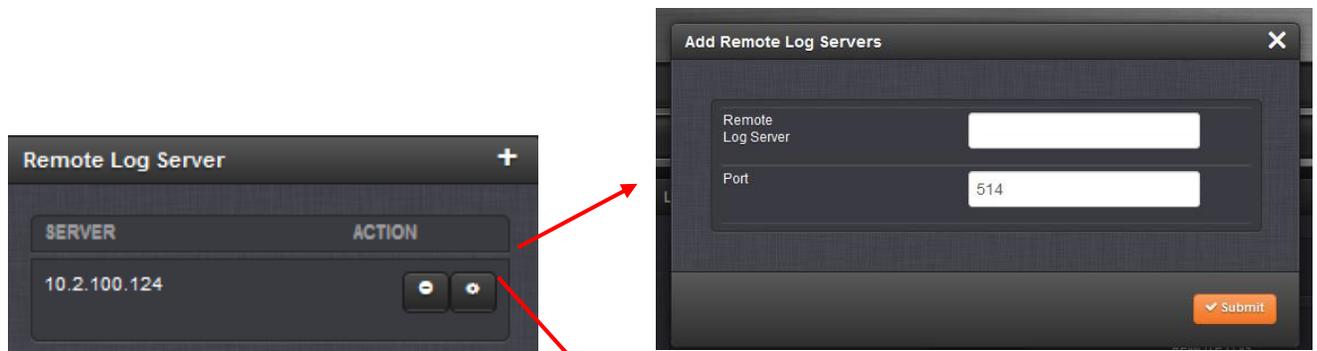
**Step 1: Add up to 8 Remote log Server (s) (left side of the Log Configuration page)**

**(Versions 5.7.1 and above)**

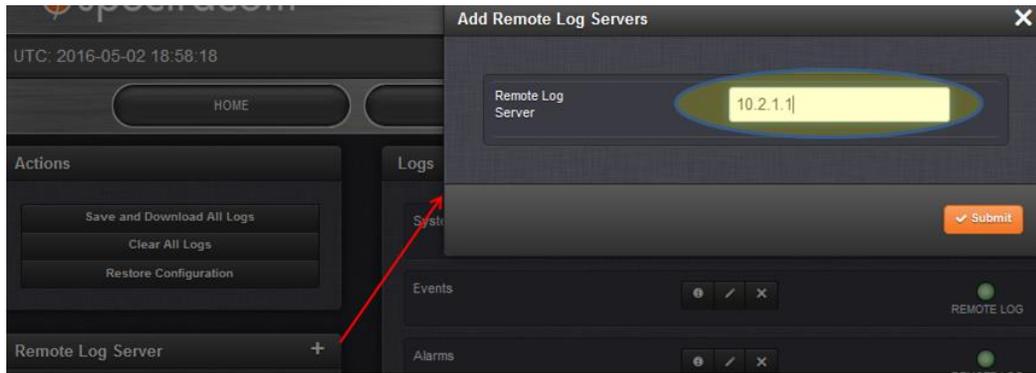
On the left side of the **Management -> Log Configuration** page of the browser, press the “+” sign to the right of “**Remote log Server**”. In the pop-up window, enter the IP address of the syslog server and Submit. Repeat as desired to enter additional.

First, add the desired syslog server(s) to the list of available syslog servers that each log type can be individually configured to be sent to (overall, multiple syslog servers can be listed, with each log file type being able to be sent to any one of the servers in this list).

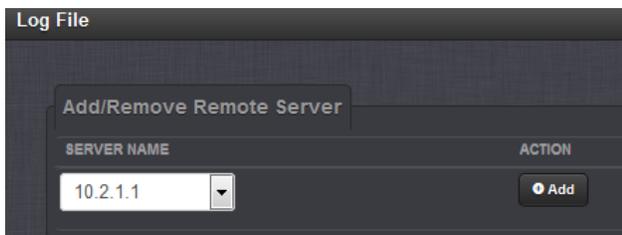
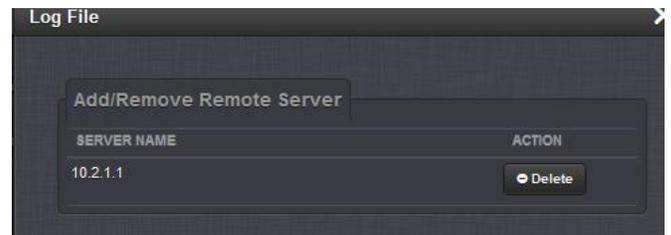
The remote logging enable for each log file/type (such as the "Qualification" log for instance) is in the **Management -> Log configuration** page of the browser. For each log file you wish for its logs to be sent to remote servers, click the middle of the three ICONS (the pencil ICON) for that log file. In the **server name**" drop-down of the pop-up window, select the particular syslog server you wish to send this log file to and then press the Add button.

The "Add" button and the "Server name" drop-down field will vanish after pressing the Add button

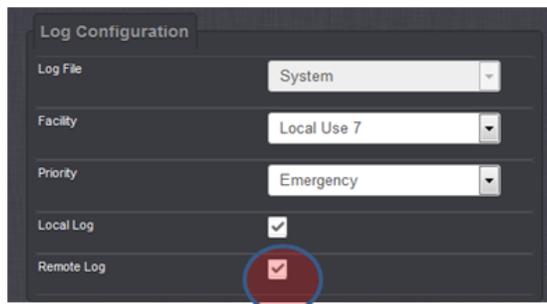
Make sure "Remote Log" checkbox is selected (it is selected for all log files by Factory default". But if it's been since unchecked, its log entries won't be sent to a remote server.

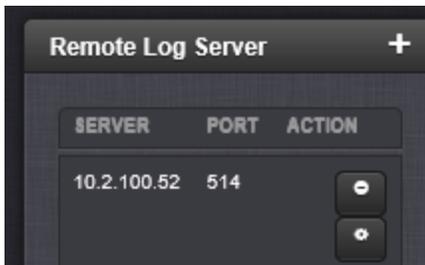
- 1) The sqlite database stores the entire list (of one or more) of the desired syslog servers (which are then displayed in the drop-down remote server field, to be able to select the desired server for each individual log file type) as shown below:

In order to restore all syslog server configs, I believe both the etc/syslog.conf file, and at least the syslog server values in the sqlite database, need to be restored,

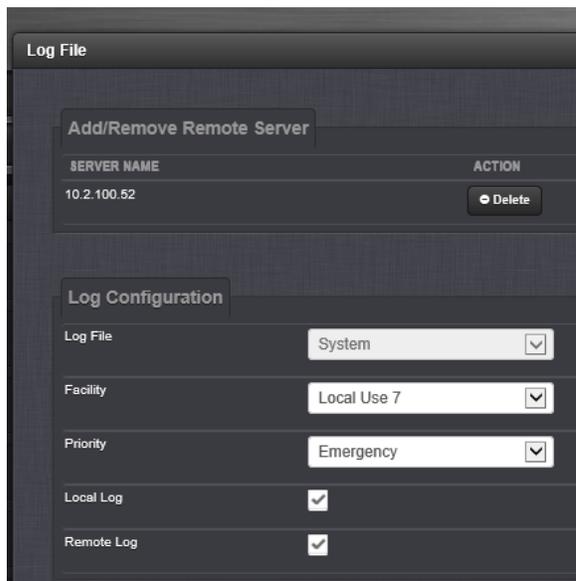
- 1) ...While the etc/syslog.conf file stores all the individual log file configurations (such as the selected syslog server for the "System log", for example, as shown towards the top of the screenshot below),,,

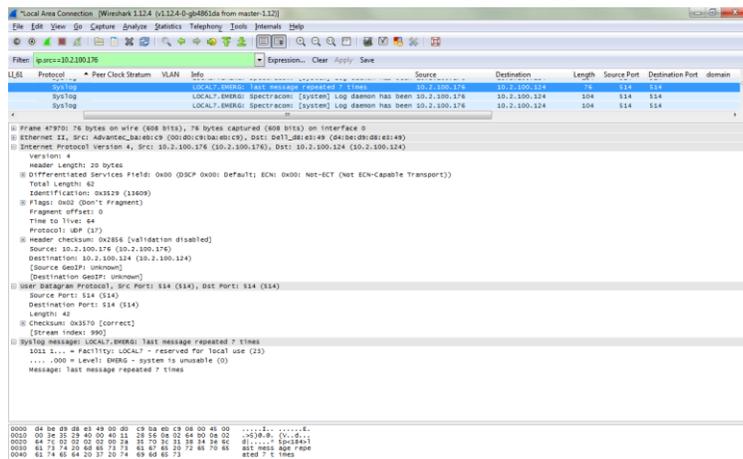
*Example Syslog packet capture*

Example filter can use: `ip.src==10.2.100.176 and udp.port==514`

**Note:** the screenshot below shows tcpdump listening on port 514 of all Ethernet interfaces (filtering for port 514 will only capture syslog messages being sent). This screenshot from v5.3.0 software shows the two separate journal log entries I caused to be sent by changing web browser configs.

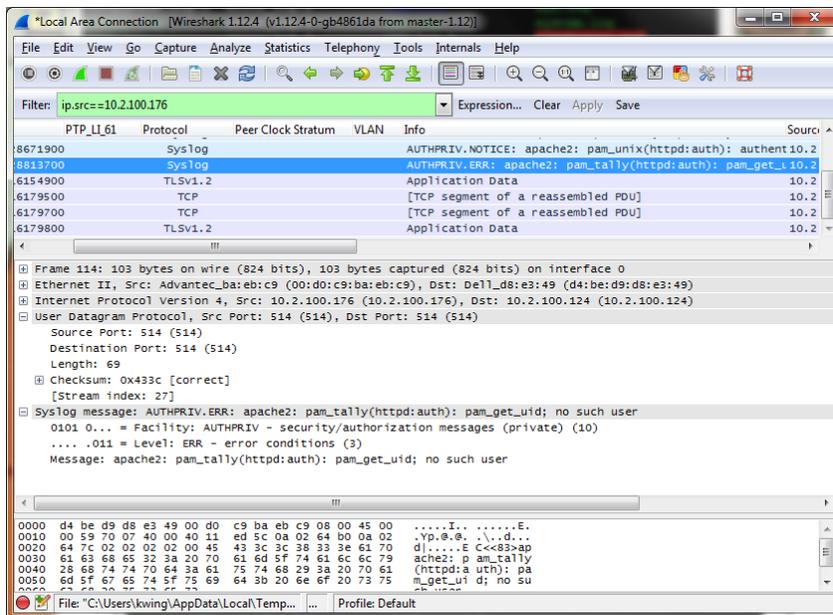
### Example capture of an Auth log entry being sent to syslog due to trying to login with invalid credentials

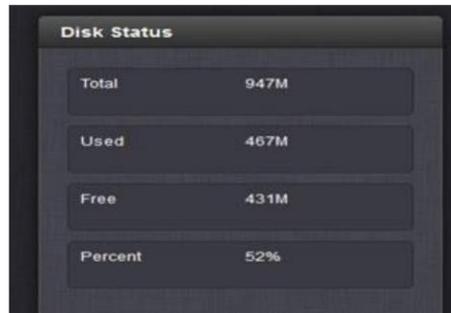
much space on the CF card is currently being used by the system/free space still available, via the `df -h` CLI command, or via the “Disk Status” section on the **Tools** -> **Upgrade/Backup** page of the browser (starting in software version 5.2.1 as shown below):

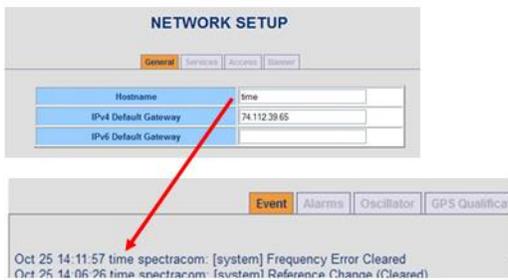
So instead of sending the IP address with the log entries, syslog uses the DNS hostname to indicate the source of the raw log data. Each of the SecureSync (and NetClock) log entries includes the unit’s hostname. This is how to identify which SecureSync sent the logs. By factory default, the hostname for the time servers is “Spectracom”. Customers can change this value as they wish. For SecureSync, the hostname is configured in the **Network -> General Setup** page of the browser, **General** tab.

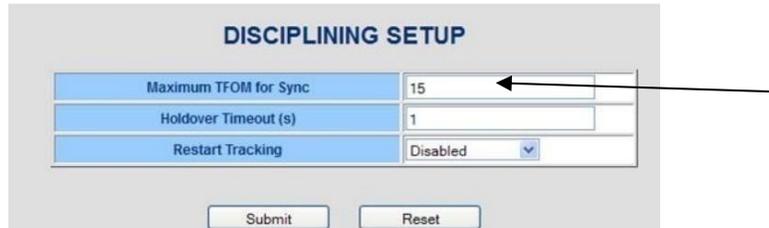
Please navigate to the **Setup -> Disciplining** page of the browser. As shown below, what is the **“Maximum TFOM for Sync”** field set to (in version 4.8.6, I believe this was abbreviated as **“Max TFOM”**)?

TFOM **15** is the factory default value which will allow any TFOM value be acceptable for sync. We suspect that you may currently have a much lower MaxTFOM value configured, such as a “3” for instance. MaxTFOM of a lower value will cause the SecureSync to go into Holdover mode, if the SecureSync’s TFOM value exceeds this set value. It will remain in Holdover mode until the TFOM value no longer exceeds this set value. If TFOM is exceeded, GPS is considered “not valid” as a reference, resulting in the SecureSync being in Holdover mode and the alarm entries you are observing being asserted!!

The simple fix I to this is to increase the TFOM to a higher value that wouldn’t occur with good GPS reception. If you wish for SecureSync to go into Holdover based on the estimated accuracy value (RTFOM), set it to a value such as a 5 or a 6, for instance. If you prefer it not to go into Holdover mode based on the TFOM value, just change it back to 15.

Regarding the “1PPS Not in Specification” alarm, this alarm only occurs if the current TFOM exceeds the user-configurable max TFOM value. The SecureSync going into Holdover mode will not initially and automatically cause the TFOM to increase and exceed the max TFOM value. However, if the unit continues to operate for an extended period of time without any valid input references, the oscillator will begin to drift. As long as the max TFOM is not set to 15, eventually, the max TFOM will be exceeded and the alarm is asserted. The type of oscillator (OCXO or Rubidium) and the setting of max TFOM will determine the typical amount of time in holdover required to exceed the max TFOM.

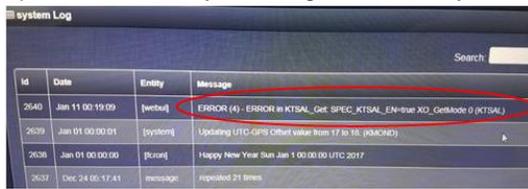
Q I have a question about system log of SecureSync.

The screenshot shows a 'system Log' window with a search bar and a table of log entries. The table has columns for 'id', 'Date', 'Entity', and 'Message'. The entry with id 2640 is circled in red. The message for this entry is 'ERROR (4) - ERROR in KTSAL\_Get: SPEC\_KTSAL\_EN=true XO\_GetMode 0 (KTSAL)'.

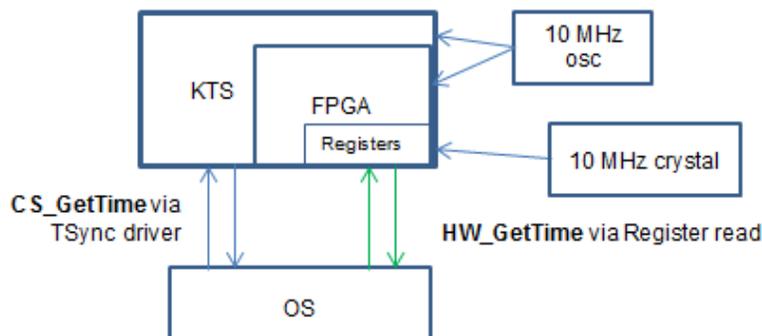
Details

- Passed HW_GetTime (possible oscillator error) (KAD) Or
- Failed HW_GetTime (probably FPGA failure) (KAD)

1. If there are at least five (5) “Failed to read alarm info from KTS (KAD)...” entries in the **System** log, first a “CS_GetTime” call is sent to KTS to see if KTS is still communicating via the TSync driver.
 - If there are less than 5 entries, nothing happens and the counter is reset
 - If there are at least 5 entries, the Tsync driver **will** be unloaded (reboot will be necessary to restore operation)
2. Then a “HW_GetTime” call is sent to the FPGA registers to see if the FPGA is communicating.
 - If this call passes, the registers are still able to respond (if KTS isn’t running, the same data may remain in

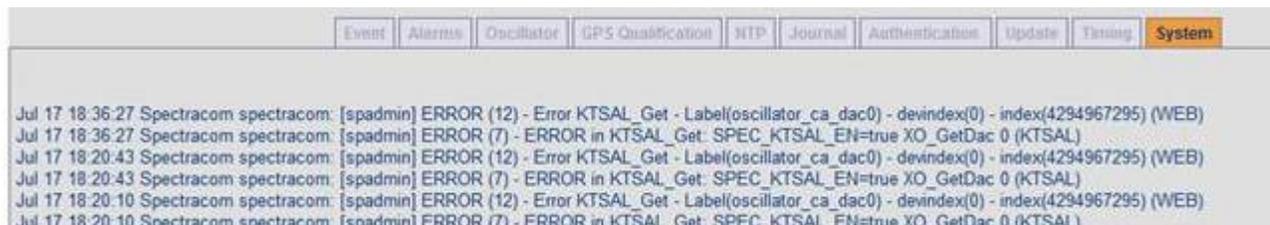
Q. I'm getting an error message in the System Log of a 1200-033 Rb. unit I just updated to 4.8.6. This occurs after I select the STATUS/TIME AND FREQUENCY (It is not happening on an OCXO unit)

A Email from Dave Sohn (6/20/12) There isn't any issue with the unit. This is just a reporting bug. The system is in the background querying the DAC value for some reporting, but that isn't a valid call for a Rubidium unit, so there is an error. There is no effect on operation, and that error doesn't mean there is any problem with the unit. You can enter a Mantis case for it, and we will discuss it in SW CCB.

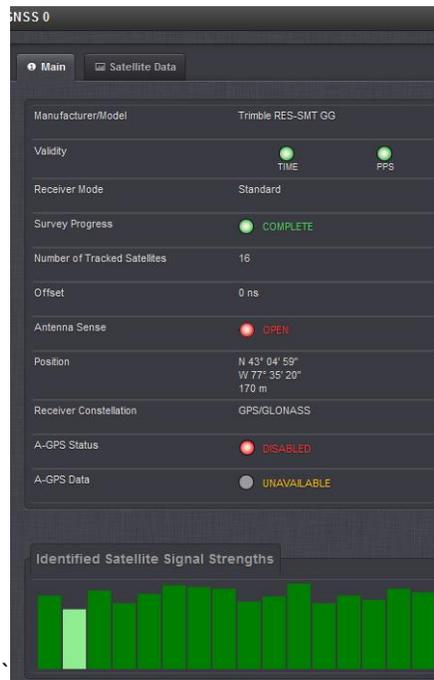
With Model 8230 GNSS antennas already installed, instead of the earlier Model 8225 antenna), in order to enable the Glonass capability, the two SecureSyncs would just need to be returned for a receiver replacement/Glonass enabling (unless they already have the newer GNSS receiver installed –then the option can be enabled in the field). If the top of the **Interfaces** -> **GNSS 0** page of the browser reports the receiver Model is a Resolution T receiver, this is a GPS only receiver and needs to be replaced for Glonass capability. The newer GPS/Glonass receiver is a Model RES-SMT receiver (as shown below):

As a quick summary of the Glonass satellite capability, this particular RES-SMT receiver is tracking satellites, seven of which are Glonass satellites.

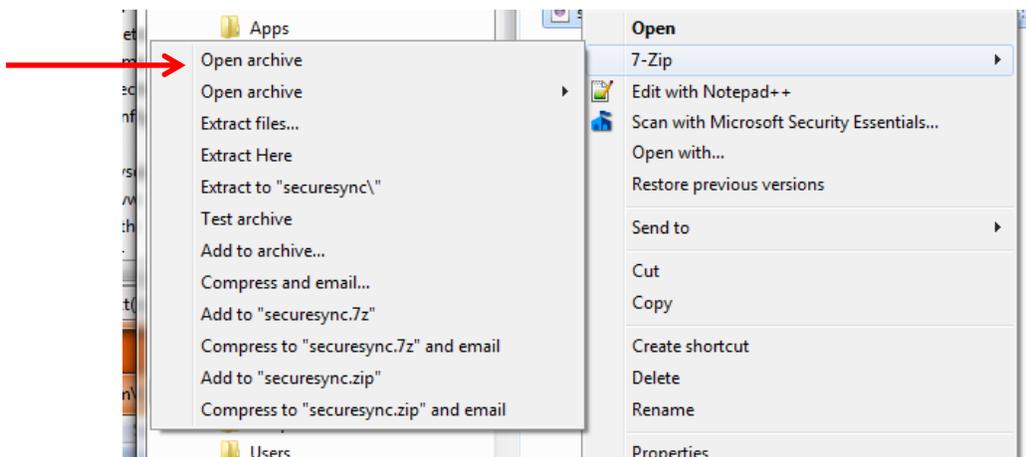
- 1) Save config backup to “temp” directory for instance
- 2) Right click and select a program to extract the file (such as 7-Zip)
- 3) Select “Open Archive”

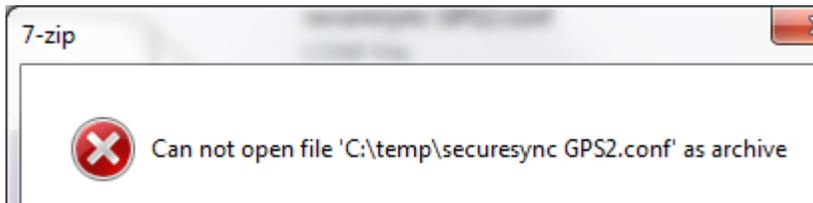
- 4) Below is an example report of a **corrupt file**.

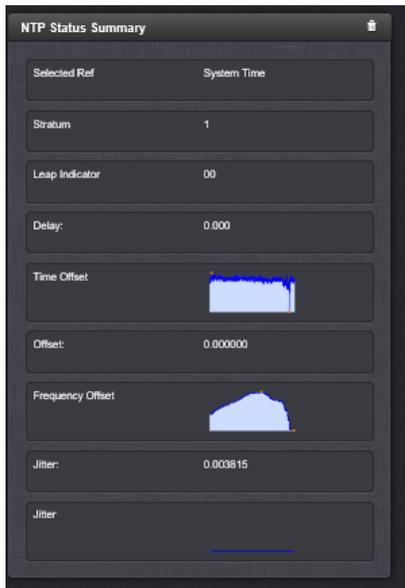
## NTP Status Summary table (in the NTP Setup page)

- bottom-left side of the Management-> NTP Setup page of the browser

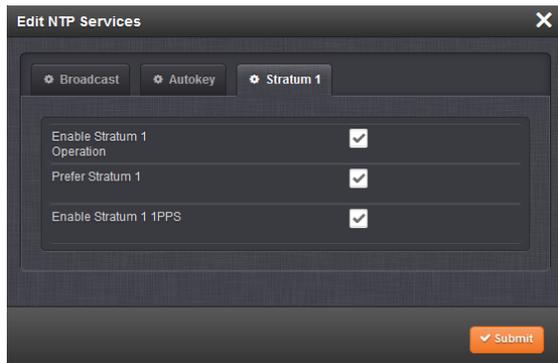
Management -> NTP Setup page of the browser (click the gear icon to the right of “NTP Services” and select the Stratum 1 tab)

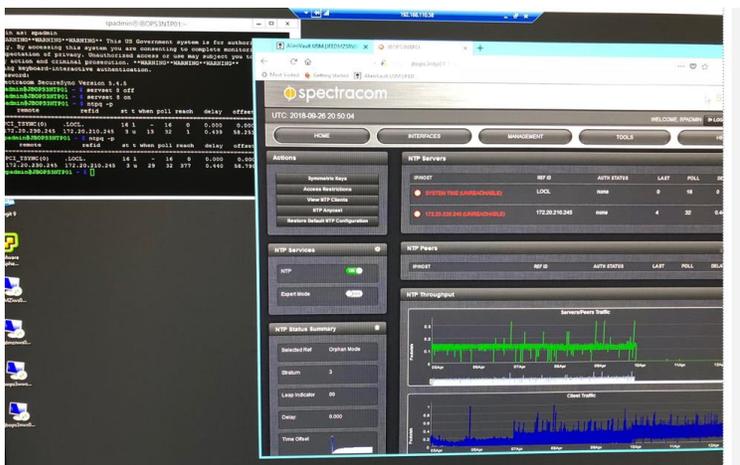
Indications of a time server being in Orphan mode are in the `ntpq -p` (peers command).

- The NTP refid will be **127.0.0.1**
- its NTP Reach value will **remain at "0"**.
