Model 1200 series SecureSync/9400 series

Lafayette (Model 1200 series SecureSync)

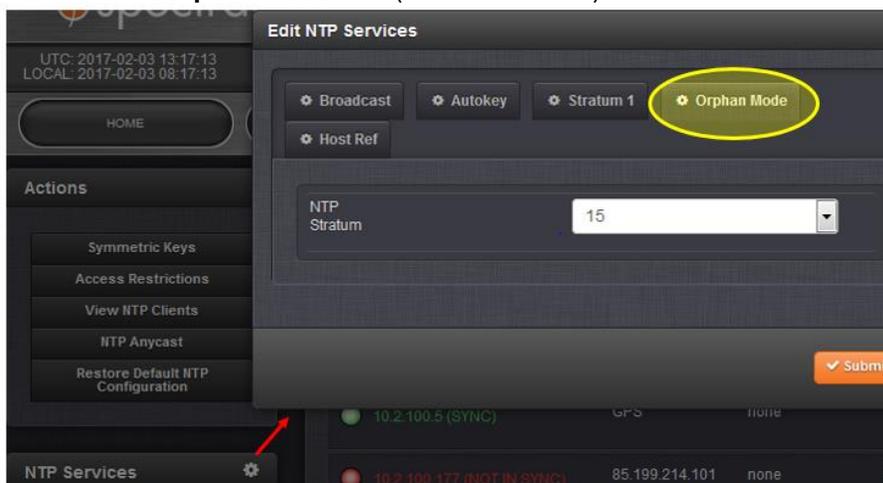
**Management** -> **NTP Setup** page of the newer browser. Press the gear ICON to the right of “NTP Services” and then select the “Orphan Mode” tab (as shown below):

- Refer also to online SecureSync user guide at:  
[http://manuals.spectracom.com/SS/Content/Global/Topics/NTP/NTP\\_Orphan.htm](http://manuals.spectracom.com/SS/Content/Global/Topics/NTP/NTP_Orphan.htm)
- Factory default value is “15” (NTP clients won’t sync to this NTP server when NTP is not synced to a reference)

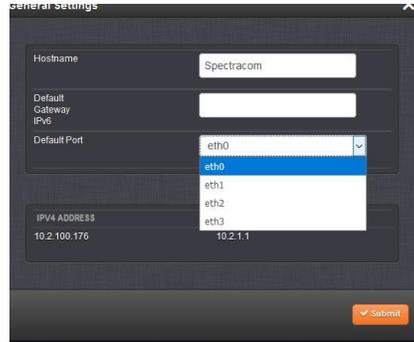
1. (if 1204-06 Gb eth card is installed) verify SecureSync's main default port/default gateway is not configured correctly (**Management -> Network Setup** page, **General Setting** button)

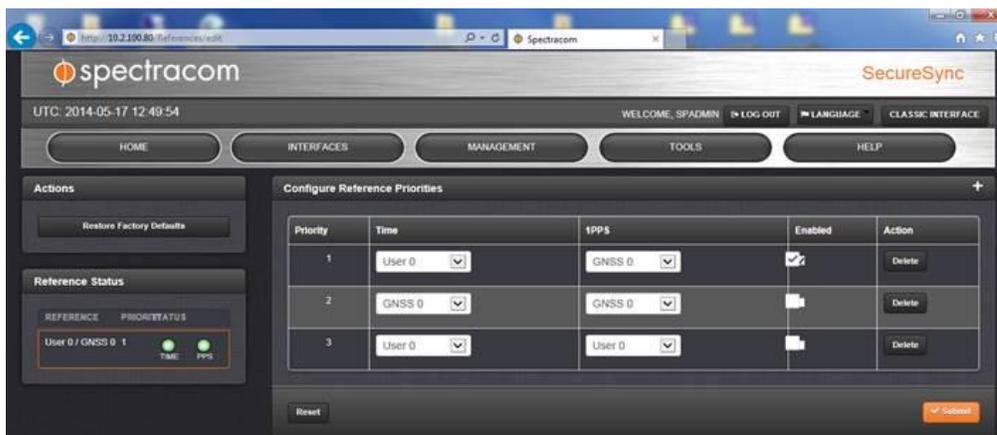
1. Create a Reference Priority Table entry for **User0 / GNSS 0**.

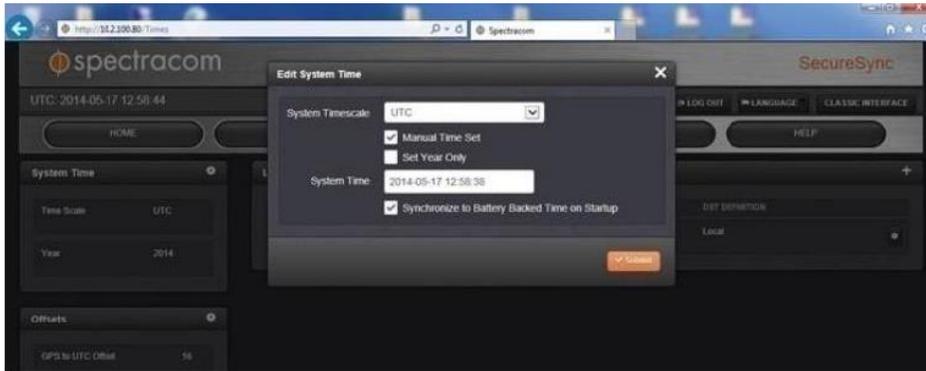
2. Next, go to the **Management -> Time Management** section and select the System Time config. Select the “**Synchronize to Battery Backed Time on Startup**” checkbox. Also select the “**Manual Time Set**” checkbox.
3. Enter your local time in the System Time field. When you hit SUBMIT it will manually set the system time and start running from there. When DST goes into effect you will have to go back to this same page and change the time manually as needed.
4. The SecureSync will start running from this manually set time and keep precisely running using the GPS 1PPS as a reference.

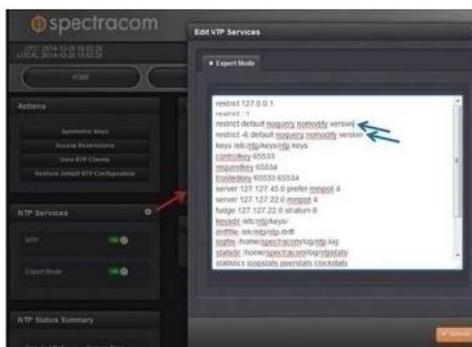
- 1) Go to the Management -> NTP Setup page
- 2) On the left side of the page, change Expert Mode to ON
- 3) Click on the Gear ICON just above the NTP switch and next to the right of “NTP Services”, This will open the “Expert Mode” Window, as shown below:

- 4) With the window open, add the word “version” to the end of the third and fourth lines in this window (after the

word “nomodify”, as shown above). This will restrict NTP responses to only version 4 clients, via either IPv4 or IPv6 addresses!

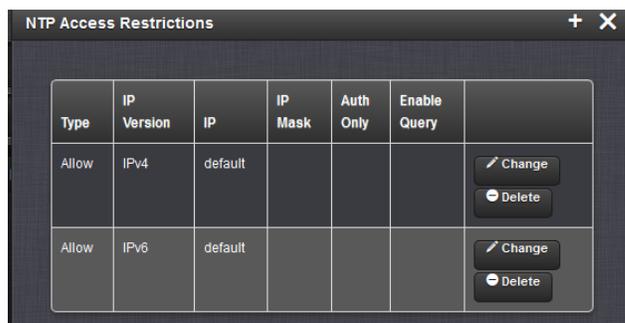
##### Factory default settings

- NTP Access Restriction and Mode 7 (NTPQ and NTPDC) are both configured in the **Management -> NTP Setup** page of the browser. Click on the Access Restrictions button on the left side of the page.

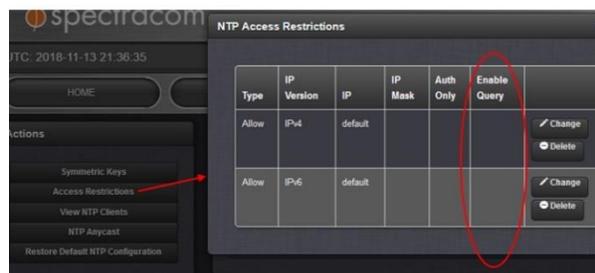
And, press the "**Access Restrictions**" button on left side of the **Management -> NTP Setup** page of the browser. This will open a pop-up window. as shown below, Mode 6 queries are still disabled if the "**Enable Query**" boxes (for IPv4 and IPv6) are both empty:

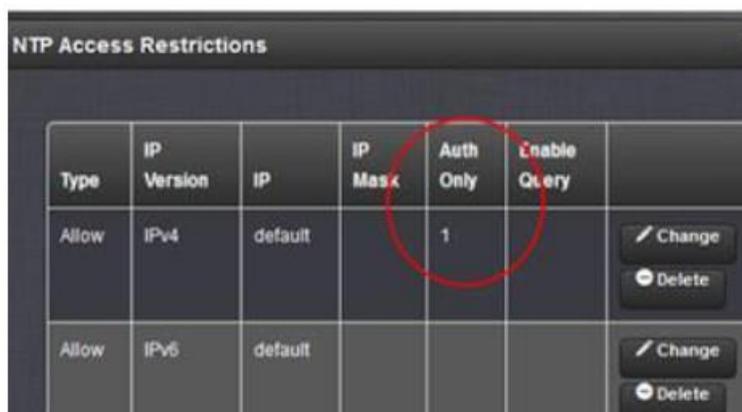
To determine if a SecureSync requires successful symmetric key authentication, on the left side of the **Management** -> NTP Setup page of the browser, click the “**Access Restrictions**” button. In the pop-up window, see if there is a “1” in the first row (for “IP4”), for the “Auth **Only**” column (as shown below):

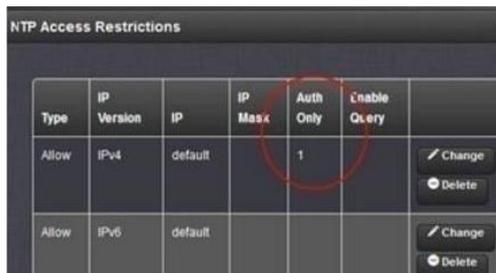
To determine if a SecureSync requires successful symmetric key authentication, on the left side of the **Management** -> NTP Setup page of the browser, click the **“Access Restrictions”** button. In the pop-up window, see if there is a **“1”** in the first row (for “IP4”), for the **“Auth Only”** column (as shown below)

If this field is blank, this SecureSync doesn’t require successful authentication in order to exchange NTP packets with other NTP clients/other SecureSyncs. But if there is a **“1”** in the field (as shown above) symmetric key is being enforced and so it will only exchange NTP packets with other devices which are configured with an identical keystring.

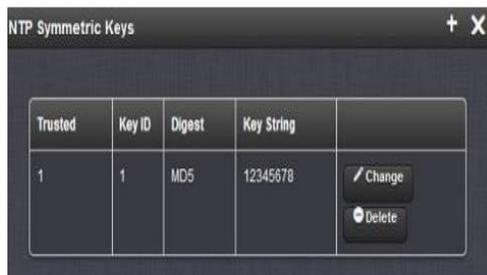
Next, to see what trusted symmetric keys, if any, have been added to every SecureSync desired to be peered together (and every NTP client you wish to sync to the SecureSync), click the **“Symmetric Key”** button, also on the left side of the **Management** -> **NTP setup** page. The pop-up table will be empty if there are no keys configured. Or it will list a key ID, digest and a keystring, for each configured key

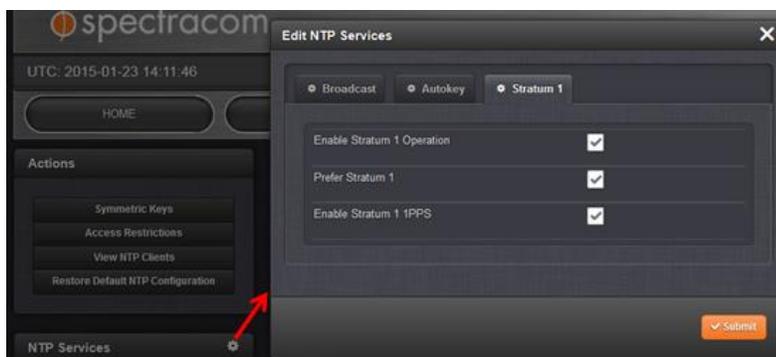
Once NTP has synced to GPS inside the SecureSync (and assuming the “**Enable Stratum 1 PPS**” checkbox is Enabled in the **Management -> NTP Setup** page of the browser, **Stratum 1** tab, after pressing the “gear” icon to the right of “NTP Services” as shown below), we enable another NTP input reference that uses the 1PPS generated by the GPS signal. This “PPS” reference helps stabilize/optimize the NTP functionality, if NTP decides to select it as its input. This input is known as NTP’s PPS clock driver and can be selected by NTP shortly after NTP syncs to GPS. If NTP selects it as its reference, NTP changes the Ref ID to “.PPS” to indicate this PPS clock driver had been enabled.

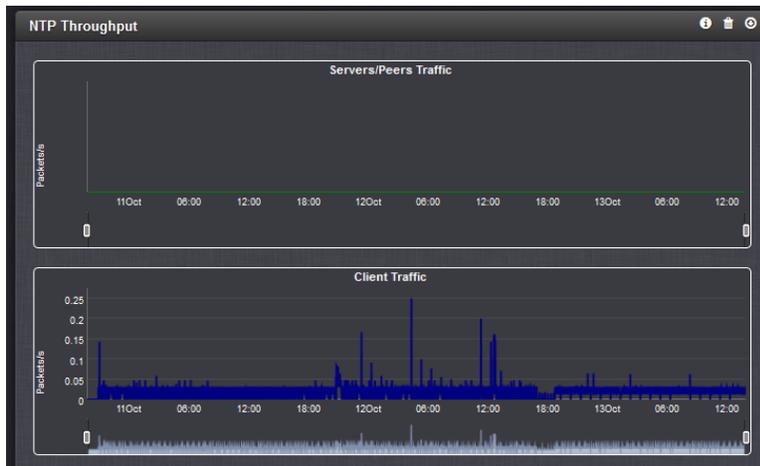
Versions 5.3.1 and higher (version 5.3.1 added NTP throughput graphs)

- In addition to the existing NTP Status graphs (discussed below), software version 5.3.1 added NTP throughput graphs/NTP Traffic graphs (The “Servers/Peers Traffic” and “Client traffic” graphs) to the Management -> NTP Setup page of the browser.
- Reports packets being exchanged each second.

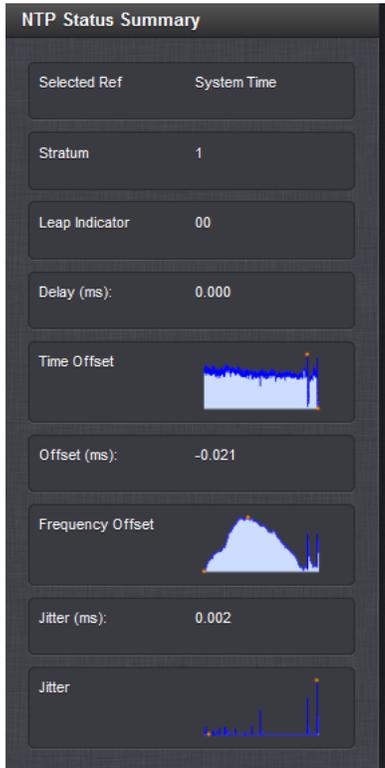
Clicking on the Time Offset, Frequency Offset or Jitter graphs opens an expanded view of that graph.

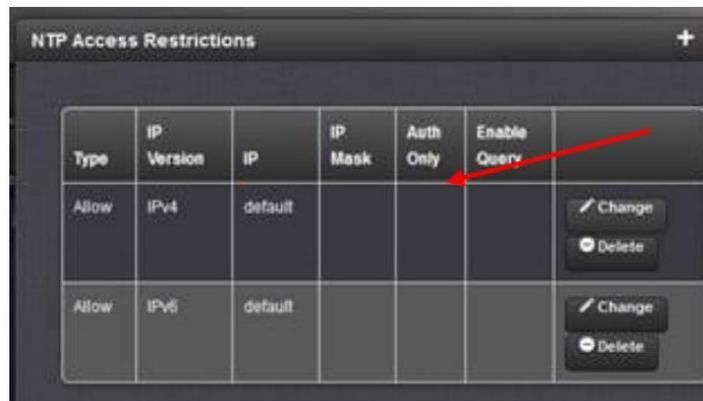
Figure 4: Location of the “Change” button

- 1) Navigate to the **Management -> NTP Setup** page of the web browser.
- 2) Click on the “**Access Restrictions**” button (on the left side of the page).
- 3) In the pop-up window, click on the “**Change**” button at the end of the “IPv4 row” (or the “IPv6 row as applicable to the network”).

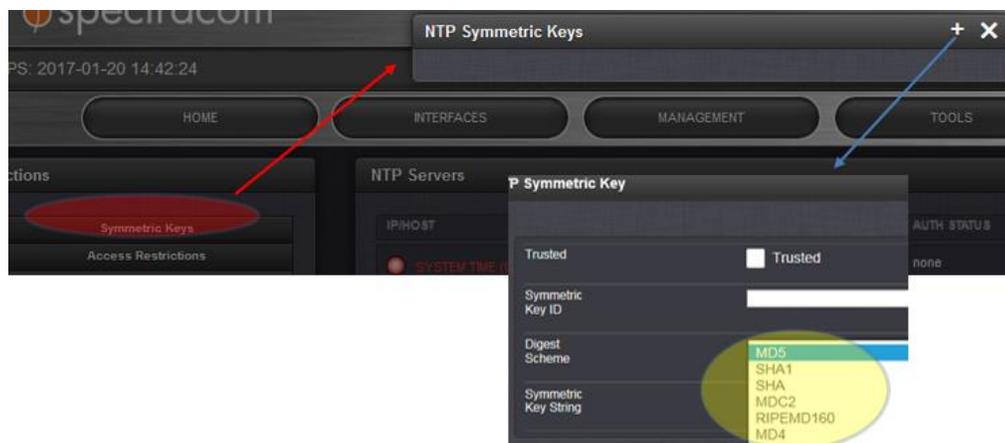
- This configuration is not available in the classic interface browser (have to use the newer black/charcoal browser)
- Selected in the *Management* -> *NTP setup* page of the newer browser:
  - Click on the “**Symmetric Keys**” button on the left side of the page. Then press the “+” sign in the upper-right corner of the pop-up window that opens:

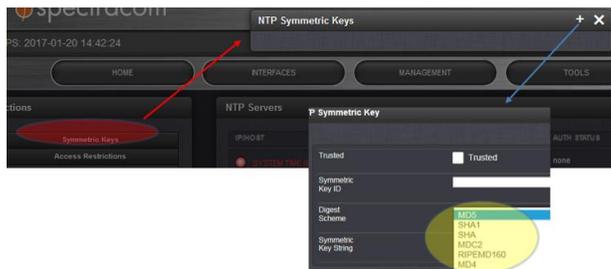
**Email Keith sent (20 Jan 17)** The Spectracom SecureSync provides the ability to either select either MD5 or a different Message Digest schemes for NTP authentication. The below screenshot shows the available schemes

(in addition to MD5) that can be configured in the **Management** -> **NTP Setup** page of the SecureSync's web browser (click on the **"Symmetric Keys"** button on the left side of the page. Then press the "+" sign in the upper-right corner of the pop-up window that opens):

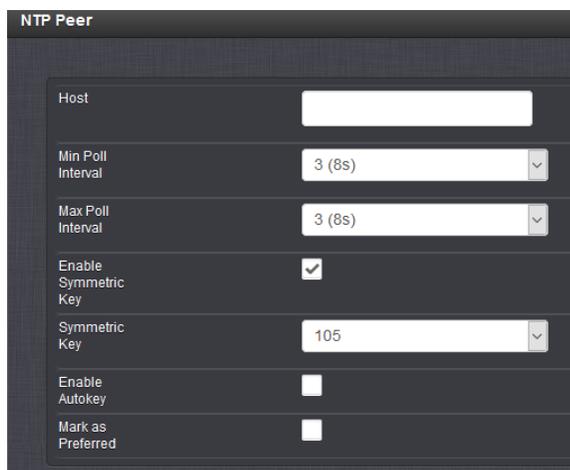
**Screenshot from 5.5.1 showing that at least v5.5.1 and above have this capability**

- At one time, SecureSync's NTP Servers table in the NTP Setup page allowed symmetric key to be configured, but the Peers table did not have this capability.
- Sometime prior to v5.5.1, symmetric key configuration had been added to the Peers table. I'm not certain, but after searching release notes, I believe this may have been added in version 5.4.5. The best inference I found to this change was in the 5.4.5 Release Notes: ["Corrected update/add/delete NTP Peer/Server line error"](#)

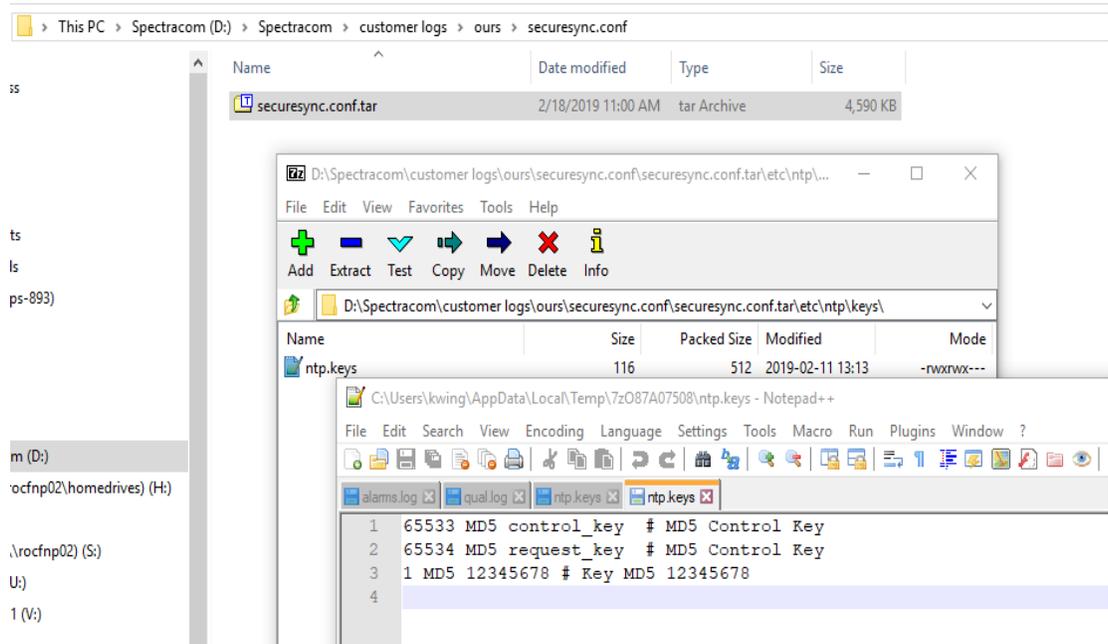
- Refer to Salesforce Cases such as **185548**
- (as of at least version 5.8.3) the ntp.keys file (Symmetric keys) **is** included in the exported config backup bundle (confirmed in v5.8.3 by Keith.on 18 Feb 2019, as shown below).
  - This means the **ntp.keys** file can be backed-up/viewed/cloned via the config bundle

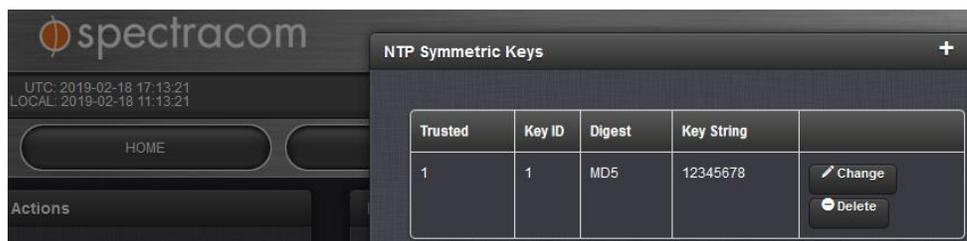
Secondly, the “**/etc/ntp.keys**” file cannot be viewed via SecureSync’s CLI interface. Within the SecureSync itself, the contents of the ntp.keys file can only be indirectly viewed, via the **Management -> NTP Setup** page of the web browser (then press the “Symmetric Keys” button on the left). The pop-up window of the “**NTP Symmetric Keys**” table will display the contents of the ntp.keys file (as shown below):

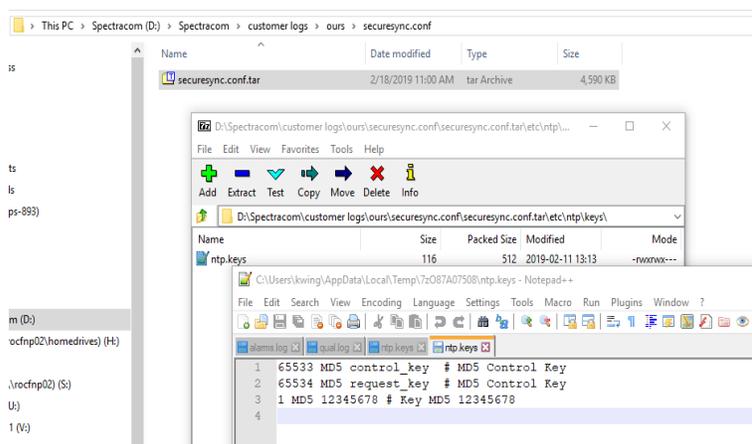
Once exported (via the browser or CLI connection) the config bundle file is a “double-compressed” tar file. The exported file needs to be uncompressed (and the uncompressed file needs to be renamed as .tar and uncompressed again) before the files will be readable.

Once finally fully uncompressed, the raw ntp.keys file for the particular SecureSync, which the config file was exported, from will be viewable (as shown below):

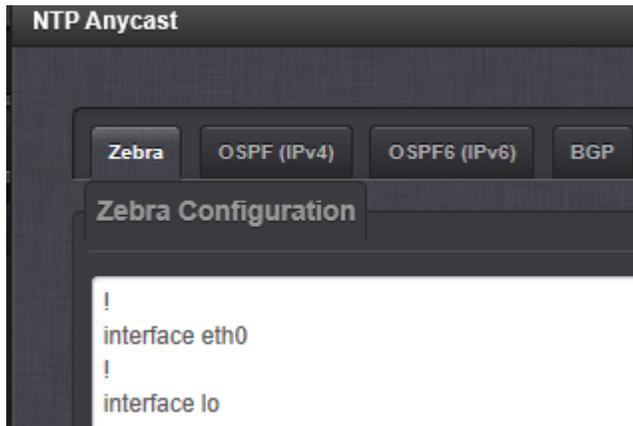
1. Navigate to the [Management](#) -> [NTP Setup](#) page of the browser
2. **Enable** NTP “**Expert Mode**” via Slider switch on left-side (if not already enabled)
3. Click the “**NTP Anycast**” button (top-left corner of the [NTP Setup](#) page, above the Expert mode switch)
4. With Expert Mode enabled, the NTP Anycast pop-up will now allow direct access to all four Anycast config files (via each of the four tabs at the top of the menu) as shown below:

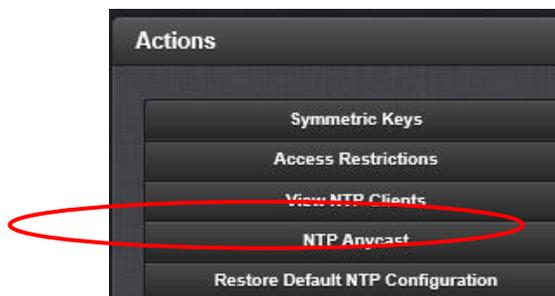
1. Confirm that your existing network infrastructure is **Anycast capable**. Determine network specifics, such as the Anycast address and port.
2. In the SecureSync Web UI, navigate to MANAGEMENT-> NTP Setup page
3. In the "Actions" Panel (left side of the screen), click "NTP Anycast".

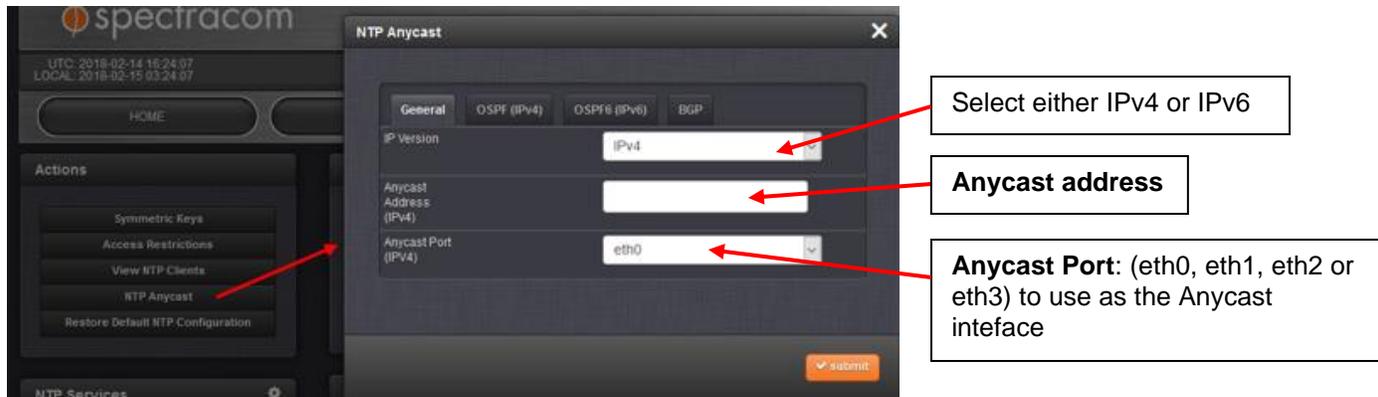
4. In the NTP **Anycast** window, select the **General** tab.

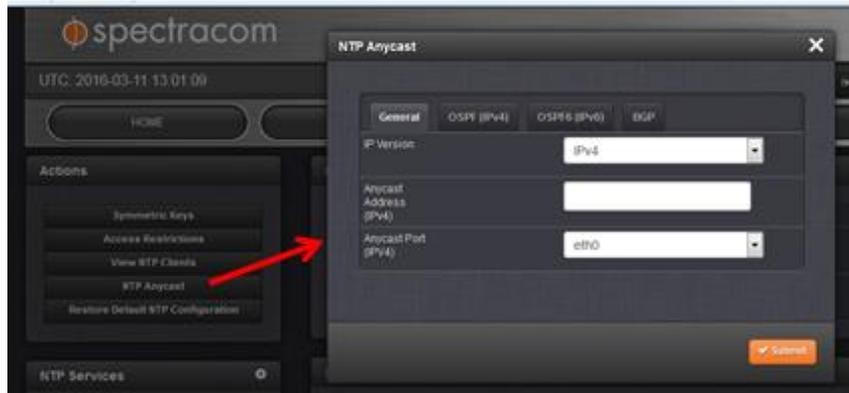
1. **Management** -> **NTP Setup** page of the browser and click on **NTP Anycast** (button on the left side of the page)

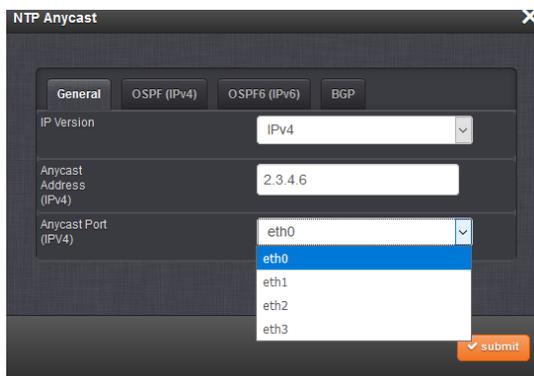
2. Select the **General** tab to configure the NTP Anycast port and Anycast address

**Anycast address:** common static address (not a unique “pre-set” value)

**OSPF port:** Which one of our Ethernet interfaces communicates with the OSPF switch.

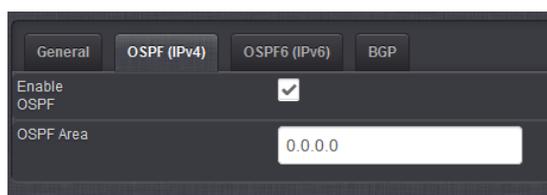
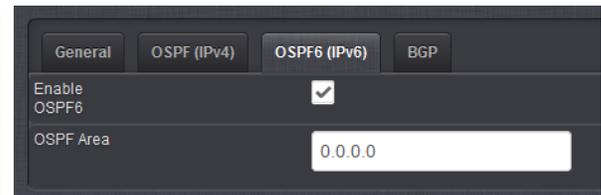
3. Select either the “**OSPF (IPv4)**” or (**OSPF (IPv6)**” tab (as applicable) to enable NTP over Anycast and to configure the OSPF area

**Enable:** Enables Anycast mode

**OSPF area:** (AKA the “backbone area, area 0 or area 0.0.0.0). It’s the IP address of a main router in an area

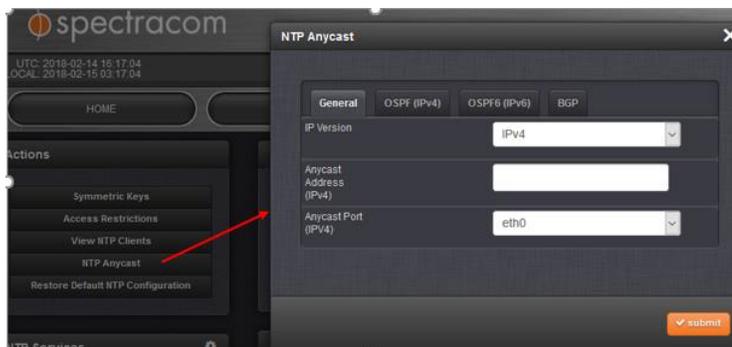
1. **Management -> NTP Setup** page of the browser and click on **NTP Anycast** (button on the left side of the page)

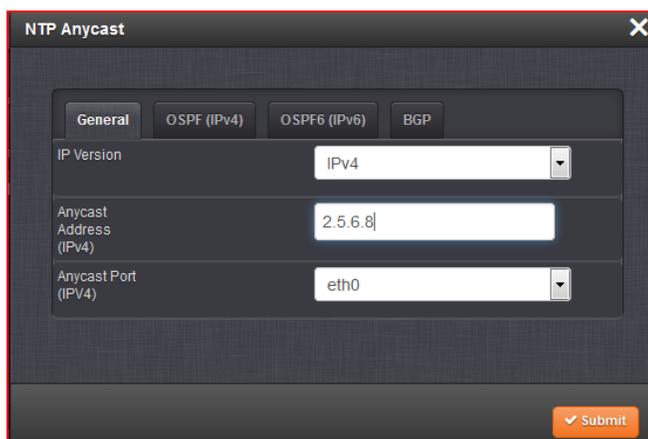
2. Select the **General** tab to configure the **NTP Anycast interface** and **Anycast address**

**Anycast address:** common static address (not a unique “pre-set” value)

**OSPF port:** Which one of our Ethernet interfaces communicates with the OSPF switch.

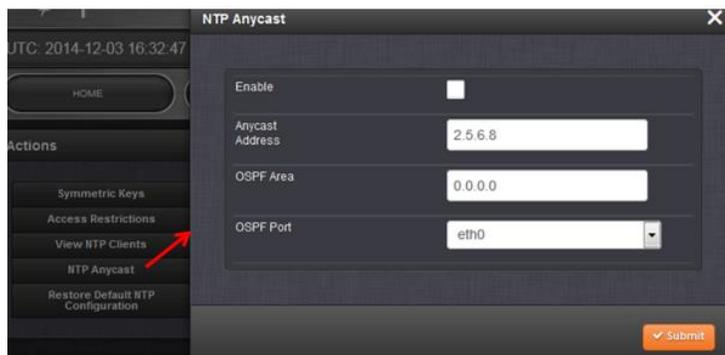
1. **Management** -> **NTP Setup** page of the browser and click on **NTP Anycast** (button on the left side of the page)

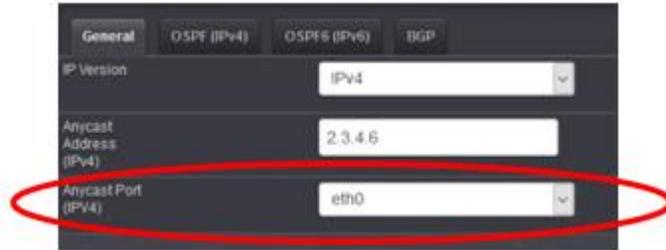
1. Verify the single configured/dedicated **Anycast address port** is connected to the network with the NTP slaves (anycast works only on the specific configured interface (and no others). As configured in the **Management -> NTP Setup** page, **NTP Anycast** button (left side of page). Then select the **General** tab

- A) Verify that this interface is on the network with the NTP clients (this is the only interface which will work with the NTP Anycast address)
  - B) Make sure this selected network interface port is reachable on the network (via its assigned "physical" IP address/hostname)
  - C) Verify NTP slaves can successfully sync when configured with the IP address of this physical interface (instead of configured with the Anycast address). This verifies factors such as DNS, SecureSync being in sync, port 123 blocked of firewall, etc,
2. Verify either OSPF or BGP is truly Enabled and running (via the **Enable** checkbox being selected in the **Management -> NTP Setup** page, **NTP Anycast** button (left side of page). Then select either the associated **BGP**, **OSPF4** or **OSPF6** tab

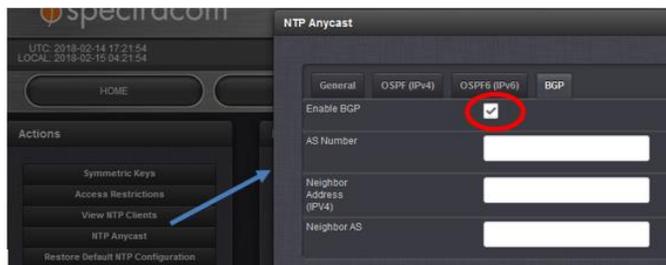
### BGP

3. (**BGP only**- not applicable to OSPF) in the **BGP** tab
  - A. Verify the values in the **AS Number** value and **Neighbor AS** fields is not the set to the same value. They must be two different unique numbers. Below is an example Journal entry showing both AS fields set to same value (65001)

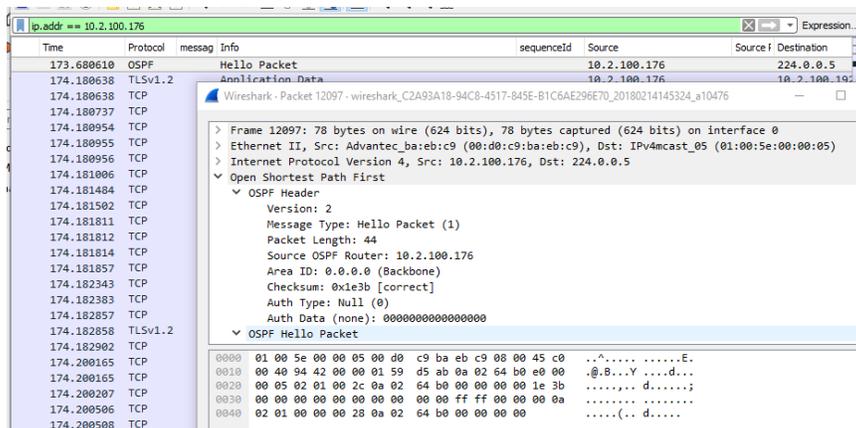
### OSPF Enabled

- look at the the **Routing table** of the SecureSync's immediate **switch connected to the Anycast port** to see if the defined Anycast address is listed in this routing table. If NTP anycast is configured and RUNNING, it should be in this routing table. Its not added or is removed from the routing table if either BGP or OSPF is not Enabled or if there is a configuration issue with Anycast mode.
- Verify the OSPF or BGP ports are open on the switch (**OSPF is on port 89** and BGP traffic is on **TCP port 179**)
- Use **tcpdump** or get a **packet capture** to look for 'hello' messages (OSPF) being sent from the SecureSync to the switch every 10 seconds (see note above about network port numbers)

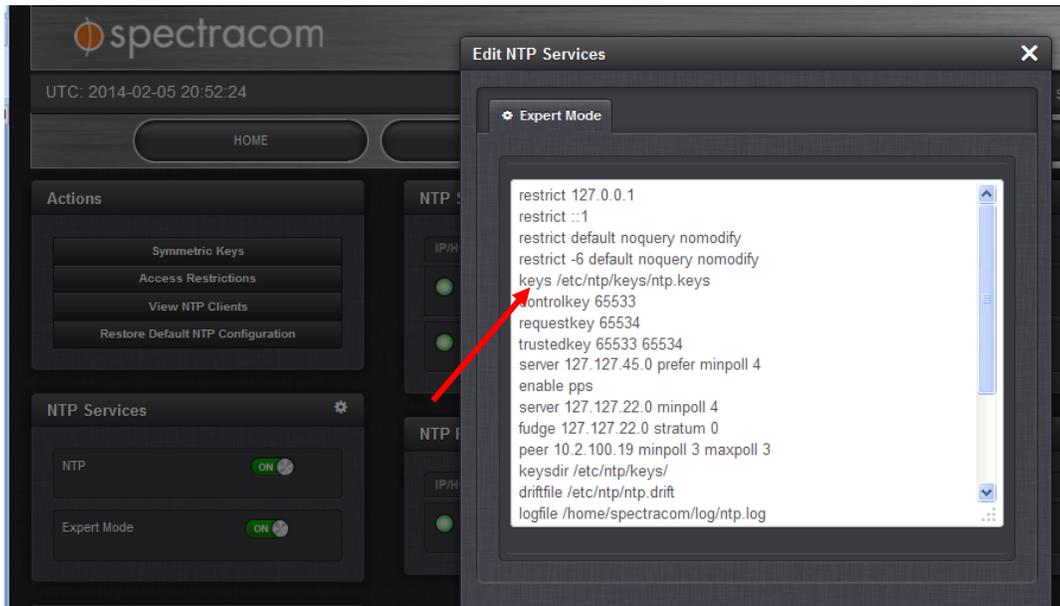
### A) New browser (Versions 5.1.2 and above)

1. Go to the **Management** -> **NTP Setup** page of the browser
2. Enable NTP Expert Mode
3. Click on the gear next to "NTP Services" to open/edit the ntp.conf file
4. Leave Expert Mode enabled to retain settings
5. Disable Expert Mode to reset ntp.conf back to factory default settings

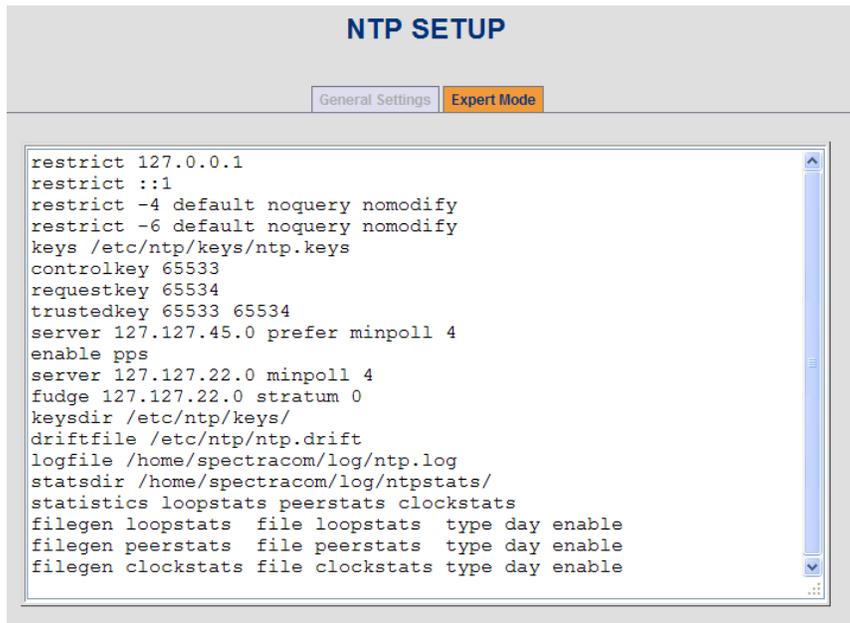
## B) Classic interface (Versions 5.0.2 and below)

1. Go to the **Network -> NTP Setup** page of the browser
2. Enable Expert Mode in the General Settings tab
3. Click on the Expert Mode tab to open/edit the ntp.conf file
4. Leave Expert Mode enabled to retain settings
5. Disable Expert Mode to reset the ntp.conf file back to factory default settings

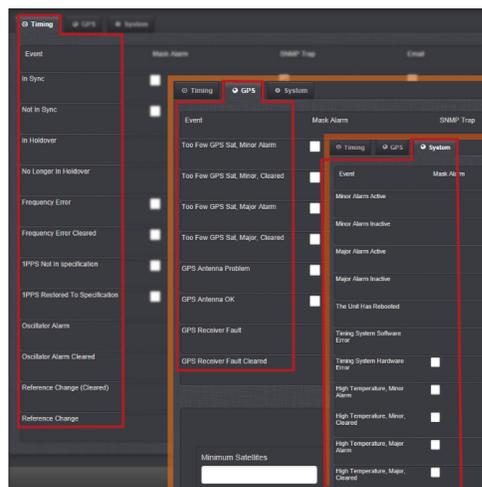
Note that with SNMP and/or Email alerts configured, the SecureSync can SNMP traps/email alert for many different conditions. All of these conditions (such as going into Holdover mode, loss of sync, etc), are shown in the **Management -> Notifications** page of the browser (via each of the three tabs at the top containing associated alerts. For your reference, Screenshots below are of the three tabs (note that each event can be individually configured to send an SNMP trap and, or an email alert but for simplicity, these screenshots are just omitting the email checkbox/email address field for each event).

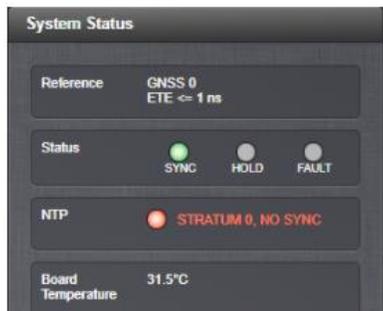
- Refer to Salesforce cases such as 271831
- Refer to JIRA SSS-1114
- When any config changes are made to Notifications, statusd (status monitor daemon) will be restarted.
- statusd is what also monitors NTP Stratum and Sync state.
- While statusd is restarting, **NTP will inherently be reported as being Stratum 0, Not in sync**

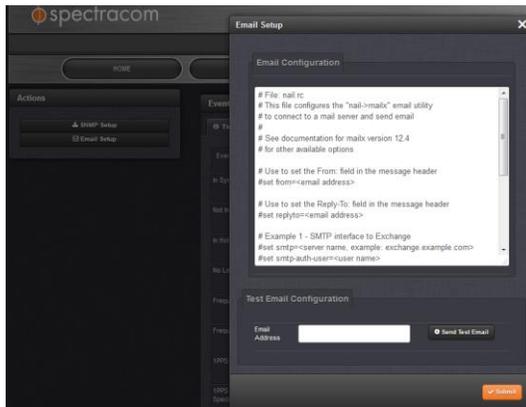
*Management* -> *Notifications* page of browser

- Press the "Email Setup" on the left side of the page.

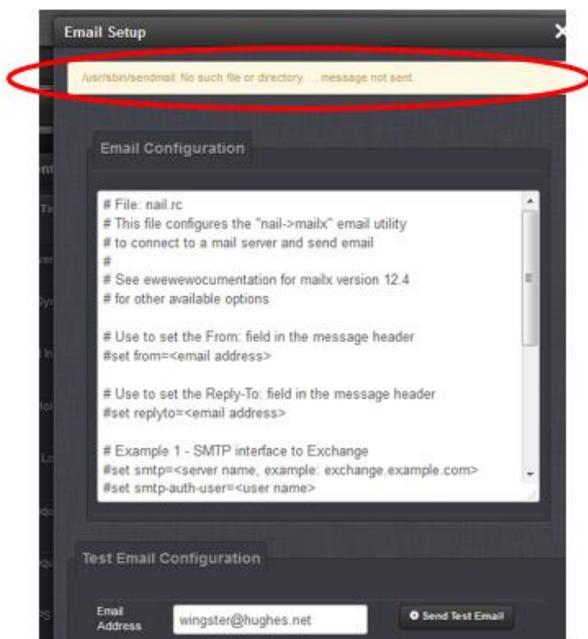
**Error message “ /usr/sbin/sendmail: No such file or directory...message not sent.” is displayed when pressing the “Send Test Email” button, while editing the configs (and before pressing Submit:**

- If the “Send Test Email” button is pressed while making any changes to the email configs, and before the Submit button is pressed to save the changes just made, this error will be displayed when pressing the Test button before hitting the Submit button
- To prevent this condition, press the “Submit” button after making any changes to the configs, and before pressing the “Send Test Email” button.

This is actually a very minor condition which occurs if you make any changes to the email configuration, **and then press the “Send Test Email” button, before pressing the “Submit” button in the same window.** The “Send Test Email” button doesn’t save the changes that are “in process”. So the Submit button needs to be pressed first, before trying to send a test email. The Submit button will close the window and the “Send Test Email” button can be pressed after re-opening the same window.

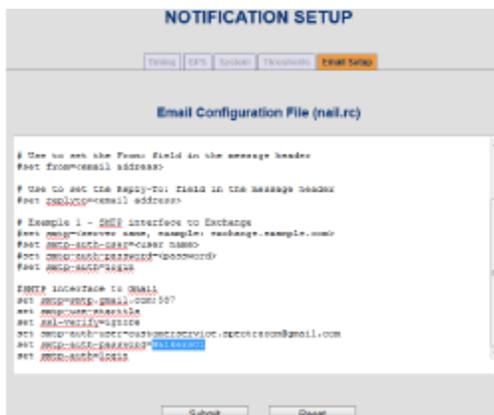
## 2. Example Gmail SMTP setup that worked using the classis interface (performed by Sam Otto)

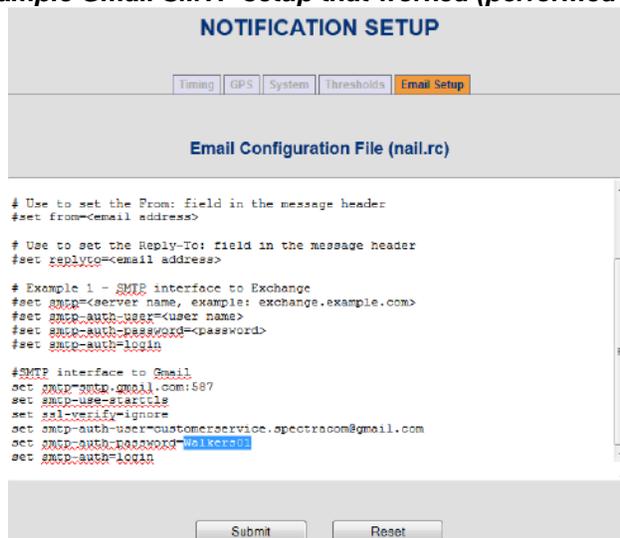
#### Example Gmail SMTP setup that worked (performed by Sam Otto)

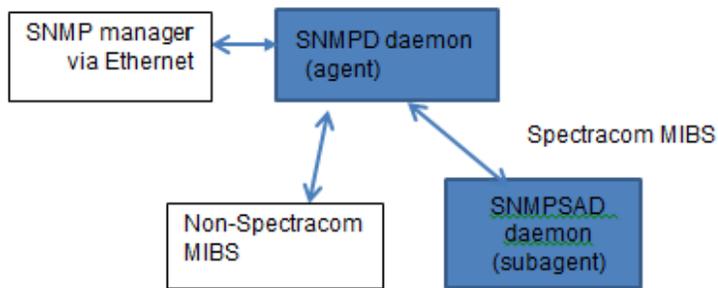
## SNMP Basic block diagram

- There are three daemons that run for SNMP:
  - **SNMPD**: the agent running in the Linux OS
  - **SNMPSAD**: the subagent running in Spectracom application
  - **SNMPSAL**: our daemon that restarts SNMPSAD if it crashes

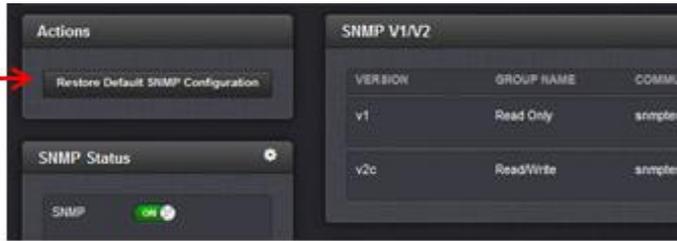
"Restore Default SNMP Configuration" button (newer web browser only)

**Note:** this function is not available in classic interface web browser

- The newer black/charcoal browser now has a “Restore Default SNMP Configuration” button in the Management -> SNMP Setup page which resets just the SNMP configs (alleviating the need to perform a full clean of all configs). Not sure what rev (either version 5.1.7 or before) this button was added to the newer browser.
- Brian Carlson with Harris was seeing weird issues with the configuration of the Notifications page and traps not being sent when they should. Using this button and reconfiguring SNMP fixed these peculiar issues.

In the upper-left corner of the **Management** -> **SNMP Setup** page of the newer (black/charcoal) web browser, there is a **“Restore Default SNMP Configuration”** button (as shown below). Unlike a **“clean”** which resets all of the configurations in the SecureSync, this particular button just resets the configs associated with SNMP. The engineer I'm working with recommended resetting and reconfiguring just the SNMP settings. Can you try this on at least one of the SecureSyncs and then try performing the **SNMPGet** command again? This button won't affect any of the other settings or operations besides SNMP.

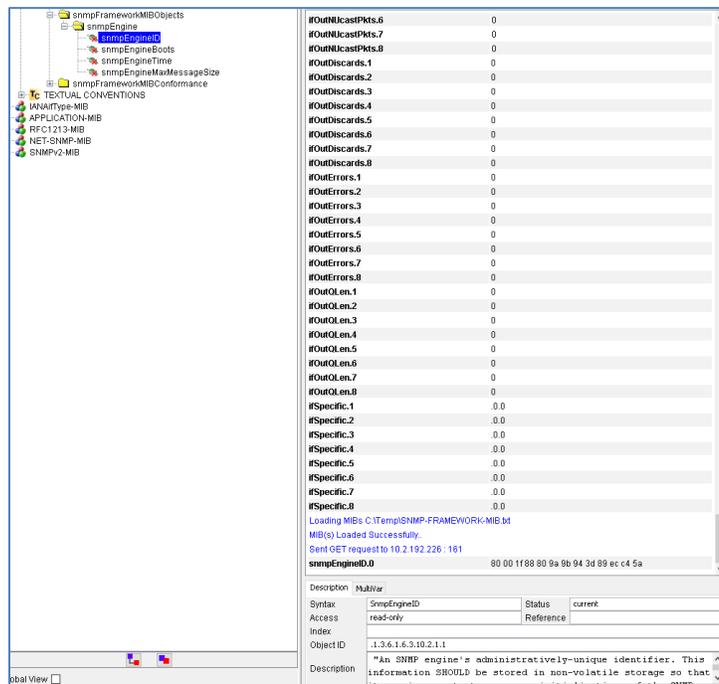
## C) Obtaining SecureSync's EngineID via an SNMP Manager program

(need to first download and install the **SNMP-Framework-MIB** file from the Internet: <http://www.net-snmp.org/docs/mibs/snmpFrameworkMIB.html>)

- 1) Take the returned value,
  - 2) Add "0x" to the front of this value and remove all the spaces between each two character value
  - 3) Place this full value (with no spaces) in the SecureSync's SNMPv3 EngineID field
- SNMPv3 traps will only be sent from the SecureSync if an EngineID (beginning with "0x") field has been populated when configuring v3 traps in the SecureSync. Without a valid engineID (which is then pasted into the V3 trap section of the SecureSync) no v3 traps are sent.
  - in at least v5.7.1 and below, the SecureSync enforces Auth, Priv in SNMPv3 (can't configure no auth,no priv).
  - The Manager sends a message to the SecureSync when it's being setup for SNMPv3 users in order to generate the contextID/engineID.

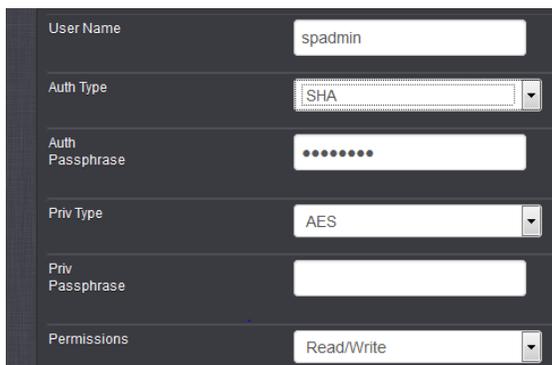
**Users for SNMP gets**

**A Keith’s response:** Correct. SecureSync is authpriv only. You can set Permissions in the snmpV3 section of the **Management -> SNMP Setup** page of the browser, to read or read/write (as shown in the screenshot below). If the user wants to setup the ‘Trap only’ user, it does not have to be reflected on the SecureSync and will need to be setup on the receiving end (SNMP Manager). The SNMP traps section of the Management -> SNMP Setup page of the web browser can configure those users. They essentially will have noauth and nopriv on SecureSync, since they are used to login to the snmptrapd remote service on the receiving end.

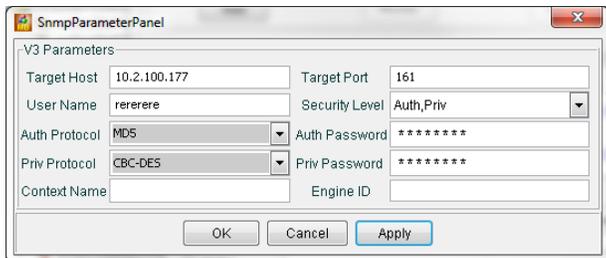
5. Enter the IP address of the SecureSync, the SNMPv3 username and change Security level to Auth,Priv. Change the Auth and Priv protocols as necessary and enter the Auth and Priv passwords to match the settings in the

SecureSync. Then press Apply (note the context name and engine id will still be blank at this point).

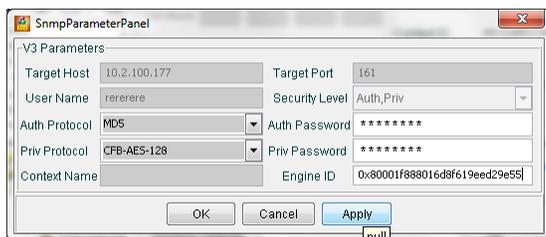
- Copy/paste this entire context value into the "engineID" field of the sub-menu (press the "modify" button at the bottom to re-open it).

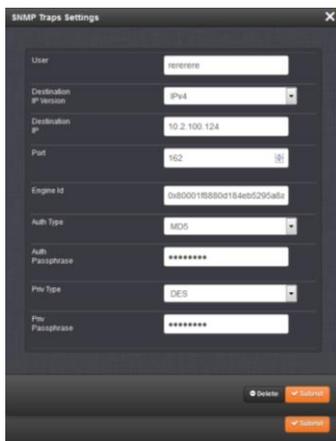
- Create a SNMPv3 trap in the SecureSync, using the same values that are used in the SNMP user. Also paste the context ID in the manageengine GUI into the "Engine ID" field of the SNMPv3 trap pop-up menu and submit.

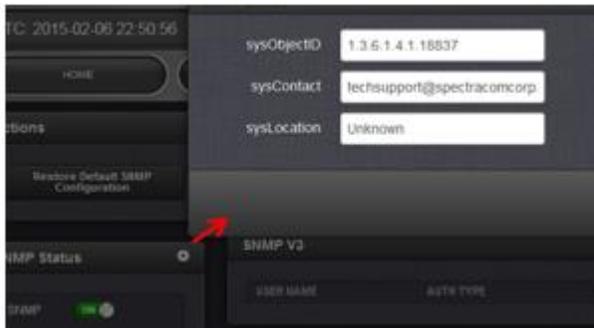
1. Click on **Gear** icon next to "SNMP Status"

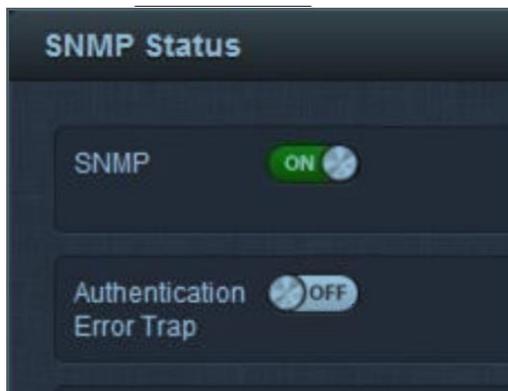
The Authentication Error trap is enabled in a separate location than the others (and it’s disabled by default). It’s on the left-side of the [Management](#) -> [SNMP](#) Setup of the browser (just below the SNMP On/Off switch as shown below:

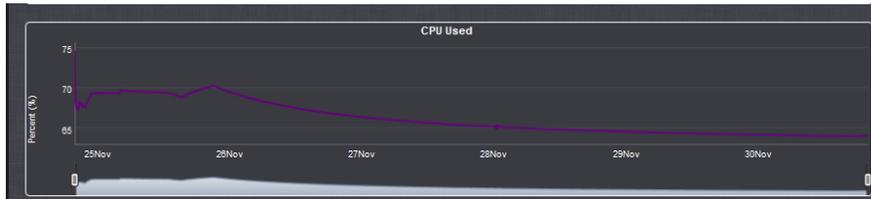
### CPU usage graph and raw data (software versions 5.3.1 and above)

- CPU usage graph was added in **version 5.3.1**
- Located at the bottom of the **Tools ->System Monitor** page of the newer browser (not available in classic interface).
- Graph data is captured/obtained/logged about once a minute, SO a high burst of short duration CPU activity might NOT be registered on the Log graphs/data for the database, but still occur.

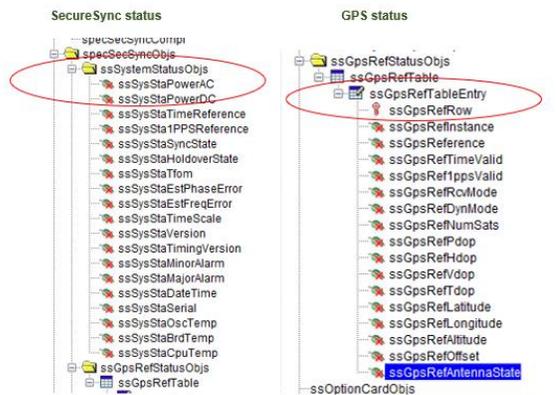
- **snmpget** command is for SNMP OIDs *stored in a folder*
- **snmpwalk** (or **snmpgetnext**) commands is used for for SNMP OIDs *stored in an SNMP table (such as GPS receiver objects)*

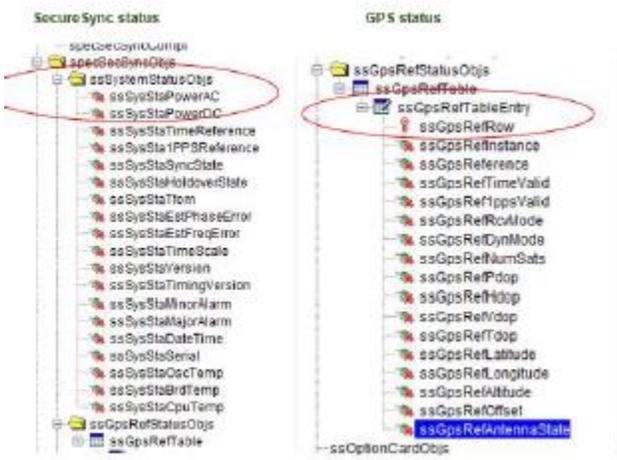
Below are two excerpts from an SNMP Manager GUI interface. The objects on the left (general SecureSync status messages, such as TFOM for instance) are listed under a folder. The objects on the right (for GPS/GNSS status) are listed in an SNMP table.

In summary, your customer should replace the word **snmpget** in the commands to obtain GPS receiver status, with either **snmpgetnext** or **snmpwalk** to obtain the antenna sense, because this GPS value is stored in an SNMP table.

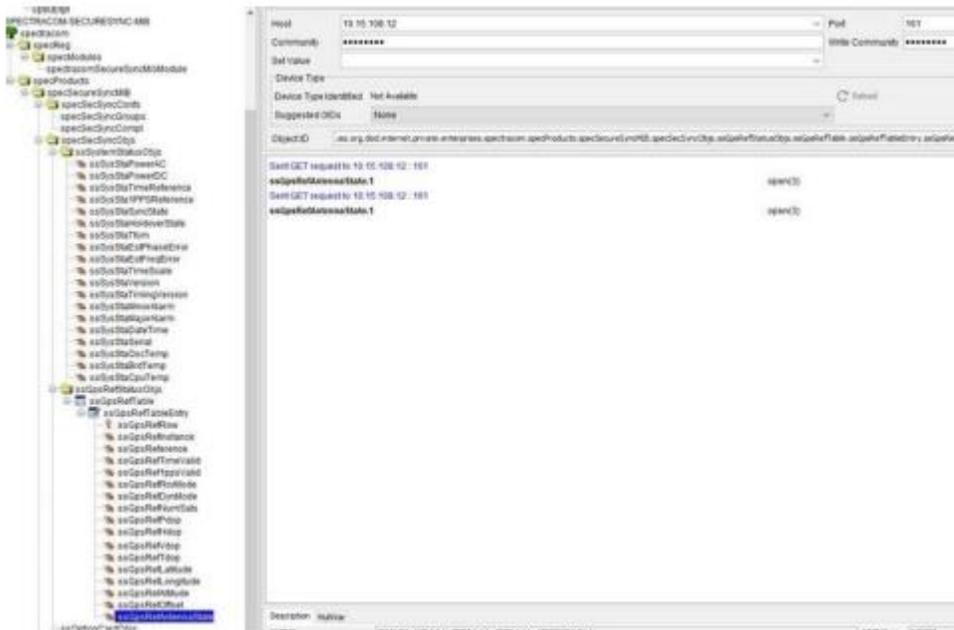
When polling objects stored in an SNMP table (instead of a folder), the SNMP manager knows how to use an “snmpget” command to poll an object from the table. This results in a successful return of the value (as shown below, and like you are successfully observing at your facility):

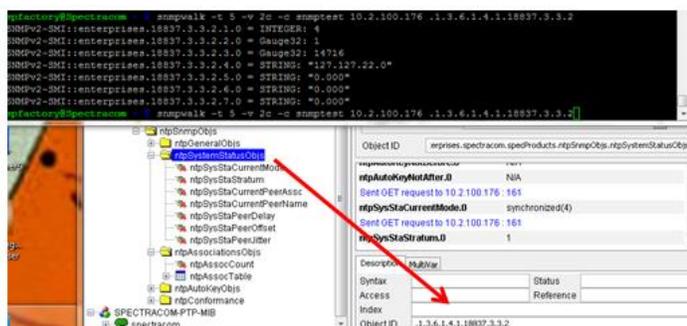
**Note:** the numbers at the end of the snmpget (after the IP address) is the full OID number for the MIB file (see screenshot below for an example)

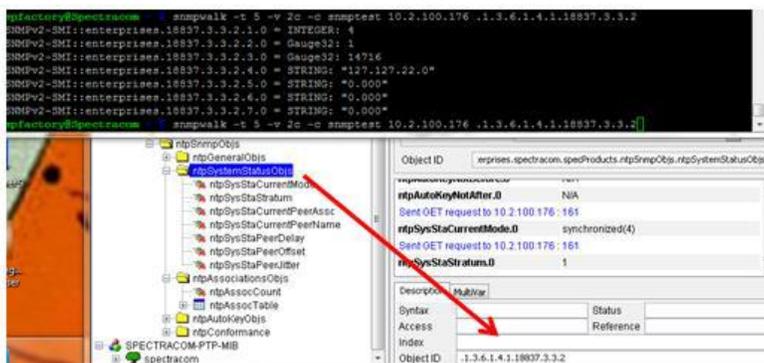
➤ **Note:** GPS/GNSS objects are stored in an SNMP table (instead of a folder). Instead of using snmpget commands, use either snmpwalk or snmpgetnext commands to obtain GNSS info

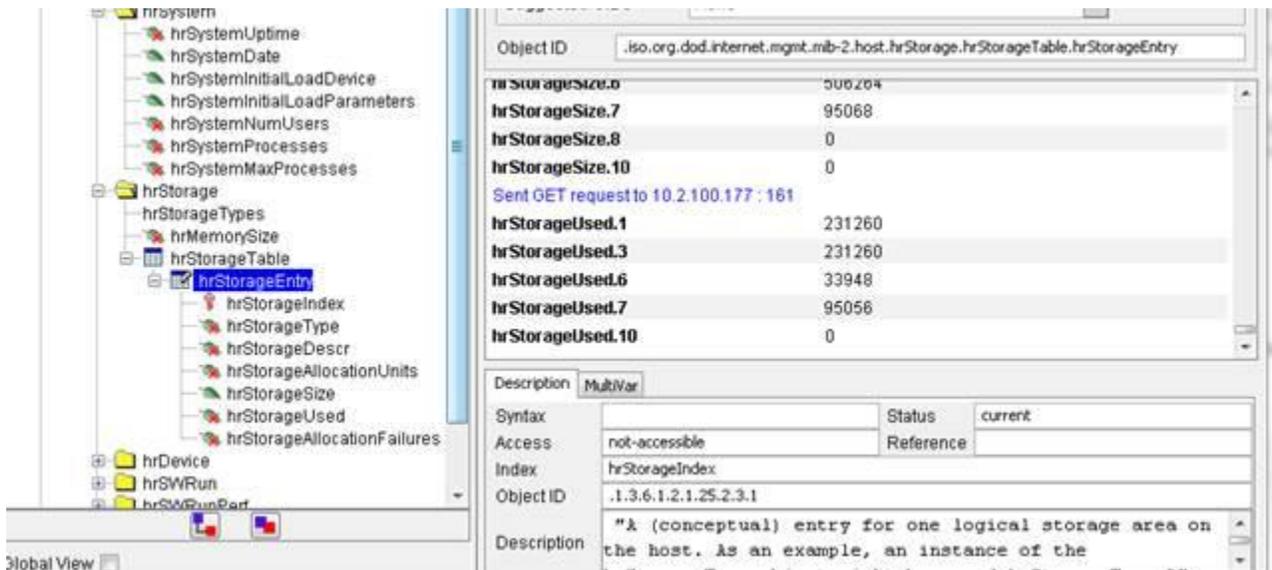
This free memory isn't currently available from any of the Spectracom MIBs or the generic SNMP MIB. However, it is available via the hrStorageTable within the Host Resources MIB (RFC 2790) which the SecureSync supports (see the screenshot below).

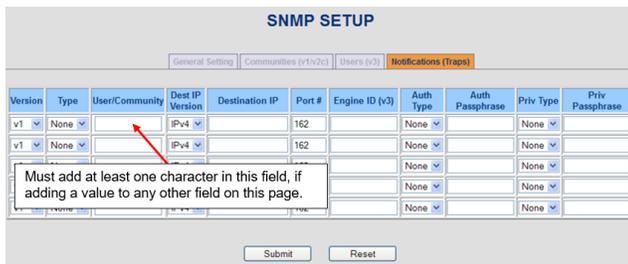
**SNMP in Archive versions 4.7.0 and below (web browser becomes inaccessible after leaving the “User/Community” field in the Notifications tab blank and then pressing Submit)**

- Note: this issue was fixed in version 4.8.0

In the **Network / SNMP Setup** page of the browser, “**Notifications**” tab, the **User/Community** field is a required field. If this field is empty (while other values have been entered in the same row) when you hit Submit, the empty field affects the web browser operation and will lock you out, like you have been observing. As long as there is something entered in this (preferably the correct value for your SNMP manager, but any character will work) and you hit Submit, you will no longer experience this lock-out condition.logs

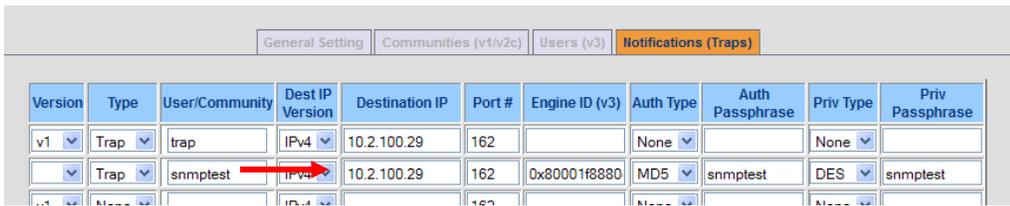
(Network -> SNMP page, Notifications tab) SNMP "Version" field displays a Null" when SNMPv3 is selected  
➤ (Reference Mantis case 1909) at least versions 4.8.7 and below.
