Model 1200 series SecureSync/9400 series

Lafayette (Model 1200 series SecureSync)

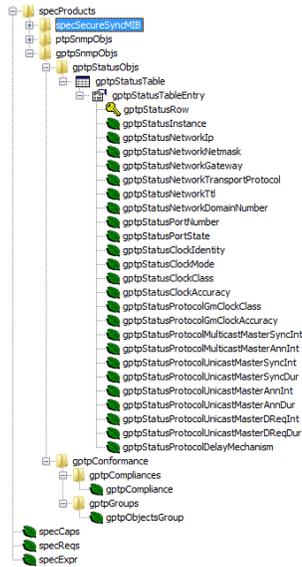
- This much more recent PTP mib file was added in software version 5.6.0 (Apr 2017) for the 1204-32 (Gb PTP Option Card)
- All of the object names begin with “gptp” (such as **gptp**StatusTable” for instance)

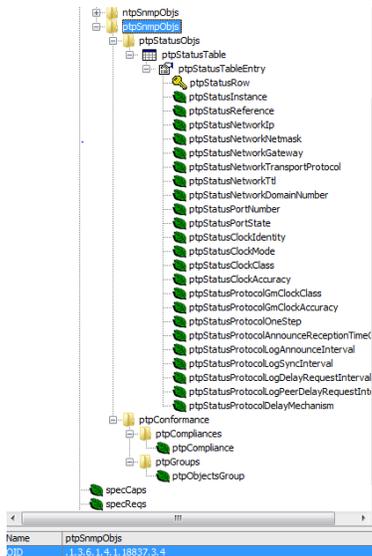
- This much earlier PTP mib file is for the Model 1204-12 (10/100 PTP Option Card)
- All of the object names begin with “ptp” (such as ptpStatusTable” for instance)

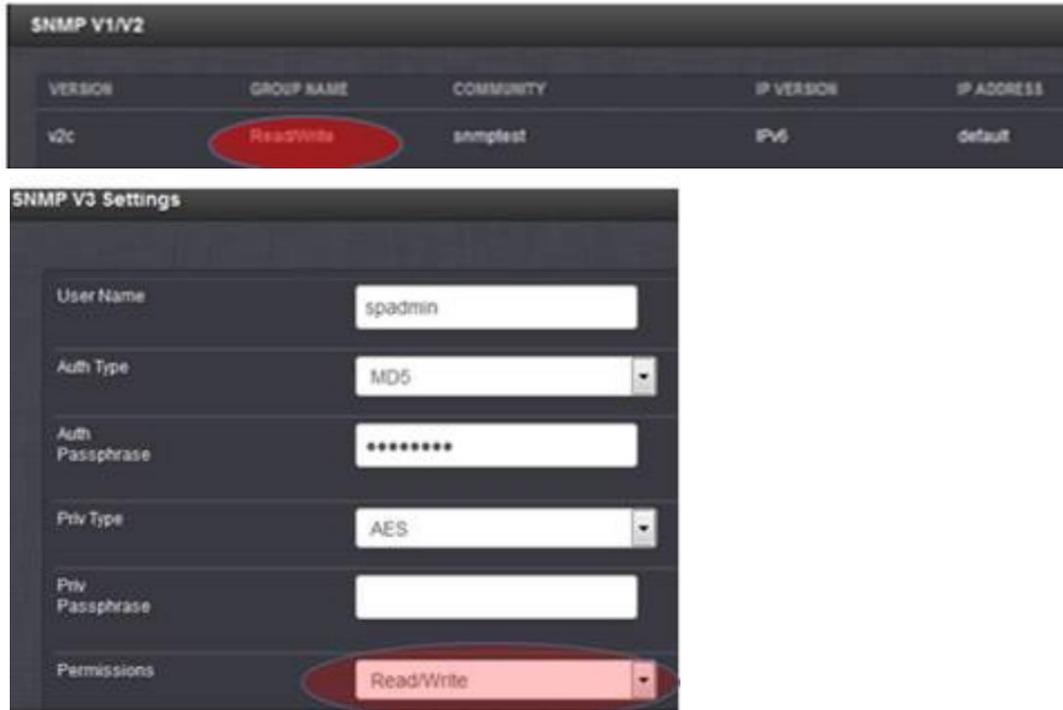
[With read/write privileges enabled in both the SecureSync (**Management -> SNMP Setup** page of the browser as shown below) and in the SNMP Manager]:

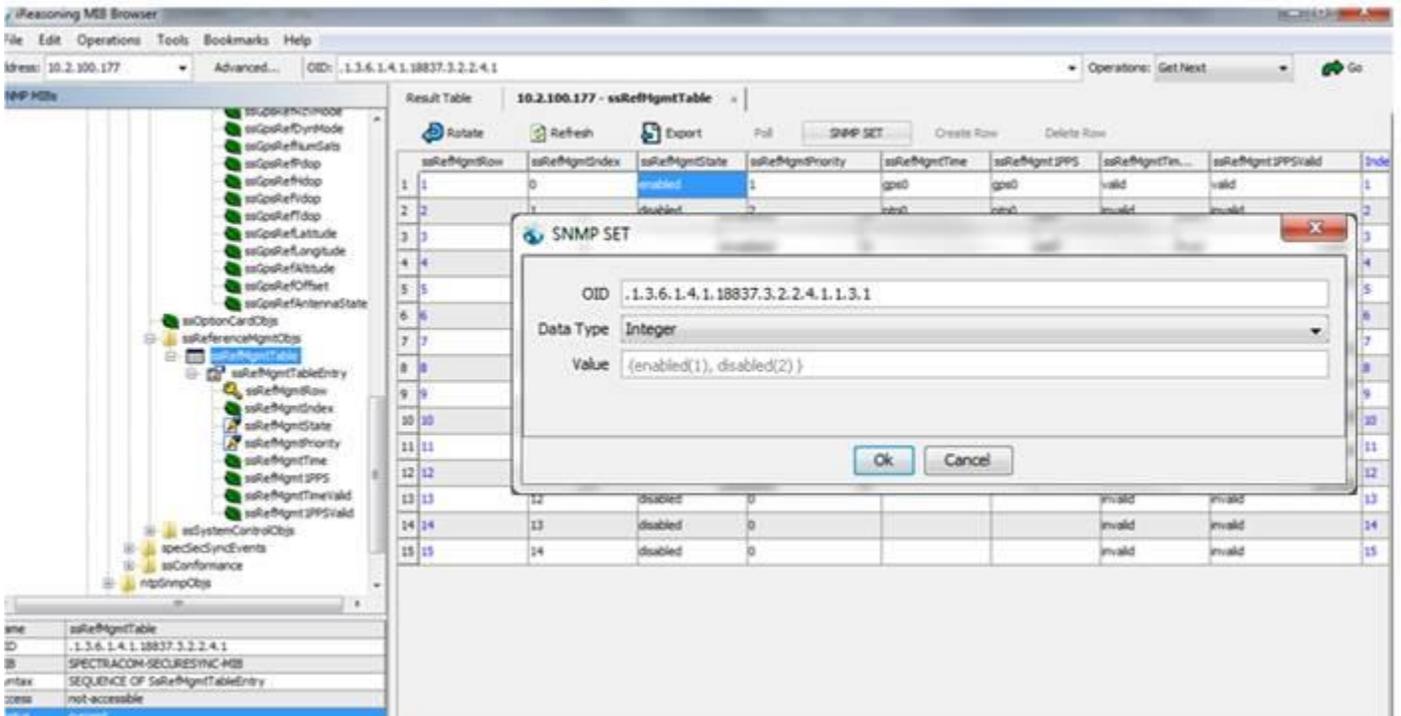
**To enable/Disable each row of the table**

In the SNMP Manager’s “Table view” (as shown below), the columns of “**ssRefMgmtState**” and “**ssRefMgmtPriority**”, **the SNMP set button** allows the applicable enable/disable for each reference, and its assigned priority value (the lower the number, the higher its order of precedence for selection). After pressing the SNMP Set button, the value can be defined as either a 1 to enable or 2 to disable

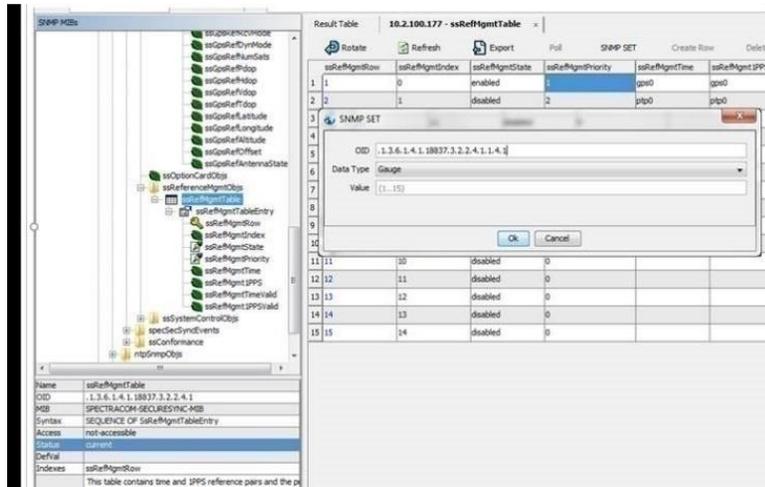
**To Change the priority of each row of the table**

Below are the specific OIDs to change the priority of each reference (available values are 1 through 15)

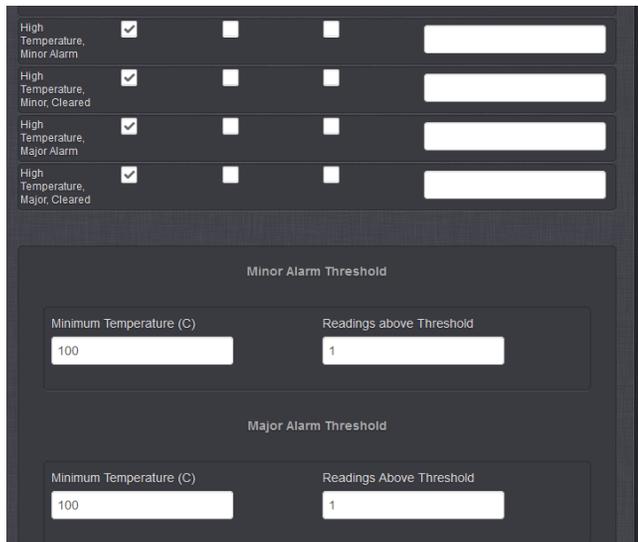
- Version 5.3.1 also added SNMP alerts for high temperatures ([Management](#) -> [Notifications](#) page, System tab)

The alarms are similar in behavior to the GPS Number of Satellite Major and Minor alarms. In this case the user can set a Minimum Temperature Threshold value for both the Major and Minor alarms. The user can also set a number of times the value above the threshold must be present before asserting the Major or Minor Alarm. A value of 1 means that the value was read once, a minute passed and on reading the value again, the temperature exceeded the threshold. The number of reads is user settable to allow for environmental conditions where more than 1 read is required to validate accurate temperature. Increasing the value requires N multiple consecutive reads of temperature above the minimum threshold before asserting the alarm.

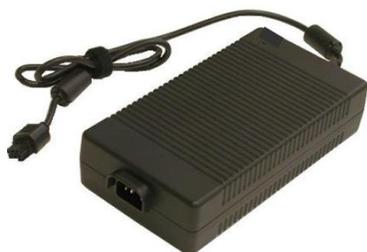
- Add Option 15 (24vdc) if it's desired to apply our AC to DC converter for "dual AC" input.

- The external power pack (our P/N **PS06R-2Z1M-DT01**) outputs 24vdc (not 12vdc)
- refer to (in this document): [\\*\\*\(PS06R-2Z1M-DT01\) Available AC to 24VDC converter for redundant AC input](#)

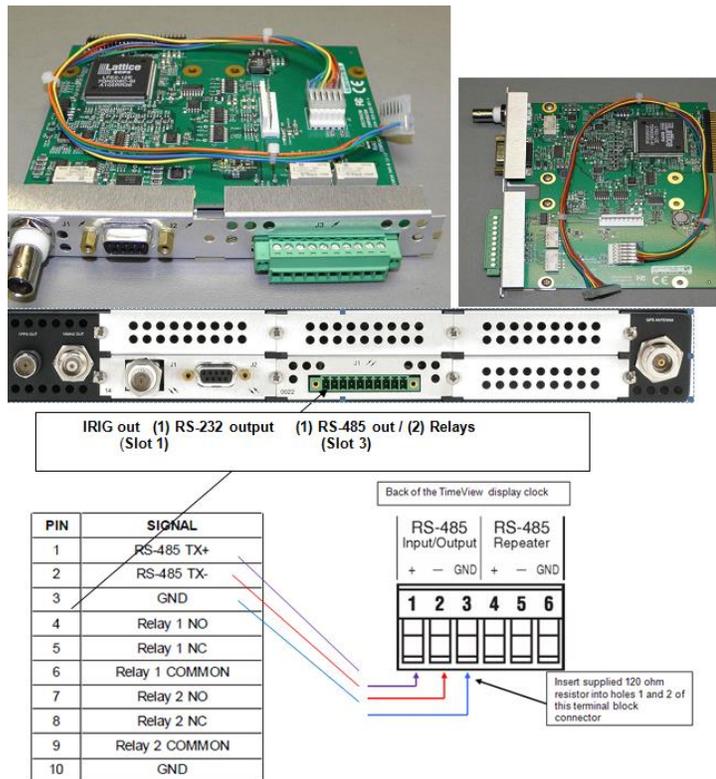
## NENA Option Card (RS-232 output, RS-485 output and IRIG output)

- Refer also to the SecureSync Option Card Document (its the 1204-1F Option Card)

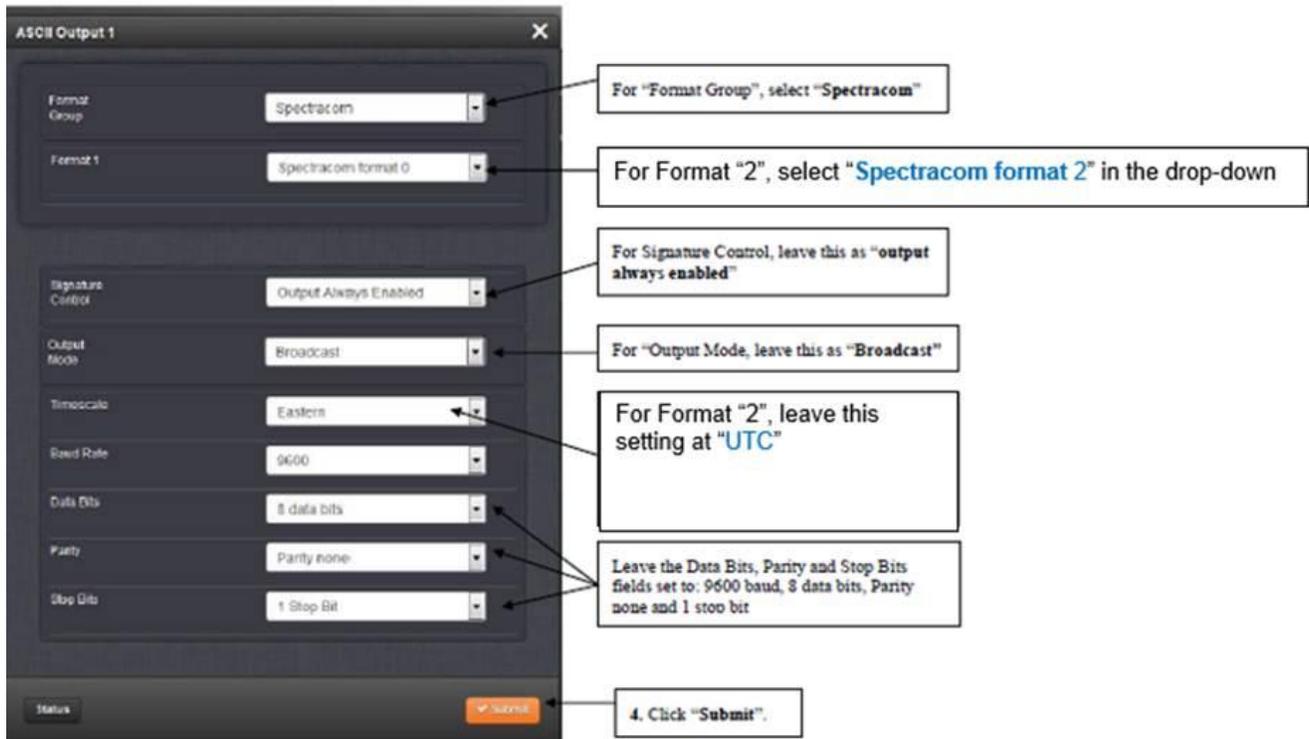
**Note:** For more info on configuring the Remote RS-485 port (referred to as "**ASCII output 1**") refer to the online Model 9483 user guide at:

After pressing Submit, the green, rear panel terminal block connector on the will start sending out ASCII Format 2 data, once-per-second.

Note the green terminal connector (starting from the left-most pin, as looking at it from the rear panel ) is pinned as follows: **+ - Ground**. Make sure that the + goes to the + on the Model 8180, - goes to -, and ground goes to ground. Incorrect pinning wont damage any equipment, but will prevent the Model 8180 from syncing to the Model 9483.
