SecureSync Option Card information

Note: This document contains both “Public Information” and “Internal Use Only Information” (do not release this document in its entirety)

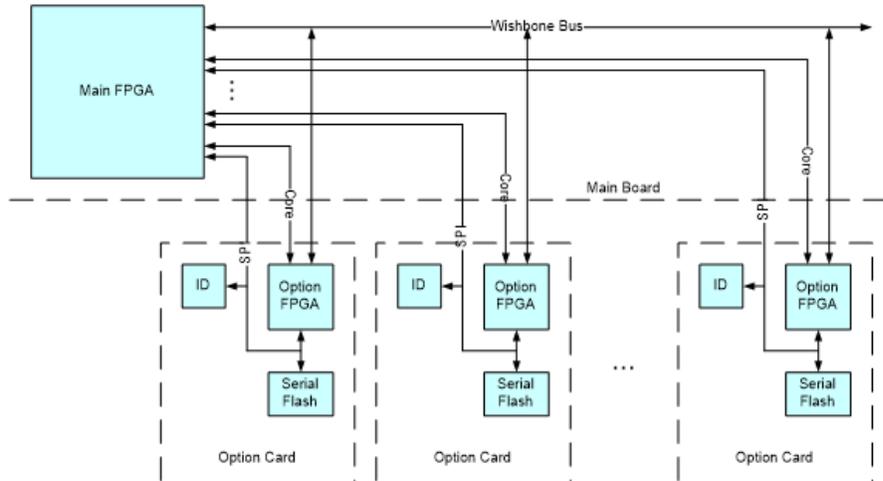
Figure 1 - Option Bus Block Diagram

- Refer to “LAF-200-B OptionBusInterface” documents in: S:\Projects\Lafayette\200 Engineering Documents\Option_Cards
- **Wishbone bus**
 - Reduced pin-count Wishbone interface with multiplexed Address and Data pins. (Identical VHDL components can be used in Main FPGA and Option FPGAs)
- **SPI bus**
 - May be used for Board ID
 - May be connected to support out of band programming of option card flash
 - May be used to control SPI peripherals if no FPGA is present
 - Three chip selects (Could be multiplexed to support seven devices)
- **Core signals**
 - Two PPS inputs from each option card
 - One PPS output to each option card
 - One IRQ from each option card
 - One 10MHz clock to each option card
- **Power**
 - +1.2V, +3.3V, and +12V power provided

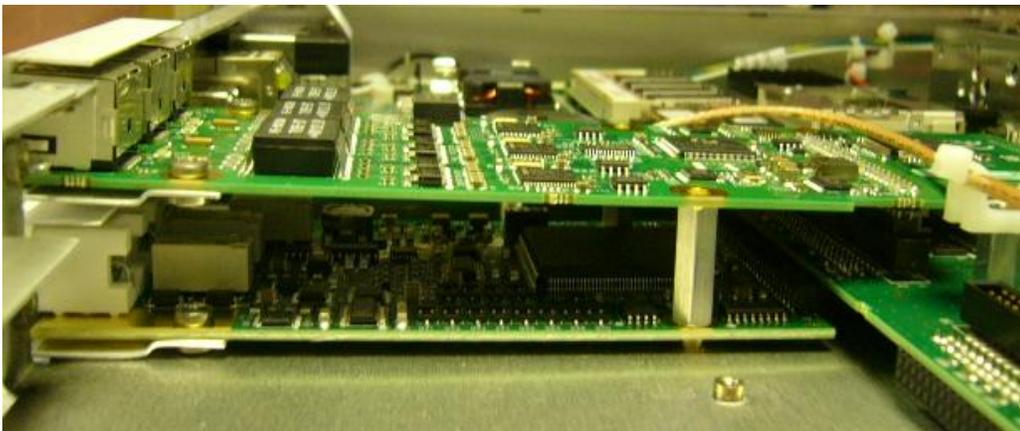
Here are the pictures of the 1204-06 mounting. The 892,3,4 show mounting with card in bottom slot and 895,6 show mounting with no card underneath (no additional spacer in place of PCB). I used a thin nylon spacer (0.5mm) + the supplied 19mm pillar to give the correct height. I think that the supplied pillars are 1mm too long.

Q. (Email from Sylvain)...we have noticed an important bending of the 1204-06 card when it is mounted with another board below. It seems the pillar is too high. The pillar can be OK when there is no board below but not for a "sandwich mode" ...

Reply from Scott Holmes (10/26/12) There are two standoffs we use for the option cards. One is longer and allows a card to be installed in an upper slot with no card below. The other is shorter and used when there are cards in both upper and lower slots. It looks like the longer standoff was used. Did they move the cards around and mix up the standoffs or was the mistake made on our production floor?

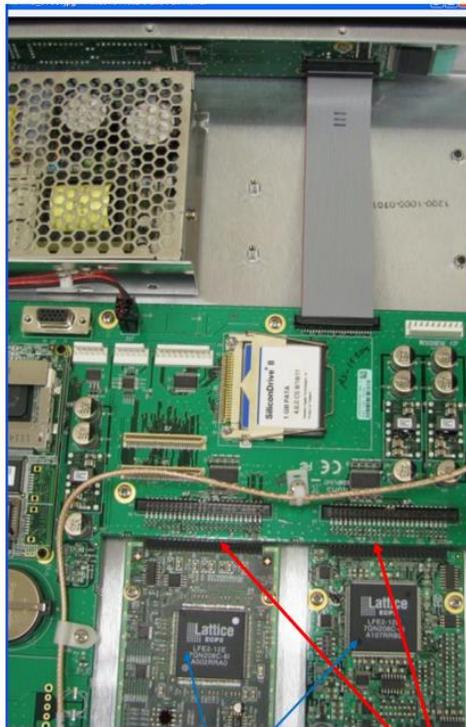
Option Cards on bottom plug straight into rear connector.

Option Cards on top are connected to the main board via a 50 pin ribbon cable (CA20R-R200-0R21)

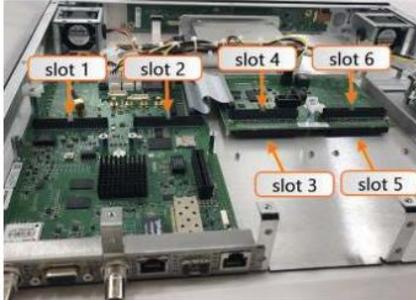
Figure 2: Unit internal view (from rear)

- Option cards installed in **Slot 1 or Slot 2** sit on top of and are screwed into pre-installed standoffs and plug in to the unit through the included ribbon cable.

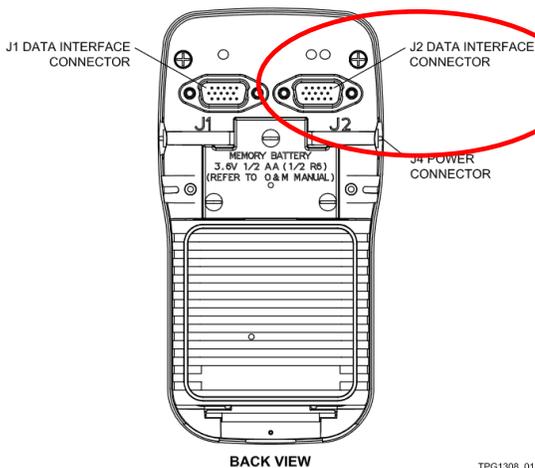
Figure 17-3. DAGR Connector Locations

- **SINGARS:** PLGR/SINGARS cable adapter connected to DAGR connector J1.
- **HAVEQUICK:** DAGR/HAVE QUICK cable connected to DAGR connector J2.
- **PPS:** DAGR/DAGR/PLGR cable connected to DAGR connector J2

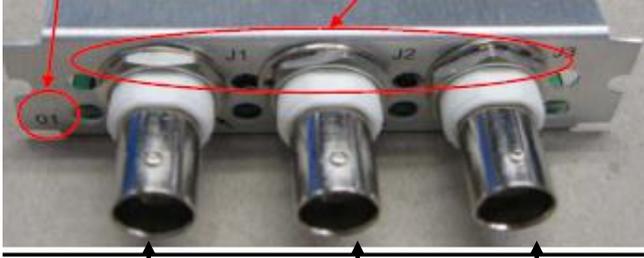
Model 1204-01 is TTL (Single-ended) outputs

(J1) Frequency Input
1 kHz to 10 MHz (sine or Square wave)

(J2) 1PPS Input (50 ohm)

(J3) 1PPS Output (50 ohm)

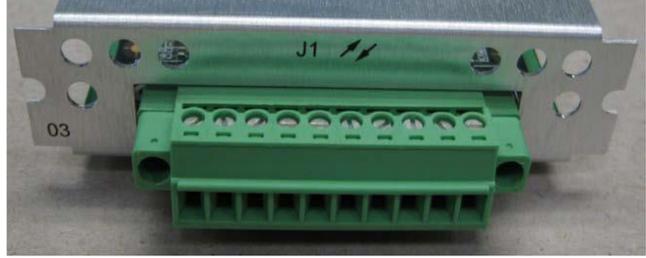
Model 1204-03 is RS-485 (Balanced) outputs

Pin Number	Signal Name	Function
1	GND	Ground
2	FREQIN_RS485+	RS-485 Frequency Input +
3	FREQIN_RS485-	RS-485 Frequency Input -
4	GND	Ground
5	PPSIN_RS485+	RS-485 1PPS Input +
6	PPSIN_RS485-	RS-485 1PPS Input -
7	GND	Ground
8	PPSOUT_RS485+	RS-485 1PPS Output +
9	PPSOUT_RS485-	RS-485 1PPS Output -
10	GND	Ground

Frequency Input
1, 5, 10 MHz
(Sine or Square)

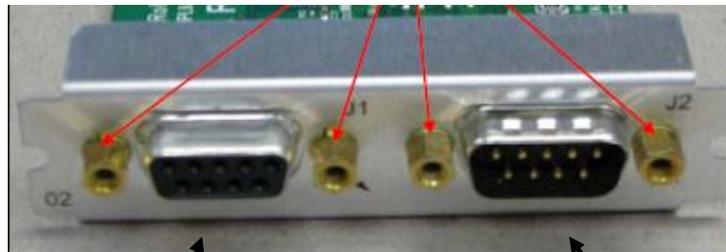
***(1204-02) ASCII RS-232 In/Out Option Card

J1: RS-232 Output

Pin Number	Signal Name	Function
Top row of 5 pins		
1	PPS_IN	1PPS input
2	SERIAL_IN_RX	RS-232 Receive data
3	SERIAL_IN_TX	RS-232 Transmit data
4	N.C.	No connection
5	GND	Ground
Bottom row of 4 pins		
6	N.C.	No connection
7	N.C.	No connection
8	N.C.	No connection
9	N.C.	No connection

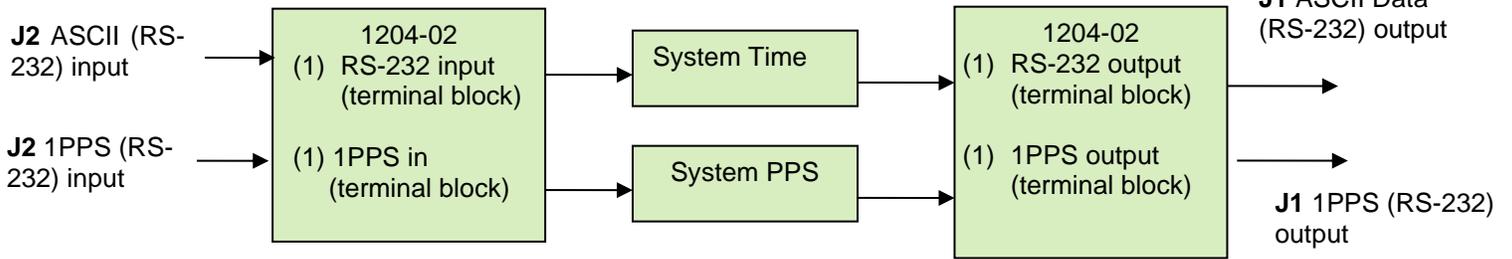
Block Diagram

BOM: (1204-0020-F000) in Arena <https://app.bom.com/items/detail-spec> . This Option Cards is derived from the 1204-0020 FOO assembly).

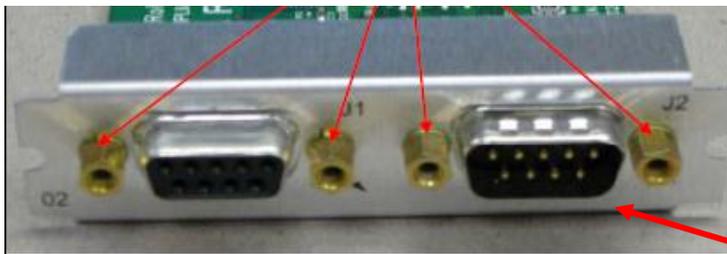
External 1PPS input pin

Pin Number	Signal Name	Function
Top row of 5 pins		
1	PPS_IN	1PPS input
2	SERIAL_IN_RX	RS-232 Receive data
3	SERIAL_IN_TX	RS-232 Transmit data
4	N.C.	No connection
5	GND	Ground
Bottom row of 4 pins

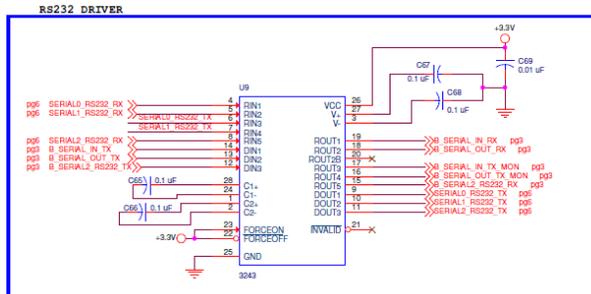
1. RS-232 pin-out (DCE device)

A) 1PPS output (RS-232) signal

RS-232 driver (U9) U050R-3243-000P (Texas Instruments Max3243E)

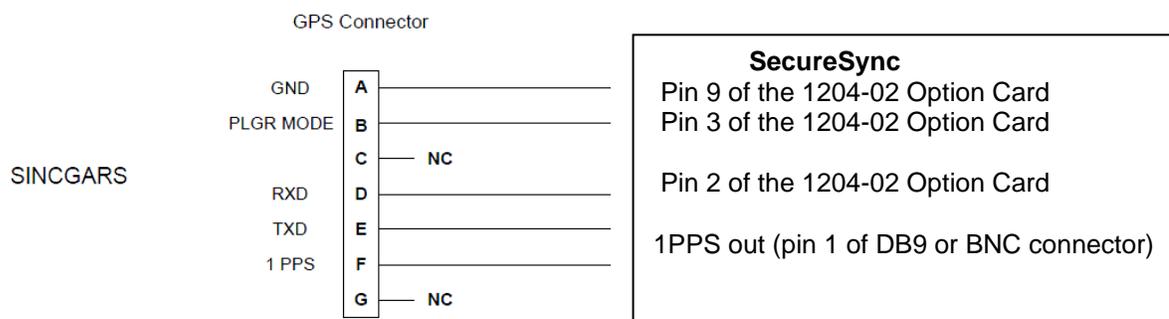
Figure 14. SINGGARS-PI

Connect SecureSync 1PPS output to SINGGARS

- Connect either the BNC 1PPS on rear panel of SecureSync or Pin 1 of the RS-232 DB port (50 ohm termination) to SINGGARS

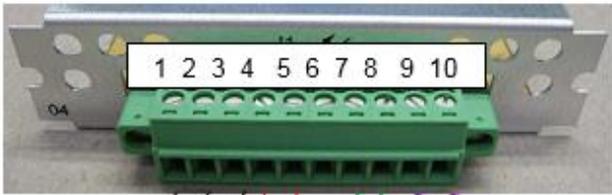
*****(1204-04) ASCII RS-485 In/Out Option Card**

Pin Number	Signal Name	Function
1	SERIALTX_RS485+	+ RS-485 data output
2	SERIALTX_RS485-	- RS-485 data output
3	GND	Ground
4	PPS_OUT_RS485+	+ 1PPS output
5	PPS_OUT_RS485-	- 1PPS output
6	SERIALRX_RS485+	+ RS-485 data input
7	SERIALRX_RS485-	- RS-485 data input
8	GND	Ground
9	PPS_IN_RS485+	+ 1PPS input
10	PPS_IN_RS485-	- 1PPS input

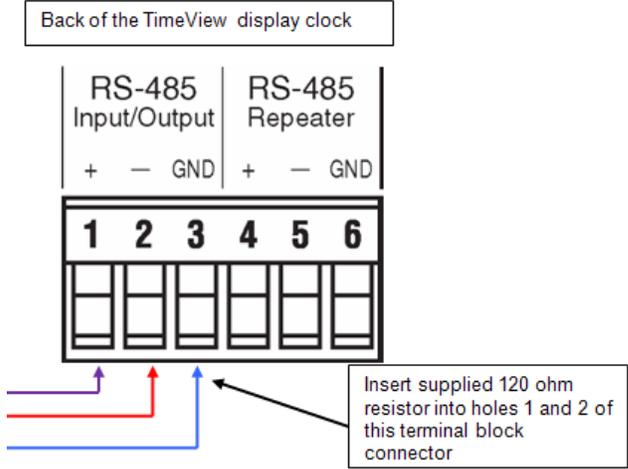
Connection to a Spectracom TimeView (RS-485 input) display clock

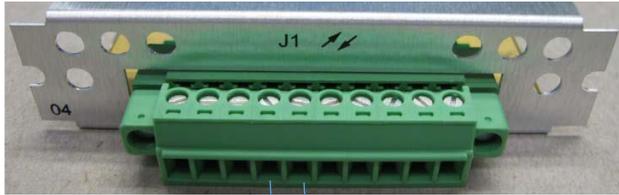
A) 1PPS output pins

RS-485 1PPS output pins (Pins 4 and 5)

Pin Number	Signal Name	Function
1	SERIALTX_RS485+	+ RS-485 data output
2	SERIALTX_RS485-	- RS-485 data output
3	GND	Ground
4	PPS_OUT_RS485+	+ 1PPS output
5	PPS_OUT_RS485-	- 1PPS output
6	SERIALRX_RS485+	+ RS-485 data input
7	SERIARX_RS485-	- RS-485 data input
8	GND	Ground
9	PPS_IN_RS485+	+ 1PPS input
10	PPS_IN_RS485-	- 1PPS input

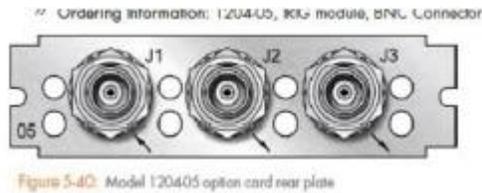
The IRIG Slave SecureSync has one 1204-05 Option card installed. This card is different than the other 1204-15 IRIG Output cards as it has one IRIG Input and two outputs. This is what the card face looks like.

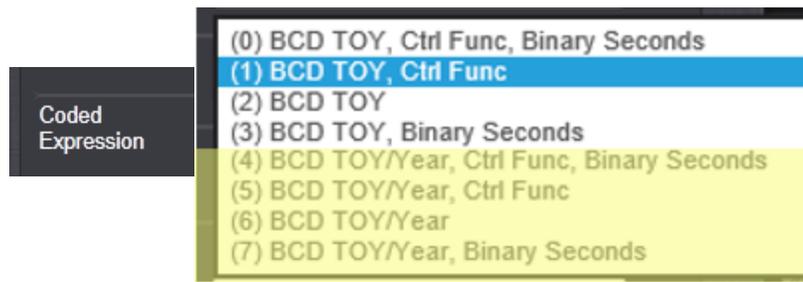
- The IRIG source can provide the current Year value in its:
 - The **BCD section** (as BCD Year) of its IRIG message: Refer to "1)" below and/or
 - The **Control Function field section** of its IRIG message: Refer to "2)" further below
 - 1) Read the current year from the BCD Section of the received message
 - The selected **Coded Expression** field must contain "BCD TOY/YEAR" (not just "BCD TOY"), as highlighted in the list below:

- Examples of IRIG B messages which the system WON'T read "BCDYear" (from EITHER the **BCD section**, or even from the **Control Function Field**): **B000, B001 B002 and B003**
- Examples of IRIG B messages which the System can read "BCDYear" (from EITHER the **BCD section** or the **Control Function Field**): **B004, B005, B006 and B007**

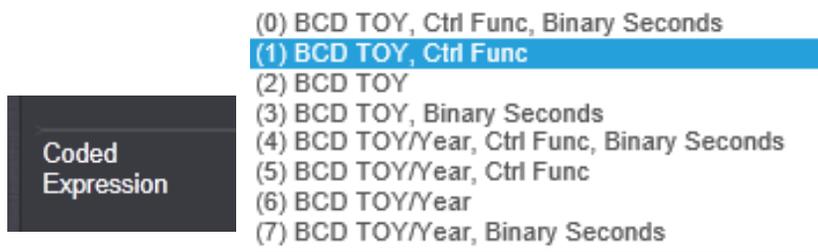
1. Because the current year value is provided in the **Control Function Field** as “**BCD Year**”, the selected **Coded Expression field** must contain BOTH “**Ctrl Func**” (**Control Function**) and “**BCD TOY/YEAR**”, like the yellow highlighted entries below (the Coded Expression field needs to be set to either “(4)” or “(5)”)

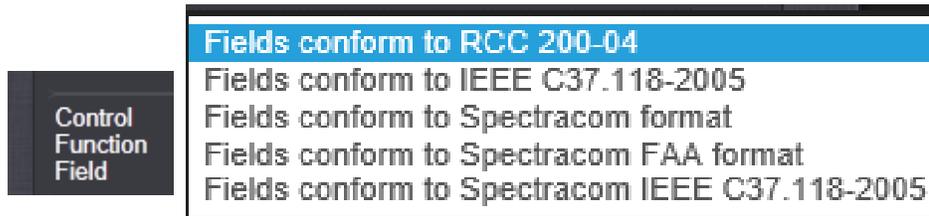
The available configurations for Control Function field are (Note the list below not in same order as the web browser, as shown in screenshot above)

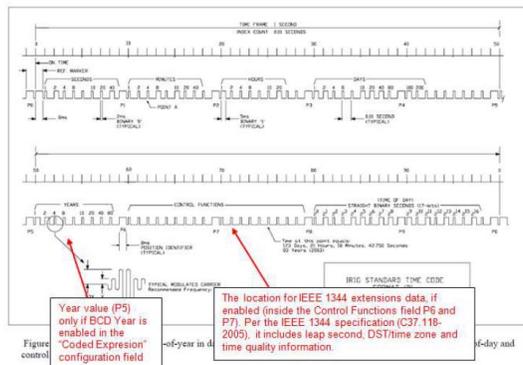
And here is the "RCC 200-04" format (available in SecureSyncs, Model 9483s and TSync-PC1e):

Notice in the "Spectracom format, "Years" is located inside the "Control Functions" field, while in the RCC-2004 spec, the "Years" is located just before the "Control Functions".

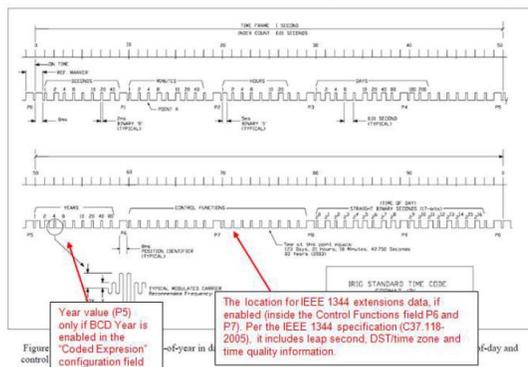
And here is the "RCC 200-04" format (available in SecureSyncs, Model 9483s and TSync-PC1e):

Notice in the "Spectracom format, "Years" is located inside the "Control Functions" field, while in the RCC-2004 spec, the "Years" is located just before the "Control Functions".

- **Spectracom Format:** Year is included in Control Field but not in the same location as RCC-2004 output (year is offset by one position). Note this selection is only available if the IRIG source is a Spectracom device!

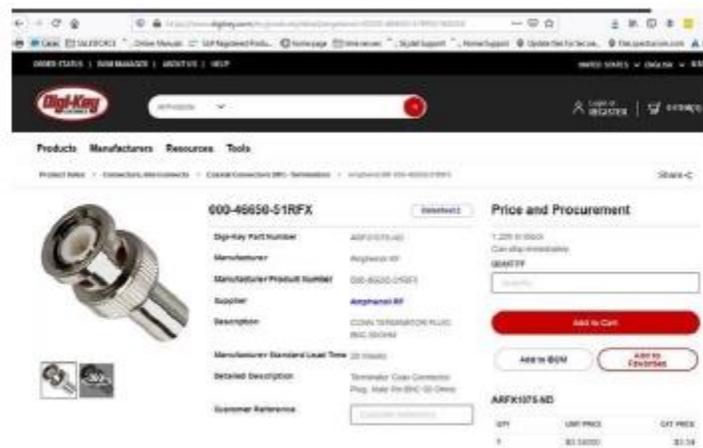
Below is a good example of a recommended 50 ohm load terminator:

Amphenol P/N: 46650-51-RFX (Digi-Key P/N: ARFX1075-ND) <https://www.digikey.com/en/products/detail/amphenol-rf/000-46650-51RFX/160255>

“BNC” type 50 ohm load terminators can be readily found online, and can be attached to the end of the coax cable via the “open” side of a BNC “T” connector (the “T” connector attaches the end of the cable to the IRIG distribution amp, and has an additional connection that the BNC 50 ohm terminator is attached to).

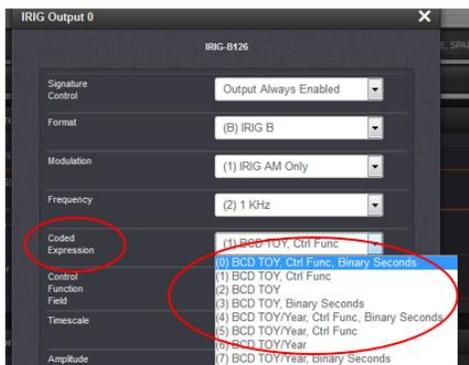
Enabling the 1344 extensions in each of the SecureSync’s IRIG output first requires the **“Coded Expression”** in the IRIG output configuration screen be set to any value which includes **“Ctrl Func”** in its selection (such as the values of “0”, “1”, “4” or “5”, as shown below):

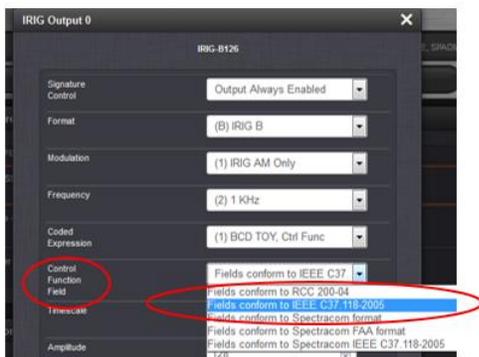
And secondly, the **“Control Function Field”** drop-down needs to be sent to **“Fields Conform to IEEE C37.118-2005** (as shown below):

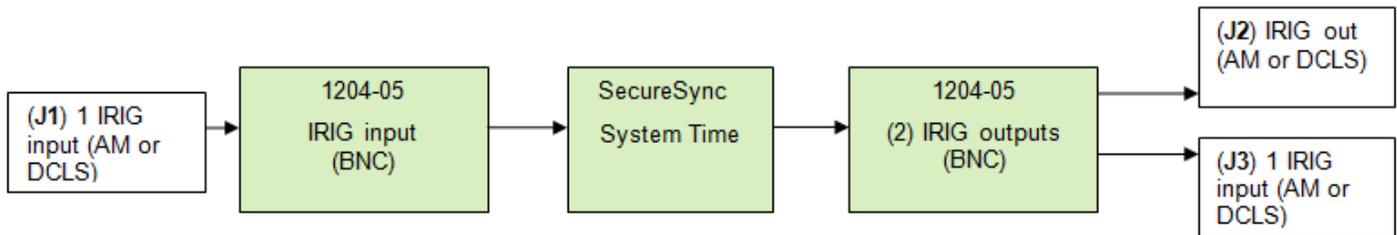
Block Diagram

One IRIG (AM or DCLS) Input (J1)

- One BNC connector (J1) for IRIG input
- AM or DCLS modulation accepted.
- The range of the IRIG input amplitude is 0.5 to 10 Volts P-P

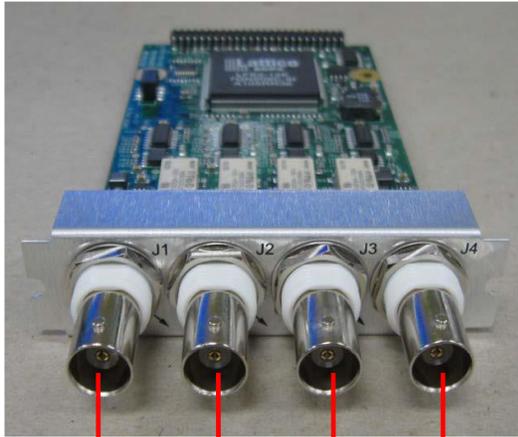
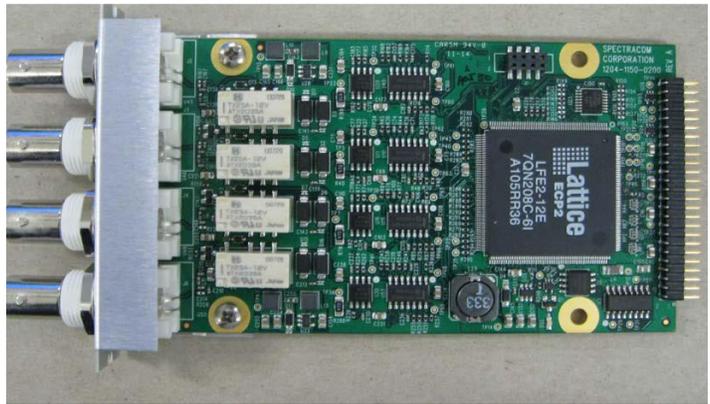
A) 1204-15 (four BNC connectors)

Connectors J1 – J4 are all IRIG outputs

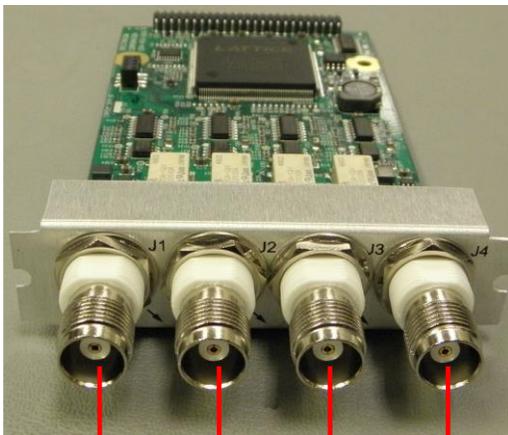
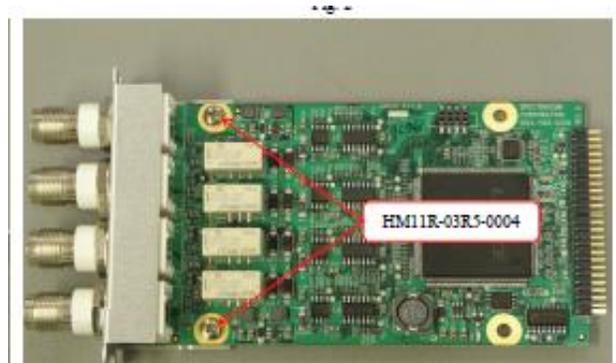
B) 1204-39 (four TNC connectors)

Connectors J1 – J4 are all IRIG outputs

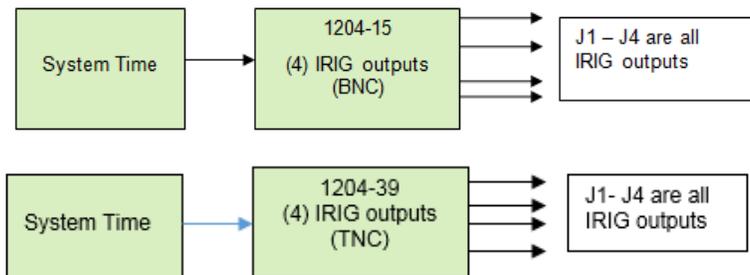
Block Diagram

- The 1204-15 and 1204-39 Option Cards do not have any IRIG inputs (Outputs only)

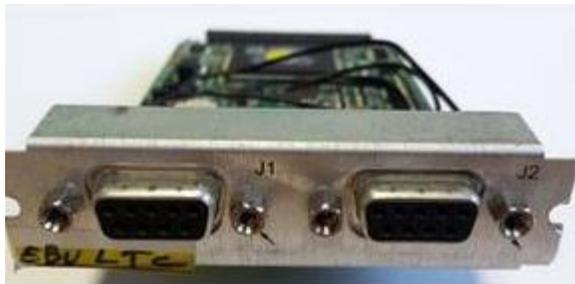
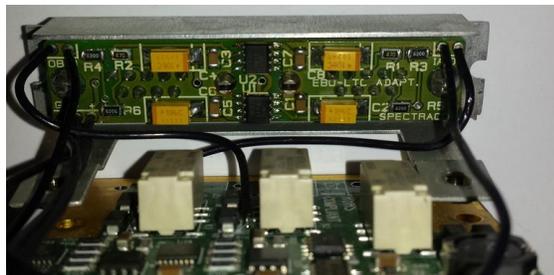
***(1204-20) EBU-LTC Option Card

- Special for customer of Spectracom France
- Modified Model **1204-05** IRIG Option Card with an EBU-LTC adapter board (40261-EBU-LTC)

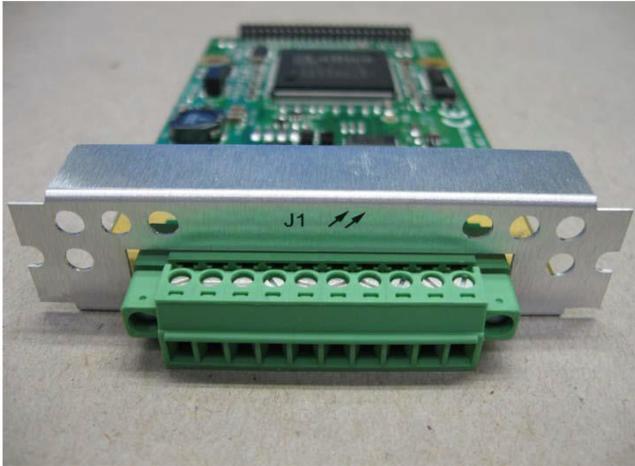
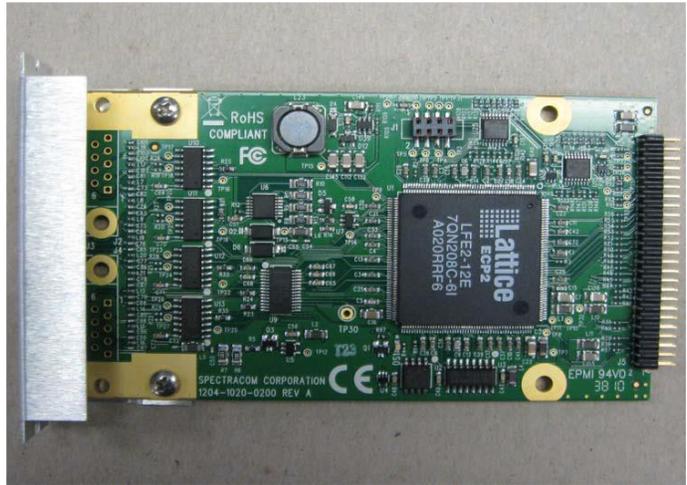
**** (1204-22) FAA IRIG (RS-485) 4 IRIG output**

P/N: 1204-0220-0600

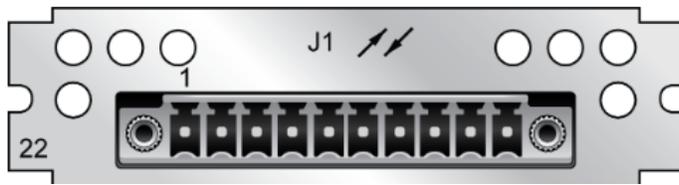
Pin-outs

(four sets of outputs)

J1 Pin No.	Function	
1	IRIG Output 1 +	Output 1
2	IRIG Output 1 -	
3	GND	
4	IRIG Output 2 +	Output 2
5	IRIG Output 2 -	
6	IRIG Output 3 +	Output 3
7	IRIG Output 3 -	
8	GND	
9	IRIG Output 4 +	Output 4
10	IRIG Output 4 -

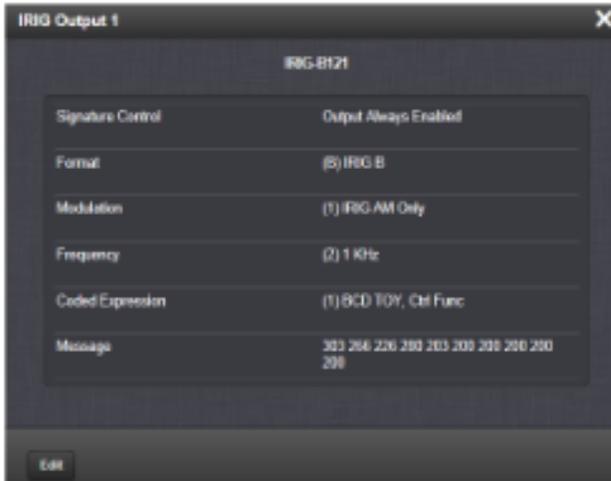
Fields conform to IEEE C37

- Fields conform to RCC 200-04
- Fields conform to IEEE C37.118-2005
- Fields conform to Spectracom format
- Fields conform to Spectracom FAA format
- Fields conform to Spectracom IEEE C37.118-2005

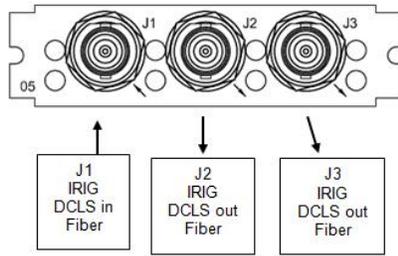
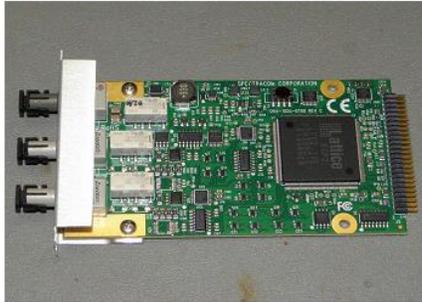
*****(1204-27) (1) IRIG Fiber In / (2) IRIG Fiber out Option Card**

- Provides (1) IRIG DCLS input only (does not support IRIG AM)!!!
- Provides (2) IRIG DCLS outputs only (does not support IRIG AM)!!!

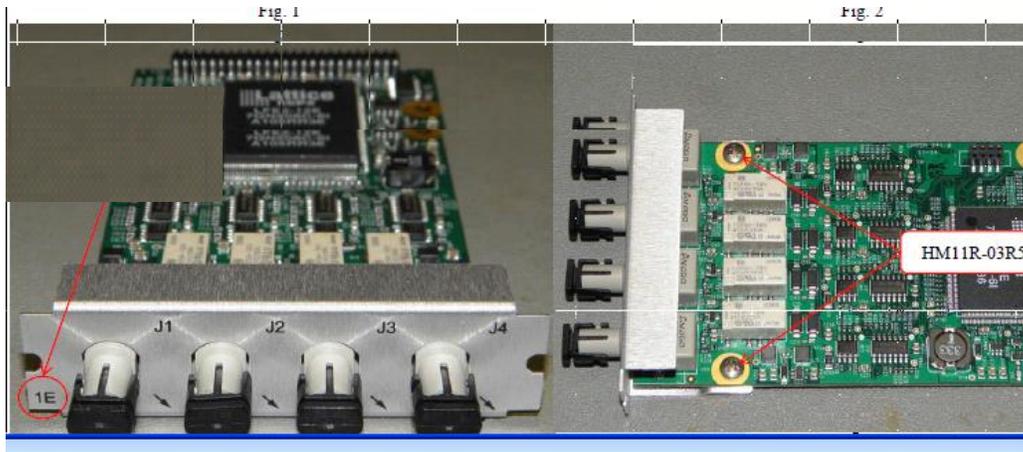
***(1204-1E) (4) IRIG (ST Fiber Optic) outputs

- Provides (4) IRIG DCLS outputs only (**does not support IRIG AM**)!!!

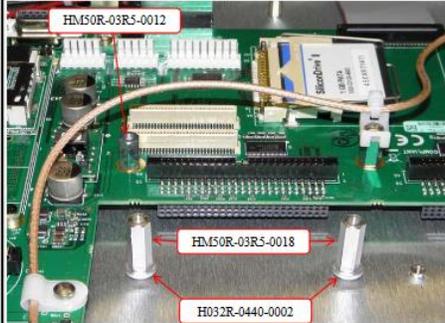
Fig.7

PD 1200-XXXX-0601			PROCESS DETAIL
Part #	Description	Qty.	
1200-XXXX-0600	SECURESYNC, XXXX	1	<p style="text-align: center;">GIGABIT ETHERNET OPTION CARD INSTALLATION:</p> <p>If no card install in slot 1: Place washers over the chassis screw holes, then screw standoffs into place above the washers. Remove screw next to J11 pin 1 and replace with HM50R-03R5-0012 spacer as shown in figure 7.</p> <p>Insert the Gigabit option card into slot 2, ensure the option card connectors are aligned properly with connectors on the main PCB, gently press down the card and secure with HM11R-03R5-0004 screws.</p> <p>If card gets install in slot 1: Install the appropriate option card into slot 1 using HM50R-03R5-0018 spacers, then remove screw next to J11 pin 1 and replace with HM50R-03R5-0012 spacer.</p> <p>Insert the Gigabit option card into slot 2, ensure the option card connectors are aligned properly with connectors on the main PCB, gently press down the card and secure with HM11R-03R5-0004 screws.</p> <p>Install 1200-1000-0709 blank plates where there are no option cards using HM11R-03R5-0004 screws. Secure the top cover to chassis using HM20-03R5-0406 screws.</p>

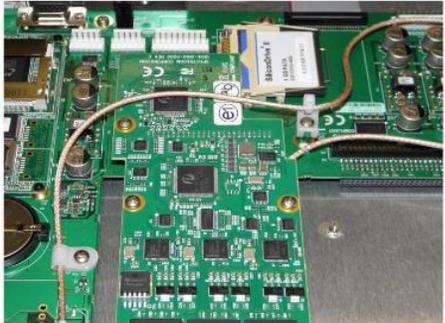
Fig.8

Upper slots require a ribbon cable. Lower slots can plug right into the motherboard.

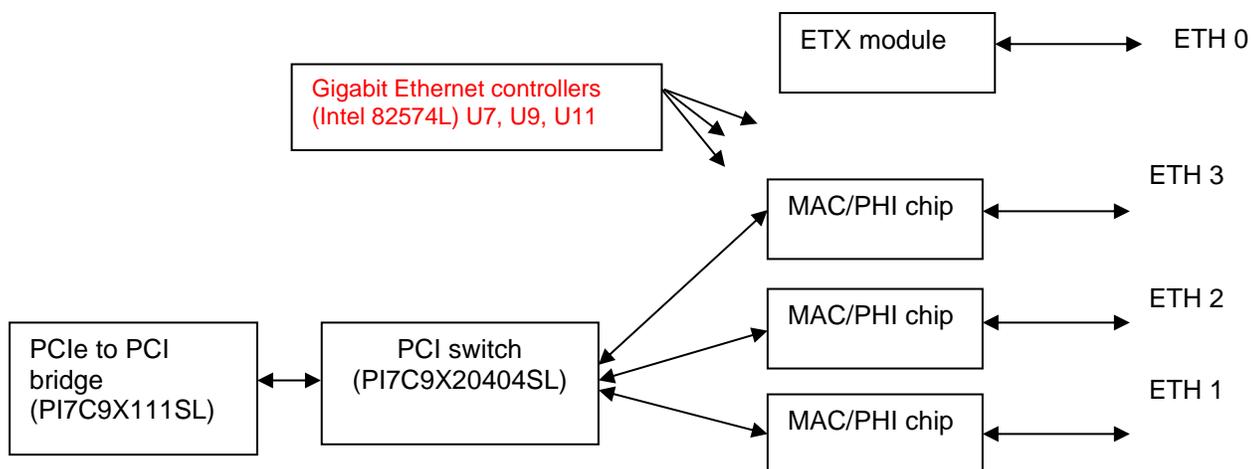
Block diagram of Gigabit Ethernet ports

(3) U190R-8257-000P Gigabit controllers (Intel P/N WG8257IT)

Each of the 3 Gigabit controllers has separate 1MB SPI memory for storing the MAC address. The other network settings, such as the IP address, Subnet mask, and gateway address are stored in the main board (not in the Gigabit Option Card)

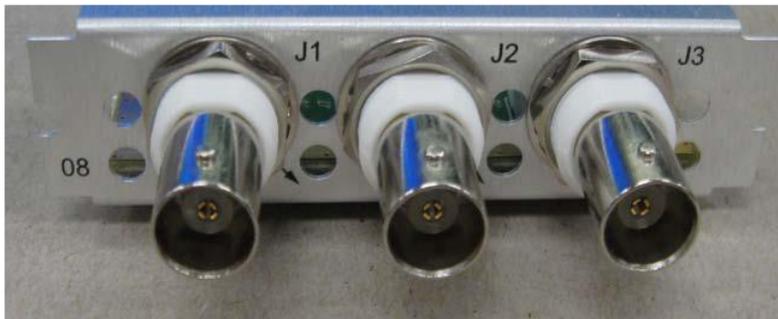
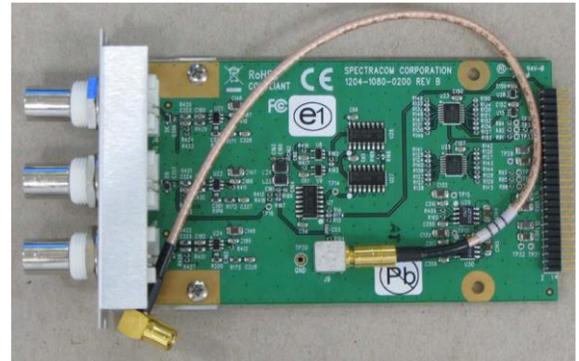
1204-08 (BNC connectors)

(J1, J2, J3) 5 MHz Sine wave outputs (50 ohms)

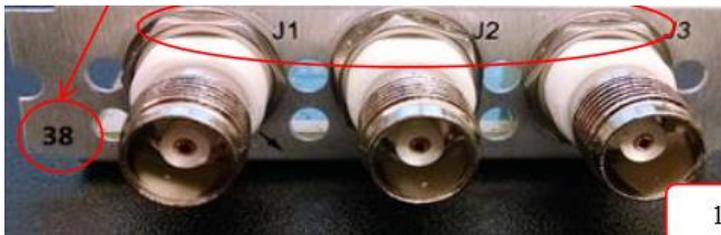
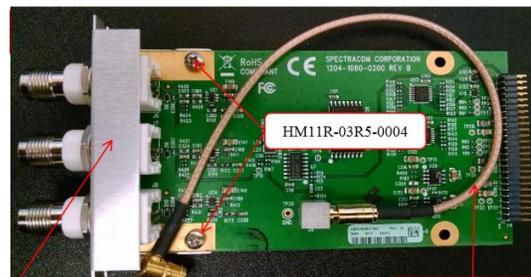
1204-38 (TNC connectors)

(J1, J2, J3) 5 MHz Sine wave outputs (50 ohms)

Note: 1204-38 Option Card was introduced with version 5.3.0 upgrade (~Jul 2015)

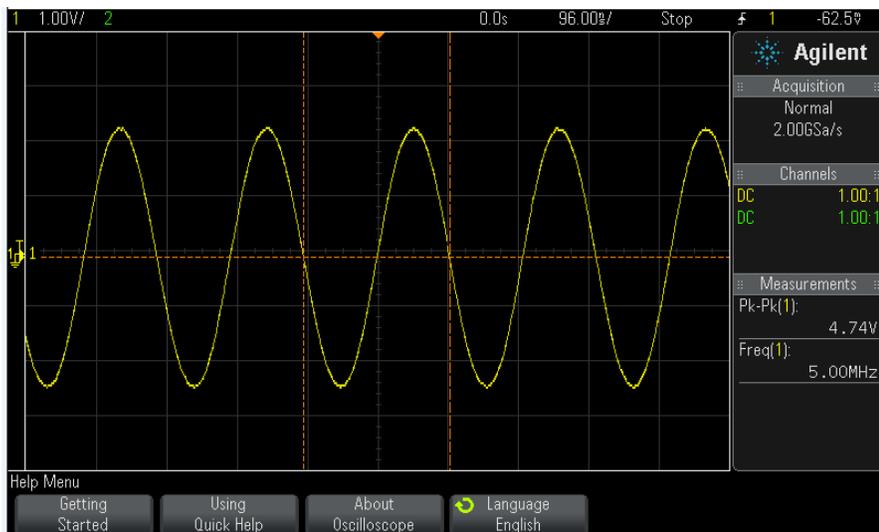
Example output (5 MHz sine-wave)

Note: Sine wave outputs only.

The Phase noise specs in the SecureSync data sheet only apply to the base 10MHz output and the (3) 10 MHz outputs on the 1204-0C / 1204-1C Option Cards. Because of how the 5 MHz and 1MHz outputs are derived from the oscillator's 10 MHz output, the phase noise of the 5MHz and 1MHz outputs is inherently much higher! We do not publish phase noise specs for the 5MHz and 1MHz outputs.

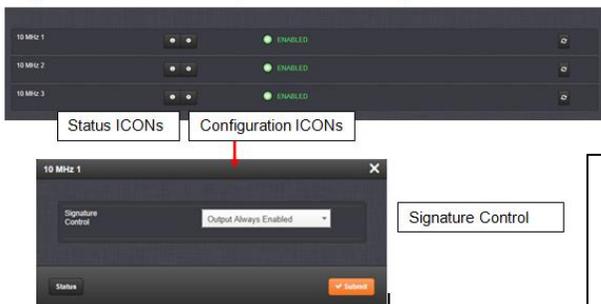
- All three outputs on the 1st 10 MHz Option Card are configured as “10 MHz 1” (the base output is “10 MHz 0”)

Same pop-up window (such as “10 MHz 1” for instance) configures all three output ports at the same time. Individual frequency outputs on the same Option Card are not independently configurable!

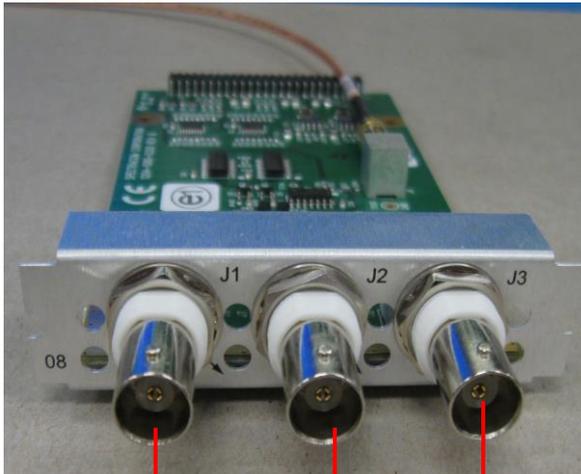
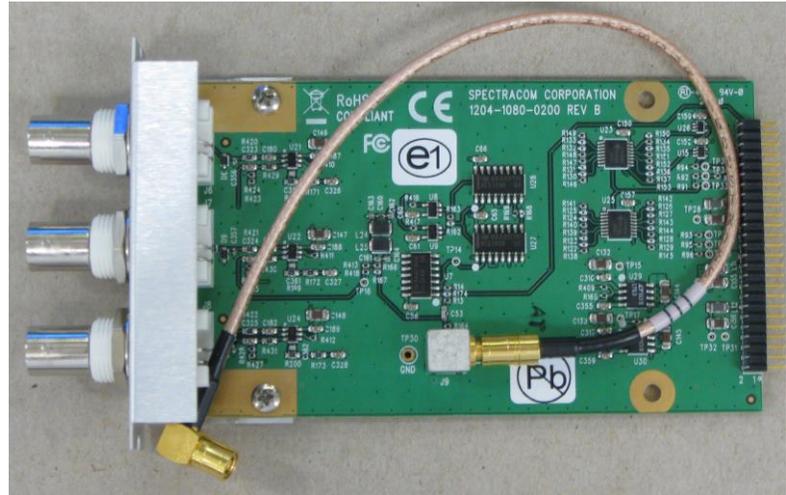
J1 J2 J3
(All three are outputs)

Schematic: (refer to 1204-0080-F000) [I:\New Released\PCB Documentation](#)

A. **Keith’s response (per Mark McGregor)** for the Model 1204-26 (1 MHz outputs), the phase noise for the outputs is worse than the “main” 10 MHz output phase noise.

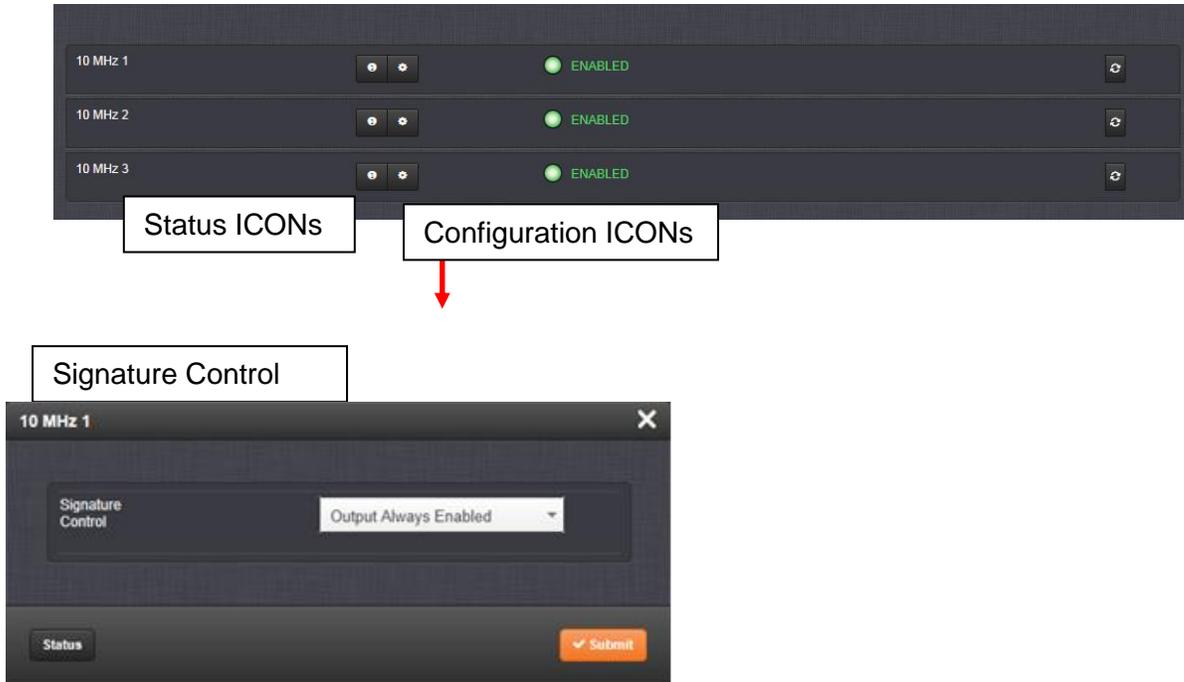
A) New web browser interface (versions 5.1.2 and above)

Signature Control: Signature Control is used to control when the 1 MHz output is present.

No Signature Control: 1 MHz output is present, even when SecureSync is not synchronized to its reference (modulation is present while in the Holdover mode).

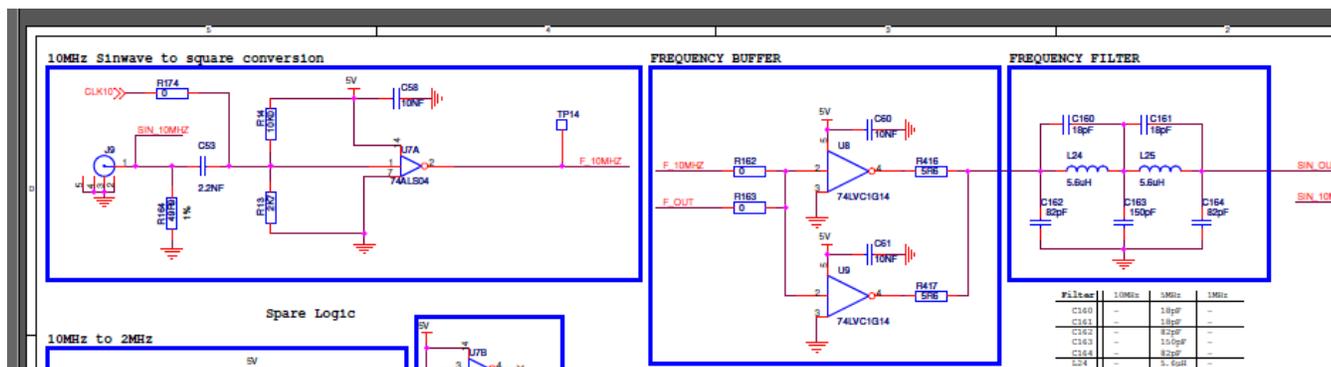
Note: Schematic for 1204-1C 10MHz Output distribution below is for internal use only.

1204-1C outputs get 10 MHz from the main board through a buffer and filter and shown below)

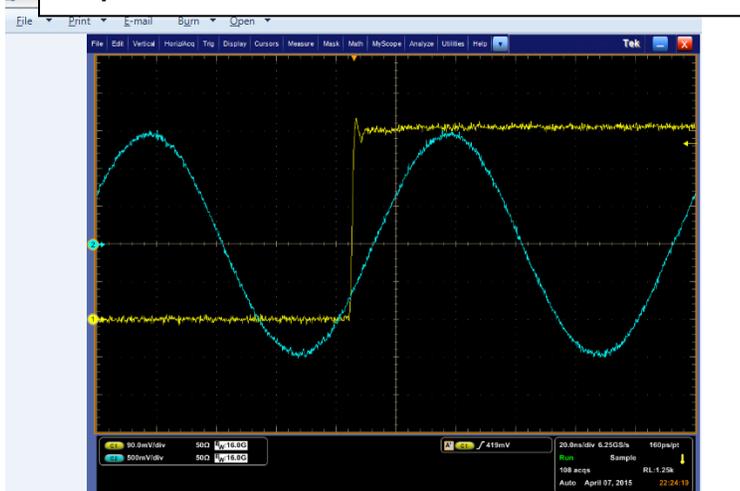
1PPS/10MHz alignment for all 1204-1C option Card outputs

Per Dave Sohn (7 Apr 2015) This is what I would expect from the system. There is no HW issue. The phase relationship on a 10MHz output is fixed with the 1PPS, but there is a difference between the outputs on the option card versus the main unit. If they need multiple outputs that have the same phase relationship, then they can just use the 1C option card outputs.

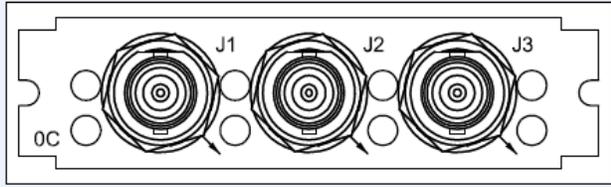
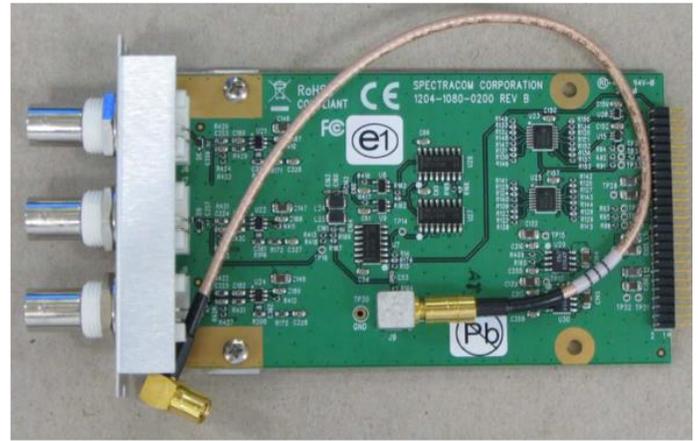
Function: Provides three 10 MHz outputs

Inputs: None

A. Keith’s response (per Mark McGregor) for the Model 1204-1C (10 MHz), the phase noise for the outputs is similar to the “main” 10 MHz output. This isn’t the case with 1MHz and 5MHz out Option Cards, but is the case for 10 MHz out.

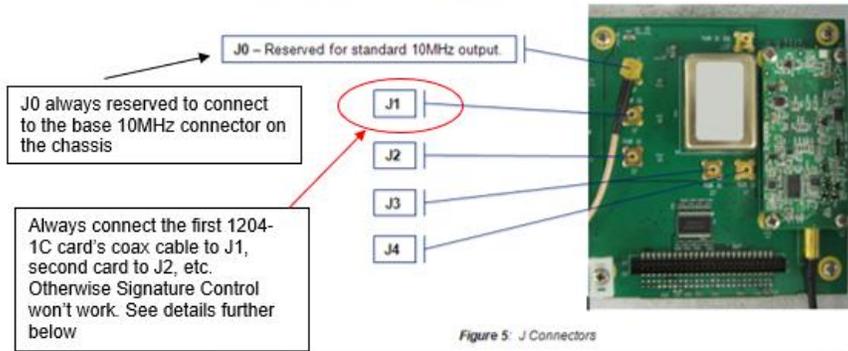
Figure 5: J Connectors

The coax cable from each Frequency Distribution Option Card (1204-1C) must be connected to each of these connectors on the main PCB, in ascending order, starting with J1)(this is important). Refer to the figure below, from the Option Card install guide.

- Install the coax cable(s) onto the main PCB, connecting them to the first available open connectors, from J1 - J4. Refer to figure below:

NOTE: For 10MHz option cards with 3 coax cables: From the rear of the option card, outputs are labeled J1, J2, J3. Start by connecting the cable attached to J1 on the card to the first available open connector on the SecureSync mainboard, then connect the cable attached to J2, then J3 etc.

With Signature Control enabled, if the Frequency outputs are still present on an Option Card, but not on the Base 10 MHz out (because it's squelched for a Signature Control condition), the Option Card's 10MHz coax cable may not be connected to the first J1 through J4 connector on the main PCB, in ascending order. If it's connected to the wrong connector, since Signature Control is applied to each of these ports individually based on what's connected to each slot, if it's not on the right connector, the 10MHz input to the Option Card won't be squelched by Signature Control. So, the ports on the card will still be present.

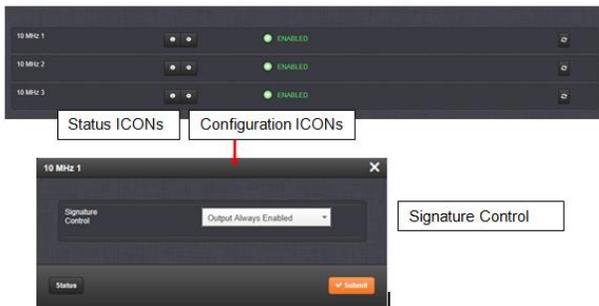
- All three outputs on the 1st 10 MHz Option Card are configured as "10 MHz 1" (the base output is "10 MHz 0")

Same pop-up window (such as "10 MHz 1" for instance) configures all three output ports at the same time. Individual frequency outputs on the same Option Card are not independently configurable!

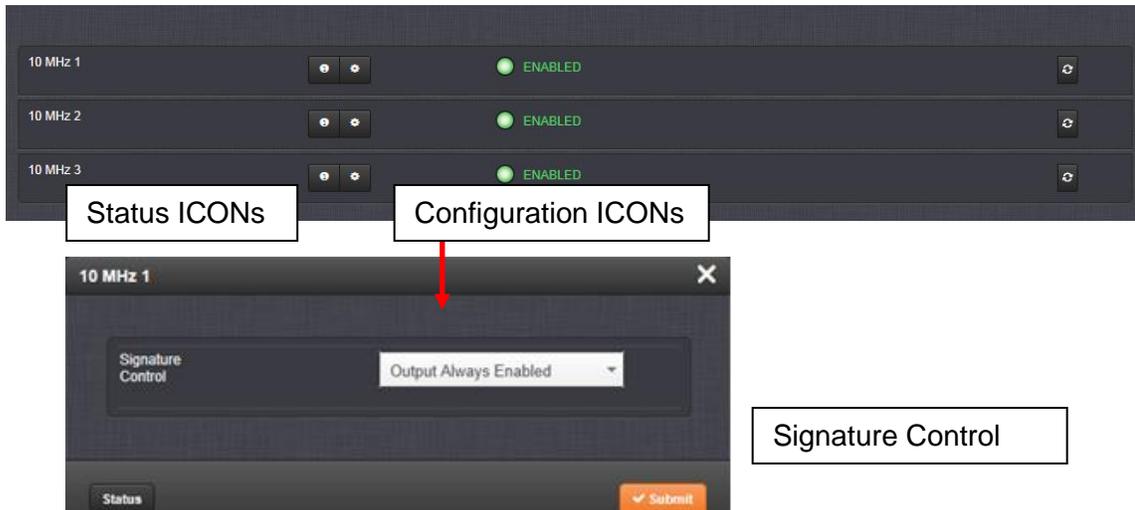
New web browser interface (versions 5.1.2 and above)

Signature Control: **Signature** Control is used to control when the 10 MHz output is present.

No Signature Control: 10 MHz output is present, even when SecureSync is not synchronized to its reference (Modulation is present while in the Holdover mode).

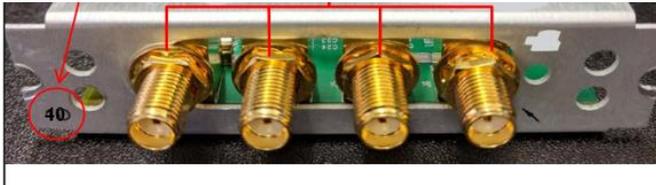
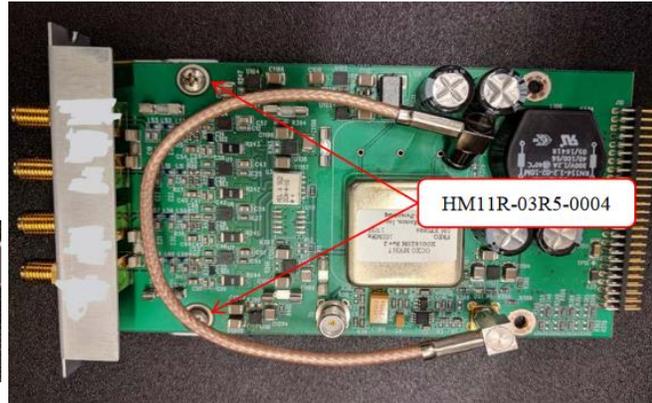
*** (1204-40) (4 SMA) LPN 100MHz sine wave output Option Card

Link to schematic (1204-1401-0200) in Arena: https://app.bom.com/items/detail-spec?item_id=1234410083&version_id=10961324798

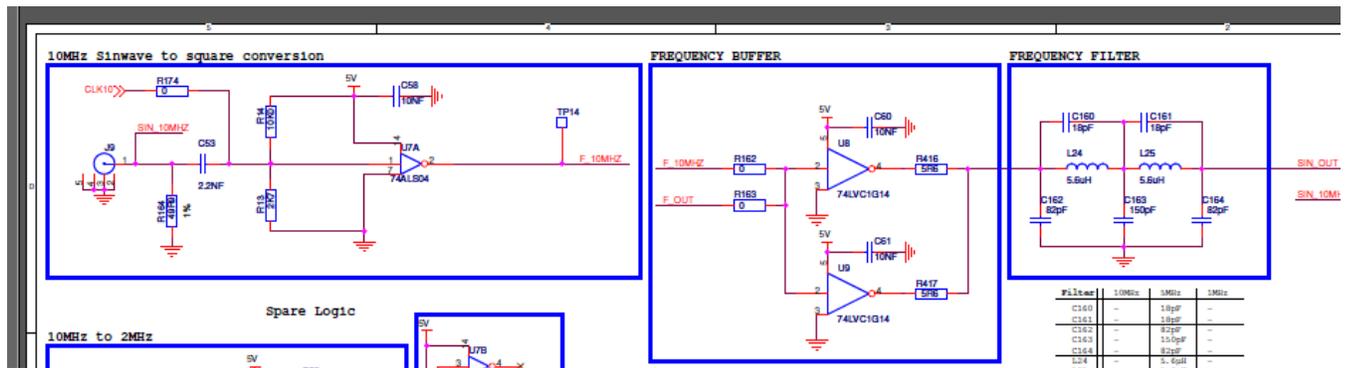
Note: Schematic for 1204-1C 10MHz Output distribution below is for internal use only.

- Refer to Salesforce case 17618.
- 1PPS /10 MHz alignment at the base 10 MHz output port is slightly different on the 1204-1C 10MHz Option Cards
- 1PPS /10 MHz alignment at the base 10 MHz output port is the same as the outputs of the earlier 2204-0C 10 MHz Option Cards.
- This is due to the 10 MHz distribution for the front base output port being different than the 1204-1C Cards (the 1204-1C outputs get 10 MHz from the main board through a buffer and filter and shown below)

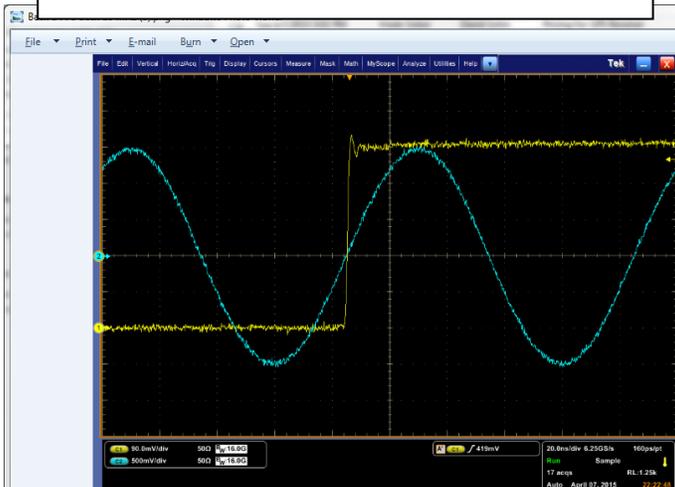
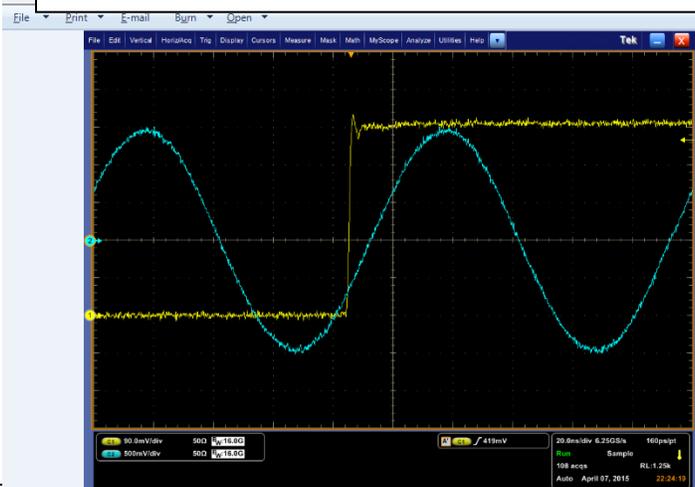
1PPS/10MHz alignment for all 1204-1C option Card outputs

1PPS/10MHz alignment for base output (and 1204-0C 10 MHz Option Cards)

Because KTS disciplining performs phase alignment of the 10 MHz output, unlike earlier NetClocks which only perform Frequency adjustments, if more than one TSync or SecureSync are synced to the same IRIG or GPS signal, the 10 MHz outputs will be in phase with each other (not just corrected for frequency).

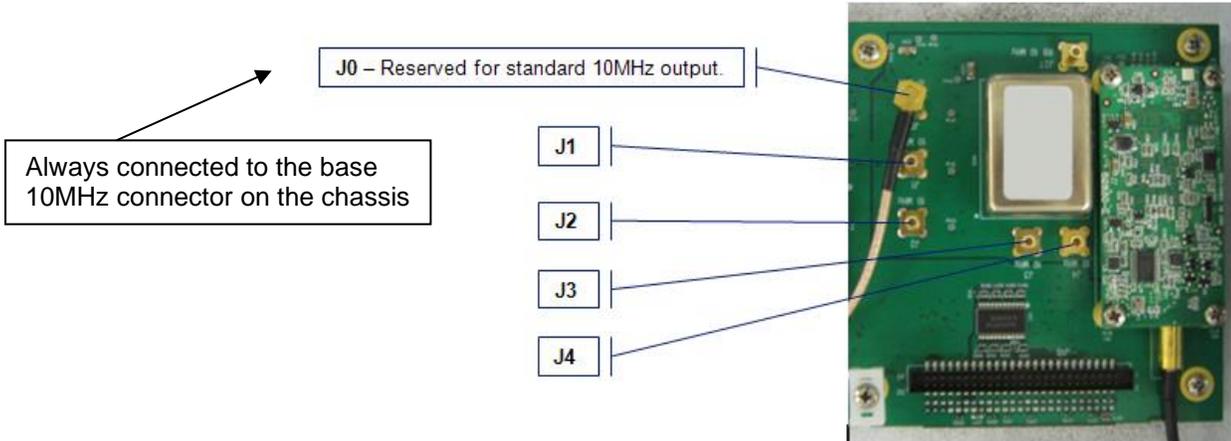
Figure 5: J Connectors

The coax cable from each Frequency Distribution Option Card should be connected to each of these connectors on the main PCB, in ascending order (this is important). Refer to the figure below, from the Option Card install guide.

- Install the coax cable(s) onto the main PCB, connecting them to the first available open connectors, from J1 - J4. Refer to figure below:

NOTE: For 10MHz option cards with 3 coax cables: From the rear of the option card, outputs are labeled J1, J2, J3. Start by connecting the cable attached to J1 on the card to the first available open connector on the SecureSync mainboard, then connect the cable attached to J2, then J3 etc.

With Signature Control enabled, if the Frequency outputs are still present on an Option Card, but not on the Base 10 MHz out (because it's squelched for a Signature Control condition), the Option Card's 10MHz coax cable may not be connected to the first J1 through J4 connector on the main PCB, in ascending order. If it's connected to the wrong connector, since Signature Control is applied to each of these ports individually based on what's connected to each slot, if it's not on the right connector, the 10MHz input to the Option Card won't be squelched by Signature Control. So, the ports on the card will still be present.
