SecureSync Option Card information

Note: This document contains both “Public Information” and “Internal Use Only Information” (do not release this document in its entirety)

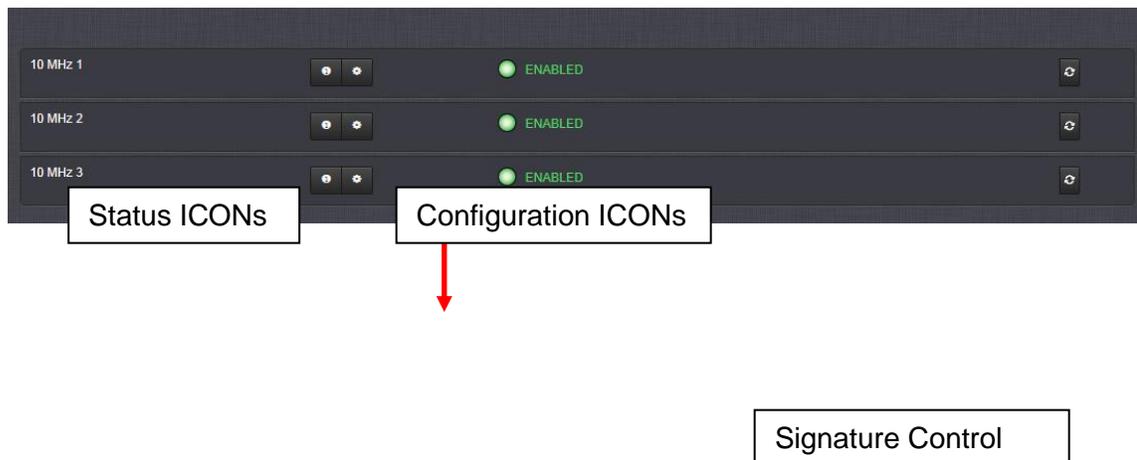
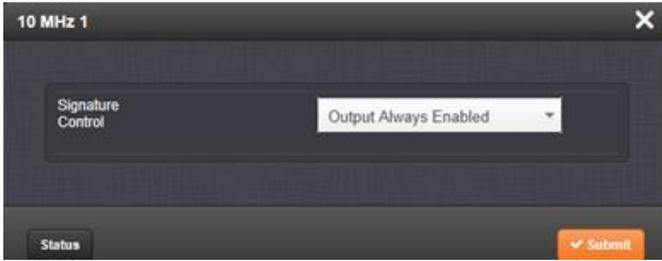
A) New web browser interface (versions 5.1.2 and above)

Signature Control: Signature Control is used to control when the 10 MHz output is present.

No Signature Control: 100 MHz output is present, even when SecureSync is not synchronized to its reference (Modulation is present while in the Holdover mode).

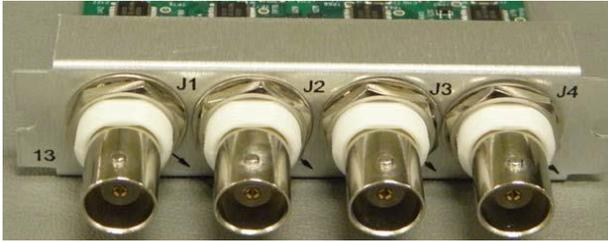
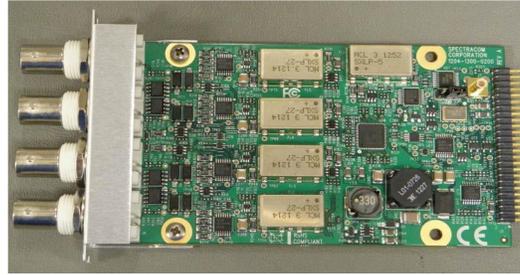
*** (1204-13) Programmable Sine wave outputs (Sine-wave out only)

The range is actually: **1Hz (1PPS) to 25MHz (25MPPS)**. The data sheet is incorrect with the range stated as being from 8kPPS(Hz) to 16384 kPPS(Hz) in 1PPS(Hz) steps

Email from Dave Sohn (16 Feb 2015) The SecureSync 1204-13 option card can generate 12.8 MHz signals with offset frequencies. Each output is individually configurable for frequency. The 1204-13 provides sine waves at +13dBm levels. These could probably be sent through a splitter to achieve what they want, within the power loss of the splitter taken into consideration. I'm not aware of anyone using SecureSync specifically to replace the Tait T801

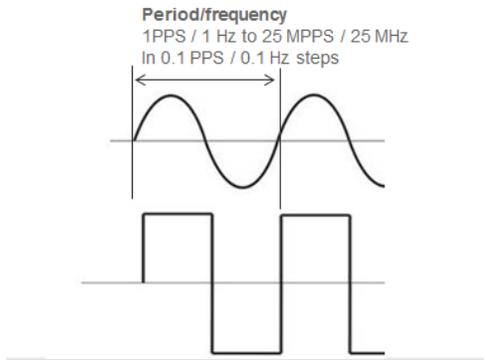
Programmable Frequency (1204-13/2F/30)

- 4 independently programmable outputs
TTL (BNC), RS-485 (terminal block), Sine versions (BNC)
- Control of period / frequency
- Compatible with N.8 frequencies

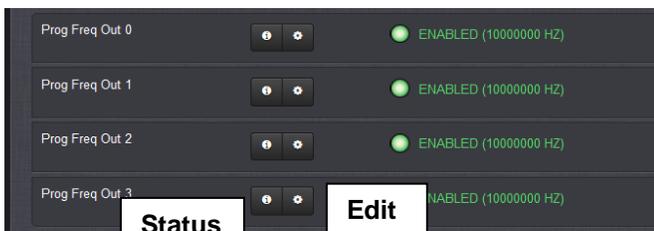
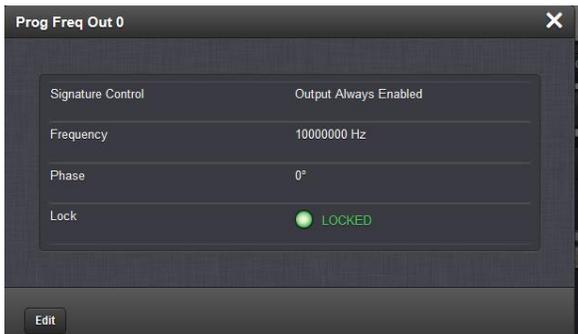
Interfaces -> Option Cards -> Prog Freq out, Sine

- **Signature Control:** Displays the current configuration of the Signature Control.
- **Frequency:** Indicates the configured frequency.
- **Phase:** Displays the configured phase offset (e.g., to account for delays caused by different cable lengths, or other latencies).
- **Lock:** Shows, if the output frequency is locked to the SecureSync system-disciplined oscillator.

NOTE: Even if an output frequency status is LOCKED, it will not be available at the output port, if the **Signature Control** for that port has been DISABLED.

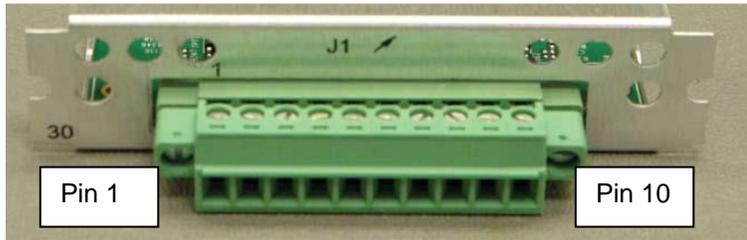
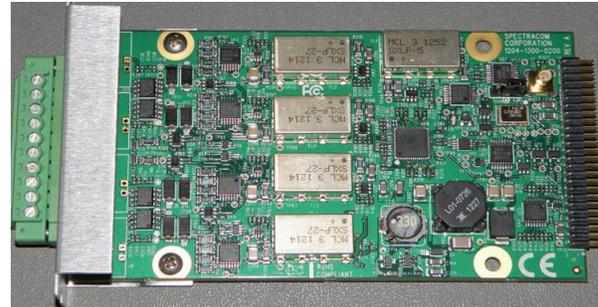
***** (1204-30) Programmable Frequency outputs (RS-485)**

Pin No	Function	Name
1	+	RS-485 Output #1 +
2	-	RS-485 Output #1 -
3	Ground	Ground
4	+	RS-485 Output #2 +
5	-	RS-485 Output #2 -
6	+	RS-485 Output #3 +
7	-	RS-485 Output #3 -
8	Ground	Ground
9	+	RS-485 Output #4 +
10	-	RS-485 Output #4 -

- (4) RS-485 outputs on a pluggable terminal block
- This RS-485 model of the programmable frequency output option card can be operated as an N.8 frequency synthesizer if frequencies are restricted to be from 8 kPPS to 8192 kPPS in 8 kPPS steps.

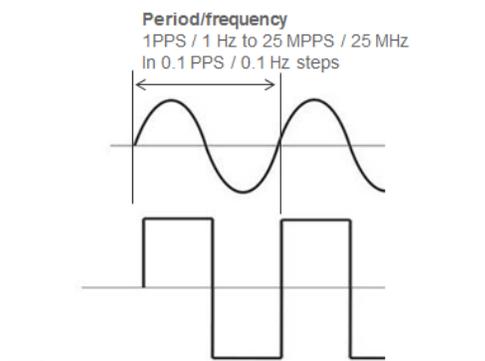
Programmable Frequency (1204-13/2F/30)

- 4 independently programmable outputs
TTL (BNC), RS-485 (terminal block), Sine versions (BNC)
- Control of period / frequency
- Compatible with N.8 frequencies

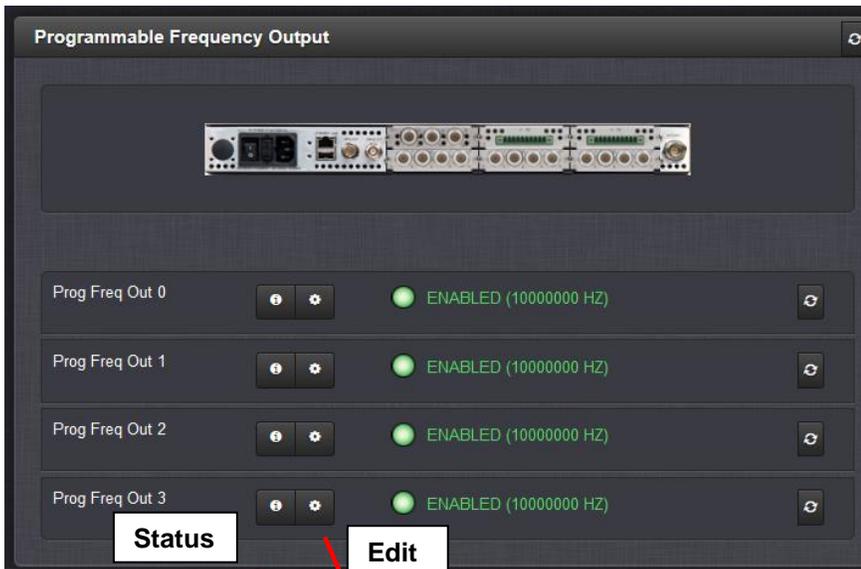
A) New web browser (versions 5.1.2 and above)
Interfaces -> Option Cards -> Prog Freq out, RS-485

Prog Freq Out 0 ✕

Signature Control	Output Always Enabled
Frequency	10000000 Hz
Phase	0

- **Signature Control:** Displays the current configuration of the **Signature Control**.
- **Frequency:** Indicates the configured frequency.
- **Phase:** Displays the configured phase offset (e.g., to account for delays caused by different cable lengths, or other latencies).
- **Lock:** Shows, if the output frequency is locked to the SecureSync system-disciplined oscillator.

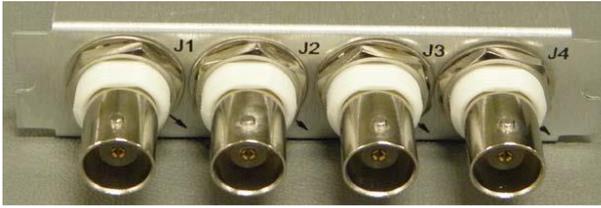
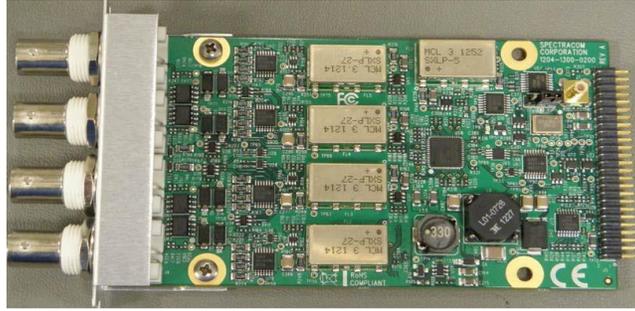
*** (1204-2F) (3) Programmable Frequency output (TTL)

Schematic: (1204-1301-0200) In Arena: https://app.bom.com/items/detail-spec?item_id=1203165573&version_id=10221245468&orb_msg_single_search_p=1&redirect_seqno=5742588471

PCB (1204-0300-F001)(in Arena): https://app.bom.com/items/detail-spec?item_id=1203165573&version_id=10221245468&orb_msg_single_search_p=1&redirect_seqno=5742588471

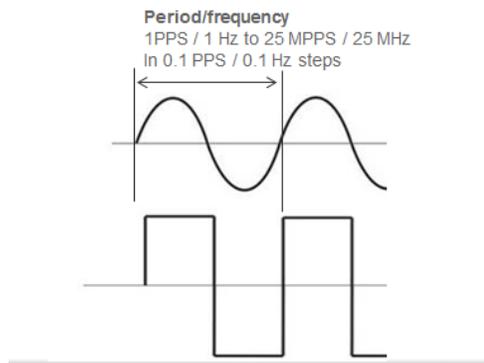
Programmable Frequency (1204-13/2F/30)

- 4 independently programmable outputs
TTL (BNC), RS-485 (terminal block), Sine versions (BNC)
- Control of period / frequency
- Compatible with N.8 frequencies

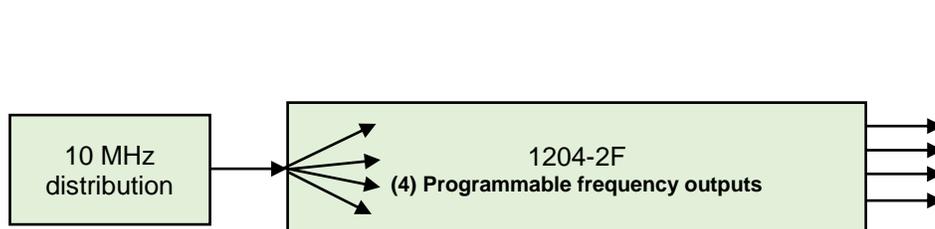
Block Diagram

Four RS-485 Square Wave outputs (Terminal block)

Each output can be phase offset as desired (0 to 360 degrees in 0.1 degree steps)

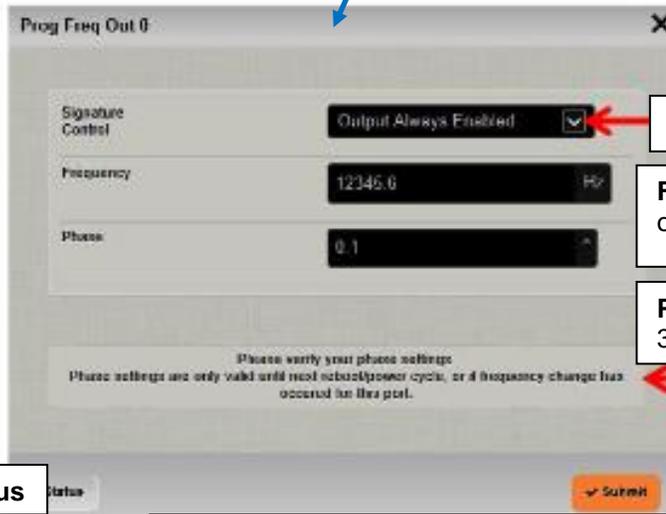
Interfaces -> Option Cards -> Prog Freq out, TTL

Signature Control

Frequency: Enter the desired output frequency. Pulse rate output in Hertz: 1 to 25,000,000 PPS (25MPPS)

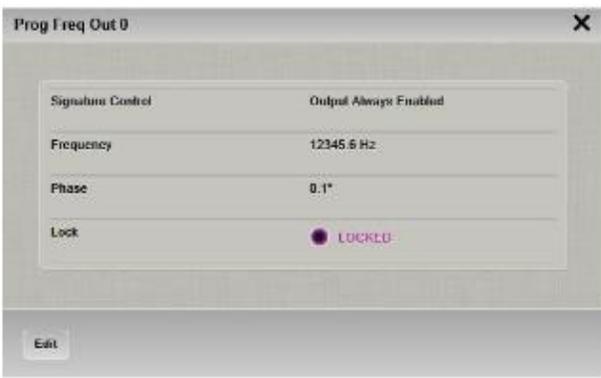
Status

- **Signature Control:** Displays the current configuration of the **Signature Control**.
- **Frequency:** Indicates the configured frequency.
- **Phase:** Displays the configured phase offset (e.g., to account for delays caused by different cable lengths, or other latencies).
- **Lock:** Shows, if the output frequency is locked to the SecureSync system-disciplined oscillator.

NOTE: Even if an output frequency status is **LOCKED**, it will not be available at the output port, if the **Signature Control** for that port has been **DISABLED**.

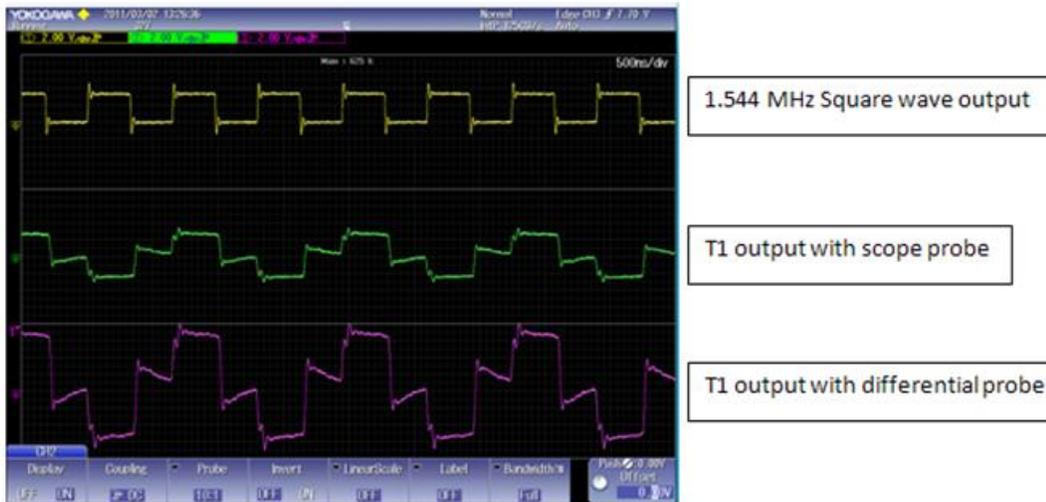
DS1 (T1 outputs on a scope)

Screenshot of DS1 output from a SecureSync DS1 output Option card

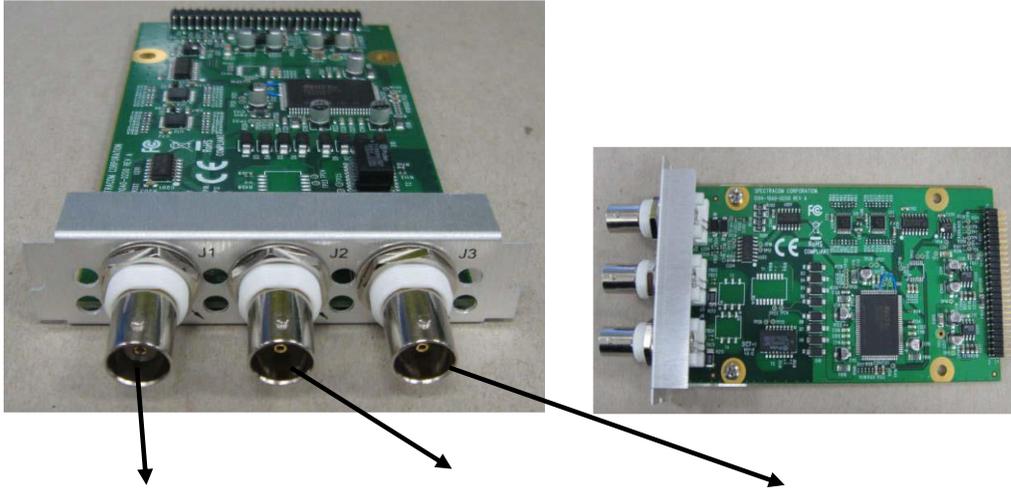
1204-09 E1/T1 - 75 Ohm, 3 BNC Option Card

(J1) 1.544MHz/2.048MHz square wave output
 (see note below about T1)
 TTL levels into 50 ohms

(J2) E1/T1 output
 (see note below about T1)
 2.37v into 75 ohms

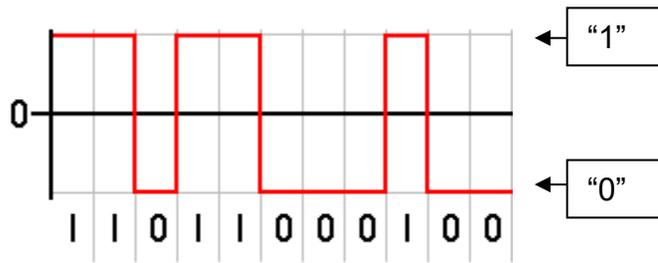
Summary: A "1" is above 0vdc. A "0" is below 0vdc.

NRZ means "non-return to zero" see this article. It is electrical, not Coding. Helps maintain zero DC bias.
<http://en.wikipedia.org/wiki/Non-return-to-zero>

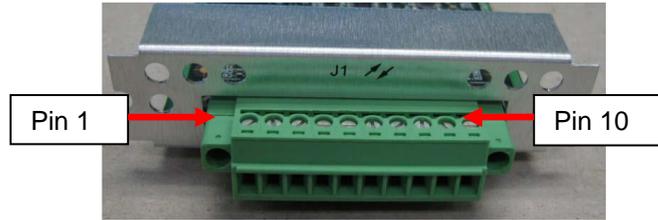
***** (1204-0A) (2) T1/E1 outputs 1.544/2.048 MHz output (120 ohm)**

Note: This card is also NetClock “Option 13: T1/E1 output”

Pin No	Function	Name	Spec
1	Ground	Gnd	
2	1.544MHz/2.048 MHz	RS-485 A termination	GR-499-core (100 ohm)
3	1.544MHz/2.048 MHz	RS-485 B termination	GR-499-core (100 ohm)
4	Ground	Gnd	
5	T1/E1 output A1 (Tip)		ITU-T G703 (120 ohm impedance)
6	T1/E1 output B1 (Ring)		ITU-T G703 (120 ohm impedance)
7	Ground	Gnd	
8	T1/E1 output A2 (Tip)		ITU-T G703 (120 ohm impedance)
9	T1/E1 output B2 (Tip)		ITU-T G703 (120 ohm impedance)
10	Ground	Gnd

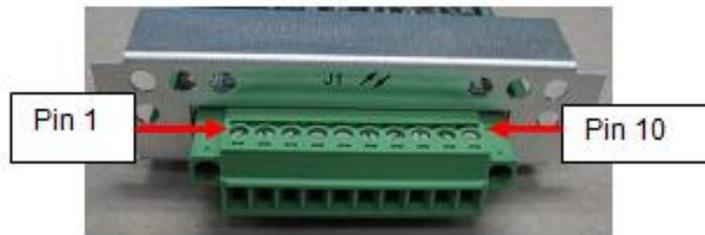
Outputs

Pin No	Function	Name	Spec
1	Ground	<u>Gnd</u>	
2	1.544MHz/2.048 MHz	RS-485 A termination	GR-499-core (100 ohm)
3	1.544MHz/2.048 MHz	RS-485 B termination	GR-499-core (100 ohm)
4	Ground	<u>Gnd</u>	
5	T1/E1 output A1 (Tip)		ITU-T G703 (120 ohm impedance)
6	T1/E1 output B1 (Ring)		ITU-T G703 (120 ohm impedance)
7	Ground	<u>Gnd</u>	
8	T1/E1 output A2 (Tip)		ITU-T G703 (120 ohm impedance)
9	T1/E1 output B2 (Tip)		ITU-T G703 (120 ohm impedance)
10	Ground	<u>Gnd</u>

→ 1.544MHz or 2.048MHz squarewave outputs

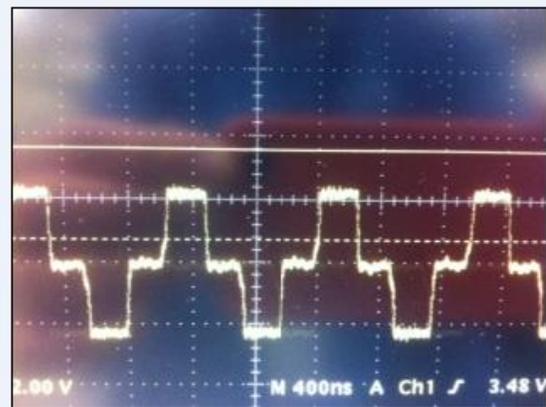
E1 output

The 1204-0A Option Card is T1 100ohm and E1 is 120ohm. The 1204-09 Option Card is E1 75ohm.

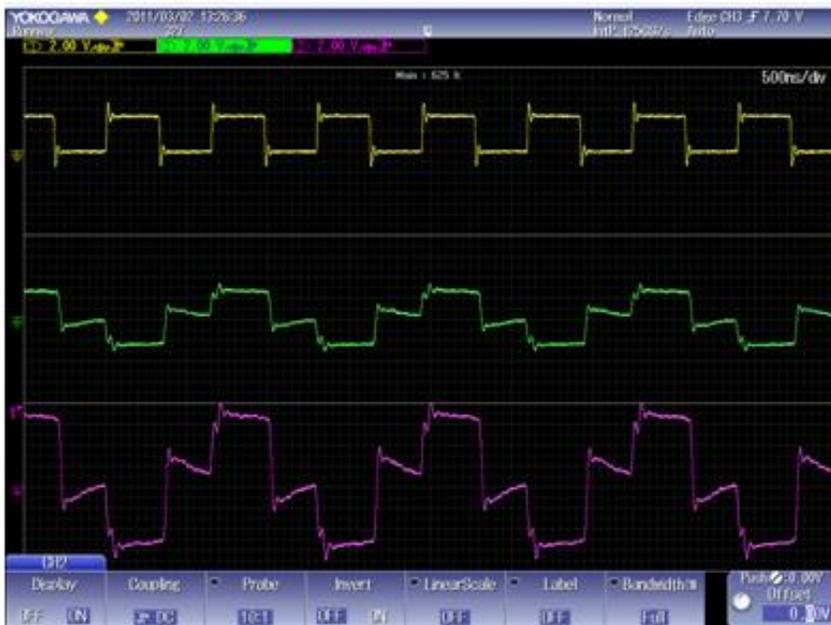
1.544 MHz Square wave output

T1 output with scope probe

T1 output with differential probe

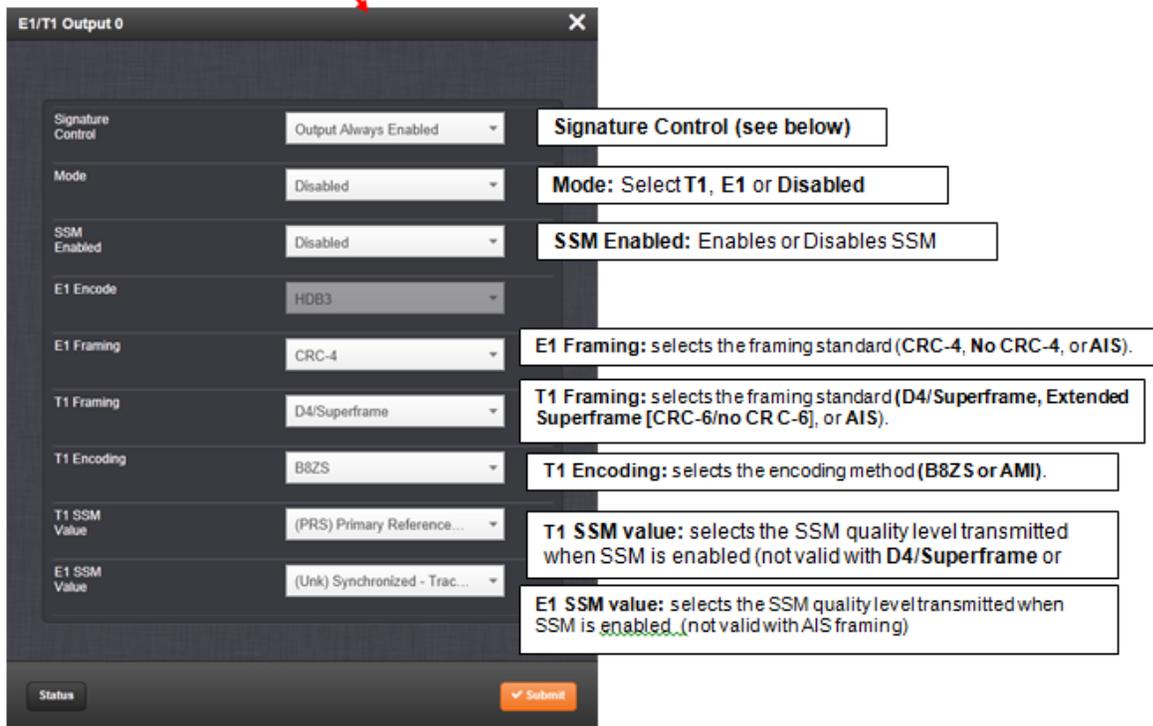
SSM configuration (versions 4.8.8 and above only)

- **Signature Control**—Controls when the output will be present. Options include:
 - **Output Always Enabled**—The output is present, even when SecureSync is not synchronized to its references.

- **Output Enabled in Holdover**—The output uses the current framing mode unless SecureSync is not synchronized to its references (the output is present while in the Holdover mode). While not synchronized, the output will change SSM states if SSM is enabled, or transition to AIS.

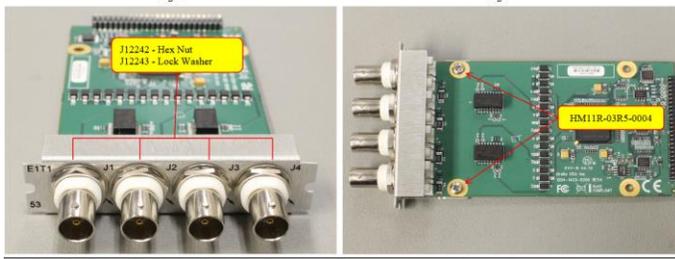
1204-53 Quad (4 port) (75 Ω) E1/T1 OUT, 4-BNC Option Card

- This newer card is a 4-port version of the original 2-port E1/T1 cards (BNC outputs)
- Refer to (in SAP) ECO-FAI-2381 (Dec 2019): https://app.bom.com/changes/detail-summary?change_id=2399435792&

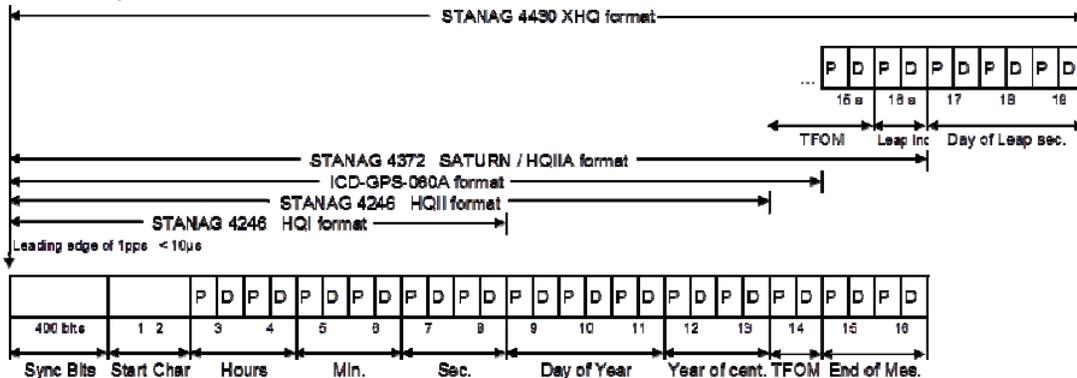
STANAG 4430 & HaveQuick Format

Time scale is UTC

Each character is one octet of Hamming code: 4 bits of parity precluding 4 bits of data except for specific Start character

Character	Meaning	Character	Meaning
1	Lead Ind. (00010001)	9	Day of Year 100's digit
2	Lead Ind. (11101001)	10	Day of Year 10's digit
3	Hours MSD	11	Day of Year 1's digit
4	Hours LSD	12	Year of century MSD
5	Minutes MSD	13	Year of century LSD
6	Minutes LSD	14	Time Figure of Merit, power of 10^{-10}
7	Seconds MSD	15	End of Message
8	Seconds LSD	16	End of Message
15a	Time Figure of Merit, scale factor	17	Leap sec. Day of Year 100's digit
16a	Leap activity indicators	18	Leap sec. Day of Year 10's digit
		19	Leap sec. Day of Year 1's digit

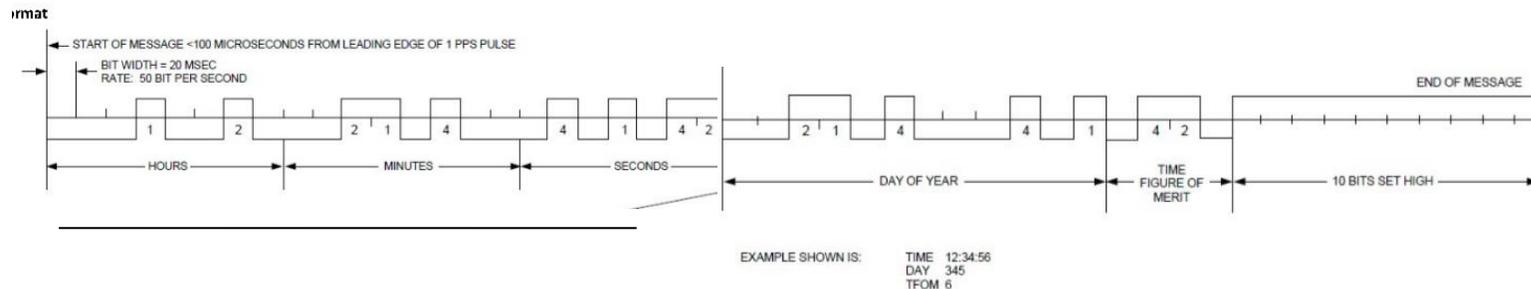
BCD Format

Timing Fault Discrete (TFD): (From ICD-GPS-060 <http://www.navcen.uscg.gov/pdf/gps/ICD-GPS-060B.pdf>):

The interfacing equipment which supplies the 1PPS and BCD data provides a timing fault discrete which informs the UE if the transmitting equipment is functioning properly. In the event that the BCD time code information is provided to the GPS UE receiver without a Timing Fault Discrete signal (hard wire), the UE receiver recognizes this condition and assumes the Timing Fault Discrete signal line to be set high, thus accepting any data that is input to the GPS receiver via the PTTI port.

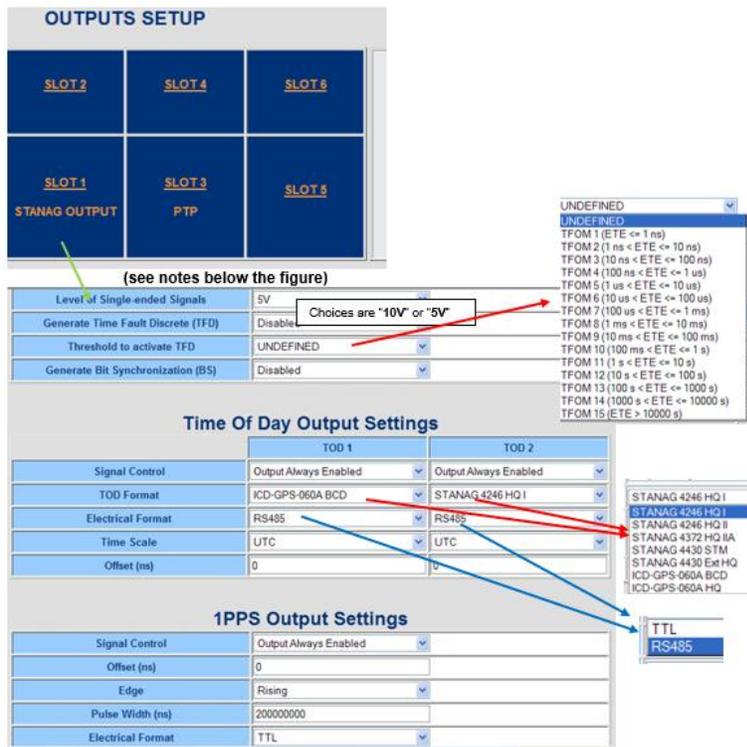
Setup -> Outputs -> Stanag Output

(Option Cards with Stanag/Havequick outputs, such as 1204-10, 1204-1B, 1204-11 and 1204-25)

(see notes below the figure)

Generate Timing Fault Discrete (TFD): (From ICD-GPS-060 <http://www.navcen.uscg.gov/pdf/gps/ICD-GPS-060B.pdf>) The interfacing equipment which supplies the 1PPS and BCD data provides a timing fault discrete which informs the UE if the transmitting equipment is functioning properly. In the event that the BCD time code information is provided to the GPS UE receiver without a Timing Fault Discrete signal (hard wire), the UE receiver recognizes this condition and assumes the Timing Fault Discrete signal line to be set high, thus accepting any data that is input to the GPS receiver via the PTTI port.

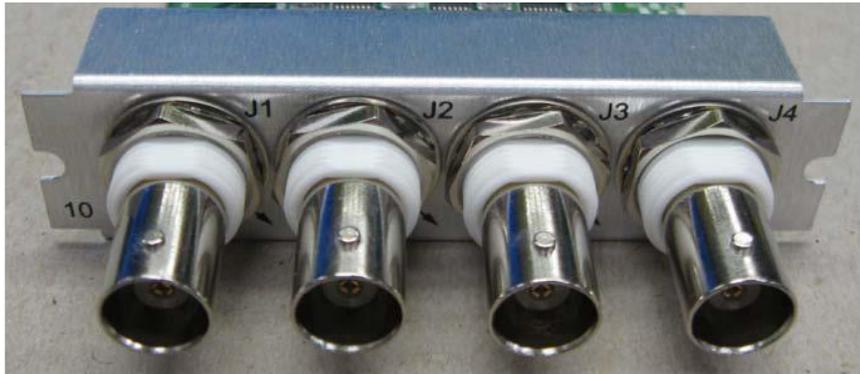
Note: Model 1204-10 is four (single-ended) havequick TTL outputs on BNC connectors

(J1 – J4) Four separate outputs (270 ohm termination)

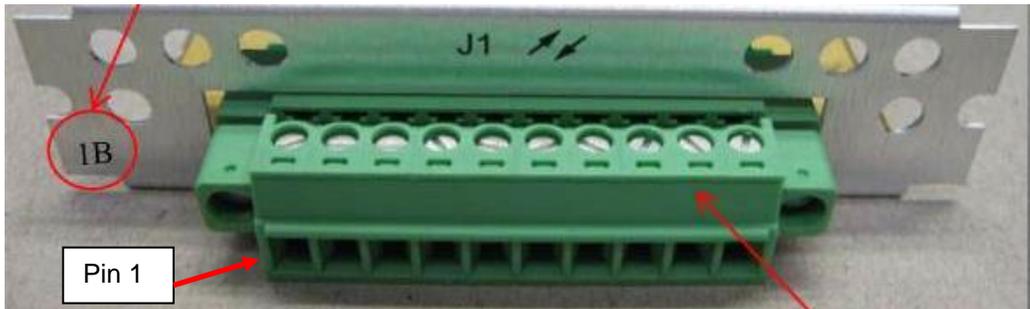
Model 1204-1B HAVE QUICK Card Pin Assignments

Model 1204-1B is four RS-485 (differential) havequick outputs on terminal block connector

Pin. No.	Function
1	HAVE QUICK Output 1 +
2	HAVE QUICK Output 1 -
3	GND
4	HAVE QUICK Output 2 +
5	HAVE QUICK Output 2 -
6	HAVE QUICK Output 3 +
7	HAVE QUICK Output 3 -
8	GND
9	HAVE QUICK Output 4 +
10	HAVE QUICK Output 4 -

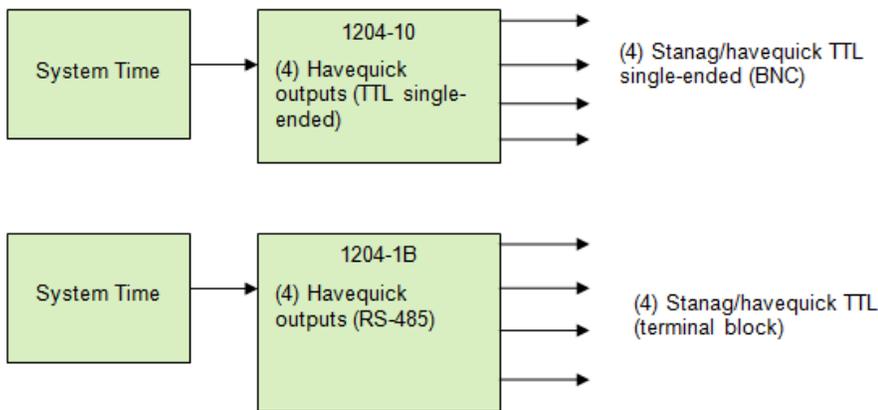
Block Diagram

Schematic: (refer to 1204-0100-F000) <I:\New Released\PCB Documentation>

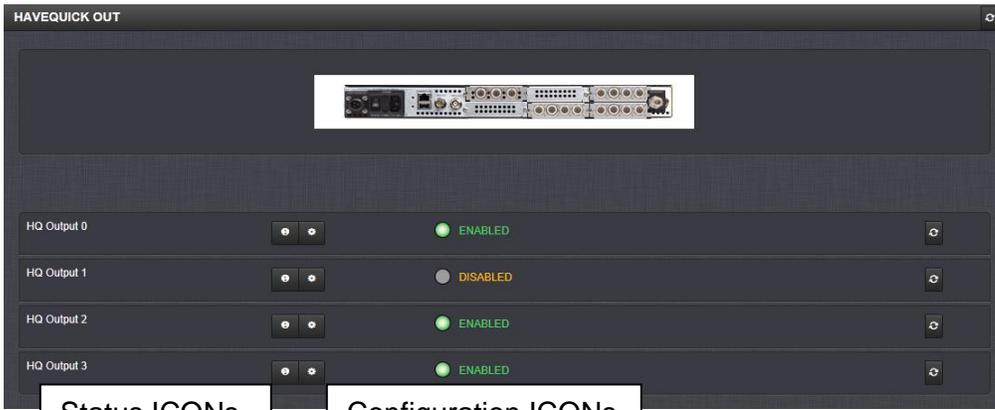
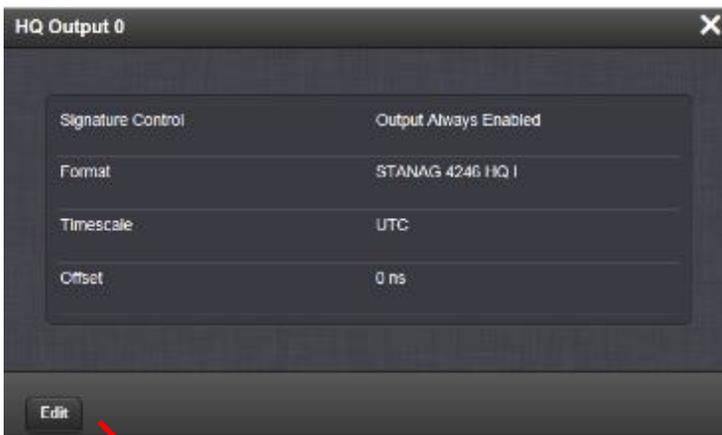
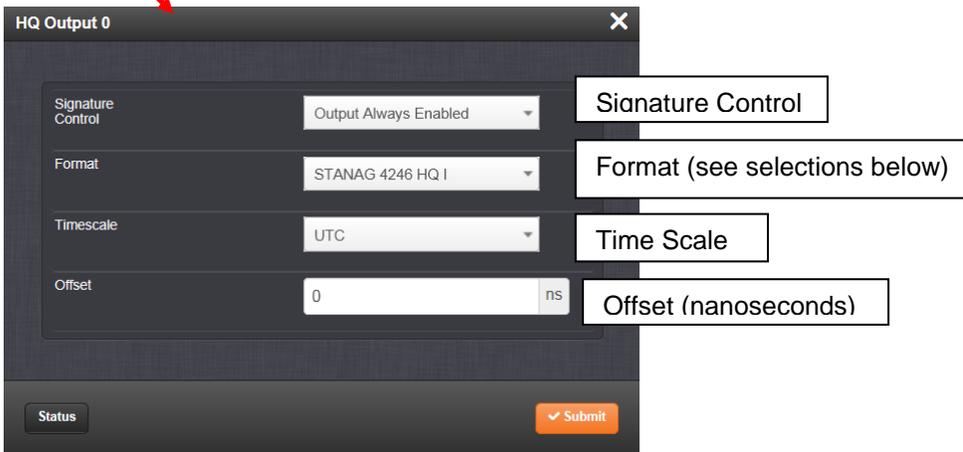
Interfaces -> Option Cards page

Format—Used to configure the formatting of the four available HAVE QUICK outputs. The available output formats are as follows:

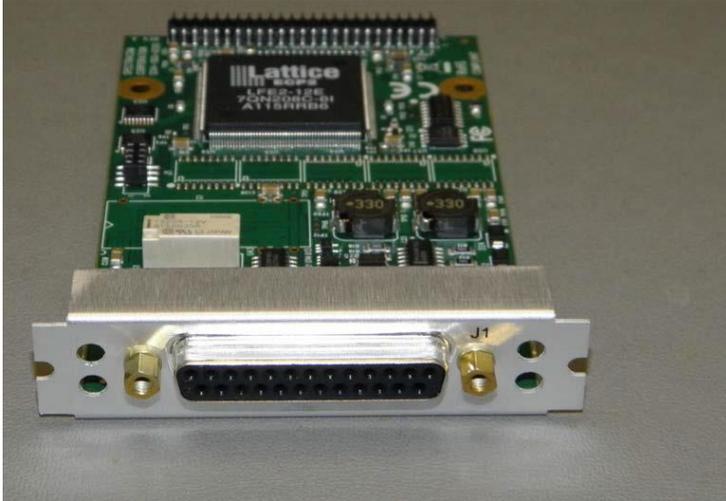
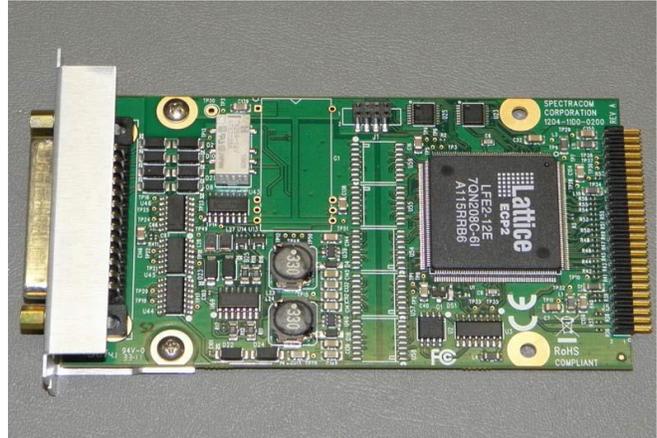
Model 1204-11 is four (single-ended) havequick non-isolated outputs on BNC connectors

Model 1204-25 is four RS-485 (differential) havequick galvanically isolated outputs on terminal block connector). Offers same Stanag functionality as Epsilon Clock EC2S)

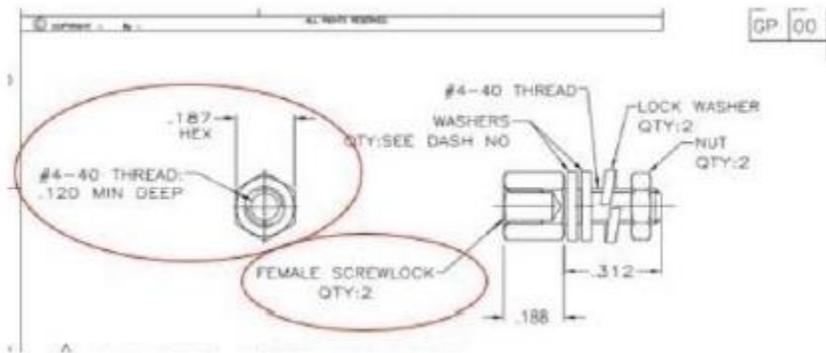
“Jack Screw”

- Our P/N J03328 (SCREWLOCK ASSY FEMALE)
- Tyco Electronics P/N 5205817-1
- MFG datasheet: https://www.mouser.com/datasheet/2/418/NG_CD_5205817_D-1252167.pdf

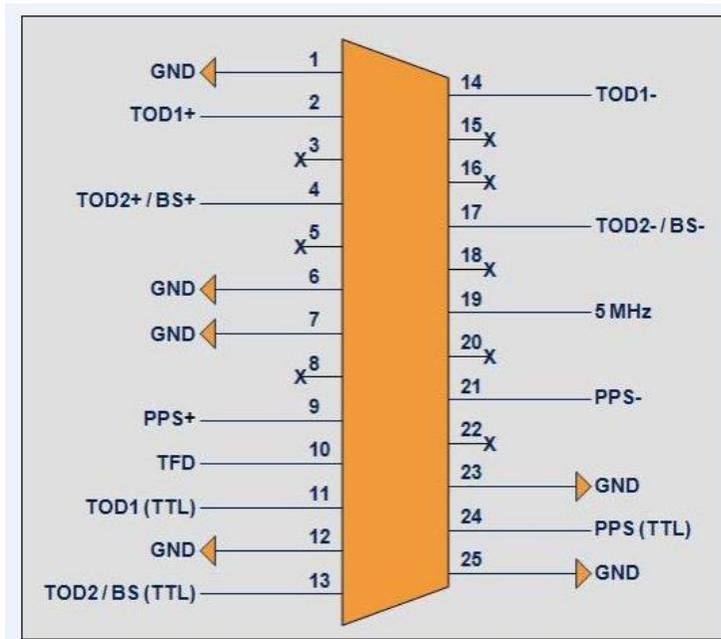
Pinouts

For the pin-out of this card, navigate to the **Setup-> Outputs /1204-11 Option Card** page of the browser. Then select the **"SUB-D Connector Pinout"** Tab

Output Index 1: PIN 2-14 for RS485 message (11 for TTL)

Output Index 2: PIN 4-17 for RS485 message (13 for TTL)

GND: PIN 1, 6, 7, 12, 23 et 25. The GND is not connected to the mechanical part (isolation).

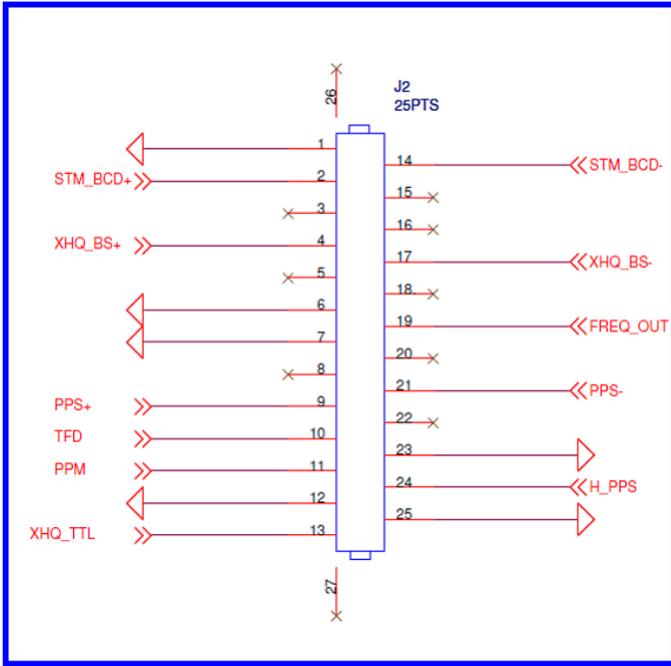
STANAG SUB-D CONNECTOR

- (2) Stanag (TOD1 and TOD2) RS-485 differential outputs in **light Green** and **dark Green**
- (2) Stanag (TOD1 and TOD2) TTL single-ended outputs in **light purple** and **dark purple**
- (1) 1PPS (RS-485 Differential) output in **light Blue**
- (1) 1PPS (TTL Single-ended) output in **dark Blue**

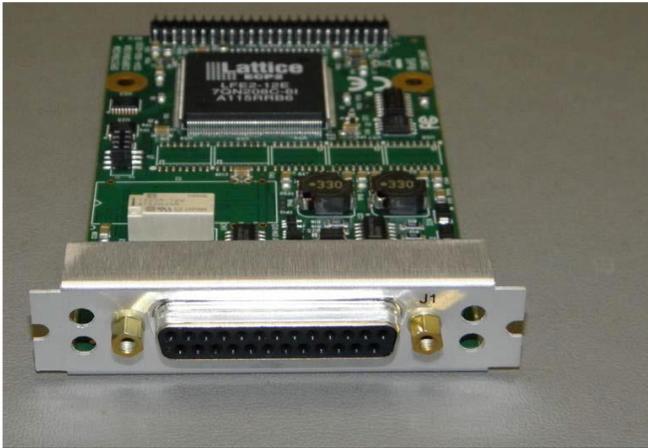
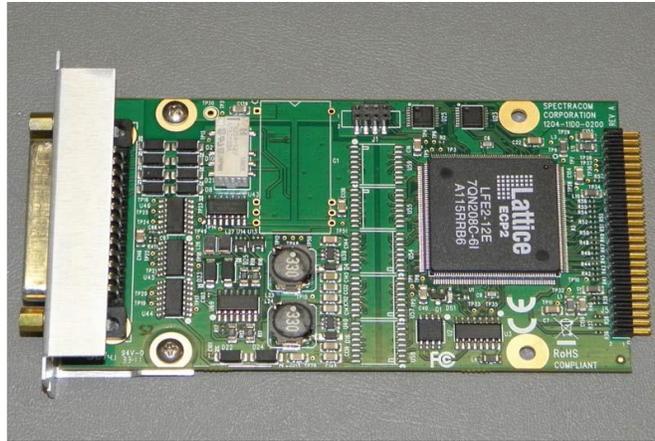
- **1204-24** is Galvanically isolated inputs
- **1204-1D** is non-isolated inputs

Inputs only (no outputs)

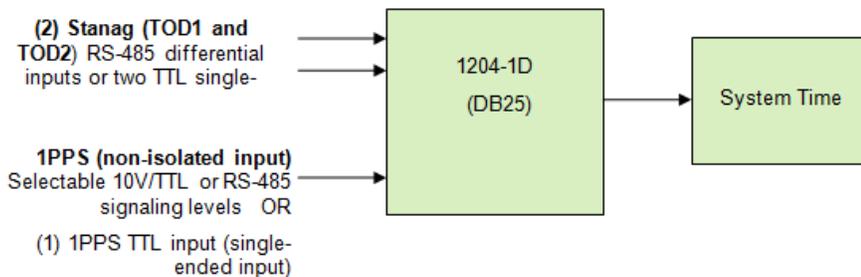
Block Diagram (1204-24 And 1204-1D)

Outputs: None

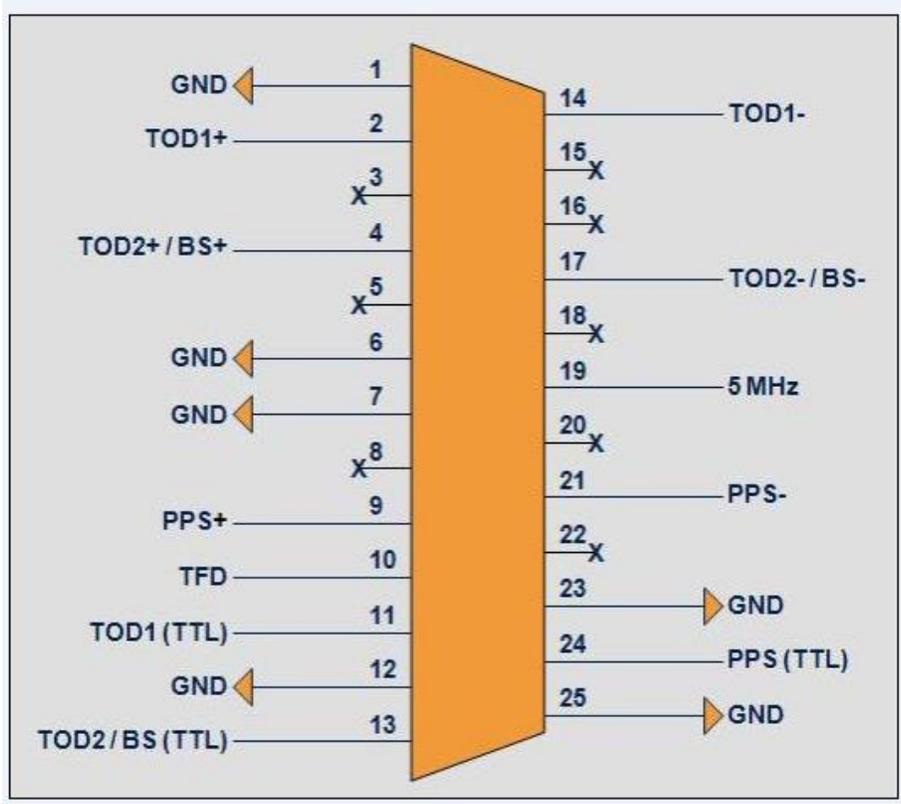
Pin-out information

Note: all input signals (no outputs available for this card)

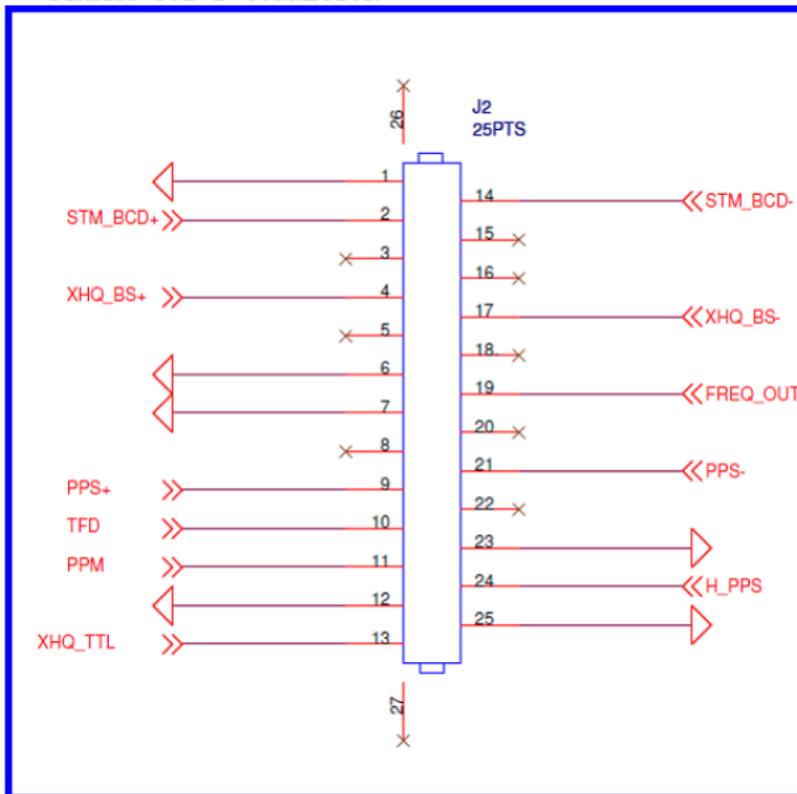
STANAG SUB-D CONNECTOR

- (2) Stanag (TOD1 and TOD2) RS-485 differential inputs in **light Green** and **dark Green**
- (2) Stanag (TOD1 and TOD2) TTL single-ended inputs in **purple** and **dark purple**
- (1) 1PPS (RS-485 Differential) input in **light Blue**
- (1) 1PPS (TTL Single-ended) input in **dark Blue**

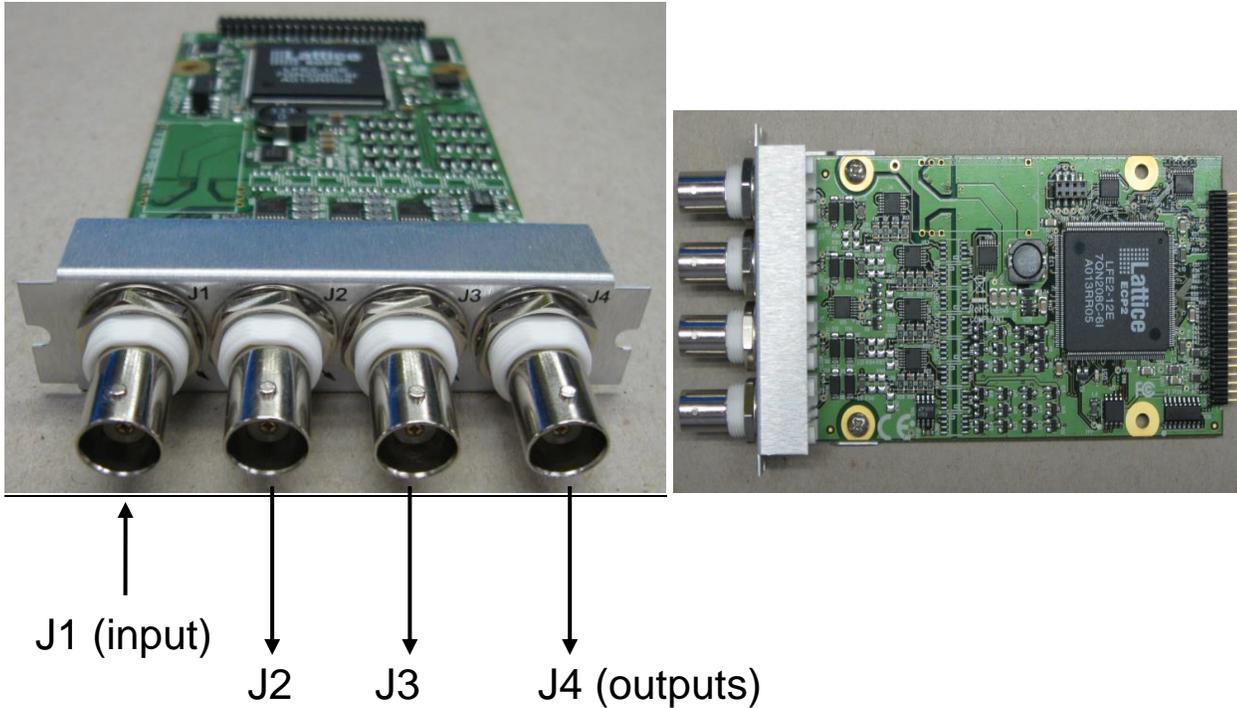
***(1204-29) (1) input/3-output Havequick Option Card (TTL single-ended BNC)

Schematic: (refer to 1204-0100-F000) [I:\New Released\PCB Documentation](#)

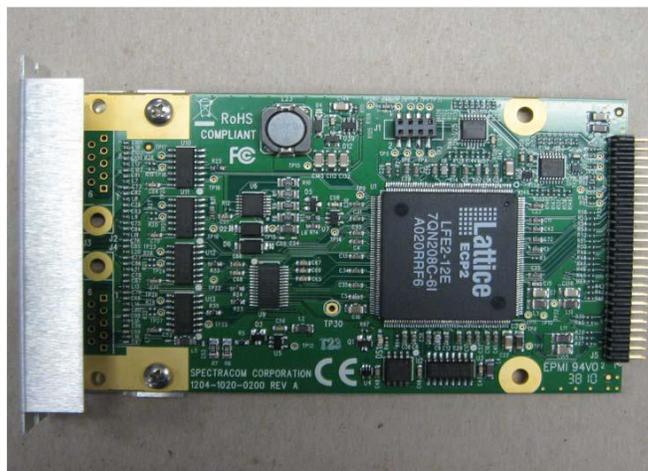
- **Model 1204-10** is four (single-ended) havequick TTL outputs on BNC connectors
- **Model 1204-1B** is four RS-485 (differential) havequick outputs on terminal block connector

Pin No.	Function	
1	HaveQuick output 1 +	→ Havequick output 1
2	HaveQuick output 1 -	
3	Gnd	
4	HaveQuick output 2 +	→ Havequick output 2
5	HaveQuick output 2 -	
6	HaveQuick output 3 +	→ Havequick output 3
7	HaveQuick output 3 -	
8	Gnd	
9	HaveQuick output 4 +	→ Havequick output 4
10	HaveQuick output 4 -

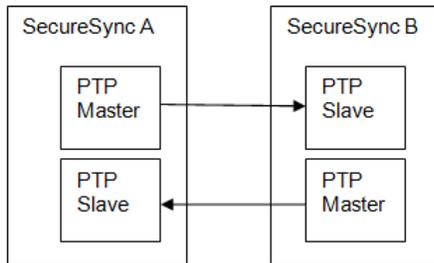
- C) Two Crossover cables:** Use a cross-over network cable from the PTP Master of one SecureSync to the PTP slave of the other SecureSync. Then use another network cross-over cable from the other PTP Master directly to the other PTP Slave card.

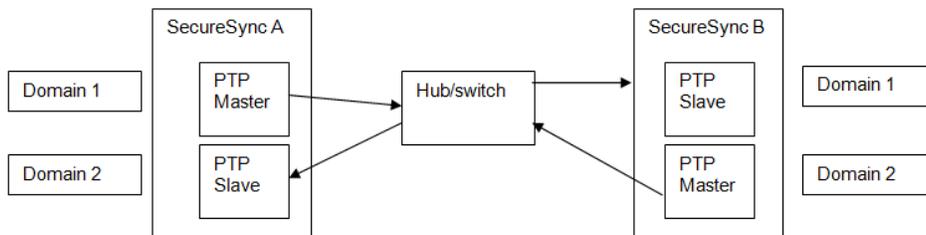
- D) Same network/different domains:** The multiple PTP Masters and PTP Slaves can be connected to the same network. Configure one set of PTP Master / PTP Slave to be on one PTP domain number (“1”). Then configure the other PTP Master / PTP slave pair to be on another PTP Domain number (“2”).

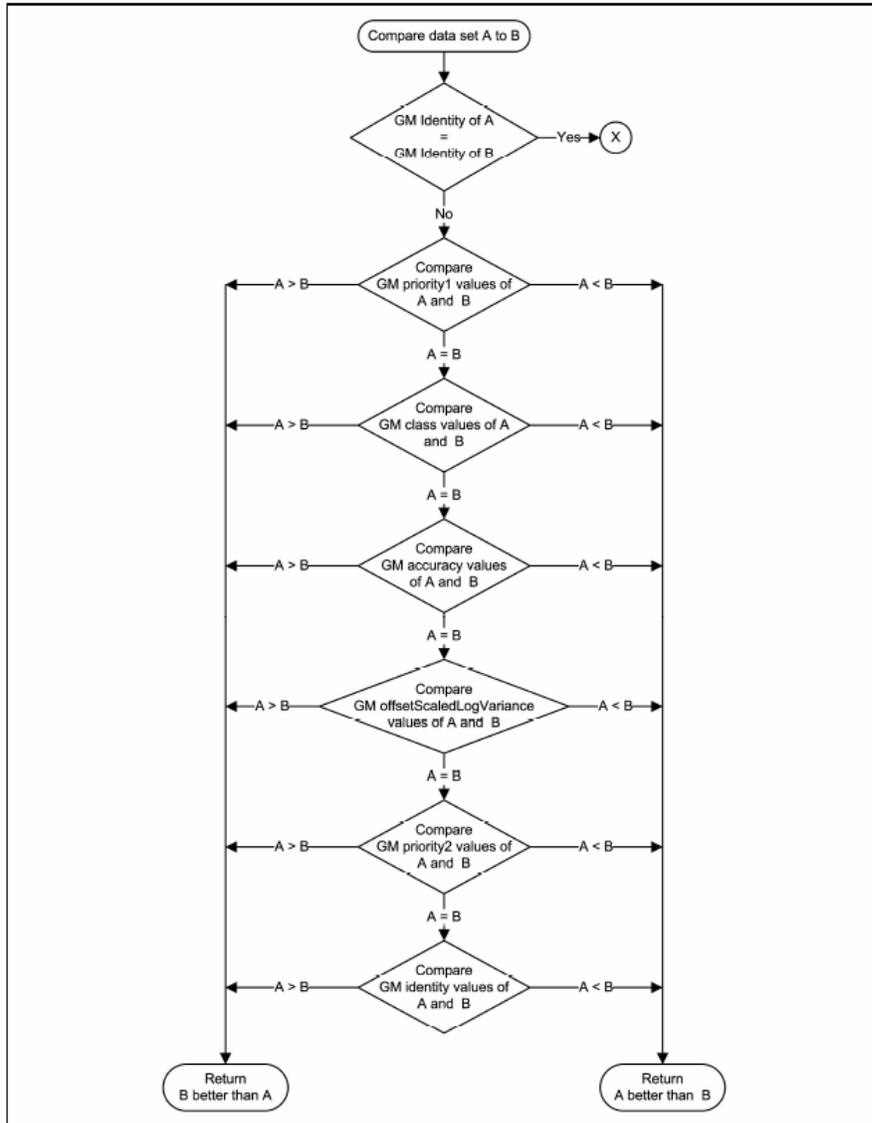
Best Master Clock (Active Master) Selection process (Passive Master when not selected)

Here is a flowchart of the master selection process.

Best Master Clock algorithm consists of the following three factors (in descending order of precedence)

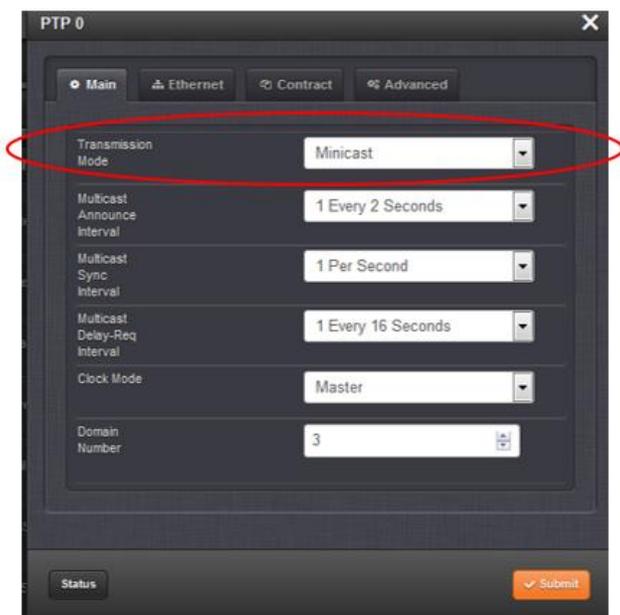
C) PTP “Minicast” mode

- Minicast is similar, but not exactly the same as Hybrid
- Minicast is a unique modification of Unicast mode.
 - PTP Slaves only **unicast contract for Delay Responses**.
 - **Announce, Sync and Follow-up packets** are still sent by Master in **multicast mode**

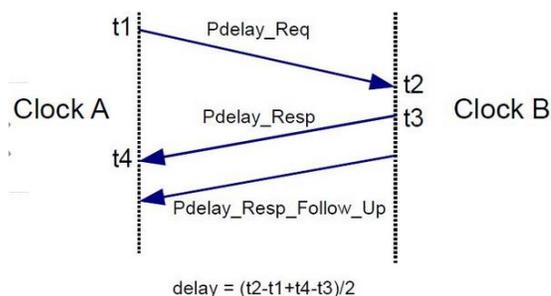
- Measures the path delays as individual delays between each host (measures network segments individually) and then combines the values for a total. Provides additional accuracies. P2P can be better, because in theory you are measuring the delay of each path separately, which will minimize problems if packets take different paths. But this requires that all your network elements in the path know how to exchange peer delay messages.

From: <https://blog.meinbergglobal.com/2013/09/19/end-end-versus-peer-peer/>

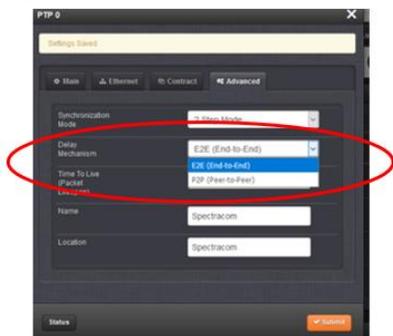
Delay mechanism configuration for 1204-12

- configured in the **Advanced** tab, “**Delay mechanism**” field

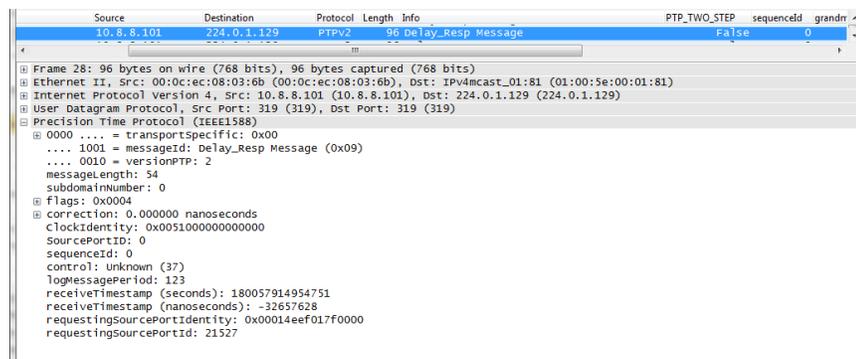
A) SequenceID (sequence ID) reported as 0 (observed in fielded unit)

- Noticed in Pico Trading packet captures that the 1204-12 card was periodically setting the Sequence ID value to 0 in Delay response and reporting other bogus info in these same packets. Example below.
 - Refer to Salesforce Case 15800 and 15817.

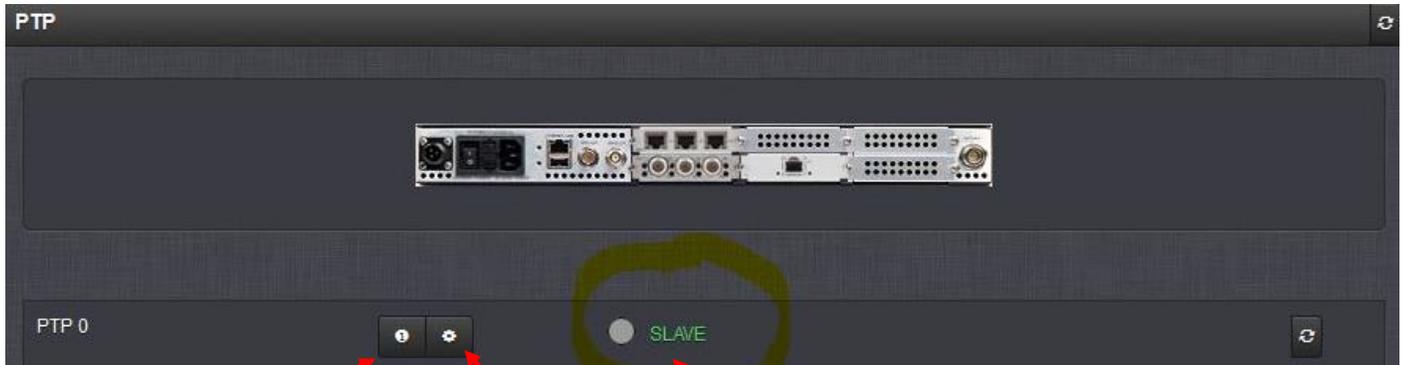
Interfaces -> PTP page

PTP: Indicates 1204-12 (10/100) Option Card
Gb PTP: Indicates 1204-32 (10/100/1000) Option Card
