SecureSync Option Card information

Note: This document contains both “Public Information” and “Internal Use Only Information” (do not release this document in its entirety)

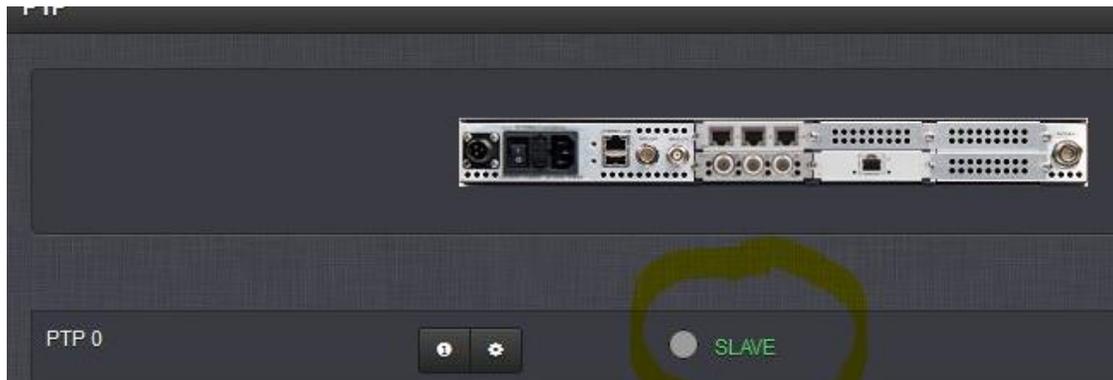
Blinking "Slave" LED

Q. The PTP Slave Led in the WEB interface is blinking all the time, is this normal?

A. **Per Denis Reilly (24 March 2014)** The blinking lights on the mini-status line are generated by the web interface, while the text is generated by direct feedback from the card. If the lights and text are conflicting, I think the text should be considered more accurate. (But they shouldn't be conflicting – please enter a mantis case if you think there is a problem.)

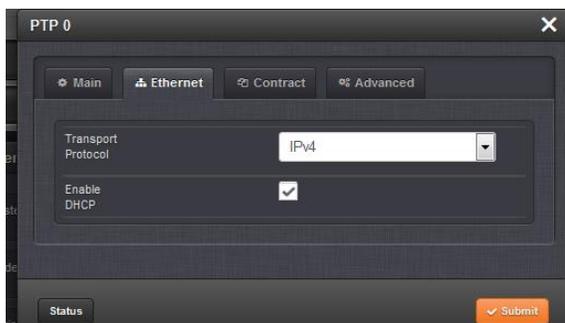
B) With DHCP enabled

The screenshot shows the 'Ethernet' tab of the 'PTP 0' configuration window. The 'Transport Protocol' dropdown menu is set to 'IPv4'. The 'Enable DHCP' checkbox is checked. The 'Advanced' tab is also visible, indicating that the 'Transport Protocol' dropdown is currently disabled.

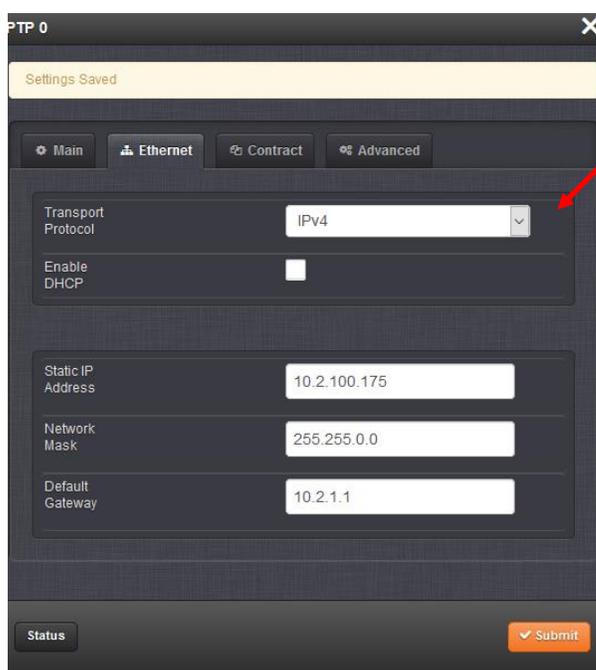
C) With DHCP not selected

The screenshot shows the 'Ethernet' tab of the 'PTP 0' configuration window. A 'Settings Saved' message is displayed at the top. The 'Transport Protocol' dropdown menu is set to 'IPv4'. The 'Enable DHCP' checkbox is unchecked. The 'Advanced' tab is visible, and the 'Transport Protocol' dropdown menu is now active, showing a list of options. Below the Ethernet settings, the 'Static IP Address' is set to '10.2.100.175', the 'Network Mask' is '255.255.0.0', and the 'Default Gateway' is '10.2.1.1'.

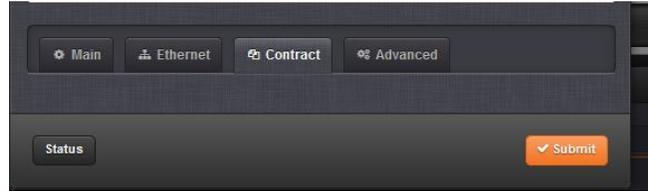
Note: The Contract fields are **not** displayed (as shown directly below) when:

- 1) **Transmission** Mode (in **Main** tab) is set to “**Multicast**”
- 2) and/or **Delay Mechanism** (**Advanced** tab) has been changed from **E2E** (default selection) to **P2P**

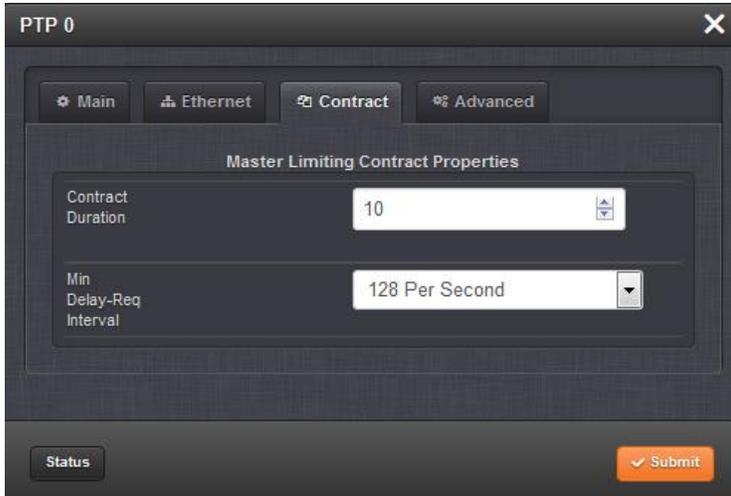
Contract tab when configured for Minicast mode (and Transmission mode in Advanced tab is not set to “Multicast”, and Delay Mechanism is set to default value “E2E”)

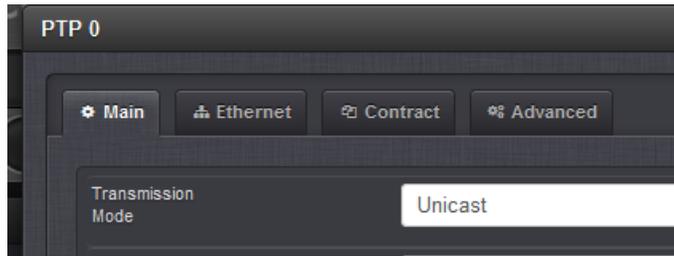
Note whether or not the various Contract configuration fields are displayed in the **Contract** tab is dependent upon which drop-down field is **selected in the "Transmission Mode" field (Main tab)**, as shown directly below

A) Contract tab when Multicast Transmission mode is selected in the Main tab

- Contracts **do not** apply to **Multicast** mode, so the fields **are not** displayed in the Contract tab

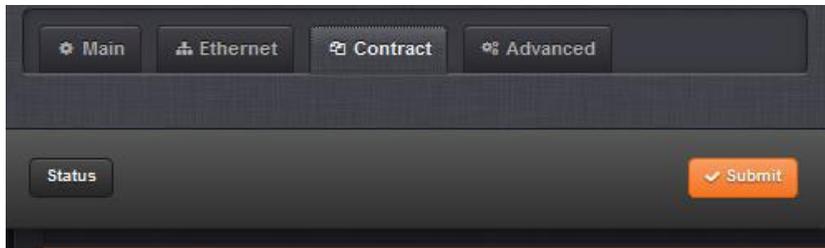
B) Contract tab when Unicast Transmission mode is selected in the Main tab

- Contracts **do** apply to **Unicast** mode, so the fields ARE displayed in the Contract tab

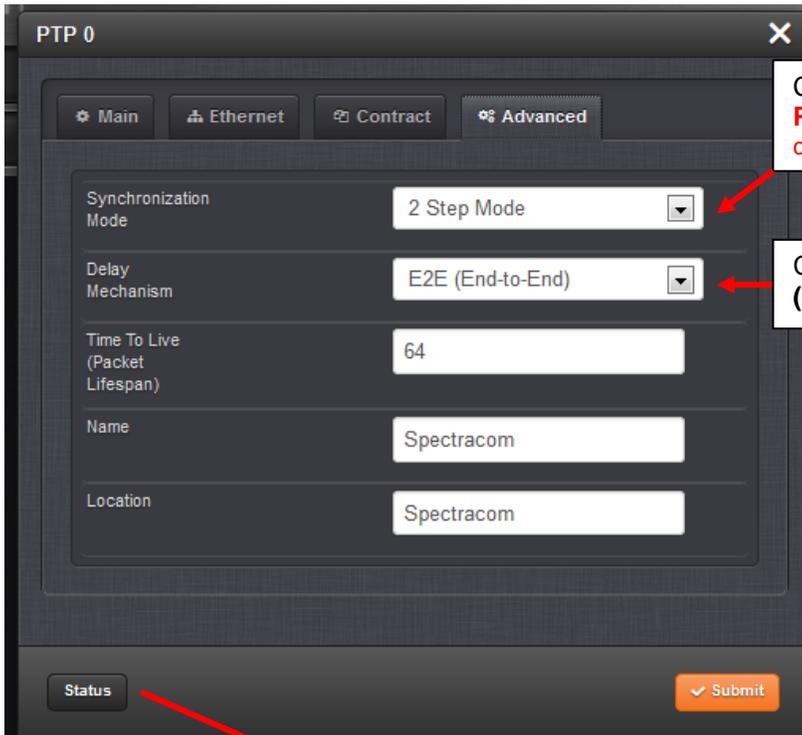
Advanced tab when configured as a PTP Slave

Choices are: **1 Step Mode** and **2 Step Mode**
Per Denis Reilly (24 Mar 2014) Although the 10-100 card supports one-step, we don't recommend it

Choices are: **"E2E (End to End)"** or **"P2P (Peer to Peer)"**

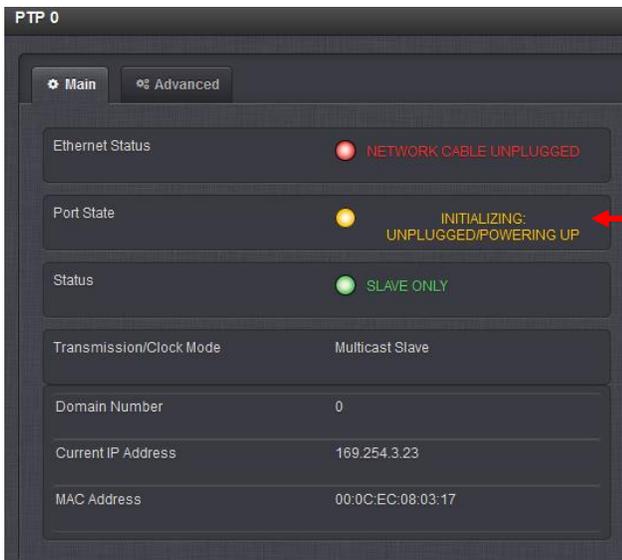
"Main" tab (Ethernet Status-link state/link status, Number of unicast slaves, PTP Domain, IP address/MAC address)

Notes about "Port State":

- **Initializing: unplugged/powering-up:** Cable is unplugged / in power-up state.
- **Listening:** PTP is looking for a Master.
- **Master:** PTP Master has become the active master on the network.
- **Passive:** PTP Master has become a passive master. (There is another Master on the network with higher priority.) This Master will wait until such time as the Best Master Clock Algorithm determines it should be the Best Master. Then it will transition to the Master state.
- **Slave:** PTP Slave is actively synchronizing to a Master on the network.
- **Uncalibrated:** PTP Slave has detected a Master on the network (See below)

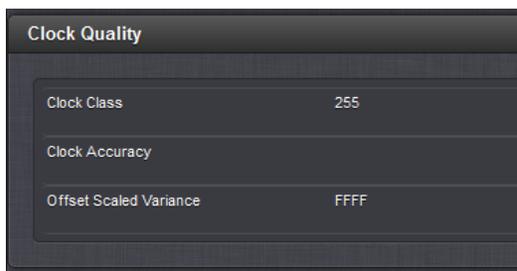
“Clock Quality” section of Advanced tab (“Clock Class”, “Clock Accuracy” and “Offset Scaled Variance”)

- Refer also to the info on these values in: <..\CustomerServiceAssistance.pdf>
- Note these values are also reported in the PTP Master’s Announce messages.

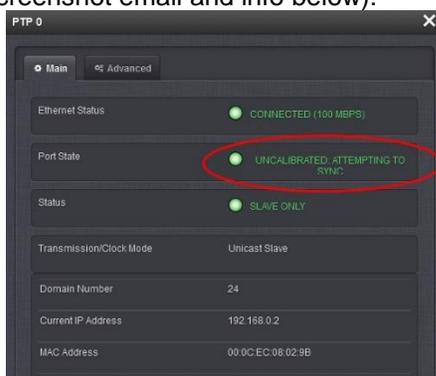
- **Initializing: unplugged/powering-up:** Cable is unplugged / in power-up state.
- **Listening: Looking for Master:** 1204-12 card is in Slave mode and looking for a Master.
- **Master:** PTP Master has become the active master on the network.
- **Passive:** PTP Master has become a passive master. (There is another Master on the network with higher priority.) This Master will wait until such time as the Best Master Clock Algorithm determines it should be the Best Master. Then it will transition to the Master state.
- **Slave:** PTP Slave is actively synchronizing to a Master on the network.
- **Uncalibrated: Attempting to Sync** PTP Slave has detected a PTP Master on the network (See example screenshot email and info below):

Per Denis Reilly (24 Mar 2014) “Uncalibrated: Attempting to Sync” in the PTP mini-status line means that the Slave sees a Master, but has not yet locked onto it. This (combined with the fact that they have to reboot the Master) leads me to believe that the Master is having problems with operating in Unicast.

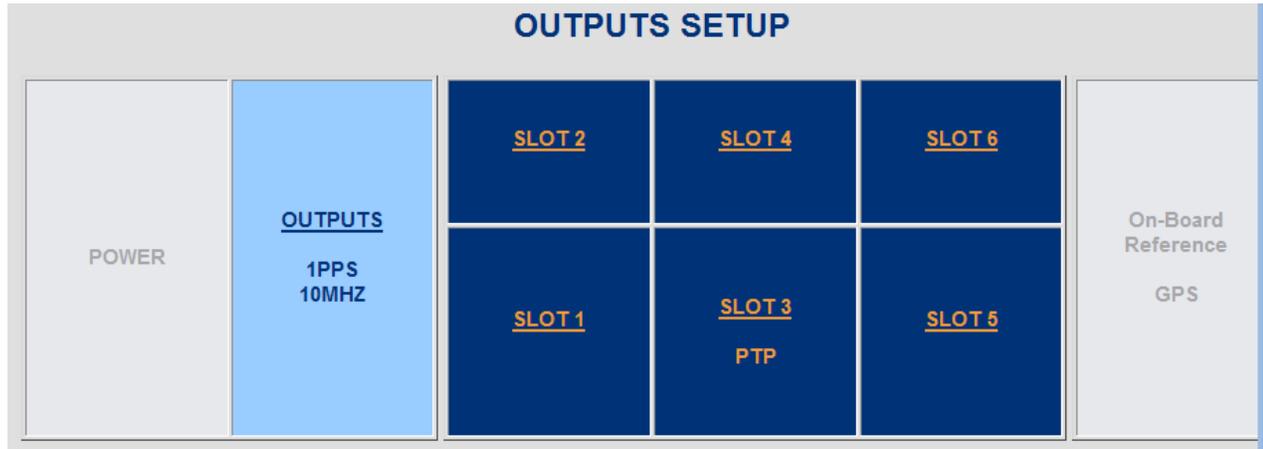
Software Versions 5.0.2 and below

Setup-> Inputs -> PTP OR Setup-> Outputs -> PTP (both go to the same pages)

Software version notes:

- ❖ Version 4.8.8 adds support for Unicast/Minicast modes.
- ❖ Version 4.8.7 removed the follow three tabs from the browser (to simplify PTP configuration) There are only three tabs present in version 4.8.7
- PTP Setup Module Tab
- PTP Setup Statistics Tab
- PTP Setup VLAN Tab
 - ❖ Version 4.8.8 PTP now has (4) tabs: “Network”, “Clock” “PTP Protocol” and the new tab “Unicast”
 - ❖ Version 4.8.7 PTP now has just three configuration tabs: “Network”, “Clock” and “PTP Protocol;”

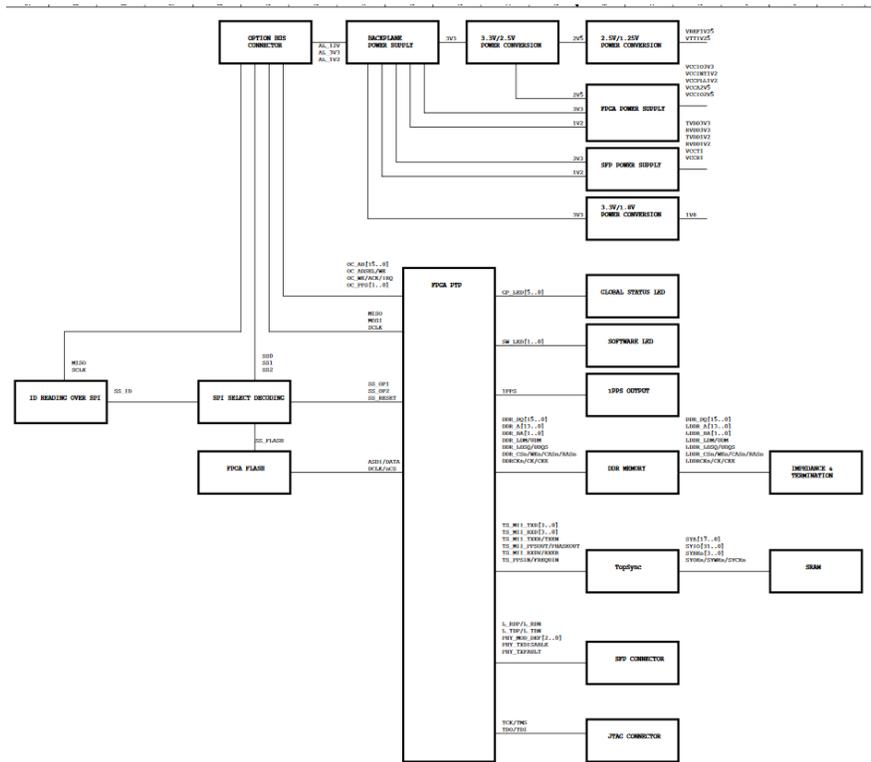
Block diagram of the 1204-32 board

- From the first page of the schematic (our P/N 400421)
- (internal use only - do not send this out to customers/dealers)

Dedicated Processor/microprocessor for the 1204-32 (doesn't use the ETX module)

- (besides timekeeper PTP) PTP using the 1204-12 and 1204-32 cards do not use the ETX module ("outer processor")
- The 1204-32 has a dedicated "software processor" (inside its onboard FPGA) which handles all the processing for its PTP functionality.

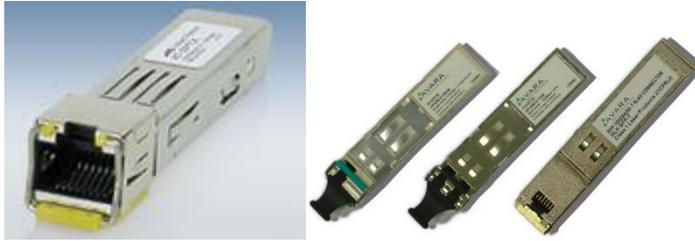
****SFP modules (interchangeable Ethernet/Fiber jack (RJ-45 connector))**

- **SFP=** (Small Form-Factor Pluggable)
- There are “**SFP**” modules and there are “**SFP+**” modules (“SFP+” modules support data rates up to 16GB/s).

- 1204-32 card is compatible with SFP modules only (1 GB and below only; the 32 card is not compatible with “SFP+” modules - so the card is not compatible with speeds faster than 1GB, such as 20 GB or 40 GB or examples).

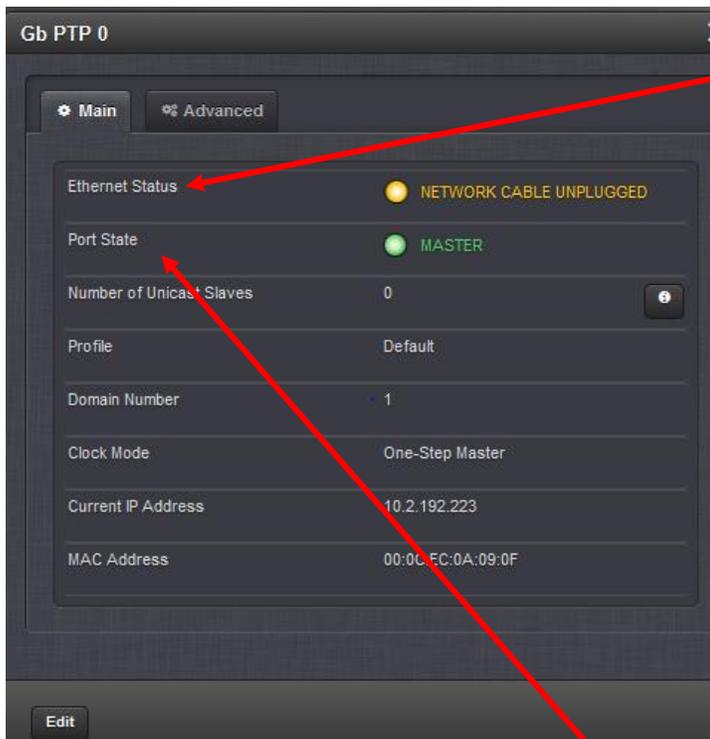
"Main" tab (Ethernet Status-link state/link status, Number of unicast slaves, PTP Domain Number, IP address/MAC address)

"Ethernet Status" (AKA "Link State") Reports either "CONNECTED" or "NETWORK CABLE UNPLUGGED"

Note: The status window doesn't have to be closed to see the displayed state change. But it may take a few seconds before the reported state automatically changes in the window once the cable status has physically changed.

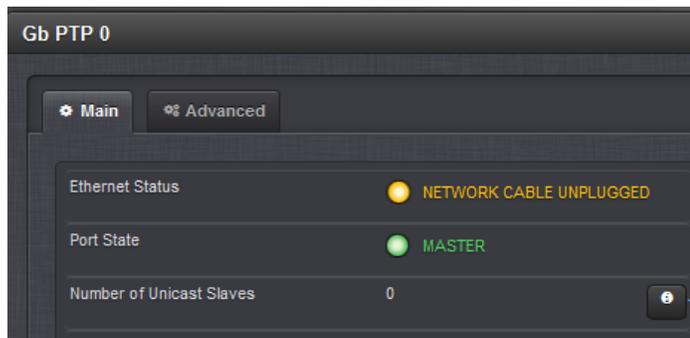
Number of unicast Slaves button

View table of up to 4000 unicast slaves found on the network

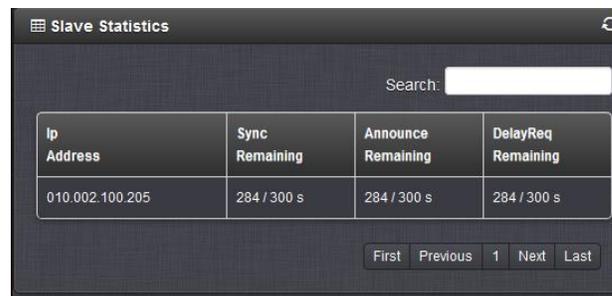
If these table rows have values, the Master is seeing unicast slave(s) on the network (which are actively using contract negotiation)

Ip Address	Sync Remaining	Announce Remaining	DelayReq Remaining
010.002.100.205	284 / 300 s	284 / 300 s	284 / 300 s

This table lists each **active unicast contract negotiation** (for Syncs, Announces and Delay Requests).

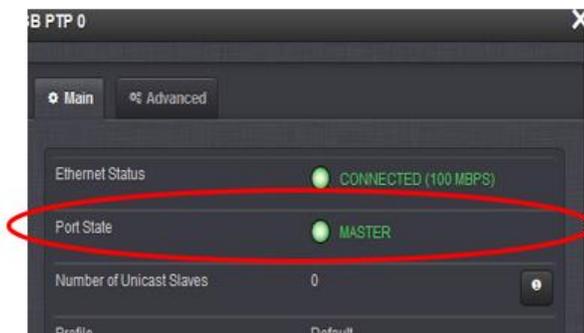
Note: Port state LED on the edge of the Option Card

- **Green** = connected
- **Orange** = not connected

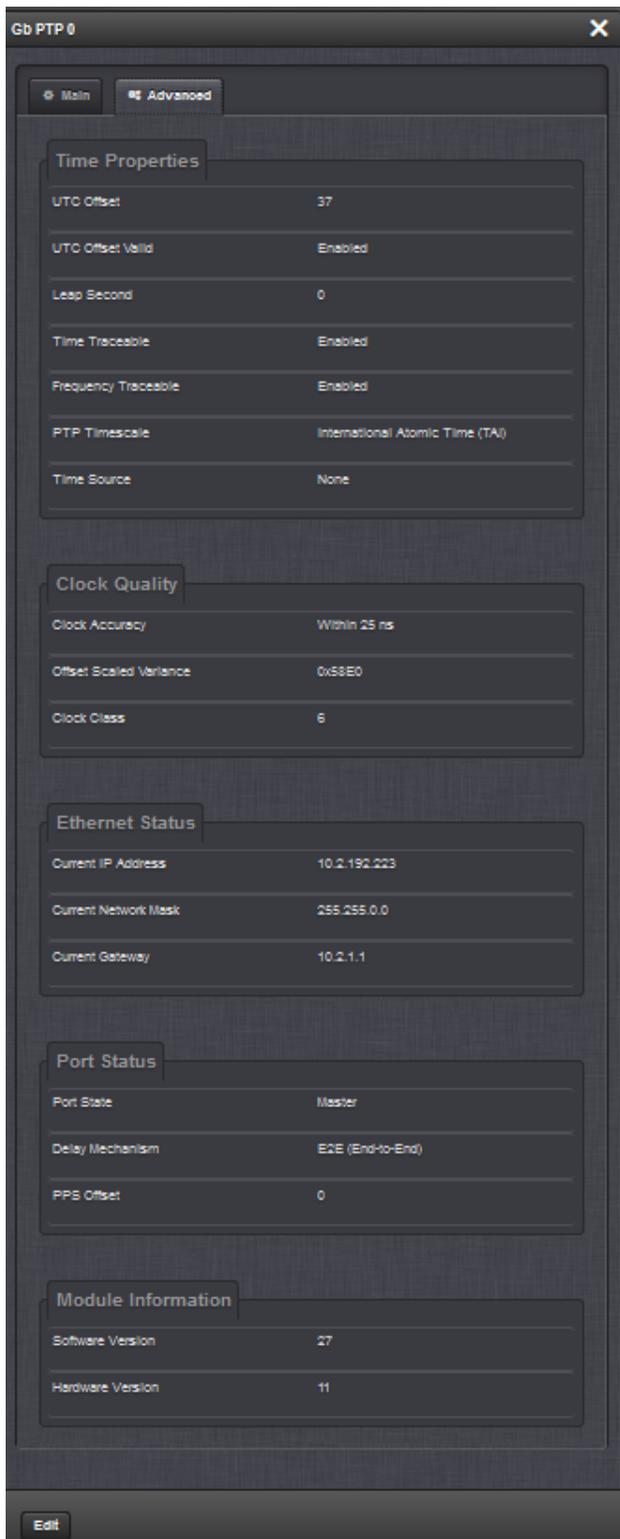
“Advanced” tab (Time info, Clock Quality, Clock accuracy, Network Setting, Port status)

Note: refer instead to the **“Main”** tab section above for info on Ethernet/link state and Port status

“Time Properties”
(UTC offset, Leap seconds, PTP timescale, Time Source)
Time Source field: (see additional info below screenshot)

“Clock Quality”
(Clock Accuracy, Offset Variance, Clock Class)
See additional info below the screenshot

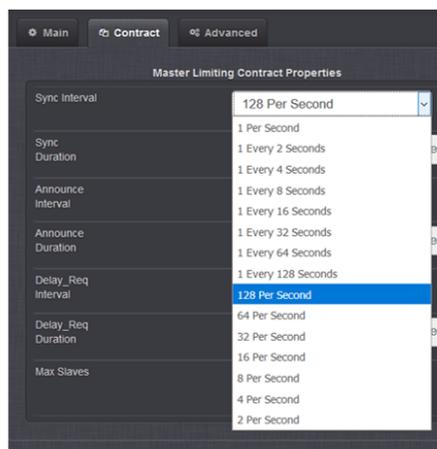
Sync, Announce and Delay Request interval drop-downs (single digit numbers in the call, starting from "0" with the first value at top)

"0" is top selection in drop-down list

"14" is last selection in drop-down list

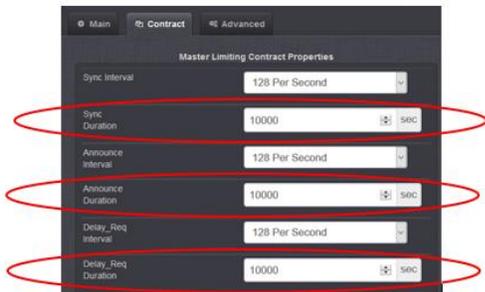
Sync, Announce, Delay Request durations (the three five-digit numbers starting from the left of the command)

“Max Slaves” (last number in the command, such as “4000”)

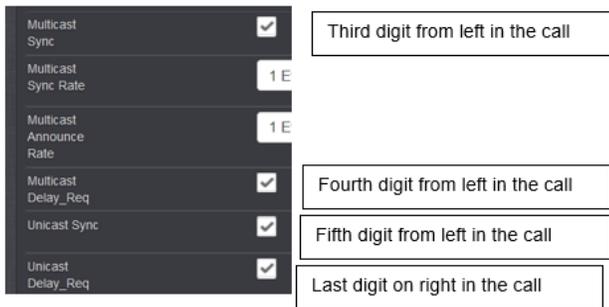
1,50,1,69,0,0,0,GPR_SetBcastMech 0 0 1 1 1 1 (left to right, the last four digits are the two “Multicast” and then the two “UNICAST” checkboxes - top to bottom, where “1” is the checkbox selected)

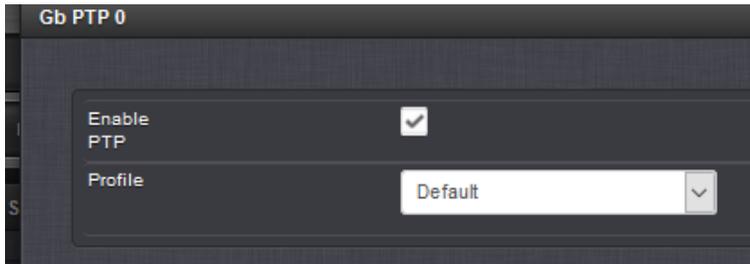
Top of all three tabs

- **Enable PTP** switch
- **Profile:** Select either Default or Telecom

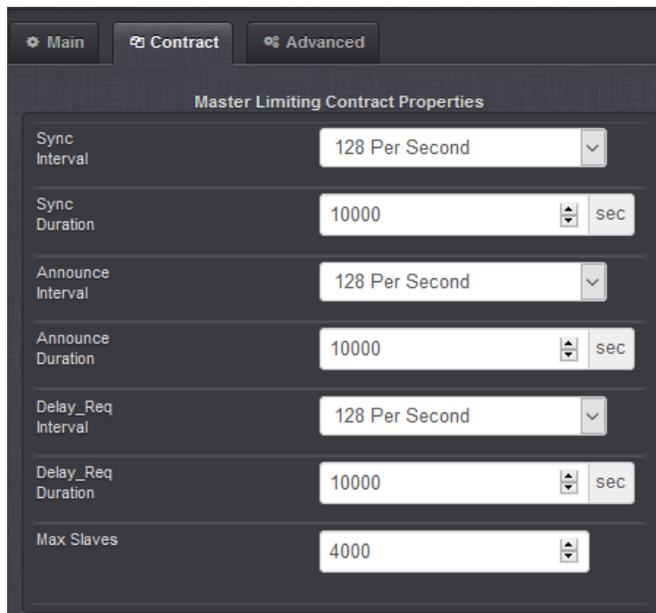
B) **Contract** tab of 1204-32 card

Property	Value
Sync Interval	128 Per Second
Sync Duration	10000 sec
Announce Interval	128 Per Second
Announce Duration	10000 sec
Delay_Req Interval	128 Per Second
Delay_Req Duration	10000 sec
Max Slaves	4000

Sync/Announce transmission intervals for negotiation

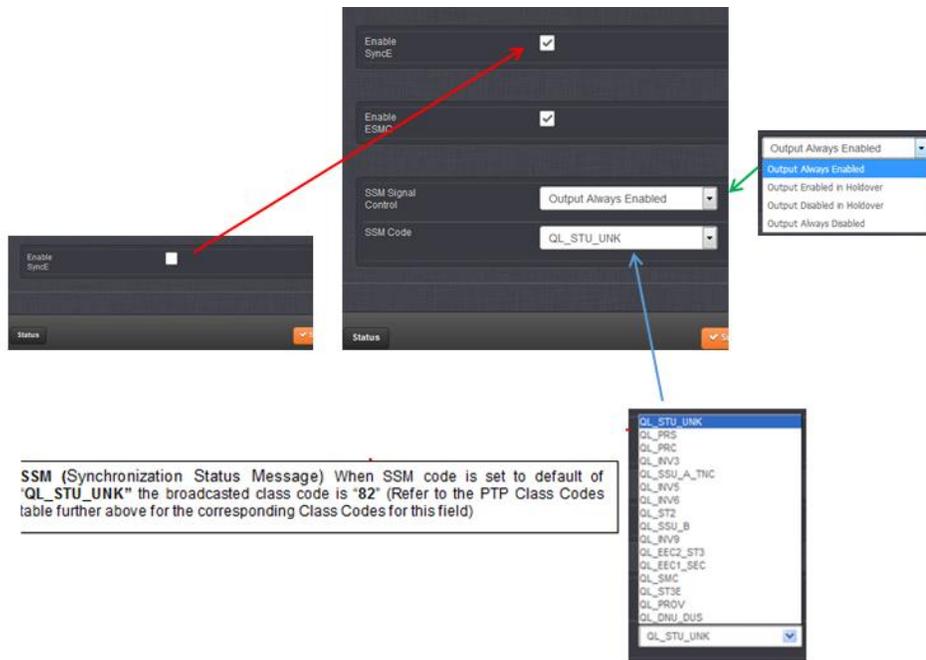
FYI: After selecting Enable SyncE, the page expands down, to show additional fields (Enable ESMC and SSM fields)

After selecting "Enable SyncE", page expands down

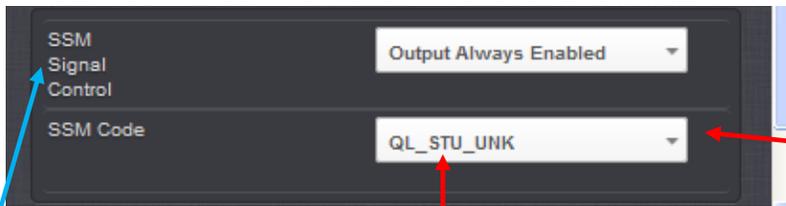
SSM Code (SSM QL Codes) (Sync Status Messaging / Quality levels)

- Configured in the **Advanced** tab (shown below)
- Refer to "Table 1" above for mapping SSM QL codes to Clock Class values

The Sync Status Messaging (SSM) code to be utilized.
Note: When SSM code is set to default of "QL_STU_UNK" the broadcasted class code is "82" (Refer to the PTP Class Codes table further above for the corresponding Class Codes for this field)

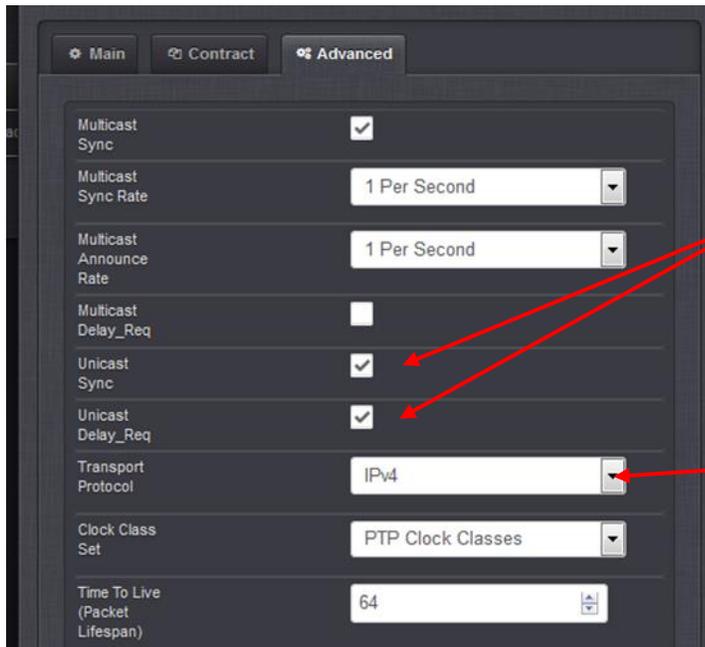
Transmission modes for 1204-32 (Multicast / Unicast / Minicast / Hybrid modes)

Configured in the “Advanced” tab

The **Unicast Sync** and **Unicast Delay Request** checkboxes are always enabled. If they are unselected and Submit is pressed, they will go back to being selected (Unicast mode is always enabled).

- **IPv4:** PTP over IPv4 protocol (also referred as the layer 3 PTP protocol). In this case, the Ethernet Type of the PTP frames is 0x0800.
- **802.3/Ethernet:** PTP over 802.3/Ethernet protocol (also referred as the layer 2 PTP protocol). In this case, the Ethernet Type of the PTP frames is 0x88F7.

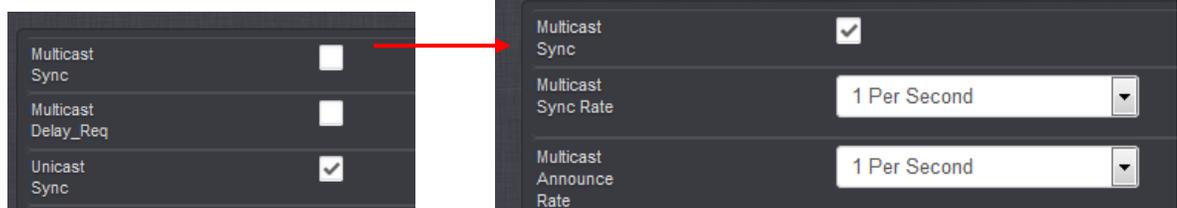
Note: Checking this box will cause two additional fields to display that will allow you to configure the:

- Multicast Sync Rate
- Multicast Announce Rate

Multicast Delay_Req: Activating this option will cause the PTP Master to respond to multicast Delay Requests (as long as it is the Best Master on the network). Deactivating this option will prevent the Master from responding to these.

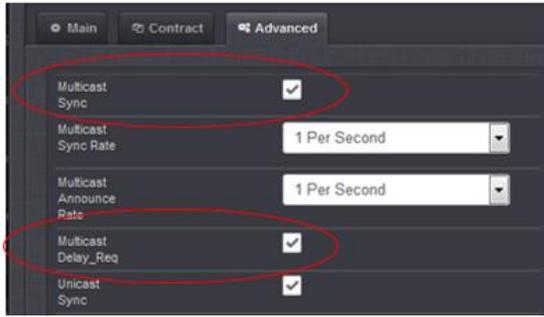
Configuring Unicast Mode

- 1) In the GB PTP “Edit” window, navigate to the **Advanced** tab.
- 2) De-select the Multicast Sync and Multicast Delay_Req checkboxes

3) Configure **Contract Negotiations** (refer to [Unicast Contracts/contract negotiations](#) further below)

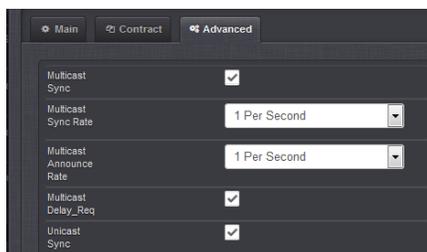
Configuring Hybrid Mode

To enter the Hybrid mode, perform the following steps:

1. In the GB PTP Edit window, navigate to the **Advanced** tab.
2. Select the **Multicast Sync** checkbox.
3. Select the desired **Multicast Sync Rate** from the drop-down list.
4. Select the desired **Multicast Announce Rate** from the drop-down list.
5. Select the **Unicast Sync** checkbox
6. Configure **Contract Negotiations** (refer to [Unicast Contracts/contract negotiations](#) further below)

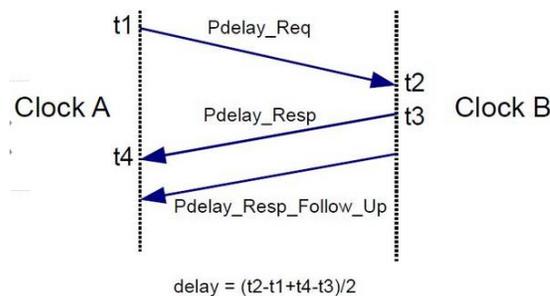
mean path delays

- Measures the path delays as individual delays between each host (measures network segments individually) and then combines the values for a total. Provides additional accuracies. P2P can be better, because in theory you are measuring the delay of each path separately, which will minimize problems if packets take different paths. But this requires that all your network elements in the path know how to exchange peer delay messages.

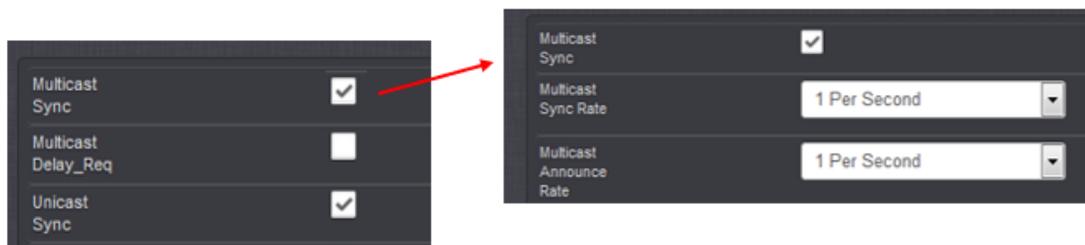
1. In the GB PTP Edit window, navigate to the **Advanced** tab.
2. Select the **Multicast Sync** checkbox.

3. Select the desired **Multicast Sync Rate** from the drop-down list.
4. Select the desired **Multicast Announce Rate** from the drop-down list.
5. Press Submit.

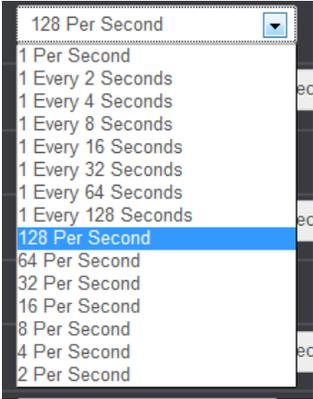
Available selections for **Min Sync Interval**, **Min Announce Interval** and **Min Delay Request Interval** fields

These fields determine the max acceptable values for the PTP slaves. They have no effect on the operation of the PTP Master.

Min Sync Interval: The minimum interval allowed between Sync Messages. If PTP Client exceeds this value, it's not assigned a contract.

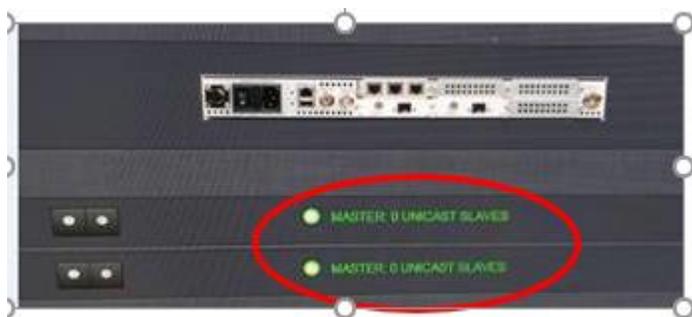
Q We use two PTP Gb option cards (1204-32) at the same time.

Outputs the same value (799638545) for both PTP accuracy and PTP Sync (799638545 as the PTP Accuracy value in the picture).

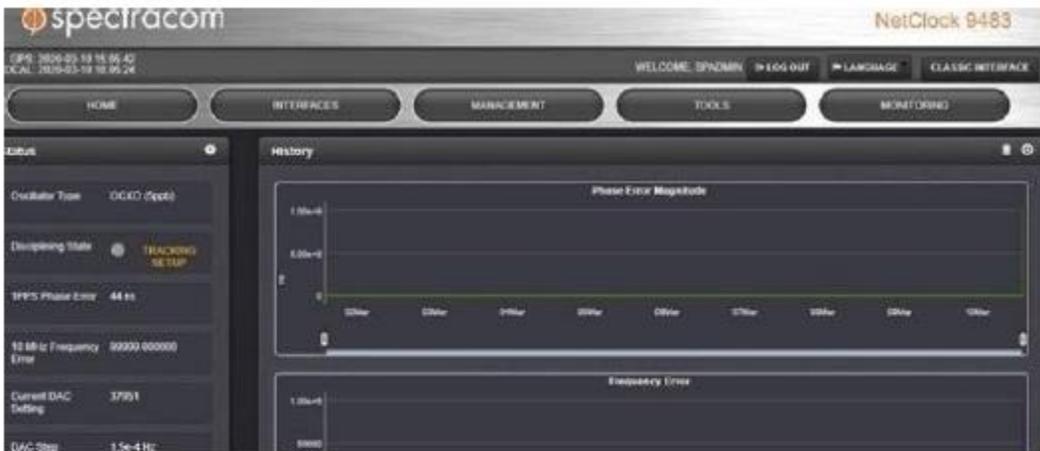
As shown below, the 32 card started sending out packets while the SecureSync was still reporting “Tracking Setup”, with the Announce messages reporting SecureSyncs time was based on its **“internal_oscillator”** (and “Time is accurate to within 10 ms”). I stopped the pcap just after I noticed packets being sent out.

# Wireshark packet capture output showing network traffic.
# The output shows a series of packets, including a PTP Announce message.
# The Announce message contains the following fields:
#   - Type: 0x00000000
#   - Version: 0
#   - Sequence ID: 0
#   - Source: 10.2.192.244
#   - Destination: 10.2.192.226
#   - Port: 1588
#   - Flags: 0x00000000
#   - Length: 100
#   - Data: ...
# The output also shows the raw bytes of the packet in hexadecimal and ASCII.

Email from Keith to Engineering (10 March 2020) I just performed a quick 1204-32 card test of my own, and BELIEVE I am seeing the condition PICO reported (the 1204-32 doesn't appear to be operating. as I would've expected- its sending packets out before in sync).

I disabled all references in the Priority table and then rebooted. With wireshark running, no packets initially sent. I then enabled only GNSS 0 and waited.

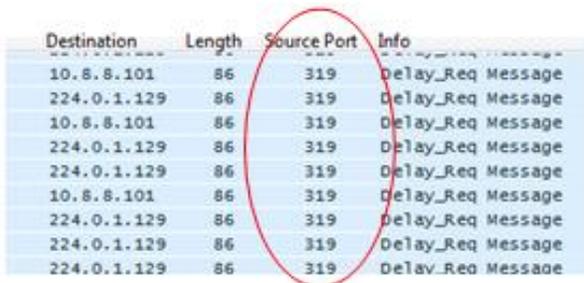
Example

All Delay Requests should on **Source/Destination** port **319**.

Destination	Length	Source Port	Info
10.8.8.101	86	319	Delay_Req Message
224.0.1.129	86	319	Delay_Req Message
10.8.8.101	86	319	Delay_Req Message
224.0.1.129	86	319	Delay_Req Message
224.0.1.129	86	319	Delay_Req Message
10.8.8.101	86	319	Delay_Req Message
224.0.1.129	86	319	Delay_Req Message
224.0.1.129	86	319	Delay_Req Message
224.0.1.129	86	319	Delay_Req Message

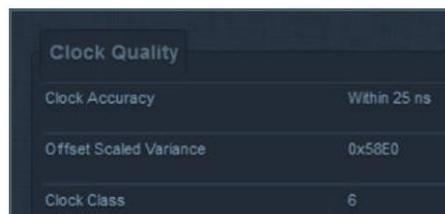
The important info is the "**Clock Class**" information reported in the outputted Announce message, which can be easily read with a packet capture or viewed in the "Clock Quality" section of the **Advanced** tab. When the SecureSync is in sync and the PTP Card is in sync with the SecureSync, the Announce message will report the PTP Master is at "ClockClass 6" and "Time is accurate within 100 ns", as shown below in the screenshot of the **Advanced** tab and the yellow highlight of the packet capture below the screenshot.

Clock Quality	
Clock Accuracy	Within 25 ns
Offset Scaled Variance	0x58E0
Clock Class	6

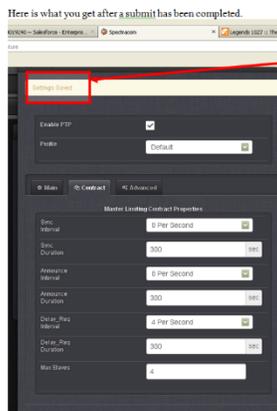
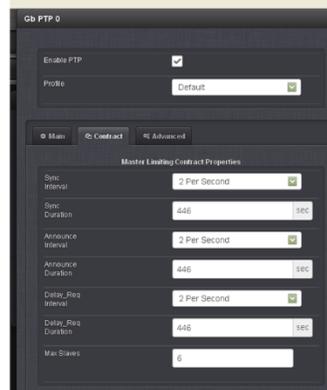
The “Contract” settings save- but are different after the page is refreshed/opened again.

Fix: At least temporarily swap the 1204-32 PTP card to any other slot besides Slot 6.

Next is what was read back after you exit this window then come back

3. Issue with PTP card not correctly persisting/saving certain settings when the 1204-32 card is installed in Slot 6.

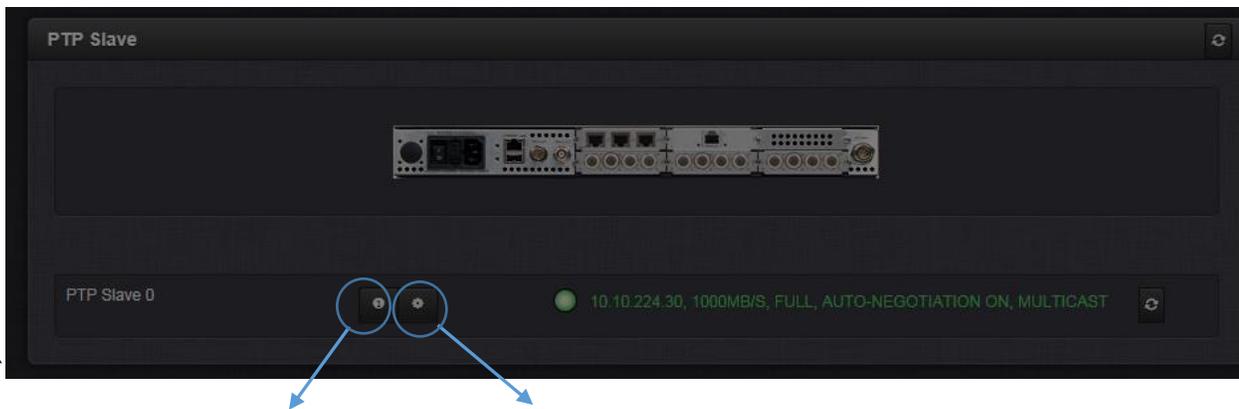
The status should appear like this:

Current IP Address	10.10.224.30
Current Network Mask	255.255.255.0
Current Gateway	10.10.224.1
Current DHCP Setting	Off
Current Primary DNS	dns-nameservers
Current Secondary DNS	10.1.1.26
Current IGMP Version	0
Current MTU	1500

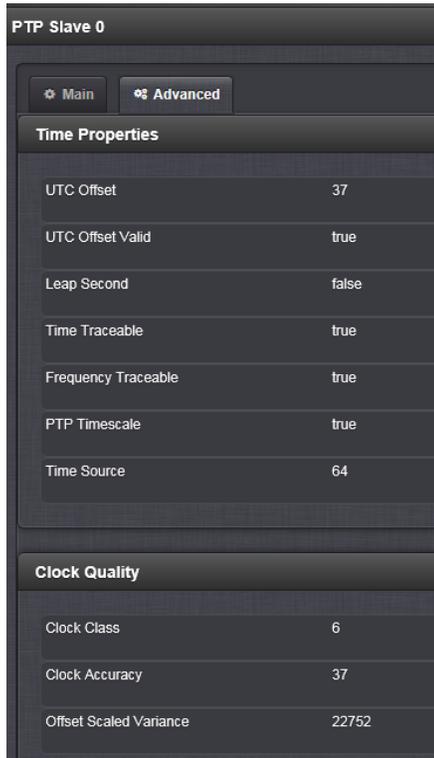
Status: Should report (“SLAVE ONLY”)

The screenshot shows a configuration page for "PTP Slave 0". It has two tabs: "Main" and "Advanced". The "Advanced" tab is selected. The page is divided into two sections: "Time Properties" and "Clock Quality".

Time Properties	
UTC Offset	37
UTC Offset Valid	true
Leap Second	false
Time Traceable	true
Frequency Traceable	true
PTP Timescale	true
Time Source	64

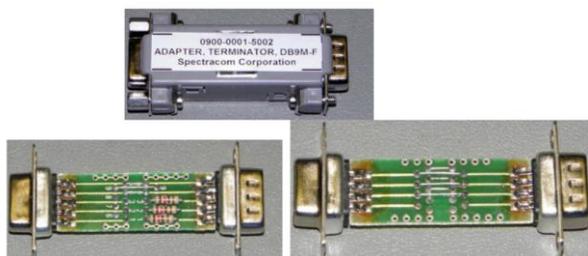
- Refer to **ECN 3183** and Salesforce **Case 8407**
- Terminator P/N: **0900-0001-5002** (DB9M to DB9F)

Email from Tom Richardson (15 Mar 2013) There is an issue with the RS-485 output from the option 14 option card, 1204-0140-0600, when used with Harris timing shelf. The timing shelf has pull-ups to 5 volts which latches the outputs into a high state until the connection to the timing shelf is removed, e.g. cable removed/replaced. This happens when the SecureSync loses power but the timing shelf doesn't. When the SecureSync comes back the output is latched. This pull-ups/power cycle was never anticipated in the design stage. **Fix:** we are sending them inline DB9 to DB9 terminators to install on units that have already shipped.

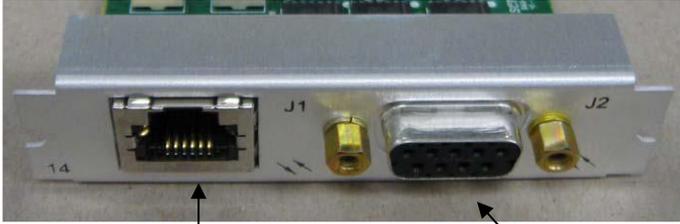
IV. Pin-outs

PIN	SIGNAL
2	ALARM Output 6 (MAJOR)
3	CTCSS OUTPUT 3+
4	CTCSS OUTPUT 3-
5	ALARM Output 5 (MINOR)

PIN	SIGNAL	819x Option 17 Mapping	Model 1204-14 Option card
1	CTCSS OUTPUT 0+	+ CTCSS #1	+ CTCSS #1
2	CTCSS OUTPUT 1 +	+18 KHZ	+18 KHZ
3	CTCSS OUTPUT 2 +	+ CTCSS #2	+ CTCSS #2
4	ALARM OUTPUT 4	MAJOR ALARM	MAJOR ALARM
6	CTCSS OUTPUT 0 -	- CTCSS #1	+ CTCSS #1
7	CTCSS OUTPUT 1 -	-18 KHZ	+18 KHZ
8	CTCSS OUTPUT 2 -	- CTCSS #2	+ CTCSS #2

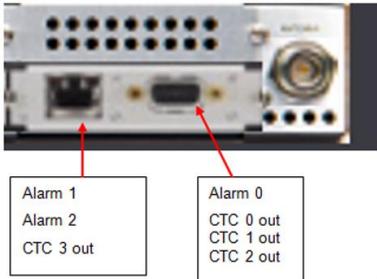
With **only one 1204-14 CTCSS Card installed**
Interfaces -> CTCSS output page of the browser

- Total of four (4) CTCSS outputs
- Total of three (3) Alarm outputs

Software issue (at least 5.9.1 and below) CTCSS numbering starts at "3" instead of "0" like it should

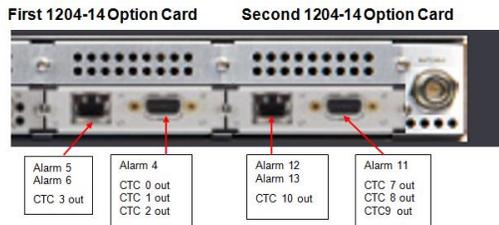
Interfaces -> CTCSS output page of the browser

- Provides SecureSync with a total of **eight (8) CTCSS outputs**
- Provides SecureSync with a total of **six (6) Alarm outputs**

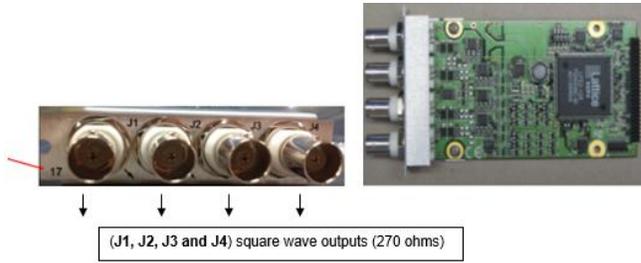
1204-17 (BNC connectors)

1204-17 Schematic (“1204-1101-0200”: Refer to the “Schematics” folder in the “1204-0100-F000 board files” folder):
<I:\Engineering\Archive\New Released\PCB Documentation>

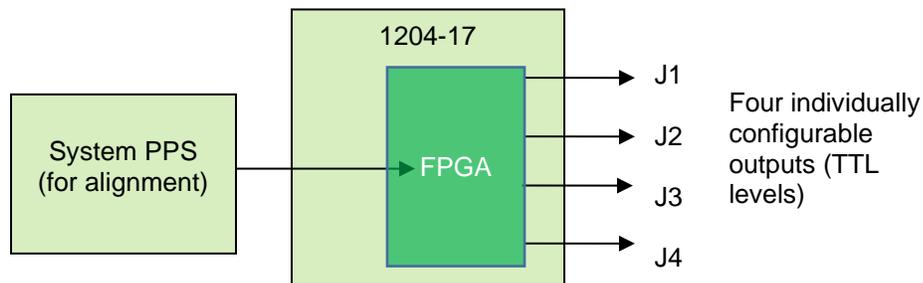
Block Diagram

Programmable Square Wave Out [1204-17]

The Model 1204-17 Square Wave output Option Card provides four programmable square wave outputs for the SecureSync platform.

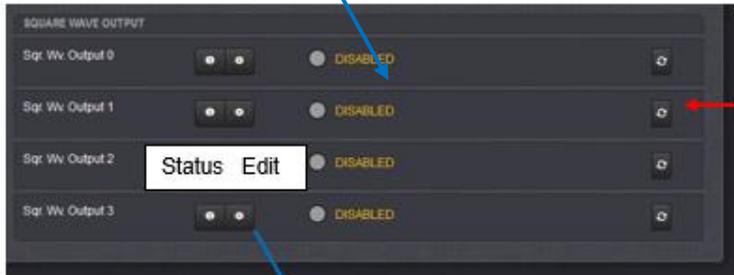
Interfaces -> Sqr Wv Output **x** (where **x** is 0 through 3) under either “Option Cards” or “Outputs”

Enable/Disable each output

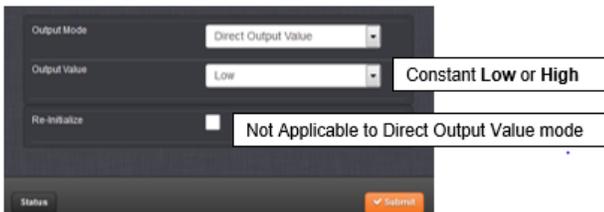
Selections available
 Direct Output
 1PPS
 1PPM
 Square wave
 Custom

“Output Mode” choices for each output:

- **Direct Output Value**—Output will be low or high determined by the output value selection.
- **1PPS** (1Pulse per second)
- **1PPM** (1 pulse per minute)
- **Square Wave**—Output will generate a programmable square wave determined by the configuration.
- **Custom**

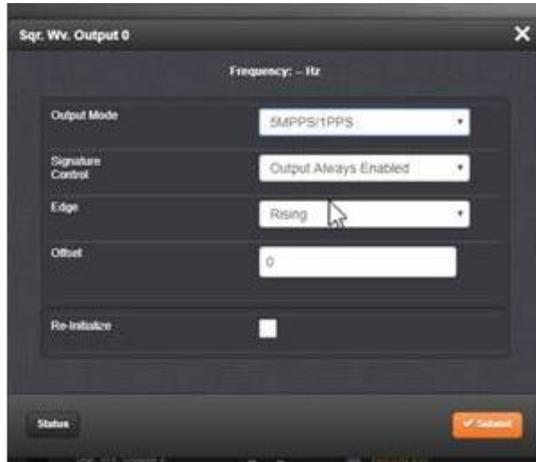
In the new web UI, go to the [INTERFACES](#) -> [Outputs](#) and select one of the “[Sqr. Wv. Outputs](#)”. Then set it up like this (as shown in the screenshot below)

Note: The “[Re-initialize](#)” checkbox should be selected, so the Edge of the squarewave is realigned to the System PPS.

Configurations automatically set, when the “[5MPPS/1PPS preset](#)” drop-down is selected.

Output Mode: Custom
Signature Control: Output Always Enabled
Edge: Rising
Offset: 0
On-Time Point Pulse Width: 150
Pulse Width: 50
Alignment Count(s): 1
Time Alignment: Enabled
Period: 200nS
Numerator: 0
Denominator: 1

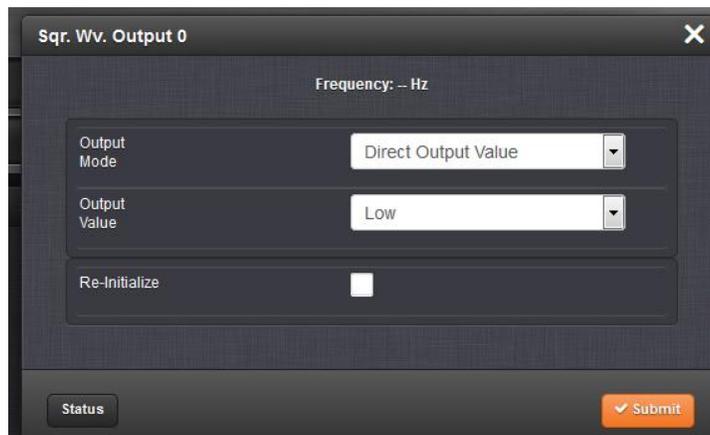
A) Direct Value output mode (the default drop-down selection)

- “Direct Output Value” is the default Output Mode drop-down selection
- This BNC connector will be low or high determined by the output value selection

Sqr. Wv. Output 0

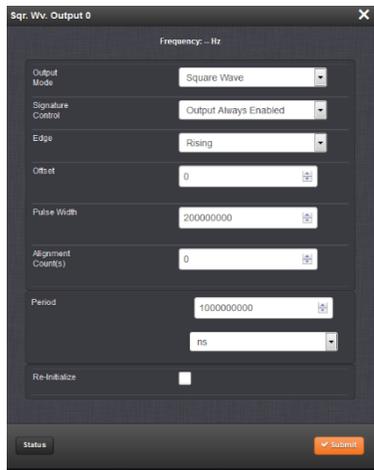
C) Square Wave output mode

- This will configure the BBC to output a continuous square wave output

Signature Control: Controls when the output will be present. Options include the following:

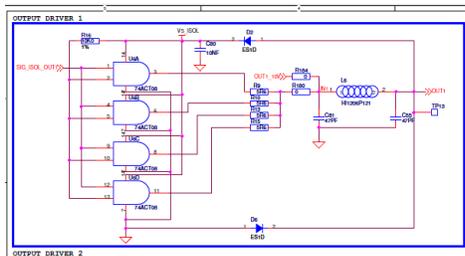
Drive capability (overshoot and undershoot)

Q (per Salesforce Case 236426) I wanted to know what driver the GPS receiver, 1200-9022-0601 with option **1204-18**, is using? How much current can it source without damaging the GPS? We have seen a large over and under shoot at the termination of another COTs unit. The termination is 50 ohms.

The reason it can overshoot and undershoot is because the logic gates have fast rise and fall times, which is desired. This output driver needs 50 ohm termination or else there will be a lot of ringing above and below the final value of the output voltage that can cause glitches in logic level. Also need to use 50 ohm coax cable.

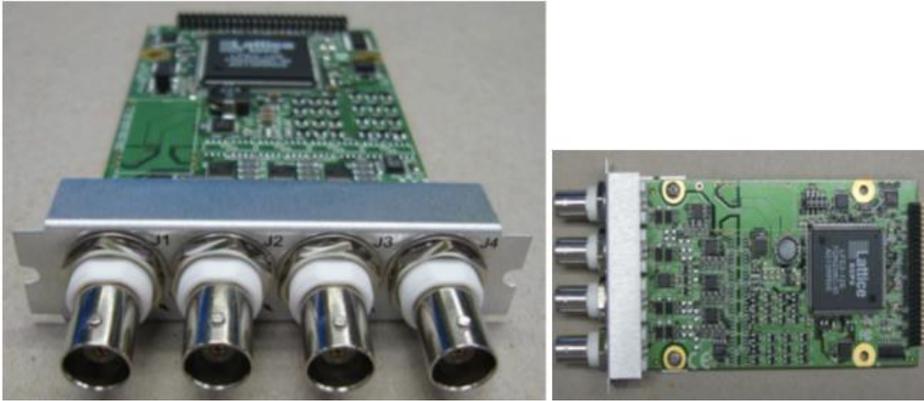
*****(1204-19) 4-1PPS 10V Output, BNC connectors**

Schematic: (refer to 1204-0100-F000) [I:\New Released\PCB Documentation](#)

A Reply from Keith (2 Jul 2019) To begin, the output levels of the 1204-19 Option Card aren't adjustable. But each output is 10Vpeak, when terminated into 50 ohms. From the pictures, it appears your scope channel is configured for high input impedance (instead of 50 ohm termination). This will inherently affect the output level being observed.

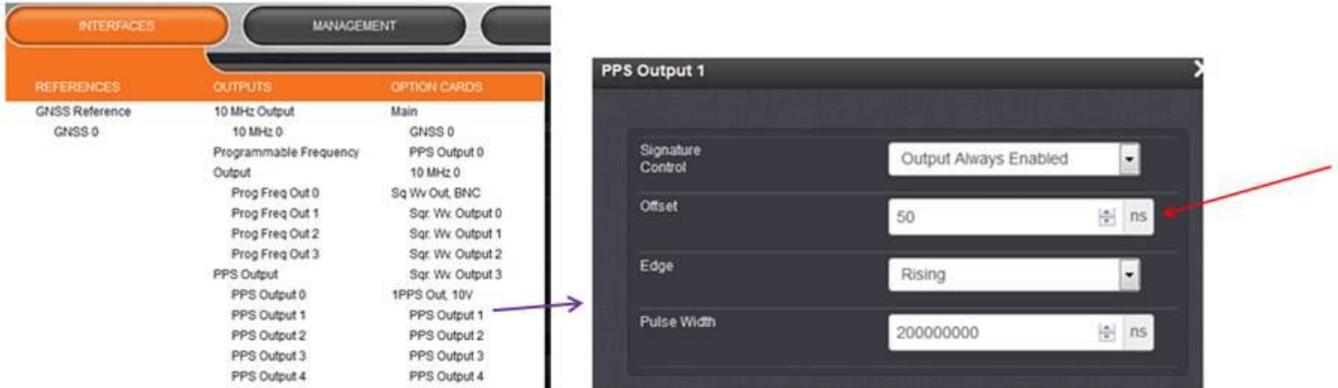
Would you please send us a screenshot showing how the setting of 5. above is made? **The phase, where the 1PPS starts, is adjusted using the "Offset" field for each individual output, as shown in the screenshot below (from the Interfaces -> 1PPS Output page of the web browser):**

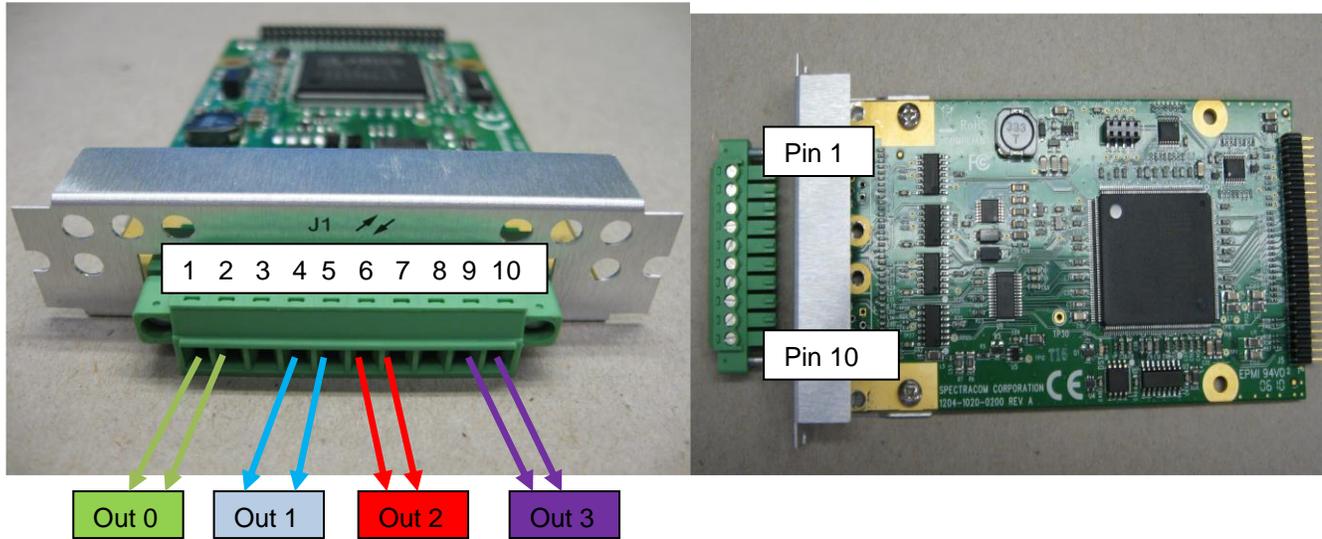
*****(1204-21) 4-1PPS OUT (RS-485/RS-422) terminal block Option Card**

Pin. No.	Function
1	1PPS Output 0 +
2	1PPS Output 0 -
3	GND
4	1PPS Output 1 +
5	1PPS Output 1 -
6	1PPS Output 2 +
7	1PPS Output 2 -
8	GND
9	1PPS Output 3 +
10	1PPS Output 3 -

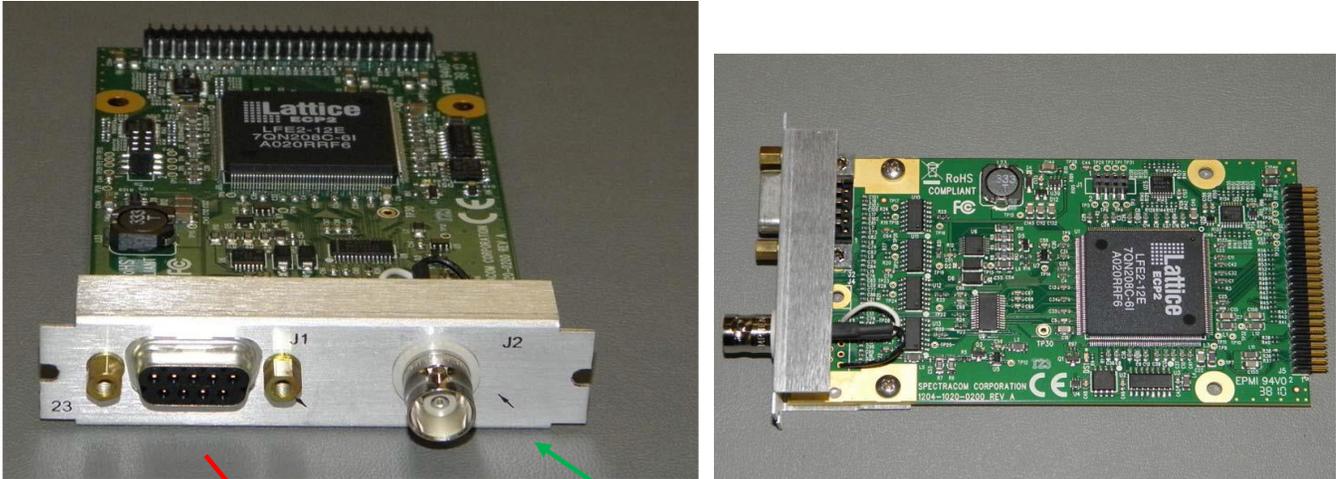
(1204-23) Event capture with broadcast over RS-232 Option Card

ASCII output messages
(DB9F connector)

Event Input (BNC connector)

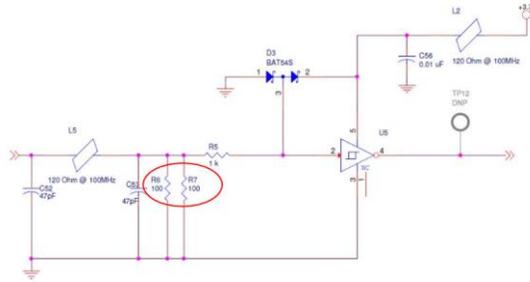
- BNC connector (J2)
- 50 ohm input impedance (as confirmed by Dave Sohn below)
Per Dave Sohn (6 Nov 2018) If it helps, here is the schematic for the input circuit showing the 50ohm (2x100ohm in parallel) termination. The option card has always had 50ohm termination from what I can see in PLM.

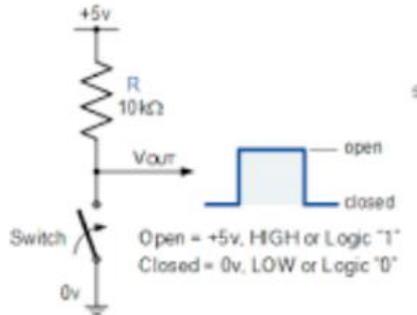
Here's an even better example of using a pull-up resistor to +5vdc on the relay's output to generate the "high" to provide into the Event input of the Option Card.
