SecureSync Option Card information

Note: This document contains both “Public Information” and “Internal Use Only Information” (do not release this document in its entirety)

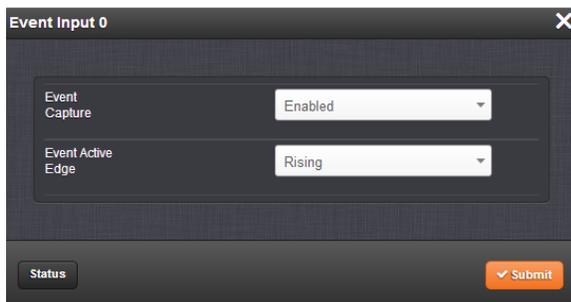
“Event Input 0” (Setup Window)

Event Enable: Enables the processing of events on the Event Input port J2.

- When set to **“Disabled”**, no event messages will be queued.
- When set to **“Enabled”**, event messages will be triggered (if a valid Format is selected).

Reset Event Buffer: When set to “Enabled”, will discard all messages waiting in the Event Buffer.

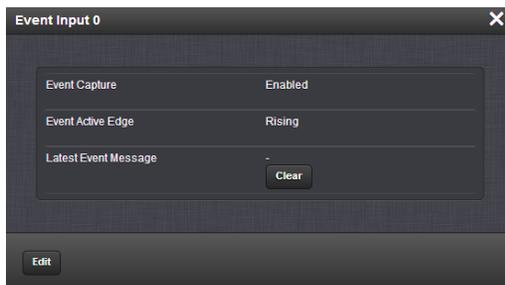
“Event Input 0” (Status Window)

Event Capture: The processing of events on the Event Input port J2. When set to “Disabled”, no event messages will be queued. When set to “Enabled”, event messages will be triggered (if a valid Format is selected).

Event Active Edge: The signal edge used for triggering events on Event Input port J2.

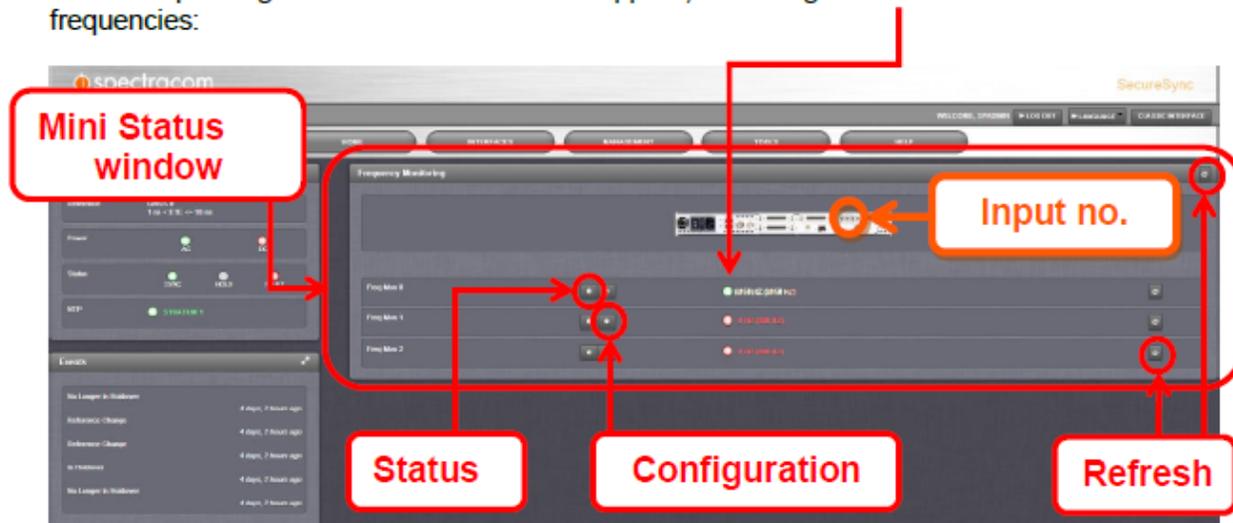
1. Select **INTERFACES > OPTION CARDS > Frequency Monitoring**.
2. The corresponding **Mini status window** will appear, indicating the **Status** of the monitored frequencies:

A **green** status lamp indicates that a frequency is monitored, and that the frequency is within its accuracy window. The first value shown next to the status light refers to the value measured by the card, and the second value (in parentheses) is the reference frequency.
A **red** lamp indicates that a frequency is either not monitored (first number = 0), or that a fault has been detected, i.e. the measured frequency is outside its accuracy window.

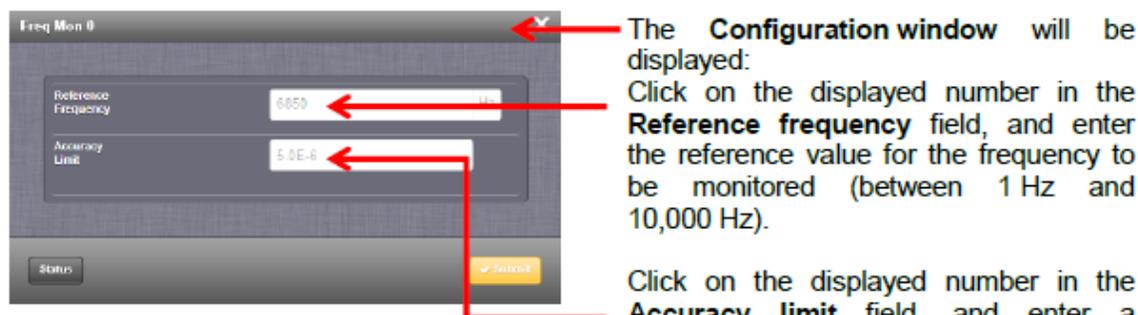
The **Configuration window** will be displayed:
Click on the displayed number in the **Reference frequency** field, and enter the reference value for the frequency to be monitored (between 1 Hz and 10,000 Hz).
Click on the displayed number in the **Accuracy limit** field, and enter a frequency value for the permitted variation. The best possible accuracy is $\leq \pm 5.0e-9$ Hz. You may also enter "0" instead of the maximum accuracy value.

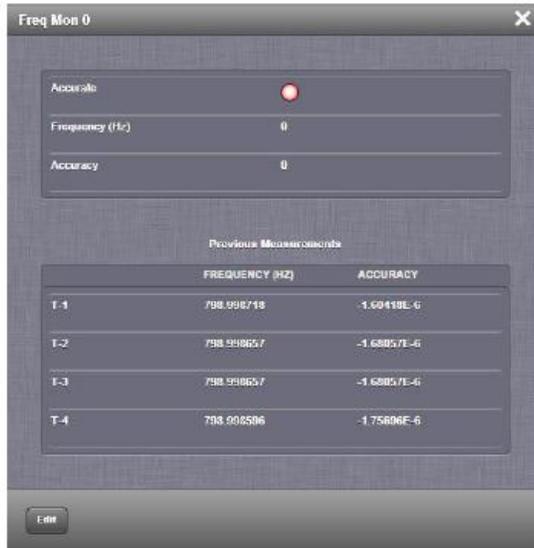
Under **Previous measurements**, the frequency data and accuracy data of previous measurements will be displayed at 1-second increments (e.g., T-4 = 4 seconds before current measurement).

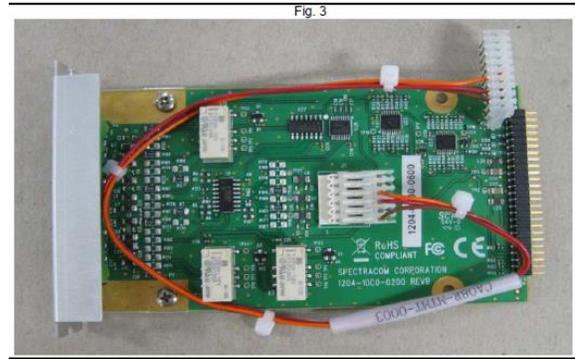
(1204-0B) RS-485 Comm Protocol Option Card

1204-0B pinout

Pin Number	Signal Name	Function
1	GND	Ground
2	RS-485 IN+	RS-485 Data Input +
3	RS-485 IN-	RS-485 Data Input -
4	GND	Ground
5	RS-485 OUT+	RS-485 Data Output +
6	RS-485 OUT-	RS-485 Data Output -
7	GND	Ground
8	NC	No Connect
9	NC	No Connect
10	GND	Ground

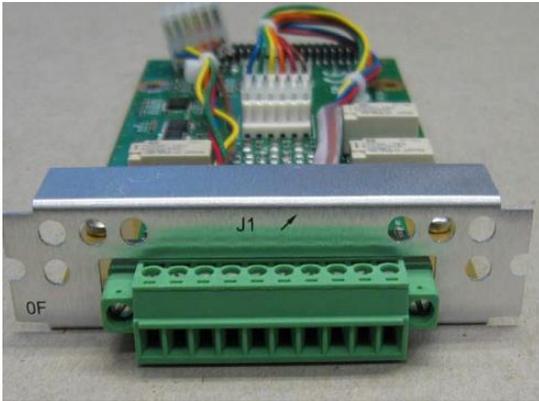
(1204-0F) Alarm Relay output Option Card (SecureSync only)

From the online SecureSync user guide
 Terminal block pin-out, alarm relay out

PIN	SIGNAL
1	GND
2	Relay 0 NO
3	Relay 0 NC
4	Relay 0 COMMON
5	Relay 1 NO
6	Relay 1 NC
7	Relay 1 COMMON
8	Relay 2 NO
9	Relay 2 NC
10	Relay 2 COMMON

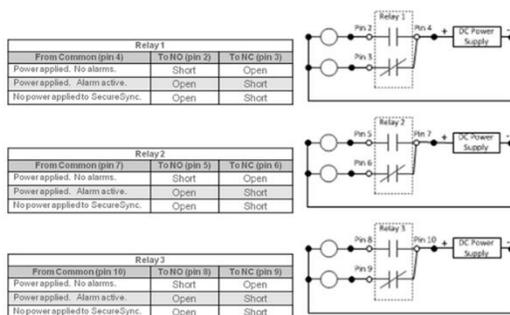
Alarm relay Interfacing Considerations

- Relays may use the same power source or separate ones.

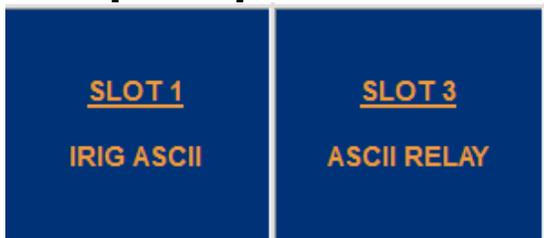
Setup/Outputs

Slot 1: IRIG output and RS-232 Serial port

Slot 3: RS-485 output port and Relays (Minor and Major)

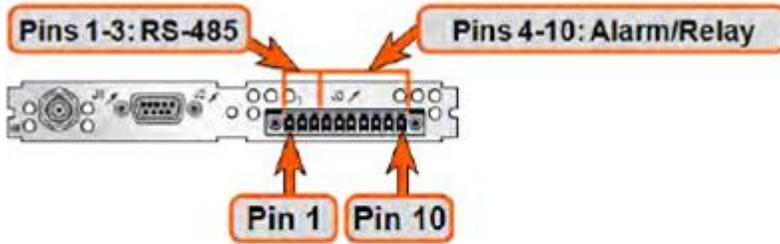
Figure 5-4: RS-485 connector "J3"

Connector Pin	Signal	Direction	Characteristics
1	RS-485 TX+	Out	0V to 3V _{DC} differential, 120 Ω load
2	RS-485 TX-	Out	0V to 3V _{DC} differential, 120 Ω load
3	GROUND	N/A	GROUND
4	Relay 1 NO	Out	Normally Open 30 V _{DC} , 2A max. switching power
5	Relay 1 NC	Out	Normally Closed 30 V _{DC} , 2A max. switching power
6	Relay 1 COMMON	Out	Common Contact 30 V _{DC} , 2A max. switching power
7	Relay 2 NO	Out	Normally Open 30 V _{DC} , 2A max. switching power
8	Relay 2 NC	Out	Normally Closed 30 V _{DC} , 2A max. switching power
9	Relay 2 COMMON	Out	Common Contact 30 V _{DC} , 2A max. switching power
10	GROUND	N/A	GROUND

Email Keith sent to Homer w/Roots after talking to Tom Richardson (29 Jul 2014) The GND ground connection is typically not used with the relays. It was added as a convenient location to ground another device, so they are tied to the same ground potential. It can also be used to make Common a ground and use the relay as a pull-up to voltage supplied by another device. Both of these are rare conditions. It is not needed for protection.

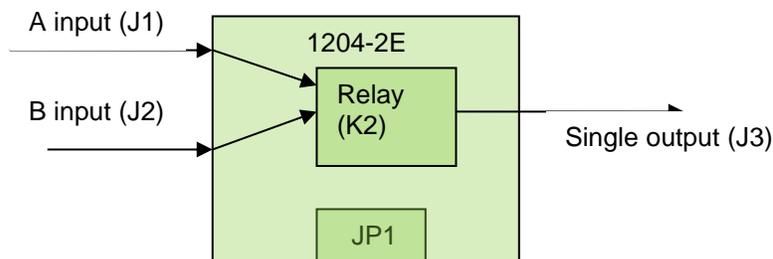
Block diagram

Note: JP1 is jumpers for selecting in/out as 1PPS, 100Hz or 10MHz

- The card automatically fails over to the secondary B input on loss of signal or power.
- It prefers the primary A input in all other conditions

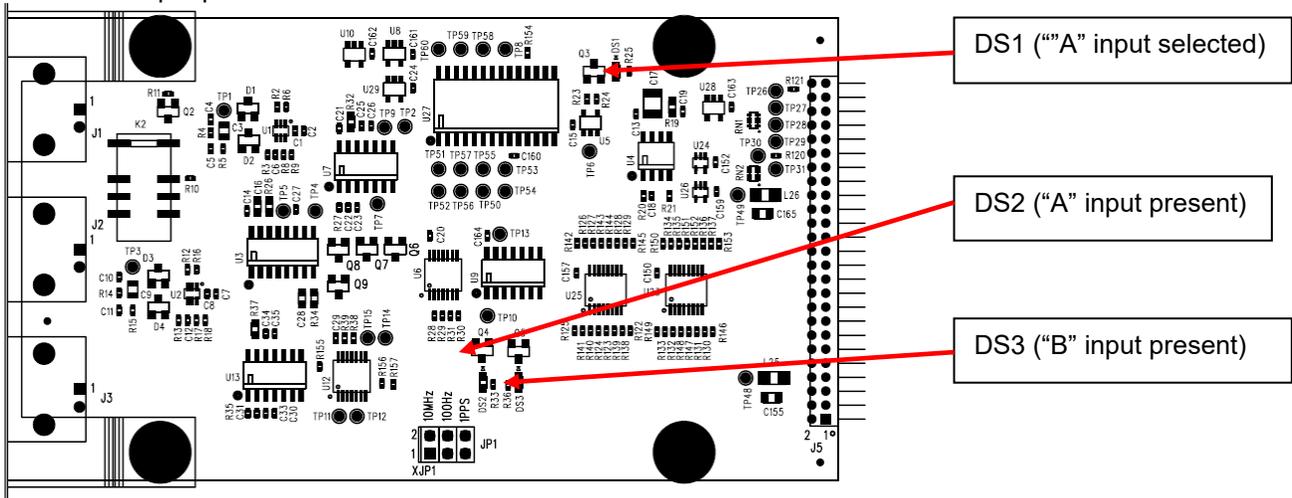
- There are three LEDs on the PCB board (not on the edge of the card so you can't see them from the back panel)
- DS1: “A” input selected
- DS2: “A” input present

- DS2: "B" input present

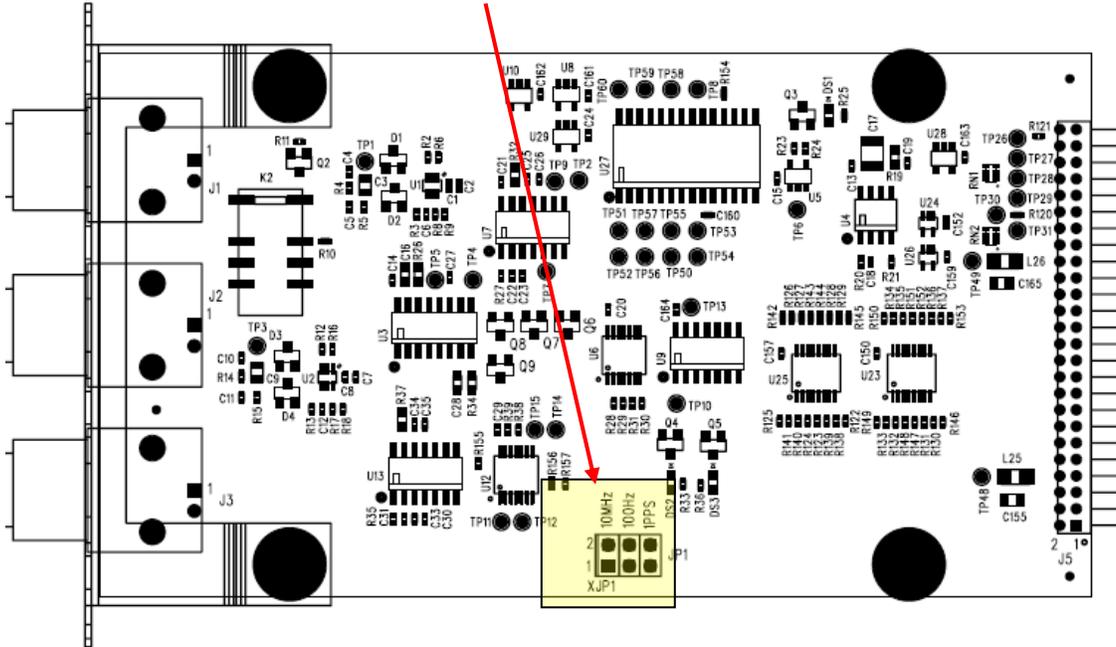
Jumper configuration for 1PPS, 100Hz and 10 MHz input

There is a (3) position jumper on the side of the board to configure the speed of the input. See drawing below.

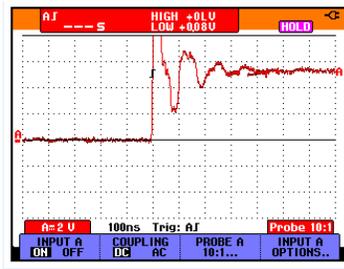
1PPS without 1204-2E selector

- Refer to Salesforce case 25319
- “It has been reported (by LA County, via Ed O’Connor) the 1204-2E Revertive Selector module is affecting rise time of 1PPS Signal and causing problems for their systems.”

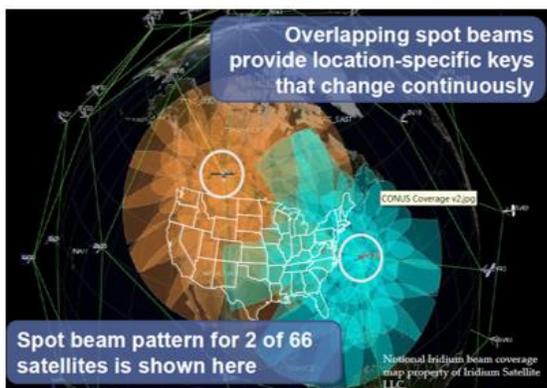
STL - HOW IT WORKS

Re-purposed paging channels

- 1620 MHz band, 25 KHz BW, QPSK
- Spread Spectrum coded signal, 90 msec frame, ~1.4 sec burst on average

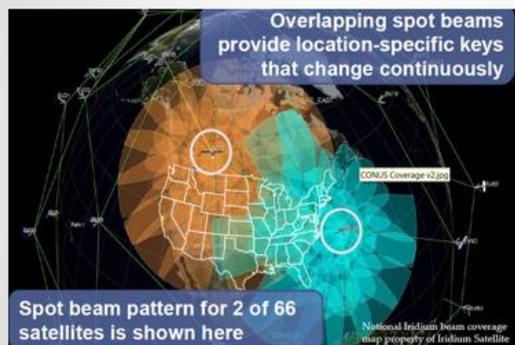
LOW EARTH ORBIT (LEO) => STRONG SIGNAL WITH SPOT BEAMS

ORBITS

- Iridium: ~100 minute
- GPS: 12 hour

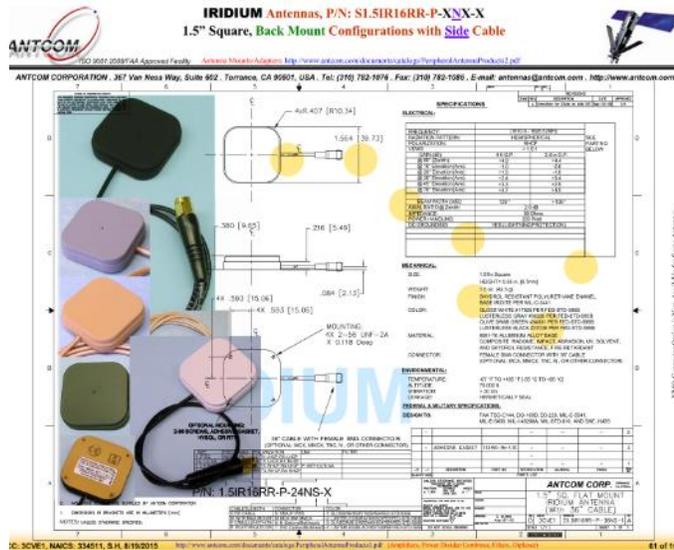
C) Earlier passive STL antenna (E050-0001-0001): for all 1204-3D and earliest 1204-3E boards (shipped prior to ~ 7 June, 2018)

- (our P/N for the earlier passive antenna E050-0001-0001) in Arena at: https://app.bom.com/items/detail-spec?item_id=1230586692&version_id=10696861268
- Antcom P/N: S1.5IR16RR-P-96NS-2
 - Includes 96-inch (2.4 meter) cable (we don't recommend extending this cable)
 - This antenna is Iridium only (not GPS/Iridium)

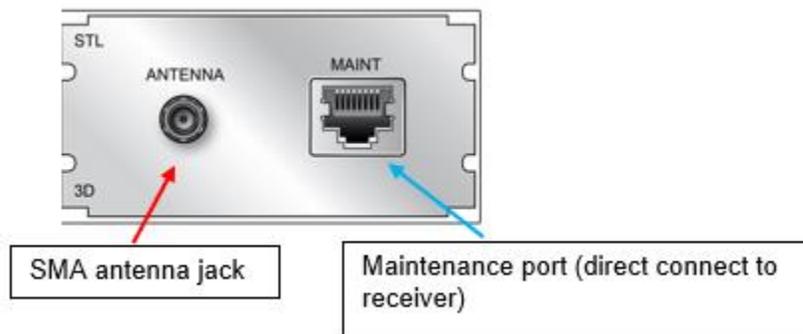
- **Satelles Module** (our P/N: MP30-0SAT-0001) in Arena at: https://app.bom.com/items/detail-spec?item_id=1230586066&version_id=10696849618

Iridium antenna input jack on rear panel: SMA connector

“Maintenance” (Ethernet connector on rear panel)

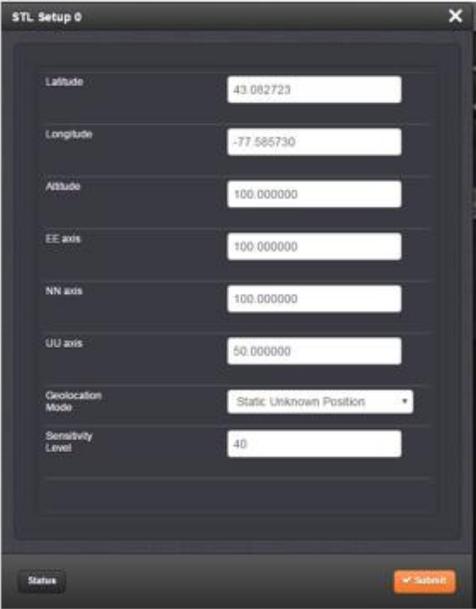
STL SETUP DEEP DIVE

LATITUDE AND LONGITUDE ARE THE PHYSICAL LOCATION OF THE STL UNIT. YOU CAN OBTAIN THIS VIA GOOGLE MAPS

ALTITUDE IS THE ALTITUDE IN METERS. THIS SHOULD NOT HAVE TO BE CHANGED.

SENSITIVITY LEVEL REFERS TO THE SENSITIVITY OF THE RECEIVER TO OBTAINING BURSTS. THE LOWER THE NUMBER, THE MORE RESPONSIVE THE RECEIVER IS TO ACKNOWLEDGING BURSTS. THIS NUMBER SHOULD REMAIN AS SHOWN HERE (40). IT IS OPTIMIZED FOR AN INDOOR ANTENNA. A STRONGER VALUE (OUTDOOR ANTENNA) COULD INCREASE THAT VALUE. IT IS NOT RECOMMENDED TO GO BELOW 40.

Sensitivity Level: [default = 40] This value determines the sensitivity of the STL receiver towards the STL signal bursts transmitted by the satellites. The lower the number, the more responsive the receiver will be to acknowledge the bursts. The default value is optimized for an indoor antenna. A higher value can be tried out for outdoor antennas. A value lower than (40) is not recommended.

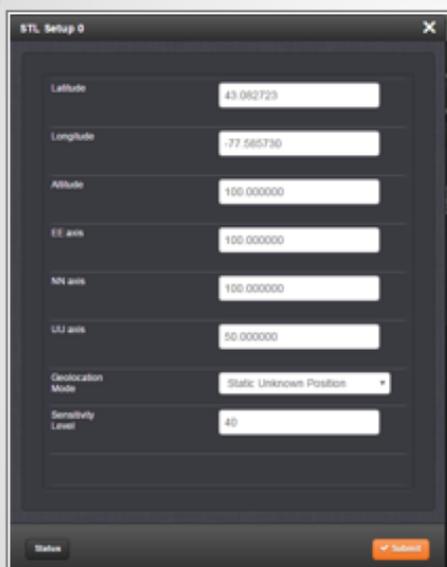
STL SETUP DEEP DIVE

LATITUDE AND LONGITUDE ARE THE PHYSICAL LOCATION OF THE STL UNIT. YOU CAN OBTAIN THIS VIA GOOGLE MAPS

ALTITUDE IS THE ALTITUDE IN METERS. THIS SHOULD NOT HAVE TO BE CHANGED.

SENSITIVITY LEVEL REFERS TO THE SENSITIVITY OF THE RECEIVER TO OBTAINING BURSTS. THE LOWER THE NUMBER, THE MORE RESPONSIVE THE RECEIVER IS TO ACKNOWLEDGING BURSTS. THIS NUMBER SHOULD REMAIN AS SHOWN HERE (40). IT IS OPTIMIZED FOR AN INDOOR ANTENNA. A STRONGER VALUE (OUTDOOR ANTENNA) COULD INCREASE THAT VALUE. IT IS NOT RECOMMENDED TO GO BELOW 40.

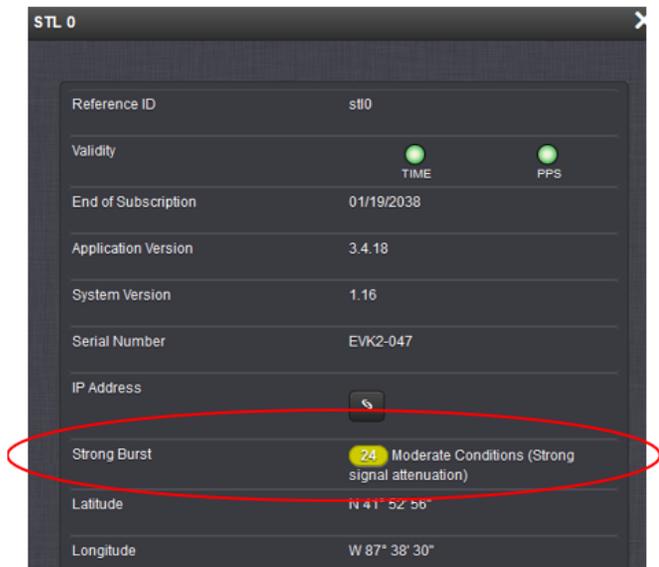
A) Use the **Interfaces-> STL 0** page of the browser (“Strong Burst” field) to check for a Strong Burst Signal

- A Strong Burst Signal, (anything over 15)
- Place the antenna as high as possible which should help with signal strength
- The higher the value the stronger the signs

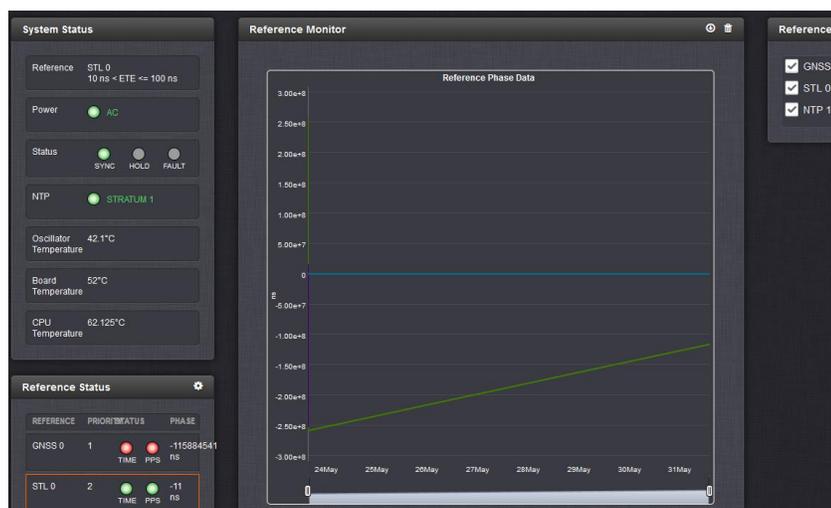
- Can Optionally export this graph data via sqlite dbase in log bundle, then view/extract data using dB browser program

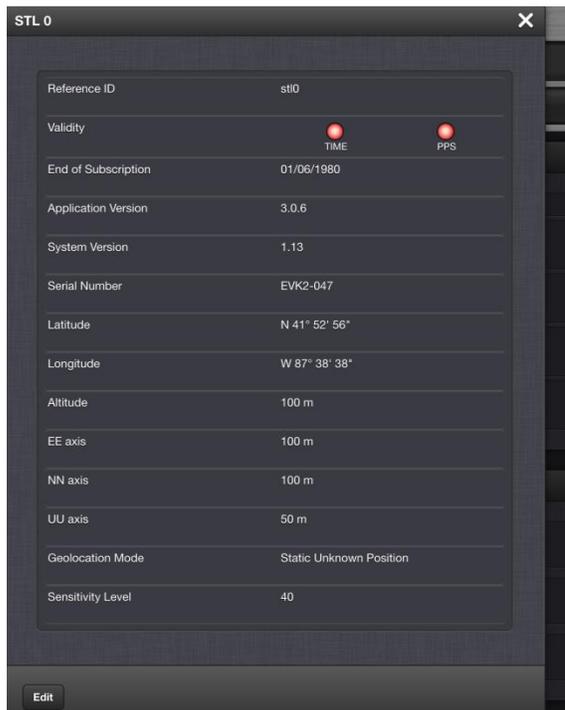
(true example below- notice the “**End of Subscription date**” has expired

- 4) If it is possible, can you also send us a photo of where the STL antenna is placed?
- 5) Can you also send me a screenshot from the STL status page in the SecureSync UI?

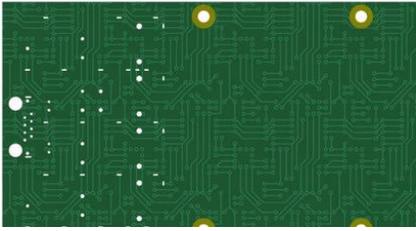
Mechanical Concept

The Board is the same for the 4 configurations. Holes in the board are limited by putting SFP cage in the center of the board and sharing holes:

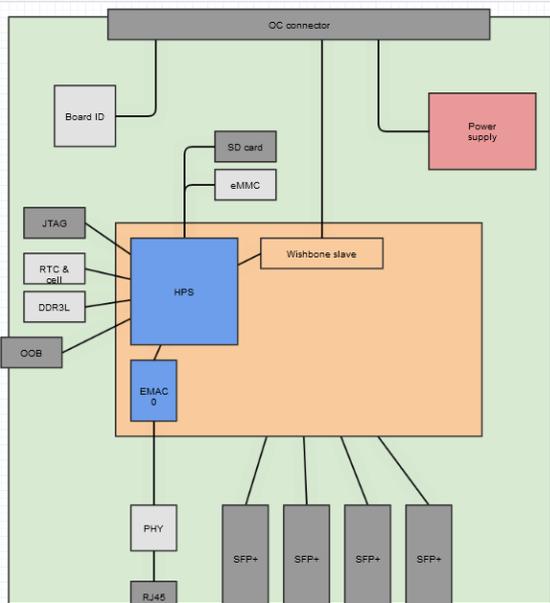
4in1_complete_diagram

Complete block diagram

Note: SFP+ cages will be used as they are better quality designed than SFP cages and they are compatible with SFP modules.

The SD Card will be used only at manufacturing to load the firmware of the Option Card the first time. It will not be used by customers.

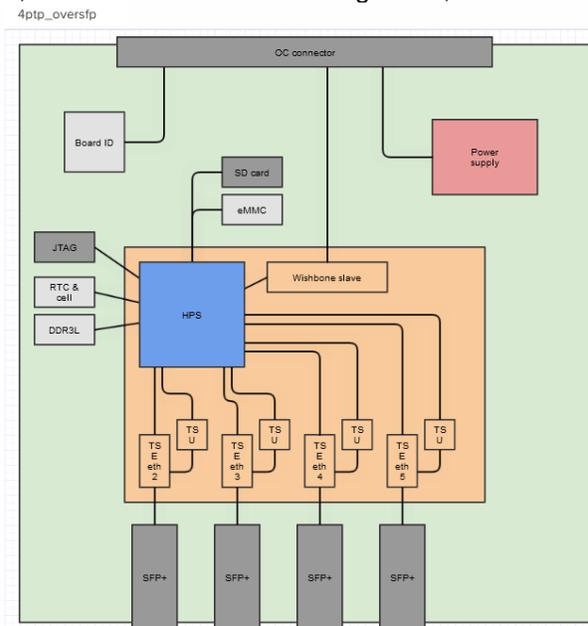
4 x SFP 1GbE PTP/NTP variant

This board is intended to replace the current Option Card 6 of the SecureSync which provides 3 x GbE ports. It provides 4 x GbE ports through SFP modules with PTP or NTP support and hardware timestamping. Therefore, it can not be used for management, diamond WebUI is not accessible on these ethernet ports.

Note: SFP+ cages will be used as they are better quality designed than SFP cages and they are compatible with SFP modules.

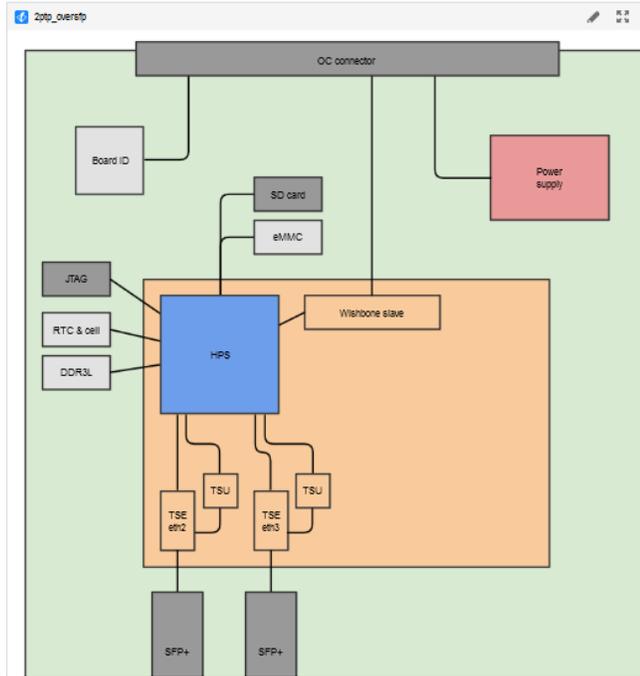
2 x SFP 1GbE PTP/NTP Variant

Provides 2 gigabit PTP or NTP interfaces on SFP+ with hardware timestamping. It can't be used for management, diamond WebUI is not accessible on these ethernet ports. This board is exactly the same than the 4 SFP variant, but has 2 SFP populated only

Note: SFP+ cages will be used as they are better quality designed than SFP cages and they are compatible with SFP modules.

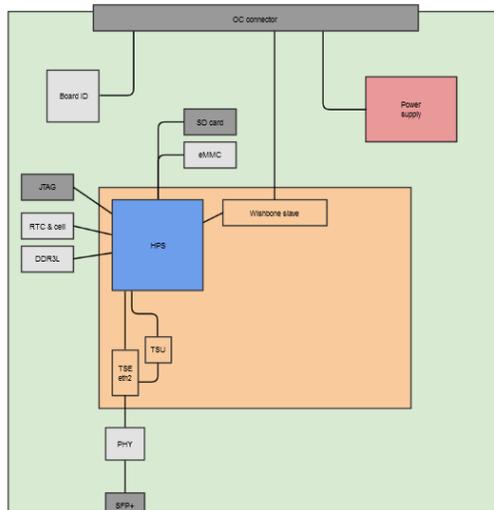
1 x SFP 1GbE PTP/NTP variant

This Option Card provides one GbE port through a SFP module with PTP or NTP hardware timestamping. It is intended to replace the Option Card 12, 32, and 3B.

It can't be used for management, diamond WebUI is not accessible on these ethernet ports.

Note: SFP+ cages will be used as they are better quality designed than SFP cages and they are compatible with SFP modules.

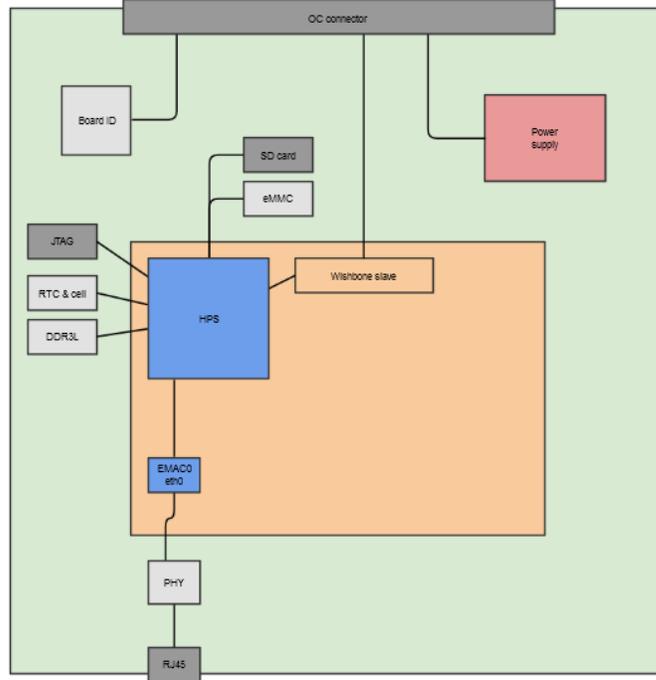
OOB Variant

Provides an Out Of Band (OOB) management interface on RJ45 connector.

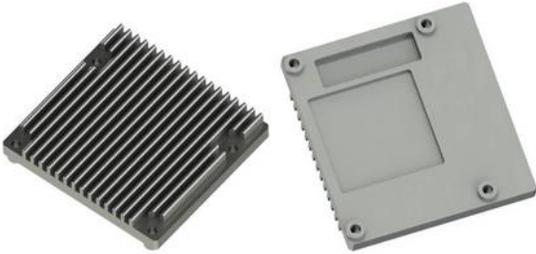
The Option Card will be cooled down using forced air. The air will be forced by the fan embedded in the host product. In case of Diamond, the Option Card will feature some temperature sensors that will allow their main CPU board to know the details of the OC temperature and adjust the fans speed accordingly. The Option Card will also likely require a custom designed heat spreader.

Temperature sensors are available on the board to monitor.

SFP, Ethernet Phy, FPGA, DDR3, Power Supply Module (2) and Oscillators Area:

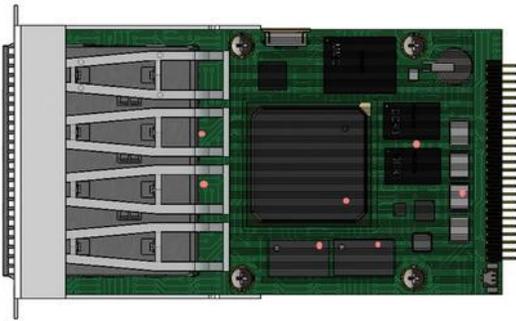
Temperature sensors are available on the board to monitor.

SFP, Ethernet Phy, FPGA, DDR3, Power Supply Module (2) and Oscillators Area:
