Software Version 5.9.5: Release Notes

Orolia (Spectracom) released a software update for SecureSync 1200 Model. Customers can download this software update at no charge from the Orolia website (see [How to download and install the new SW.](#)) This software update will upgrade the unit's system software to **Version 5.9.5**.

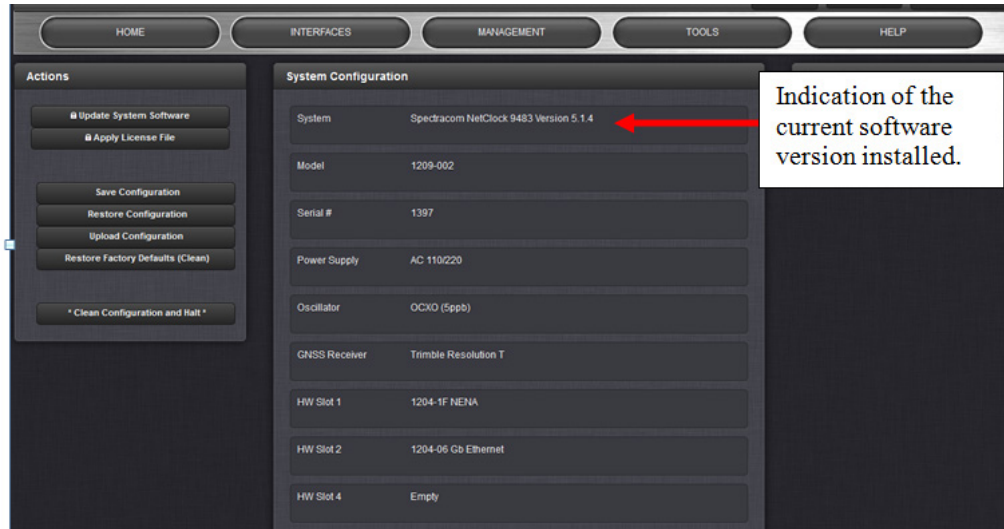
- A) **Using the new Web UI (Software versions 5.1.0 and above)**
 Log in to the unit's Web UI. Click on "Tools", then "Upgrade/Backup". The "System Configuration" table on this page contains a "System" field. The number next to this is the current Archive software version:

Figure 1: Software revision reported in the **Tools -> Upgrade/Backup** Page
