dBus-level timing board (TSync and TPRO/TSAT families) support assistance document

Note: This document contains both “Public Information” and “Internal Use Only Information” (do not release this document in its entirety to anyone outside of Orolia)

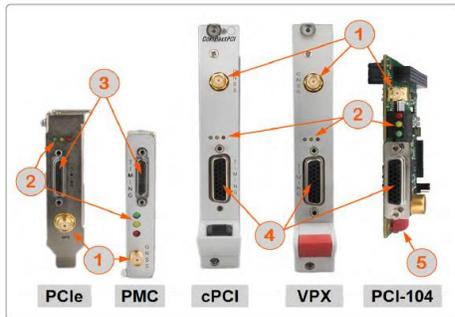
Figure 2-1: Tsync faceplates

NOTES:
 PCIe shown with half-height faceplate.
 All units shown without thermal frames.
 All units shown with internal GNSS receivers.

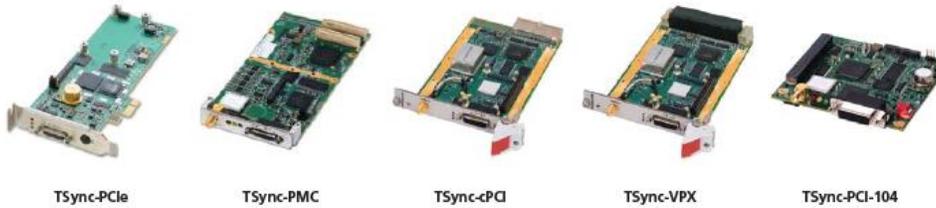
Form Factor/Bus Type (AAAA)	X= Custom Options			Y= Internal Options /OSC			Z= External References			
	0=NONE	1=TF	3=CC	0=TCXO	1=OCXO	2=Rugged OCXO	0=IRIG or Other	1=Internal GPS/GNSS	2=External GPS/GNSS	3=SAASM GPS
PCle (PCI Express)	x		x	x	x		x	x	x	
PMC (PCI mezzanine card)	x	x	x	x	x		x	x		
ePCI (compact PCI)	x	x	x	x	x	x	x	x	x	x
VPX	x		x	x	x	x	x	x		
PCI-104	x		x	x	x		x	x		x

Where:
 TF = Thermal Frame
 CC= Conformal Coating

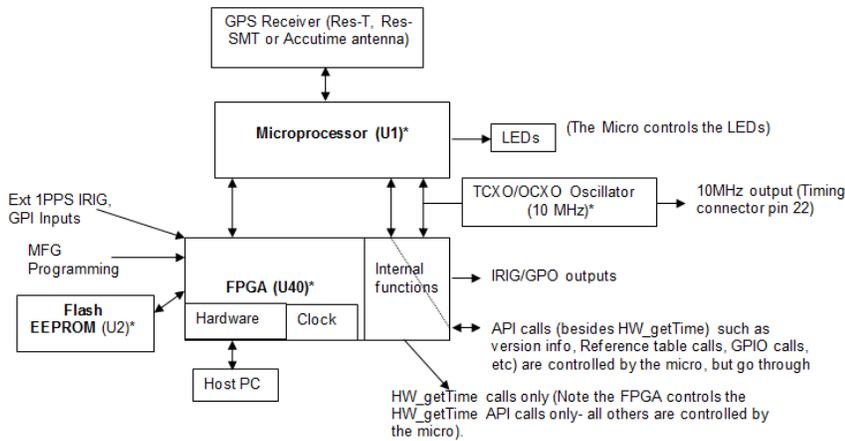
Hardware block diagram (for internal use only)

* denotes item is part of the Kramden Timing System (KTS)

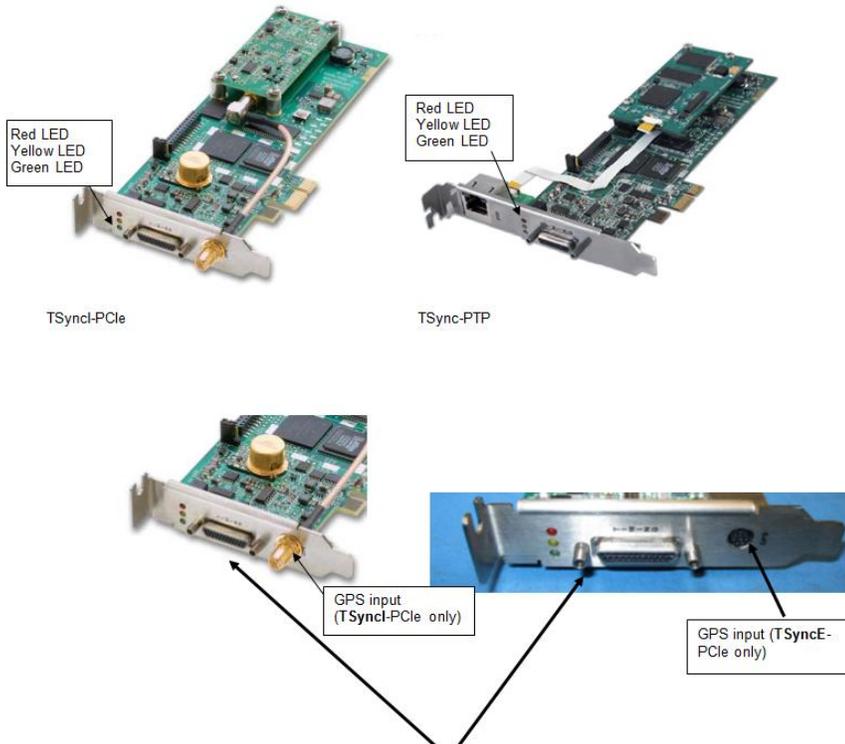
TSync-PCIe timing boards

3.1.1 Timing Connector Pinout

Pin	Signal	Pin	Signal
1	GPIO Output 2	14	GPIO Output 3
2	Ground	15	Ground
3	GPIO Output 0	16	GPIO Output 1
4	GPIO Input 2	17	GPIO Input 3
5	Ground	18	Ground
6	GPIO Input 0	19	GPIO Input 1
7	External 1PPS Input	20	1PPS Output
8	Ground	21	Ground
9	IRIG AM Output	22	10MHz Output
10	IRIG AM Input +	23	Ground
11	IRIG AM Input -	24	IRIG DCLS Input -
12	IRIG DCLS Output -	25	IRIG DCLS Input +
13	IRIG DCLS Output +

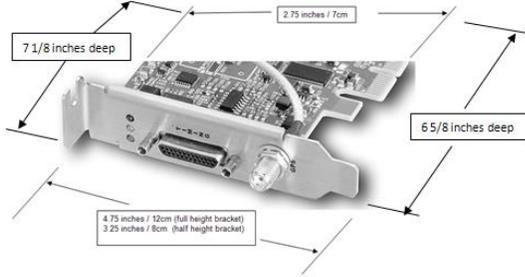
For your information, the TSync-PCIe board itself is about 2.75 inches high, at its widest point (including the connectors that plug into the PCIe slots). The TSync-PCIe board ships with a half height bracket attached to the board (for attaching the board to the PC) with a full height bracket also included (the picture below shows a half height).

Note: Half-height bracket not available with TSync-PCIe-PTP boards due to need for Ethernet jack.

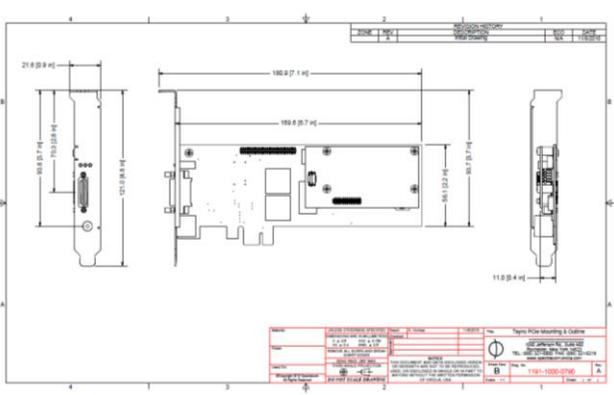
Dimensional drawing of the TSync-PCIe board

- Refer to (1191-1000-0790): <\\.\EQUIPMENT\SPECTRACOM EQUIPMENT\Timing boards\TSync family\TSYNC-PCIe\Drawings>

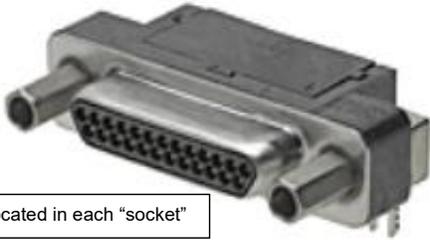
Timing Connector for all TSync variants

- Micro-D Sub 25 (D25) connector on the TSync board.
- The **Micro-D Sub connector (J8)** is a Molex connector (Molex P/N is 83614-9012).

Small pin located in each "socket"

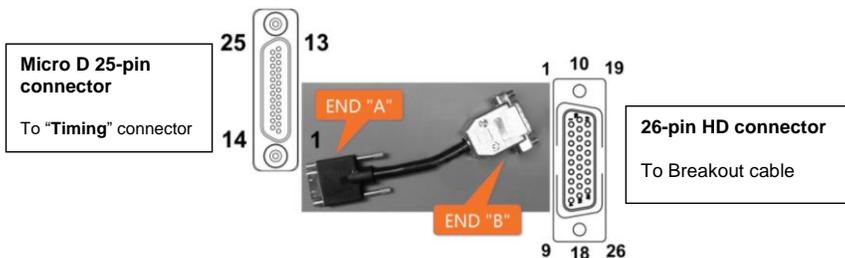
CA08R-DMD6-0001 (Micro-D25 to HD26 adapter cable)

PCIe and PMC cards are shipped with a 15 cm (6") adapter cable that is used to connect the micro 25-pin timing interface connector on the card to the breakout cable:

Note: This adapter cable ships standard with both Standard and Premium breakout cables (not included in the anc kit- its shipped separately)

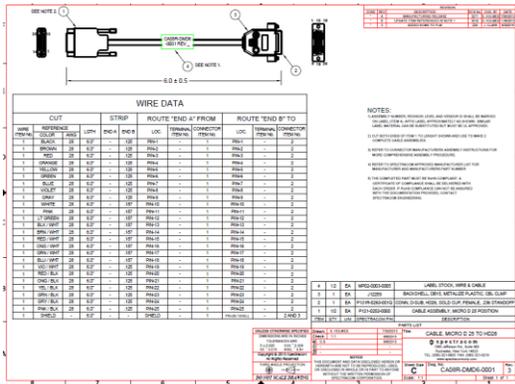
- Installed between TSync board and the newer design breakout cables (which started shipping around Nov 2013)
- Micro-D25 end of adapter attaches to TSync's Timing connector.
- HD (High Density) 26 end attaches to the new design breakout cable.
- Refer to "Connector Change" further below for the reason for this adapter cable being required when using newer breakout cables. since about the end of 2013.

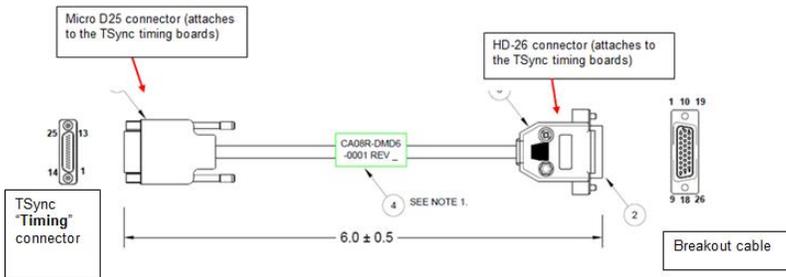
A Reply from Dave Lorah (10 Apr 2019) The cable conductors are 28 AWG. Attached is a drawing for the cable assembly.

Note: Pin 26 of HD-26 doesn't connect to the Micro D25 connector. It is connected to the shell of the HD-26 connector.

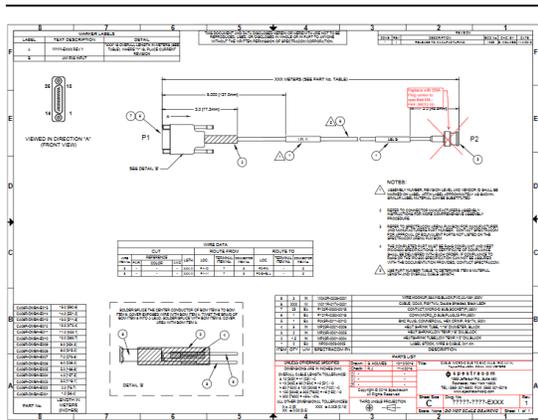
TSync cables with SMA connector for Raytheon (1 to 8 meter lengths)

- Refer to ECO-1662 (in Arena): https://app.bom.com/changes/detail-ecrs?change_id=2393442862
- SMA connector must be MIL-PRF-39012-55 compliant
- Refer to cable spec drawing (in Arena): https://app.bom.com/ecrs/detail-attach?ecr_id=1450527169

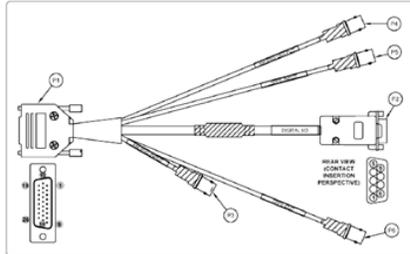
Table S-2: Pinout, basic breakout cable (unspecified pins in the table are not connected)

Pin	Signal	Pin	Signal
P1—Timing Connector			
3	GPIO Output 0	11	IRIG AM Input -
5	Ground	16	GPIO Output 1
6	GPIO Input 0	18	Ground
7	External 1PPS Input	21	Ground
8	Ground	24	IRIG DCIS Input -
9	IRIG AM Output	25	IRIG DCIS Input +
10	IRIG AM Input +		
P2—Digital I/O (DB-9 Female)			
1	Ground	6	GPIO Output 0
2	GPIO Input 0	7	Ground
3	Ground	8	GPIO Output 1

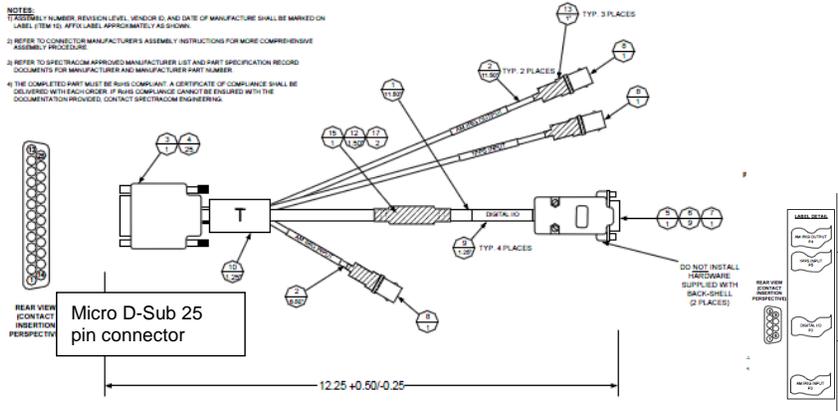
Shortcut to picture of discontinued standard breakout cable (**CA08R-0000-0003**, as shown below): in Arena https://app.bom.com/items/detail-spec?item_id=1202841926&version_id=10294592608&orb_msg_Single_Search_p=1&redirect_Seqno=7068646412

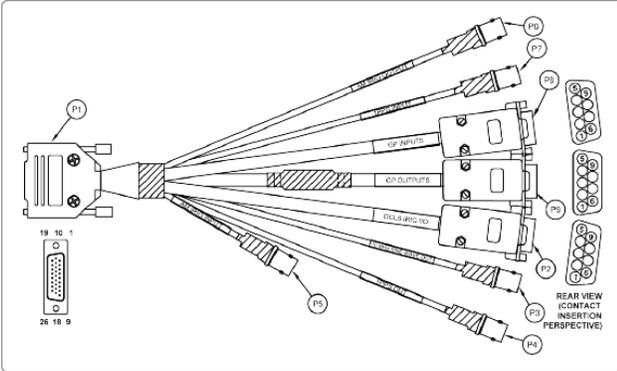
Premium Breakout Cable

The premium breakout cable breaks out all features from the timing connector to separate BNC and DB-9 connectors for use. See table below for details.

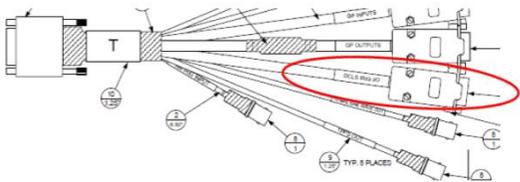
- 1 ea. IRIG DCLS (D Connector on end of "DCLS IRIG I/O" cable – P2)

Signal	Timing Connector pin	B/O cable D Connector – P2 pin
DCLS IRIG In + (or single ended)	25	4
DCLS IRIG In -	24	5

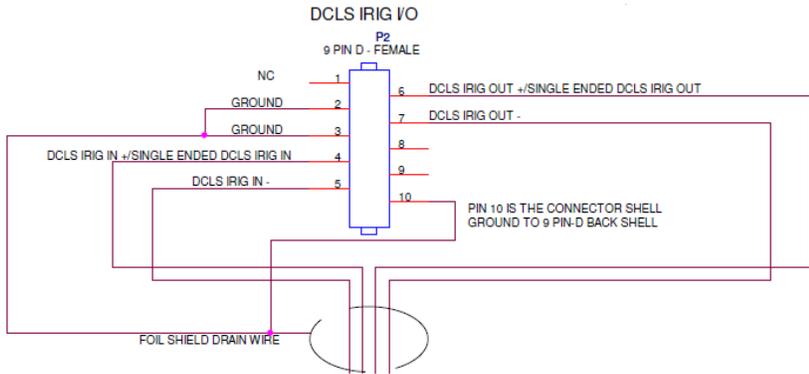
1 ea. IRIG DCLS (D Connector on end of "DCLS IRIG I/O" cable - P2)

Signal	Timing Connector pin	B/O cable D Connector – P2 pin
DCLS IRIG Out + (or single ended)	13	6
DCLS IRIG Out -	12	7
Ground	2,15	10

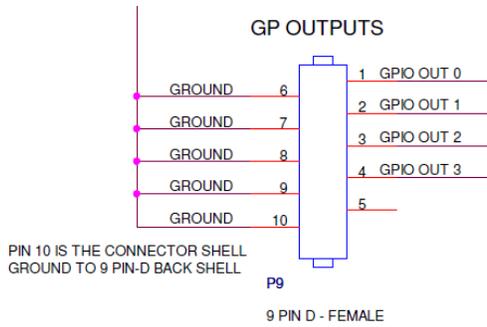
Signal	Timing Connector pin	B/O cable D Connector – P9 pin
GPI Output 0	6	1
GPI Output 1	19	2
GPI Output 2	4	3
GPI Output 3	17	4
Ground	2, 15	6,7,8,9,10

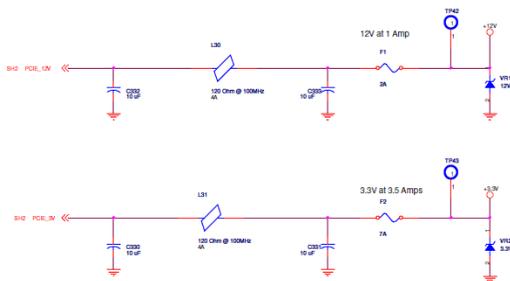
Fuses

- **Fuse F1:** for 12vdc input from PCIe bus slot
- **Fuse F2:** for 3.3vdc input from PCIe bus slot

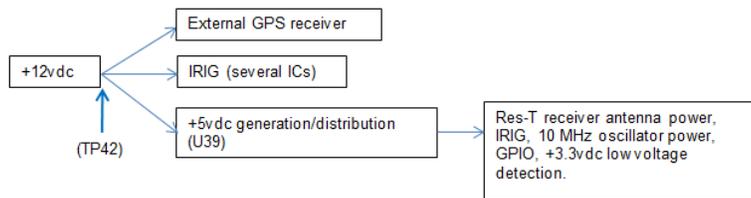
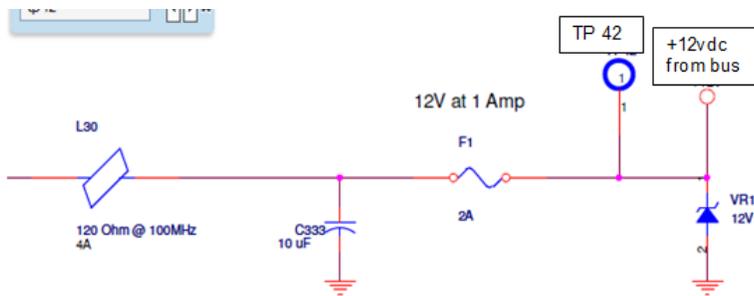
E) Fuse F1: for 12vdc input from PCIe bus slot

- +12vdc generates +5vdc
- +12vdc also generates -12vdc
- +12vdc /-12vdc used with IRIG.

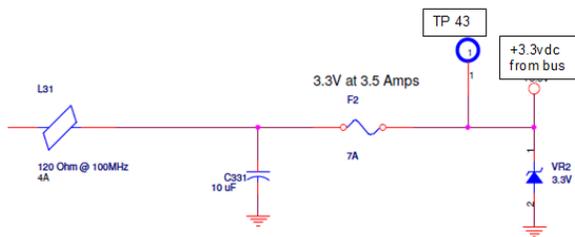
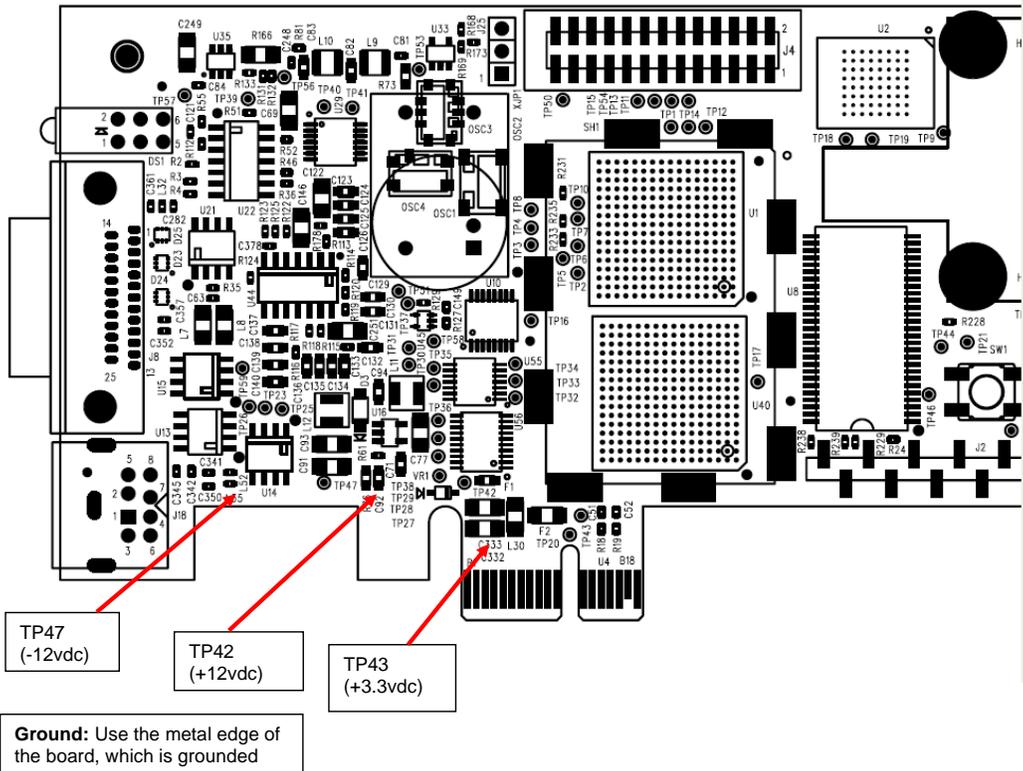
3.3vdc Low voltage detection circuit

- 3.3vdc is essential for operation of the board.
- If 3.3vdc is good, the three status LEDs on the edge of the board will all momentarily turn-on at power-up, then all will go out (thereafter, they remain dark until it syncs).
- If 3.3vdc is low, low voltage detection circuit will hold the board in reset- resulting in all of the LEDs remaining lit.
- If no 3.3 vdc present, the LEDS won't even momentarily turn on.

Your testing confirms what we were thinking is the problem. The 3.3v rail is dropping causing the low voltage IC on the board to hold it in reset mode. The threshold for the low voltage IC is 3.07v +/- 0.5% typ acc. So if you do the math, our spec for the 3.3v rail is 5% or about 3.14v, just above the threshold voltage.

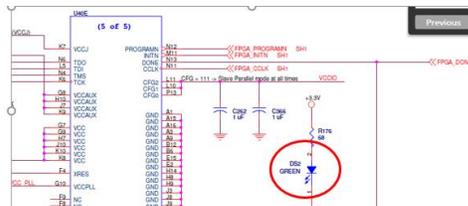
(Below is from 1191-1001-0200)

- Green LED located on **bottom** of PCB board (same underneath area as J25 program header)

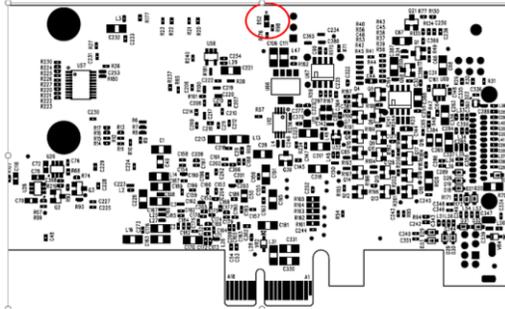
(Below is from 1191-1000-0200)

DS2 LED Blink/flash patterns indicating a potential issue

- The code indicates the fault condition. It blinks the number of times indicated with a 2-second pause between each set.
 - 1 Blink (1 Flash) = FPGA programming error
 - 2 Blinks (2 Flashes) = Failure to decompress
 - 3 Blinks (3 Flashes) = CRC failure writing to flash
 - 4 Blinks (4 Flashes) = Self-test failure
 - 5 Blinks (5 Flashes) = Timing system failure (**Note:** refer to SR 5558 in SAP for an actual example)

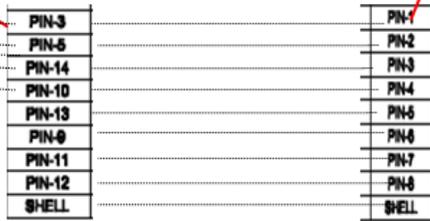
CA05-1512-0100 Cable (to Accutime antenna)

Antenna cable (CA05-1512-0100 and CA05-1512-0200) pin-out:

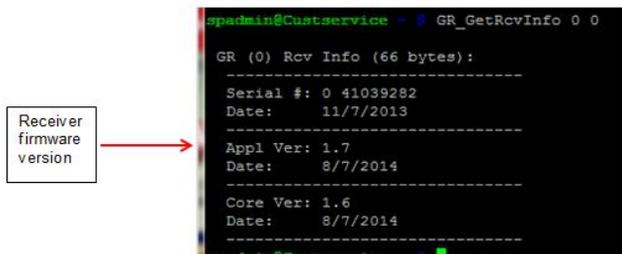
- Reports receiver firmware version (Example below is with a RES-SMT-GG receiver)

Note: Trimble refers to this release as 1.0.7, but the receiver reports it is 1.7 by dropping the “.0” in the response)

```
spadmin@Custservice ~ $ GR_GetRcvInfo 0 0
GR (0) Rcv Info (66 bytes):
-----
Serial #: 0 41039282
Date: 11/7/2013
-----
Appl Ver: 1.7
Date: 8/7/2014
-----
Core Ver: 1.6
Date: 8/7/2014
-----
```

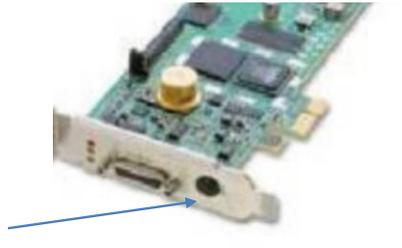
****Acutime antennas (“TSyncE” / “TSync-PCle-002 / TSync-PCle-012”)**

- Refer to: “Acutime antennas” in the custserviceassist doc: [..\CustomerServiceAssistance.pdf](#)
- External GPS or GNSS receiver (GPS/GNSS receiver is inside the Acutime antenna housing- not on the TSync-PCle board)

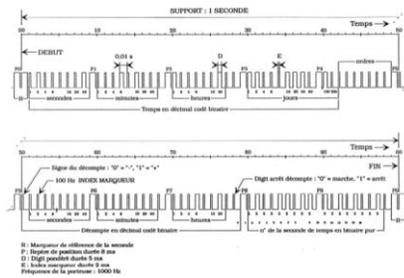
It is a pseudo IRIG B signal distributing the normal time reference (called TU) placed on P0,P1 ... Of the Frame + a countdown signal (called TD “temps Décompte”) placed in P5,P6,P7,P8,P9 of the frame. See below the detail of the frame:

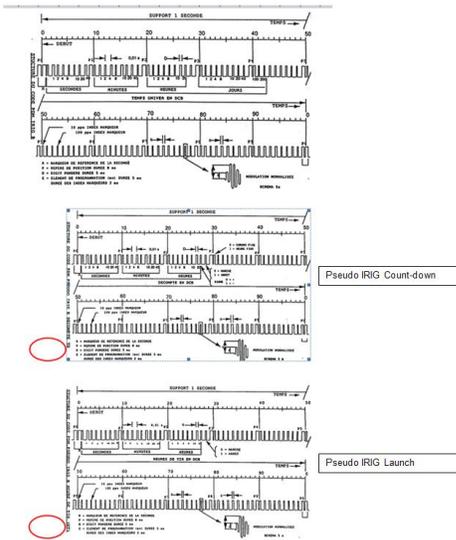
Pseudo IRIG B does not contain the time-of-day but a countdown / countup time. Both countdown and countup times are incrementing in the same direction but countdown time is displayed as a negative quantity which gets smaller as it approaches zero.

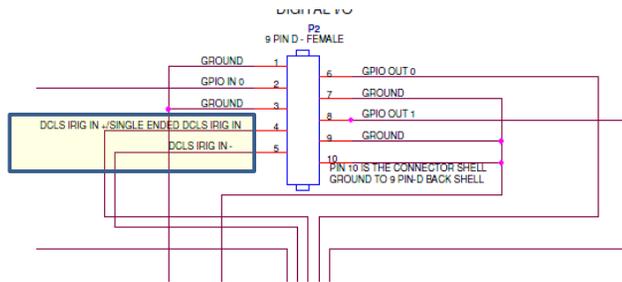
1. Using a Standard Breakout cable

Note: The actual pin-out depends on whether the IRIG input is balanced (A further below) or single-ended (B further below)

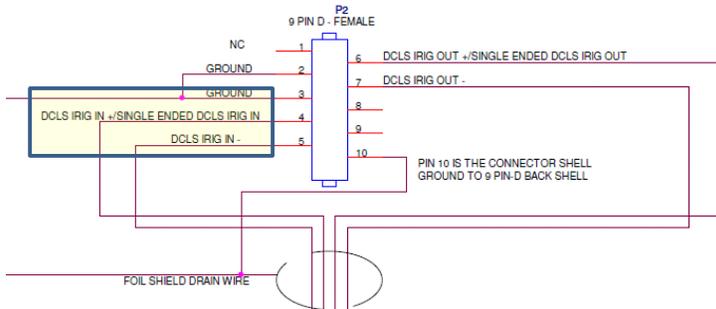
2. Using a Premium Breakout cable

Note: The actual pin-out depends on whether the IRIG input is balanced (A further below) or single-ended (B further below)

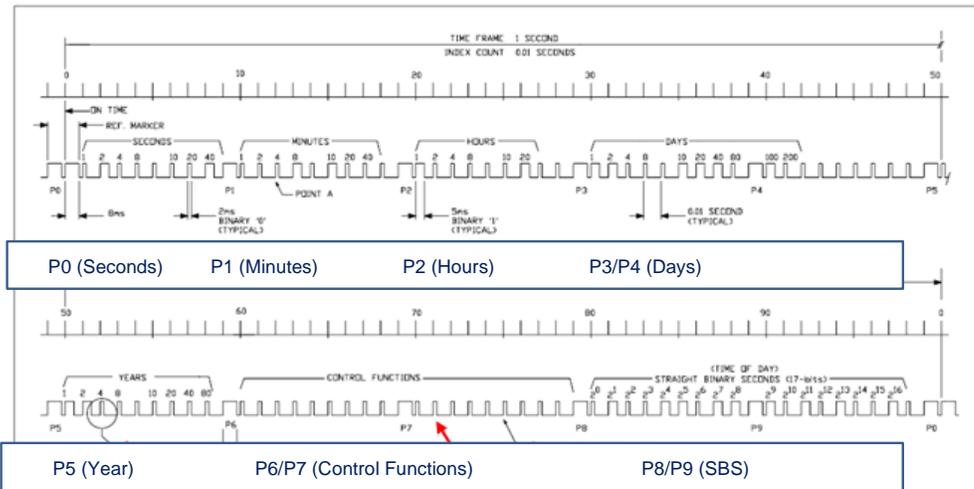
BCD Code Decimal Digits	Decimal Digits Follow Position Identifier	Digits Occupy Index Count Positions
Units of Seconds Tens of Seconds	P ₀	1-4 6-8
Units of Minutes Tens of Minutes	P ₁	10-13 15-17
Units of Hours Tens of Hours	P ₂	20-23 25-26
Units of Days Tens of Days	P ₃	30-33 35-38
Hundreds of Days Tenths of Seconds	P ₄	40-41 45-48
Hundredths of Seconds	P ₅	50-53

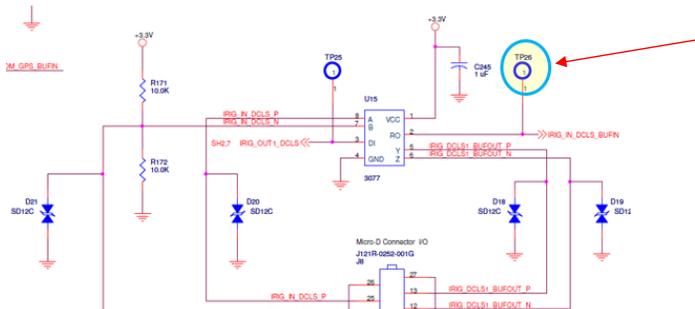
- 2) Make sure the IRIG source is configured to output IRIG B DCLS (1000 hz)
- 3) Configure the TSync's IRIG input as follows:
 - IR_SetMode 0 0 1** (For manual input configuration mode)
 - IR_SetFormat 0 0 1** (For IRIG B input) (B is the default setting. But it can accept A, B, G or E)
 - Note:** IRIG B is always 1kHz input -This is the default setting, and since it can't be changed, no need to configure this value with **IR_SetFreq 0 1 1**
 - IR_SetCodedExpr 0 0 2** (for BCD only)
 - Note:** (IRIG DCLS input) **IR_getMod 0 0 1** should always indicate "(0) DCLS" (Can't be configured as AM)
- 4) Verify the green Sync LED on the edge of the TSync-PCIe board illuminates.
- 5) IRIG DCLS signal should be present at **TP26**.

- 6) If the IRIG source is expecting 50 ohm termination, need to add 50 ohm termination resistor to the IRIG DCLS input (the TSync's IRIG DCLS input is high impedance).

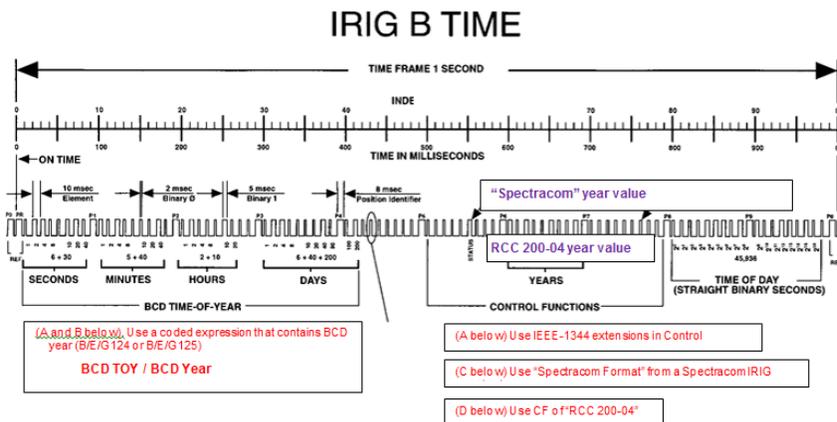
Via an IRIG input from an IRIG generator

Note: The Coded expression defines both the BCD format and whether CF functions are present

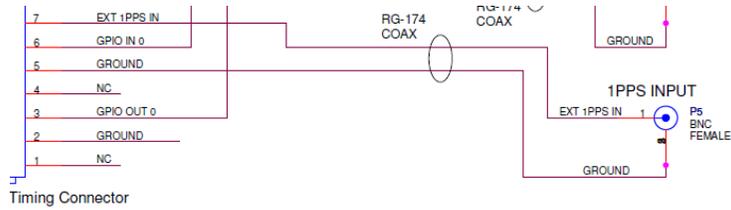
- 1) Using Standard Breakout cable (BNC Connector P5)**

1PPS Signal	Connector P5 - pin	Goes to Pin on Timing connector
Ext 1PPS In	Center pin	7
Ground	Shield	5

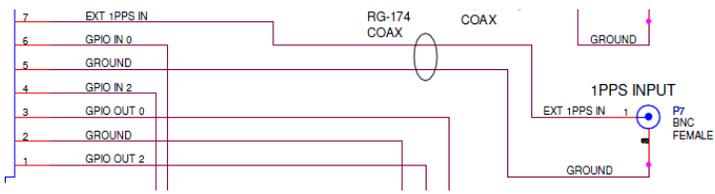
2) Using Premium Breakout cable (BNC Connector P7)

1PPS Signal	Connector P7 - pin	Goes to Pin on Timing connector
Ext 1PPS In	Center pin	7
Ground	Shield	5

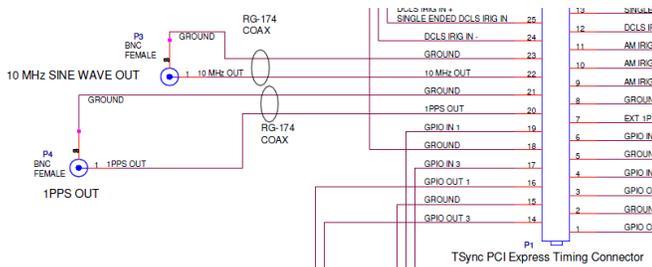
- Not available on Basic/Standard Breakout cable
- Using Premium Breakout cable (BNC Connector P3)

10MHZ Signal	Connector P3 - pin	Goes to Pin on Timing connector
10MHz	Center pin	22
Ground	Shield	23

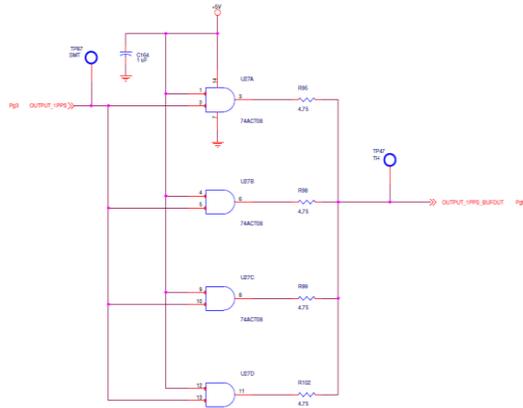
1PPS OUTPUTS, 5V with 50 Ohm LOAD

Other TSync family boards 1PPS: U27 is a 74ACT08 for 50 ohm load (as shown below)

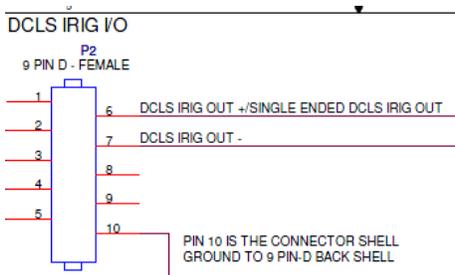
B) Using Premium Breakout cable (DB9 Connector P2)

IRIG DCLS output Signal	Connector P4 - pin	From Pin on Timing connector
IRIG DCLS out + (or single-ended)	6	13
IRIG DCLS out -	7	12

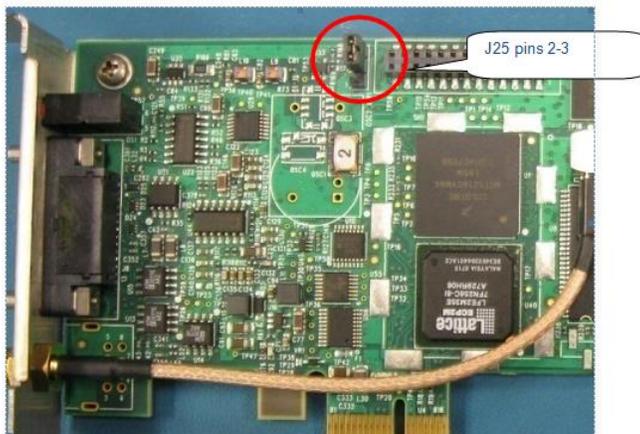
You can check jumper setting on J25 and make sure that it is configured on the pins to the outside edge of the board (pins 2 and 3), as seen in the red circle in the photo below:

If the jumper is not in the correct position, please change the jumper and try again. With the jumper moved to the correct position, operation of the board should then be restored. With Signature Control remaining disabled, a modulated IRIG output should now be present.

For two TSync boards to be acting the same way, one potential configuration issue comes to mind. If a certain jumper j25 in the correct position upon power-up, the TSync-PCle boards would be "stuck" loading the bootloader and therefore the TSync-PCle would not be able to operate. This jumper is only used for initial programming of the TSync-PCle boards.

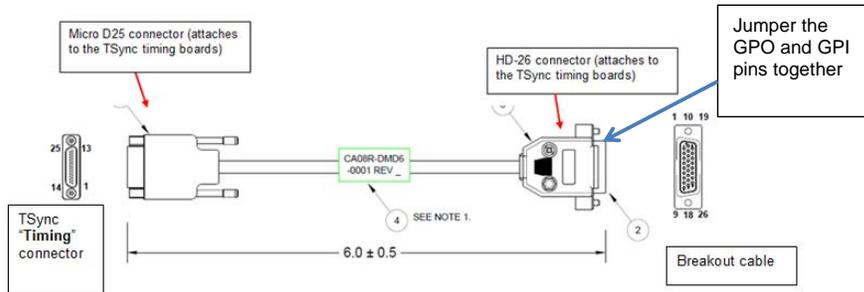
- Link to schematic (CA08R-DMD6-0001) in Arena: <https://app.bom.com/items/detail-spec>
- Installed between TSync board and the newer design breakout cables (which started shipping around Nov 2013)
- Micro-D25 end of adapter attaches to TSync’s Timing connector.
- HD (High Density) 26 end attaches to the new design breakout cable

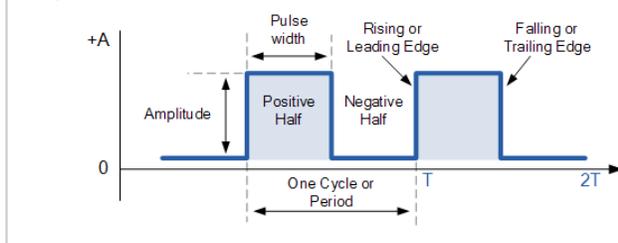
A Square Wave Waveform

In **square wave** mode, an interrupt is generated whenever the GPO output generates the active edge as selected by the GPIO output square wave active edge bit in the GPIO output control / status register. This can be used to generate a periodic interrupt at the rate of the square wave.

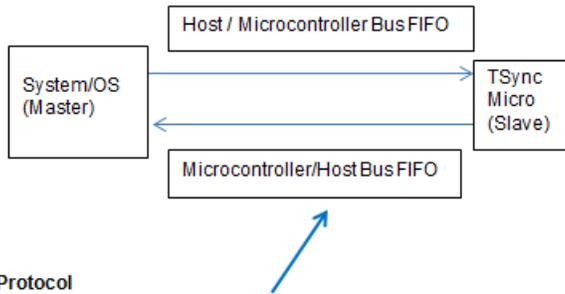
Shared Memory Interface
0x160	Host / Microcontroller Bus FIFO Control / Status
0x180	Host / Microcontroller Bus FIFO Data
0x1C0	Microcontroller / Host Bus FIFO Data

Notes: Addresses listed are the offset from the memory space base address

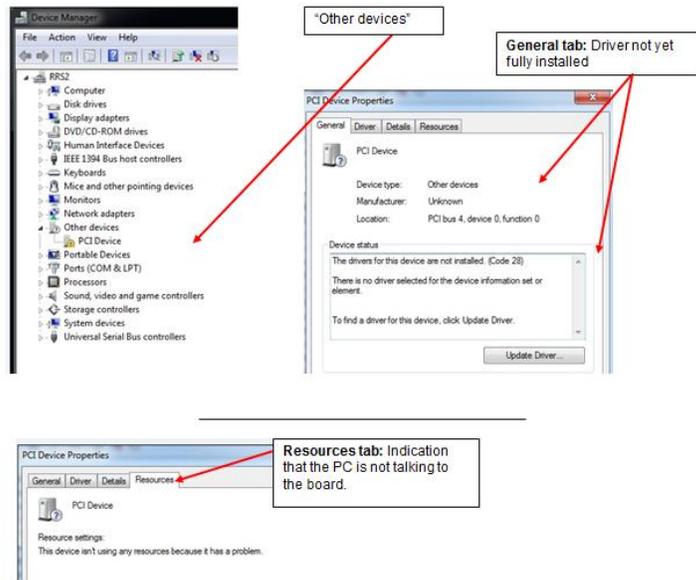
Note: Before the Windows driver is fully installed (with the board installed), it may show up as simply "PCI device" (under "other devices" as shown below:

- With the board installed in a Windows PC (whether or not the driver has been installed yet) "TSync-PCI" should be seen in "Device Manager" (**Start-> All Programs -> System -> Hardware-> Device Manager**). Device Manager should list "Timing Boards" (with "**TSync-PCI Timing board**" below it).

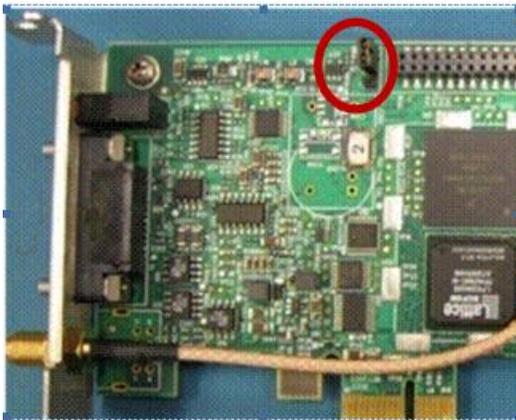
Check jumper setting on J25 and make sure that it is configured on the pins to the outside edge of the board, as seen in the red circle in the photo below:

If this jumper is in the wrong position, on a reboot the timing board will never look for the new images and will always load the bootloader (Green and Red LED s will be blinking and the Yellow LED will be not lit). Please place this two position jumper as shown in the picture above (with the jumper across the two outer pins (closest to the edge of the TSync-PCIe board).

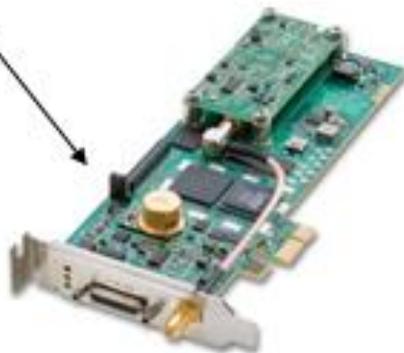
The green FPGA load LED is located on the back side of the PCB, in the same area as the programming jumper.

The LED should turn on shortly after the board boots-up and then should remain lit.

There is also a **green** "load" LED on the back-side of the TSync-PCIe boards (in the same area of the board as the jumper described above, but on the other side of the timing board. This LED should light shortly after the TSync-PCIe board powers-up and then should remain lit, from that point forward. Please let me know if this LED turns on and then remains lit green while the PC is on.

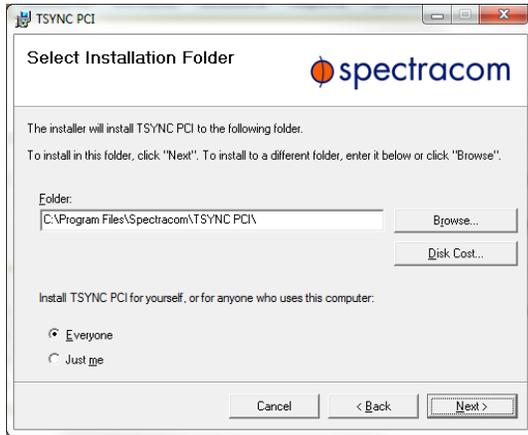
A. Reply from Keith (14 Jul 2014) When installing the Windows driver, it does allow you to select where it will be installed (as shown below):

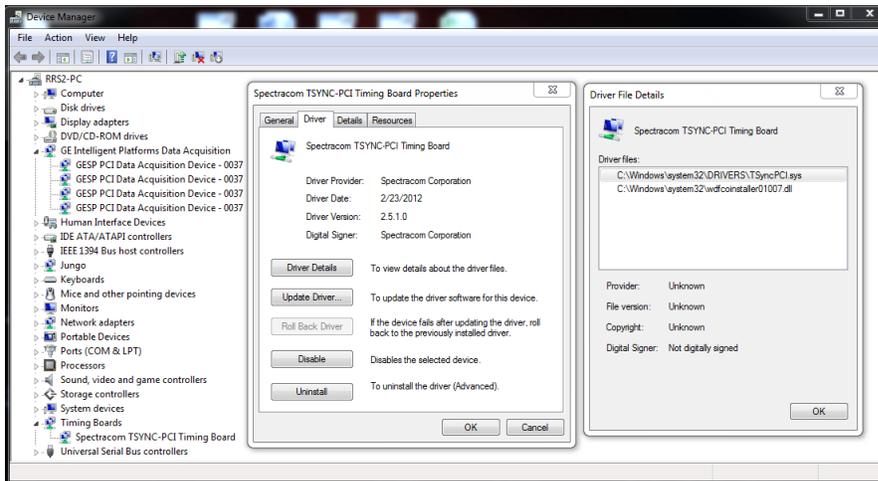
- 1) Right click on each product and select “**Properties**”.
- 2) Select the **Driver** tab.
- 3) Select “**Driver Details**”.

This should list which driver(s) each installed board is linked to. We want to make sure the TSync-PCIe board is not linked to any other drivers and the other products are not linked to the TSync-PCIe driver. Please send a screenshot of this list to us.

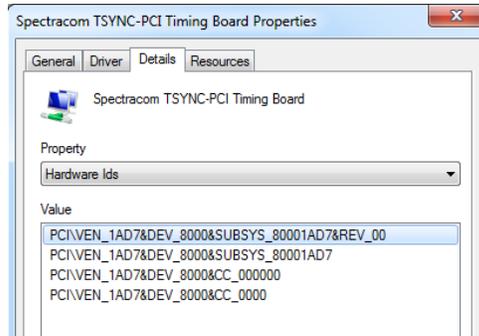
- 4) Now click on the **Details** tab.
- 5) In the drop-down in the Details tab, choose “**Hardware Ids**”.
- 6) This tab shows the sub-system ID information. Send us a screenshot of this list for all of the products.

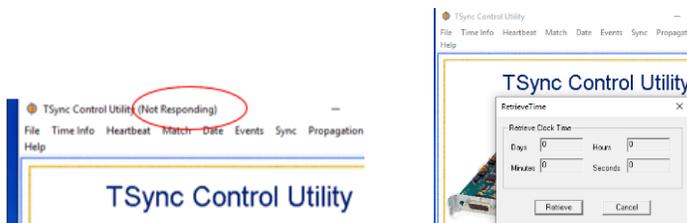
Example symptoms observed with this issue

Email from Dave Sohn to Dave Lorah (29 May 2019) I mentioned to Keith, but we should check and see if these units already have the Base Address Register fix that we released to resolve some Windows 10 access issues for Schneider Electric. The screenshots from the driver seem to indicate it is installed fine. Denis or Ron may have an idea of how we can check the Base Address Register in the unit to see if it is potentially this issue

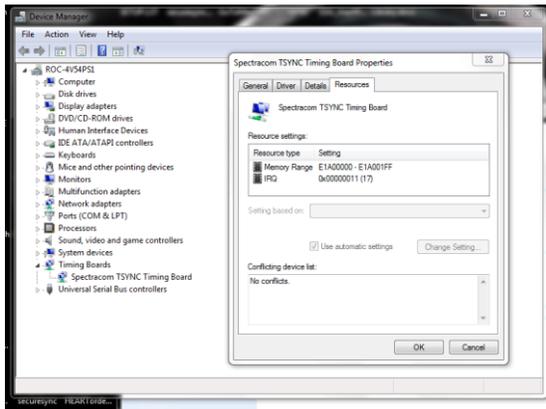
Reply from Dave L to Denis I will ask the customer to verify this address for us. Attached (below) is a pic from my personal

Tsync system as an example.

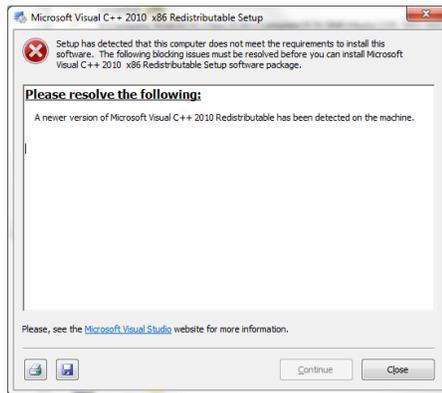
It appears the issue you are observing with the TSync-PCIe driver is associated with newer versions of the "Microsoft Visual C++ Redistributable" (related to Visual Studio 2012) already being installed in this PC. When the TSync-PCIe version 2.5.1 driver is being installed, it wants to install a specific version of the Microsoft 2010 Redistributable. But if there is already newer versions of the Redistributable installed, the TSync driver can't install its version, and it can't proceed past this required step. The screenshot below will be displayed:

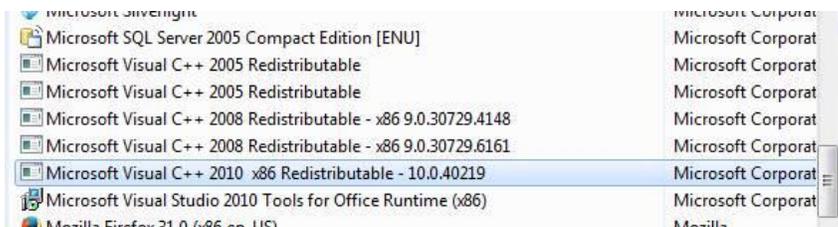
Newer version Redistributable can be uninstalled without the need to uninstall or alter Visual Studio. To uninstall newer Microsoft Redistributables, go to Control Panel -> Programs and then select View installed programs, There should be a list of installed "Microsoft Visual C++ Redistributables" (as shown below):

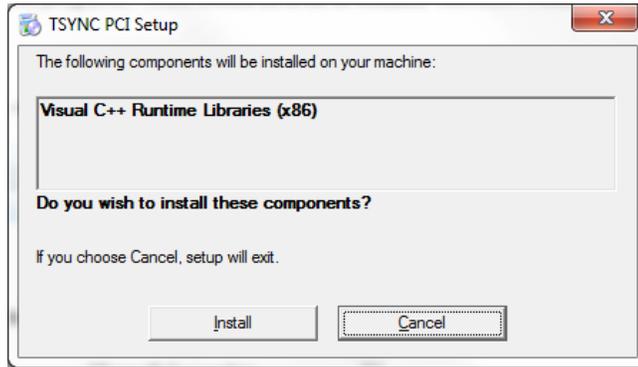
Uninstall the 2010 Redistributables. Then run the TSync driver setup.exe installer program again. During the install, it

will prompt you if you wish to install the "Visual C++ Runtime Libraries (x86)" as shown below. Click install to continue and complete the driver install and then reinstall newer Redistributables as required.

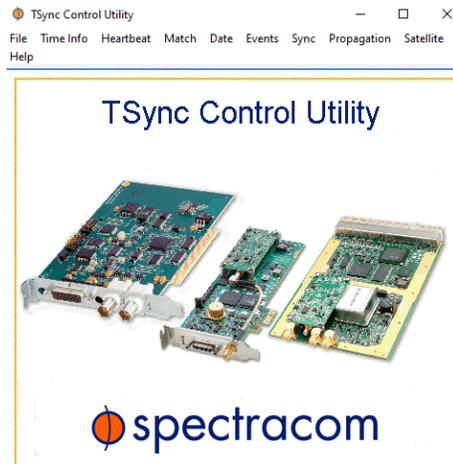
**Windows Control Utility GUI interface

- **To open the Control Utility:** Start / All Programs / Spectracom Corp (now Orolia)/ TSync PCI / TSync Control Utility
- Provides a basic interface with the TSync-PCIe board via a GUI (such as reading the current Sync status, for example)
- The TSync-PCIe board does not need to be installed to use this GUI. Install the Windows driver and this GUI can be run in a “demo” mode to demonstrate the capabilities of the utility

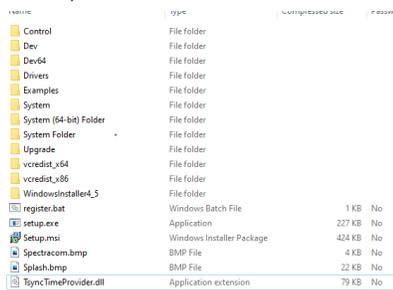
- in Windows server 2016 (and Windows 10) the customer can take advantage of the TSync Time Provider (“TsyncTimeProvider.dll” file) included with the 64 bit version of the driver.

File Name	Type	Size	Attributes
Control	File folder		
Dev	File folder		
Dev64	File folder		
Drivers	File folder		
Examples	File folder		
System	File folder		
System (64-bit) Folder	File folder		
System Folder	File folder		
Upgrade	File folder		
vcredist_x64	File folder		
vcredist_x86	File folder		
WindowsInstaller4_5	File folder		
register.bat	Windows Batch File	1 KB	No
setup.exe	Application	227 KB	No
Setup.msi	Windows Installer Package	424 KB	No
Spectracom.bmp	BMP File	4 KB	No
Splash.bmp	BMP File	22 KB	No
TsyncTimeProvider.dll	Application extension	79 KB	No

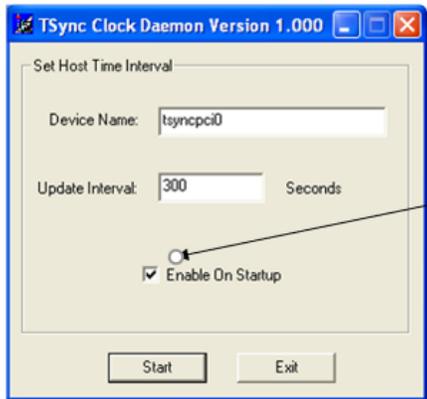
For the Clock Daemon program:

Enable On Startup: Checking this box will automatically start system clock synchronization by the clock daemon whenever the program itself starts. Alternatively, the synchronization can be started or stopped manually.

Per the *Clock Daemon* section of the driver guide, it can optionally sync at Windows start-up, instead of waiting for the first interval after the program has started:

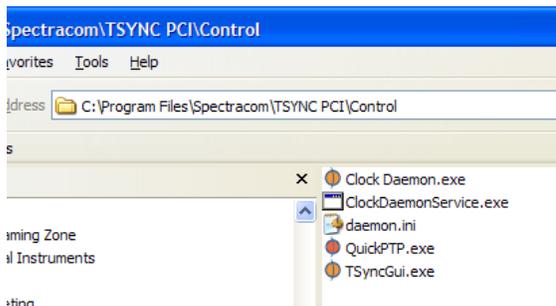
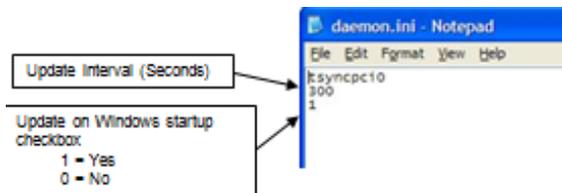
For the Clock Daemon Service:

- The controls for device name and update interval are setup by the “daemon.ini” located in the “Spectracom\TSYNC PCI\Control” folder with the clock daemon executables. This initialization file is shared by both clock daemon executables.

The “1” is “Enable on Startup” selected. When not selected, the PC will wait the Update Interval after the program starts before its first sync.

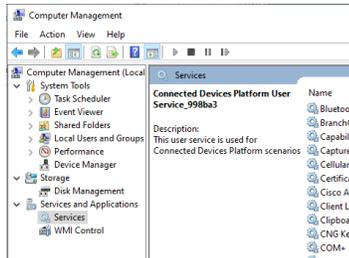
- **Windows Start > Computer Management.** Select **Services** and then scroll down the list of Services to **Clock Service**

Per Ron Dries (25 Feb 2020) The clock daemon will start a service that will be running/ so he will need to check the Windows Services menu, or see if there is a icon in the bottom right task bar that says “**clock daemon**”. It runs in the background.

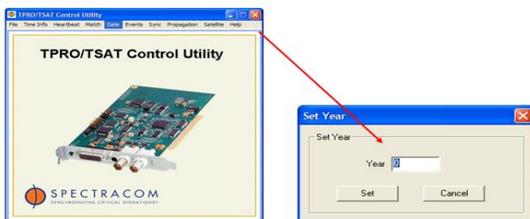
With both TPRO and TSync boards, in addition to setting the year with an API call after each boot-up, the year can also be manually set (or the current year value in the boards can be obtained) using the Windows Control utility that is installed as part of the Windows driver (as shown below, its set using the **Date -> Set Year** menu. The current year set in the board is obtained using the **Date -> Retrieve Gregorian Date** menu).

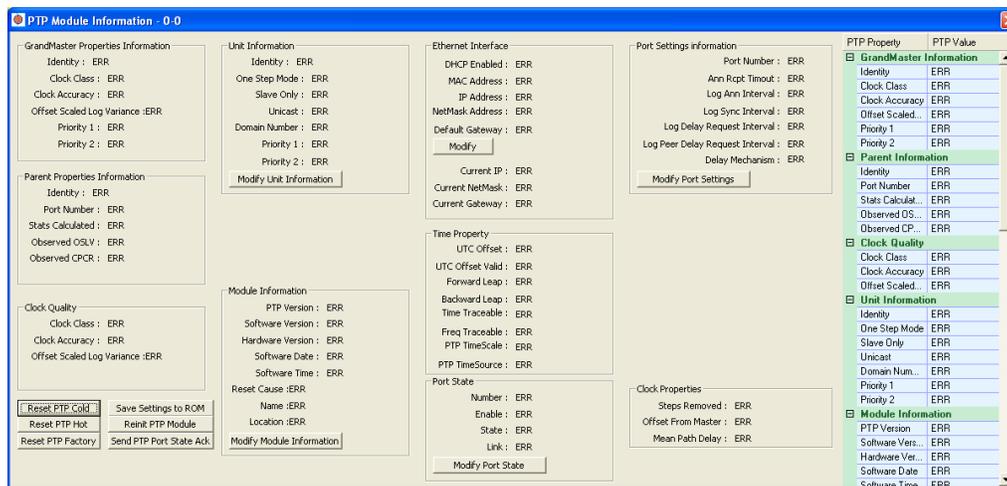
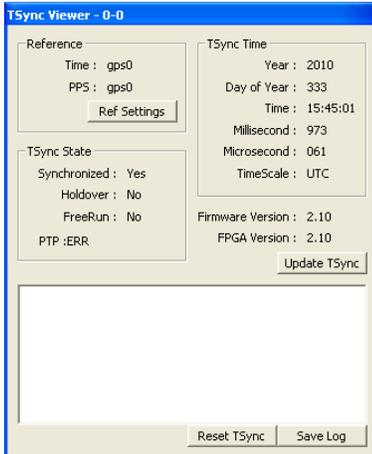
- **To open the QuickPTP interface:** Start / All Programs / Spectracom Corp / TSync PTP / QuickPTP
- Provides a basic interface with the TSync-PTP board (configure the IP address of the PTP module, for instance)
- The TSync-PCIe board DOES need to be installed to use this GUI. Install the Windows driver and this interface can be used, as long as a TSync board is installed (Unlike the Control Utility, QuickPTP does not have a “demo” mode available).

These values will report “ERR” (Error) when this utility is used with the TSync-PCIe boards. (they were planned to be used with SecureSync-PTP, but this has since changed. Quick-PTP no longer compatible with SecureSync.

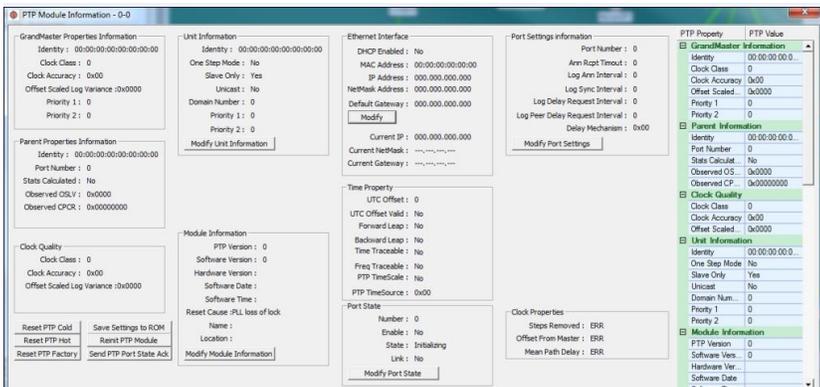
PTP module shows Information displays all "0"s after cold reset (example screenshot below)

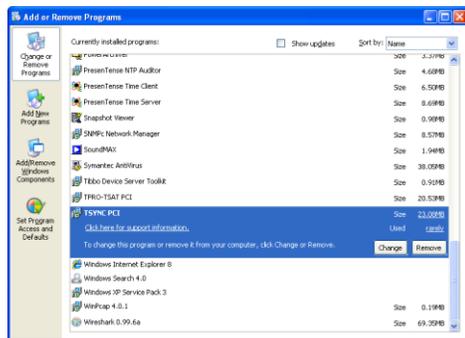
Below is an example of using the windows Add or Remove Programs to uninstall the original driver.

To begin, the older Windows driver should be removed before installing the latest version of the driver. The original version can be installed using the standard Windows uninstall program (depending on the version of Windows, such as Control Panel/ Add or Remove programs, for example). When clicking on this Windows program, "TSync PCI" driver will be listed as one of the installed programs that can be removed from the PC. Click on the "Remove" button.

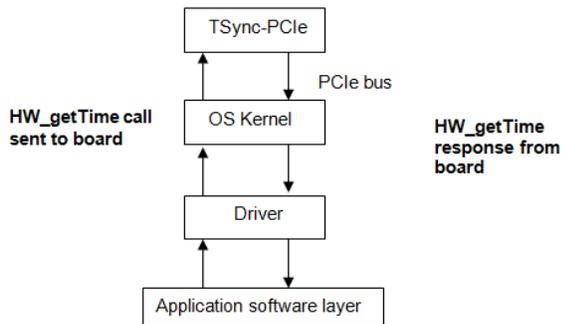
There are a couple of factors to keep in mind when performing time reads of the TSync-PCIe timing board. One of these is inherent latencies between time reads that occur and another is the accuracy of each time read (as compared to the input reference for the board). Latency is the amount of time required between each time read occurring (as determined by the board, the computer, software, etc). The amount of elapsed time between each read explains why you are seeing 3.58 microseconds to read the time from the Tsync board. If you try to read the time twice in the same microsecond for example, the second read will lag the first read by the amount of time required between reads to occur (the latency). Responses to time reads cannot occur faster than the latency time permits. To prevent seeing delays in the time reads, allow a delay of about 4 microseconds between each time read. This will negate the ~4microsecond delays you are seeing.

The accuracy of each individual time read will be dependent upon the accuracy of the input reference to the TSync-PCIe board combined with the latencies you are measuring on each time read. The latencies may always be a set length of time, or they may vary from one read to the next. The more consistent the latency measurements are, the better the representation of the accuracy of the time reads (consistent latencies indicates more accurate time reads).

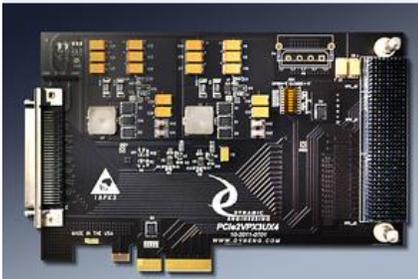
PCIe Carrier board for VPX (VPX to PCIe adapter board)

- **Our P/N:** MP41R-0001-0001
- **In Arena:** https://app.bom.com/items/detail-spec?item_id=1208880424&version_id=10315943908&orb_msg_single_search_p=1
- **Can be used to test TSync-VPX boards** on a standard system not having VPX bus connectors

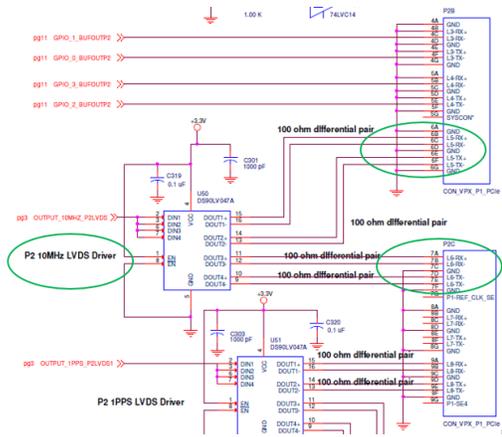
Three VPX P2 Backplane Signal Definitions						Rev 1
Backplane	Stat 1 - P2	B	I	GN2	Power	
Backplane	Stat 1 - P2	7	A	OUTPUT_10MHz_P2LVDS+	10MHz Output + LVDS	
Backplane	Stat 1 - P2	7	B	OUTPUT_10MHz_P2LVDS-	10MHz Output - LVDS	
Backplane	Stat 1 - P2	7	C	GN2	Power	
Backplane	Stat 1 - P2	7	D	GN2	Power	
Backplane	Stat 1 - P2	7	E	OUTPUT_10MHz_P2LVDS+	10MHz Output + LVDS	
Backplane	Stat 1 - P2	7	F	OUTPUT_10MHz_P2LVDS-	10MHz Output - LVDS

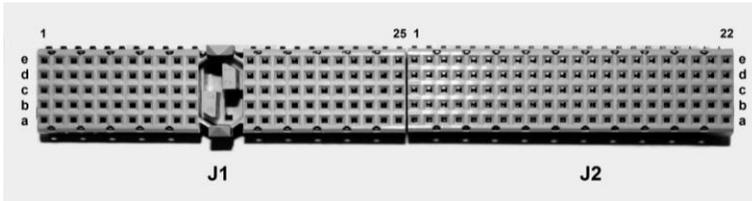
PMC Bus connectors (J1 and J2)

Note: Refer to the TSync-PMC manual for the pin-outs (likely on pages 3-1 through 3-3)

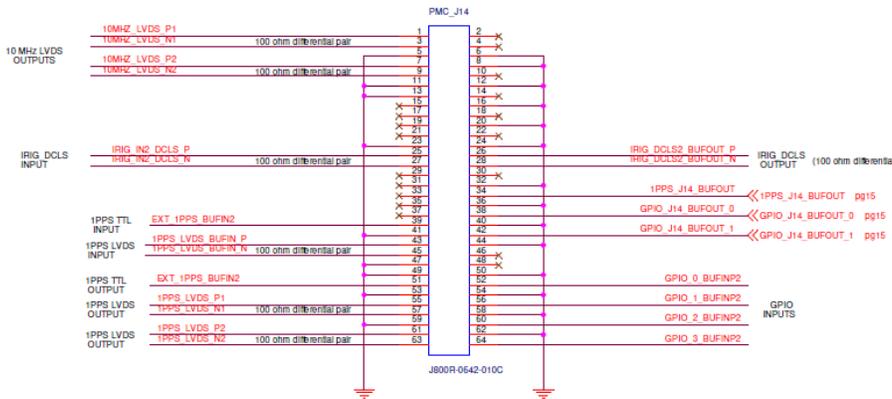
PMC J14 CONNECTOR User-Defined I/O

From Schematic: 1221-1001-0200 rev 4:

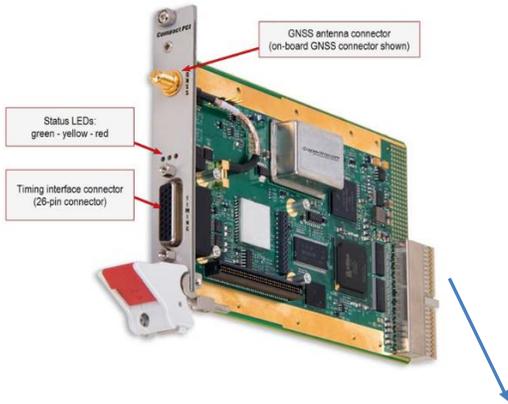
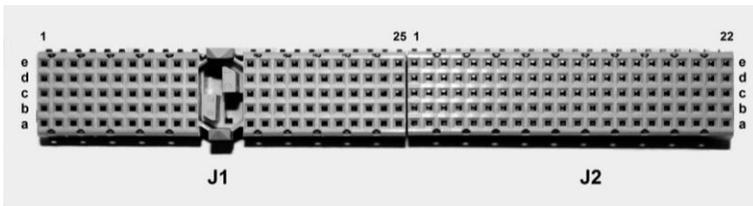
TSync-cPCI Bus connectors (J1 and J2)

Note: Refer to the TSync-cPCI manual for the pin-outs (likely on pages 3-1 through 3-3)

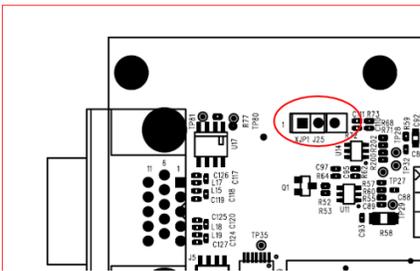
1. Header/Jumper for programming (J25)

➤ Located on **top** of board

NOTE: DS1 flashing (after program) means either jumper J25 is in wrong position, or problem with the PCB.

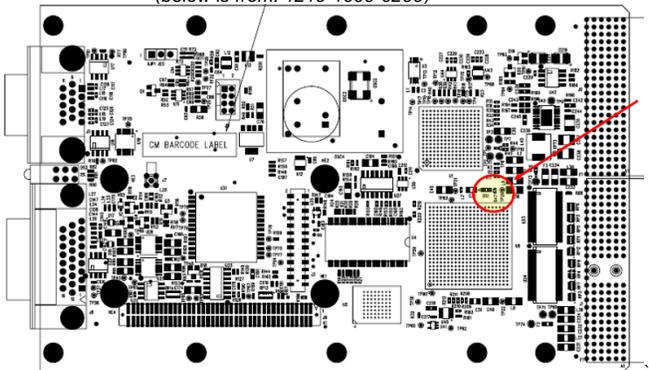
2. Green FPGA Program load LED (DS1)

➤ Unlike TSync-PCIE boards, the green FPGA Programming LED (DS1) is on the **TOP** of the board
(below is from: 1219-1000-0200)

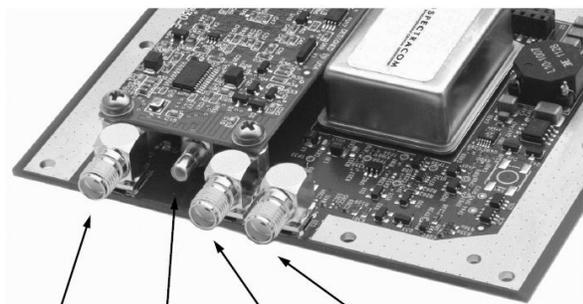
CTC-cPCI (CTC/Blitz) and Tsync-cPCI-121(“TSync-cPCI-CC” commercial version of CTC-cPCI)

G19 1PPS Out

GPS Connector
(On-board GPS
Connector shown)

G18 1PPS In

G20 10 MHz In
