dBus-level timing board (TSync and TPRO/TSAT families) support assistance document

Note: This document contains both “Public Information” and “Internal Use Only Information” (do not release this document in its entirety to anyone outside of Orolia)

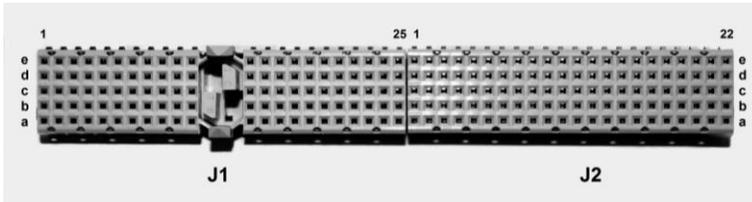
Bus connectors (J1 and J2)

Note: Refer to the TSync-cPCI manual for the pin-outs (likely on pages 3-1 through 3-3)
Link to manual: <I:\New Released\Manuals\1205-xxxx-xxx>

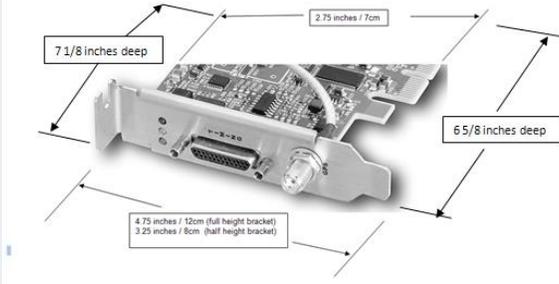
For your information, the TSync-PCIe board itself is about 2.75 inches high, at its widest point (including the connectors that plug into the PCIe slots). The TSync-PCIe board ships with a half height bracket attached to the board (for attaching the board to the PC) with a full height bracket also included (the picture below shows a half height).

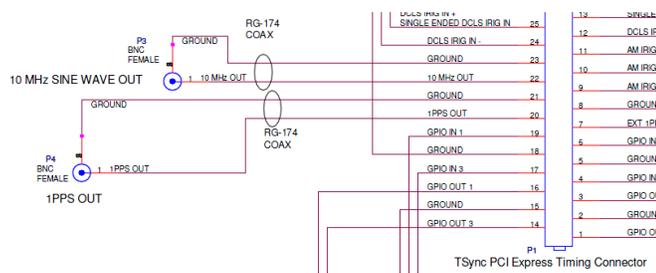
10MHz output pin-outs

- Not available on Basic/Standard Breakout cable
- Using Premium Breakout cable (BNC Connector P3)

10MHZ Signal	Connector P3 - pin	Goes to Pin on Timing connector
10MHz	Center pin	22
Ground	Shield	23

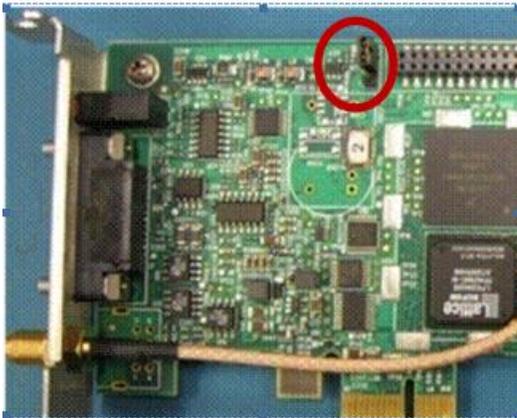
Check jumper setting on J25 and make sure that it is configured on the pins to the outside edge of the board, as seen in the red circle in the photo below:

If this jumper is in the wrong position, on a reboot the timing board will never look for the new images and will always load the bootloader (Green and Red LED s will be blinking and the Yellow LED will be not lit). Please place this two position jumper as shown in the picture above (with the jumper across the two outer pins (closest to the edge of the TSync-PCIe board).

Verify the green "FPGA" loaded LED is lit (verify Jumper J25 is in the correct position)

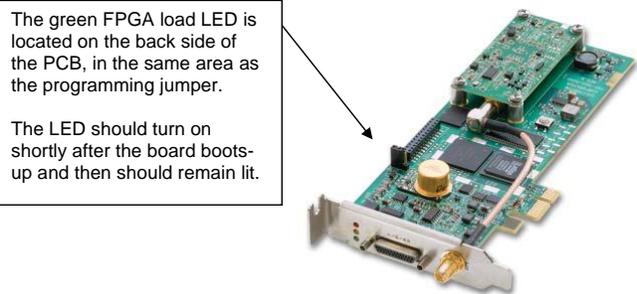
There is also a **green** "load" LED on the back-side of the TSync-PCIe boards (in the same area of the board as the jumper described above, but on the other side of the timing board. This LED should light shortly after the TSync-PCIe board powers-up and then should remain lit, from that point forward. Please let me know if this LED turns on and then remains lit green while the PC is on.

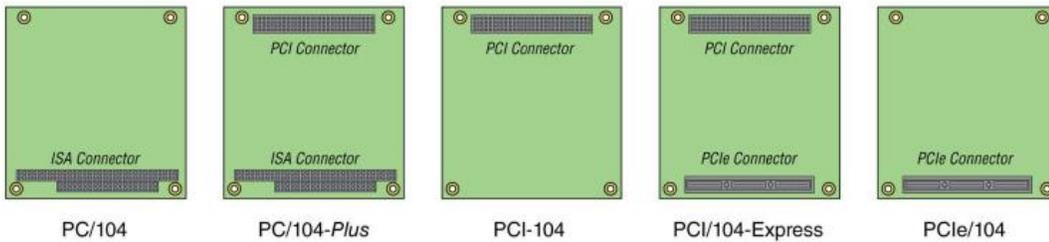
HOST PCI-104 BUS interface

PCI-104 is another stacking form factor like PC/104. See images below.

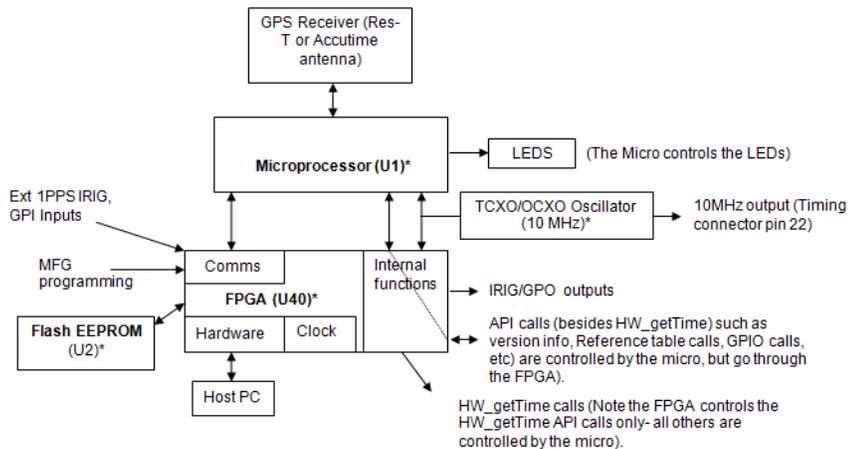
Hardware block diagram (for internal use only)

* denotes item is part of the Kramden Timing System (KTS)

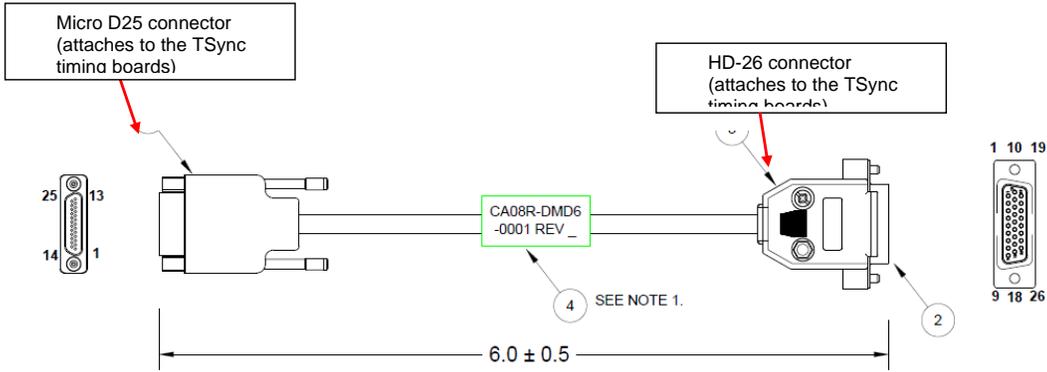
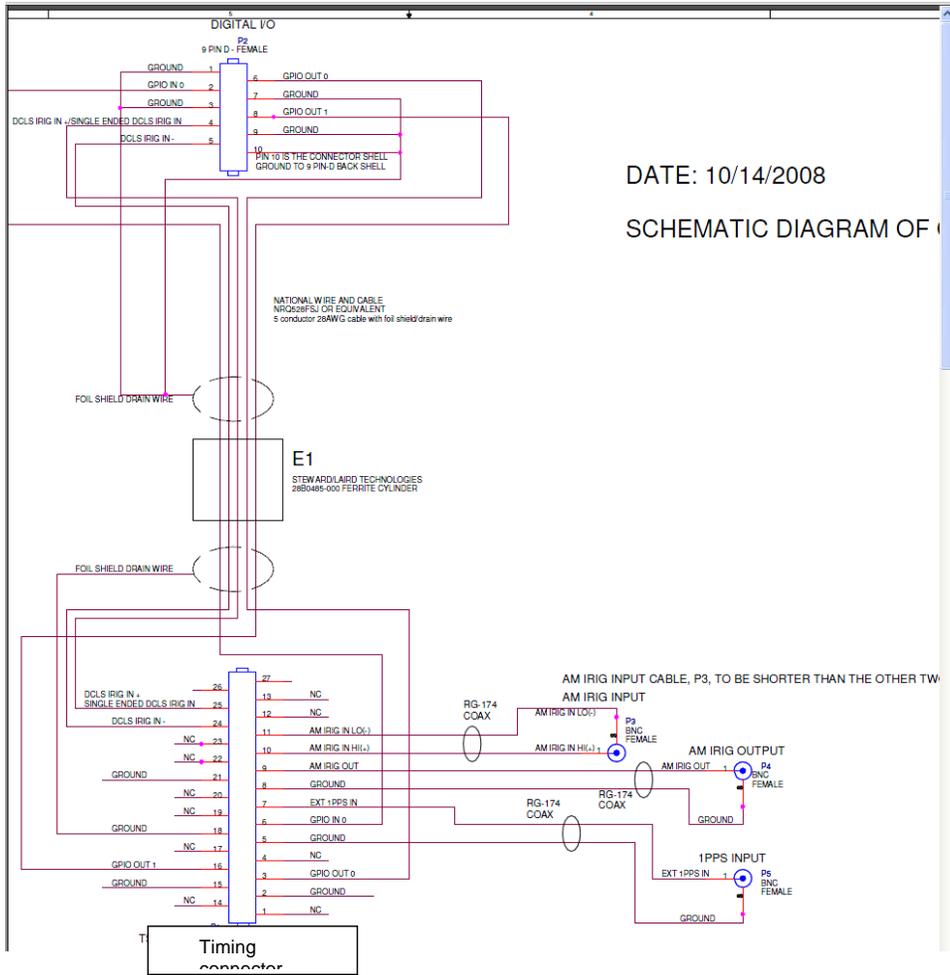
- Link to schematic (CA08R-DMD6-0001) <I:\New Released\Cable Drawings>
- (installed between TSync boards and newer breakout cables which started shipping around Nov 2013)
- Micro D25 end attaches to timing board.

➤ HD26 end attaches to breakout cable

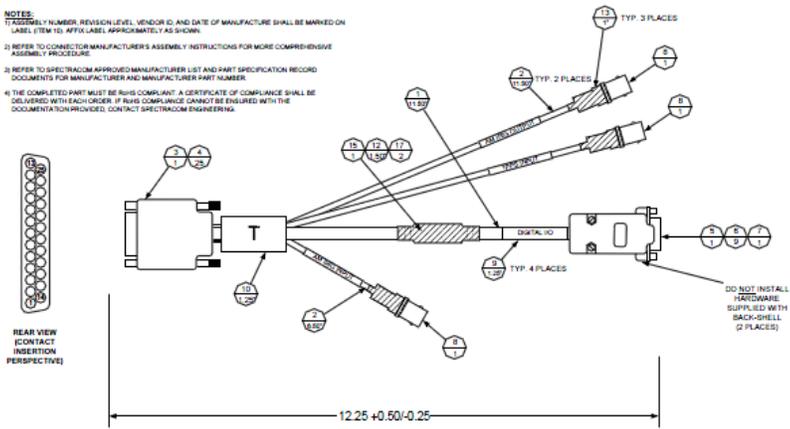
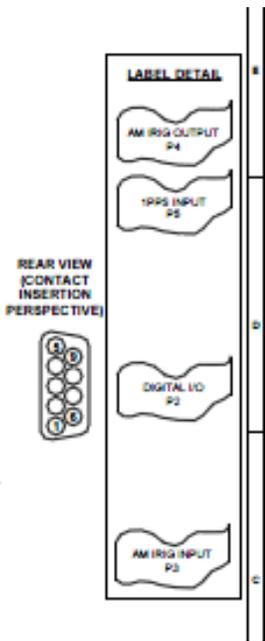
Shortcut to picture of standard breakout cable (CA08R-0000-0003, as shown below):

Standard Breakout Cable supports the following:

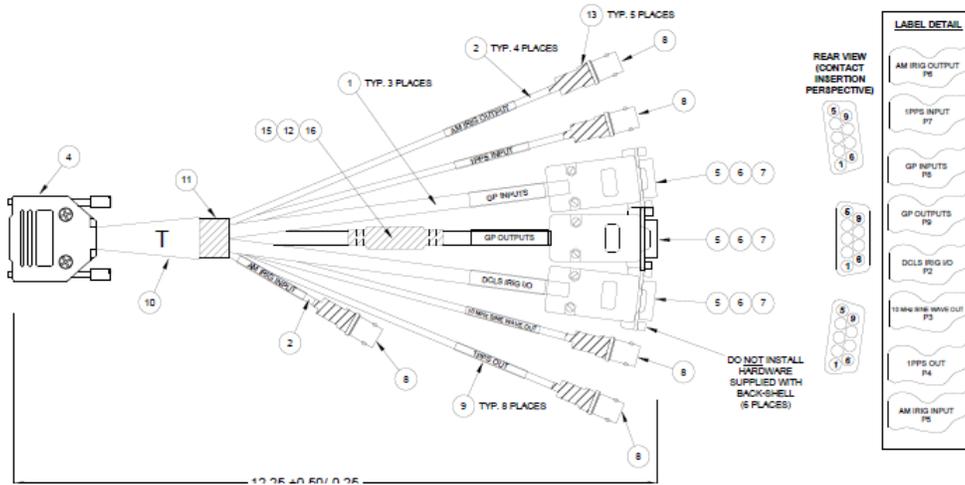
- CA08R-0000-0005 (More recent as of –Apr 2014)
- Shortcut to schematics (CA08R-0000-0005) in Arena at: https://app.bom.com/items/detail-spec?item_id=1203165794&version_id=10257958418&orb_msg_Single_Search_p=1&redirect_Seqno=7069085981
- Replaces discontinued breakout cable CA08R-0000-0001 (ECN 3433, Mar 2014)

➤ **Note:** To use these newer breakout cables, an adaptor will also be needed. (CA08R-DMD6-0001)

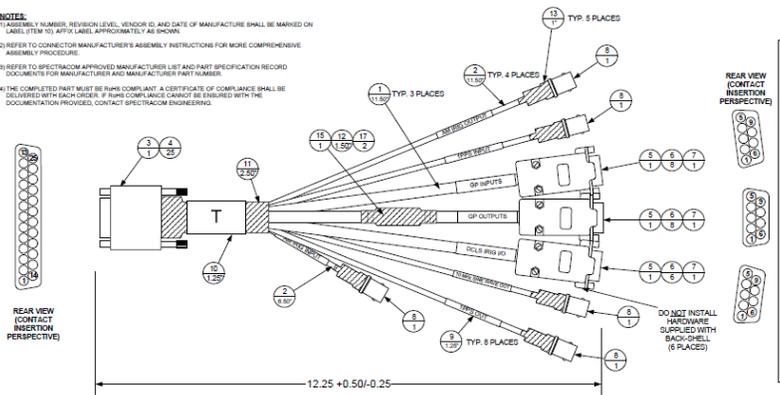
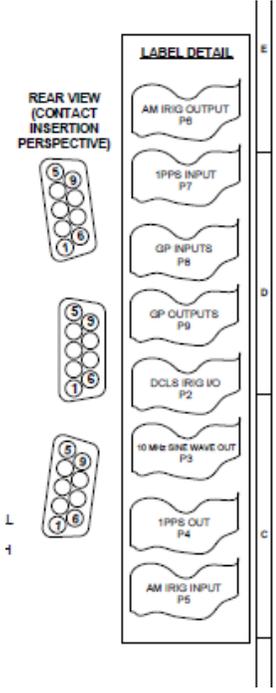
Shortcut to premium Breakout cable schematics (1191-1001-0400) <I:\Engineering\Schematic\1191-1001-0400>

Premium Breakout Cable supports the following:
 Input Signals:
 1 ea. IRIG AM (BNC - P5)
 ➤ ea. IRIG DCLS (D Connector – P2)

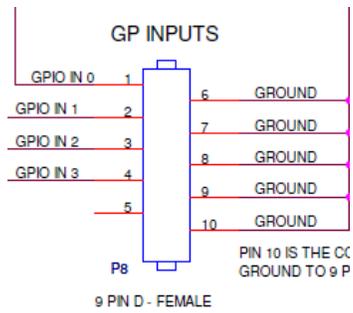
4 ea. GPI (General Purpose Inputs) (DB9F Connector - P8)

Signal	Timing Connector pin	B/O cable D Connector – P8 pin
GPI in 0	6	1
GPI in 1	19	2
GPI in 2	4	3
GPI in 3	17	4
Ground	2,15	6,7,8,9

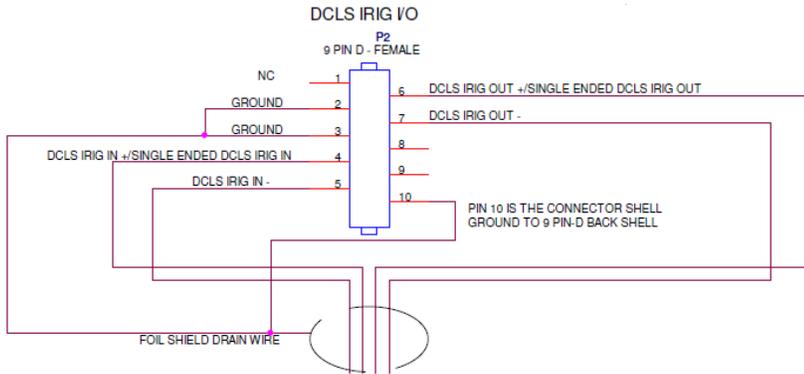
➤ 1 ea. IRIG DCLS (D Connector – P2)

Signal	Timing Connector pin	B/O cable D Connector – P2 pin
DCLS IRIG Out + (or single ended)	13	6
DCLS IRIG Out -	12	7
Ground	2,15	10

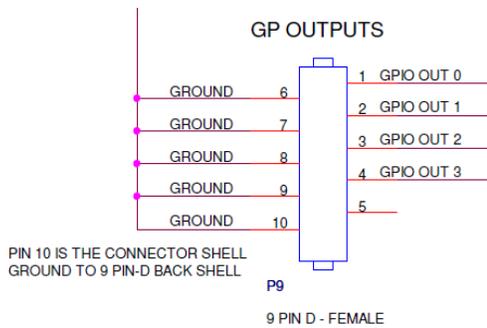
4 ea. GPO (General Purpose Outputs) (DB9F Connector – P9)

Signal	Timing Connector pin	B/O cable D Connector – P9 pin
GPI Output 0	6	1
GPI Output 1	19	2
GPI Output 2	4	3
GPI Output 3	17	4
Ground	2, 15	6,7,8,9,10

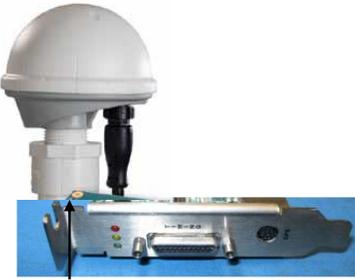
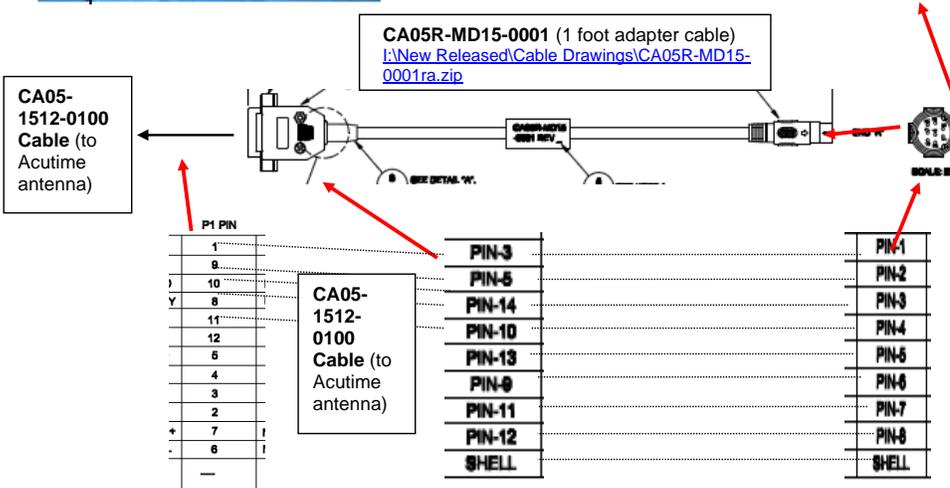
Acutime GPS antenna (E025-0004-0002)

More detailed cable drawing

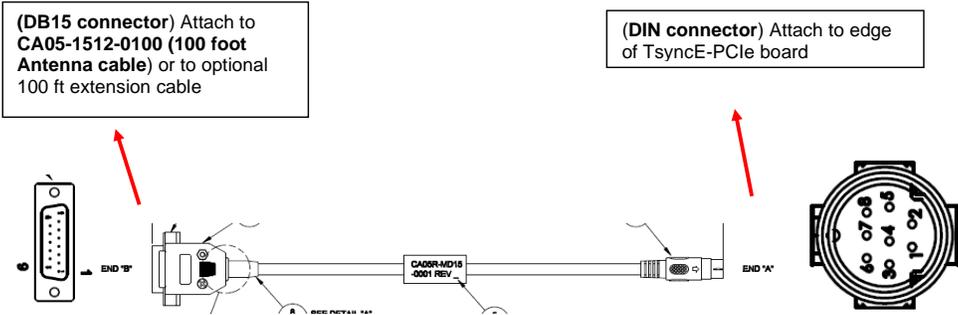
CA05R-MD15-0001 (supplied 1 foot adapter cable)

- refer to partial drawing below or full drawing in <\\rocfnp01\drivedata\Engineering\Archive\New Released\Cable Drawings> (CA05R-MD15-0001) is included in the TsyncE ancillary kit (1191-0000-0703)
- One side of this **CA05R-MD15-0001** adapter cable plugs into the 8 pin MINI-DIN connector on the edge of the TsyncE board. Then, the other end of the **CA05-1512-100** cable is connected to the D Sub 15 pin connector on the other end of the supplied 100 ft adapter cable.

Signal Direction	End B (DB 15)	Signal	Wire Color	END A (mini DIN)
←	Pin 3	+12vdc to GPS receiver	Lt. Blue	Pin 1
↔	Pin 5	Ground	Lt. Green	Pin 2
→	Pin 9	"PPS +" (from GPS receiver)	Yellow	Pin 6
→	Pin 14	"PPS - RX" (from GPS receiver)	Purple	Pin 3
→	Pin 10	"Rcvr TX +" (from GPS receiver)	White	Pin 4
→	Pin 11	"Rcvr TX -" (from GPS receiver)	Brown	Pin 7
←	Pin 12	"Rcvr RX+" (to GPS receiver)	Red	Pin 8
←	Pin 13	"Rcvr RX -" (to GPS receiver)	Orange	Pin 5
↔	Shell		Braid	Shell

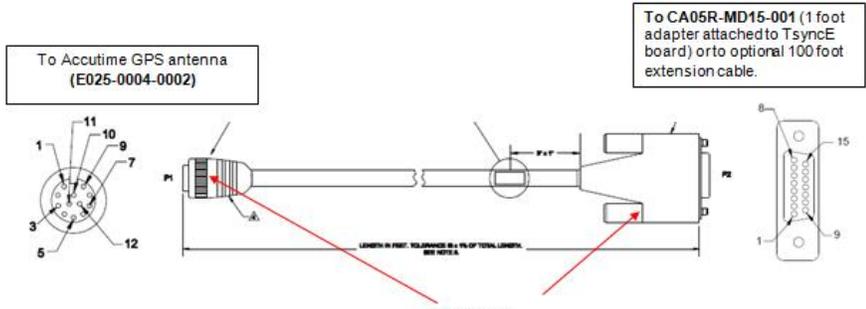
CA05-1512-0100 (100 foot Antenna cable) and CA05-1512-0200 (200 foot Antenna cable)

GPS (Acutime) antenna cable used with TSyncE-PCIe boards (CA05-1512-0100) and (CA05-1512-0200).

pin-out [\\rocfnp02\drive\Engineering\Archive\New Released\Cable Drawings\](#) (CA05-1512-0XXX)

SIGNAL	ITEM 2	ITEM 3	COLOR
PAIRED	+12V	1	3	RED
	GND	9	5	BLACK
PAIRED	UNUSED	10	NO CONNECT	BLUE
	BATTERY	8	NO CONNECT	GREEN
PAIRED	IPPS +	11	9	ORGWHT
	IPPS -	12	14	BLKWHT
PAIRED	DOWN +	5	10	YELLOW
	DOWN -	4	11	BROWN
PAIRED	UP +	3	12	ORANGE
	UP -	2	13	VIOLET
PAIRED	PORT A +	7	NO CONNECT	GRAY
	PORT A -	6	NO CONNECT	WHITE
FOIL AND DRAIN WIRE	SHIELD	---	SHELL	---

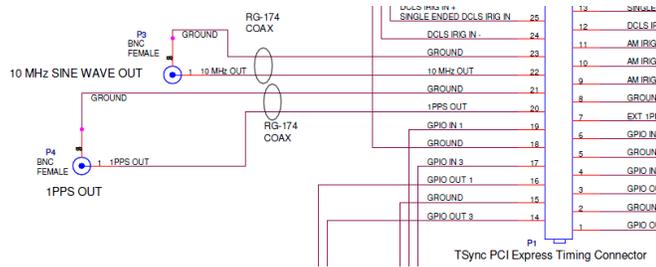
10MHz output pin-outs

- Not available on Basic/Standard Breakout cable
- Using Premium Breakout cable (BNC Connector P3)

10MHz Signal	Connector P3 - pin	Goes to Pin on Timing connector
10MHz	Center pin	22
Ground	Shield	23

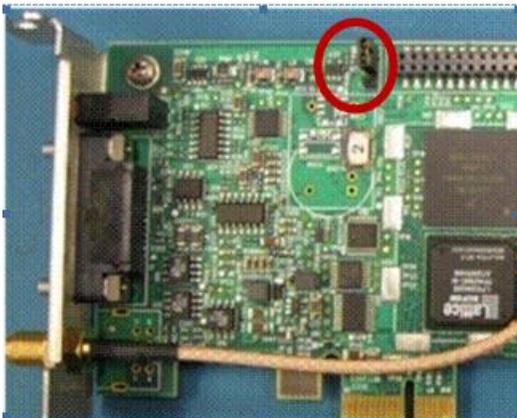
Check jumper setting on J25 and make sure that it is configured on the pins to the outside edge of the board, as seen in the red circle in the photo below:

If this jumper is in the wrong position, on a reboot the timing board will never look for the new images and will always load the bootloader (Green and Red LED s will be blinking and the Yellow LED will be not lit). Please place this two position jumper as shown in the picture above (with the jumper across the two outer pins (closest to the edge of the TSync-PMC board).

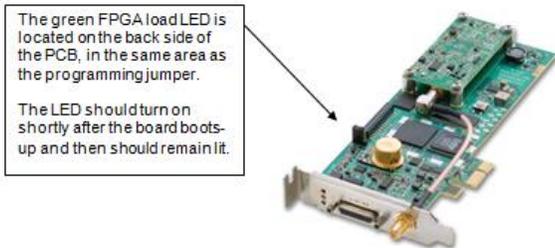
There is also a **green** "load" LED on the back-side of the TSync-PMC boards (in the same area of the board as the jumper described above, but on the other side of the timing board. This LED should light shortly after the TSync-PMC board powers-up and then should remain lit, from that point forward. Please let me know if this LED turns on and then remains lit green while the PC is on.

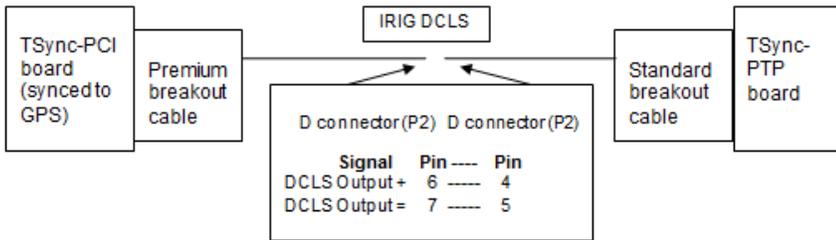
Using the one Premium breakout cable attached to the TSync-PCIe board, the IRIG DCLS output is connected to the TSync-PTP board (via the Standard breakout cable). The IRIG DCLS signal provides both the “Time” and “PPS” references needed for the TSync-PTP board to declare sync.

Note: This requires a special connection between the two D connectors (can't just plug them in to each other) See the diagram below.

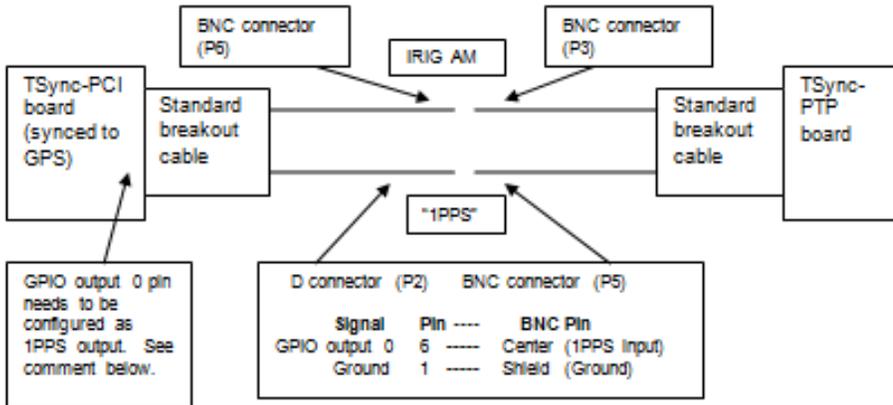
The IRIG AM and GPIO 0 output of the standard breakout cable is connected to the IRIG AM and GPIO input of the TSsync-PTP board (via the Standard Breakout cable). The IRIG AM signal provides the "Time" reference and the PPS signal from the GPIO output pin provides the "PPS" reference that are needed for the TSsync-PTP board to declare snc.

Note: The reason for the IRIG AM being combined with 1PPS from the GPO output is the IRIG AM signal does not have a crisp ontime point, so the 1PPS from the GPIO pin is used to provide a good ontime point for the TSsync-PTP board.

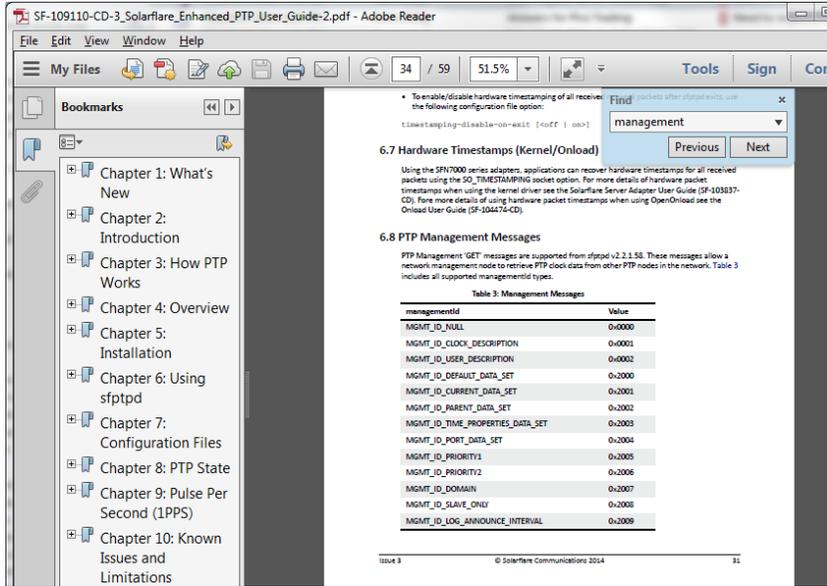
List of PTP Management commands (from a Solarflare manual)

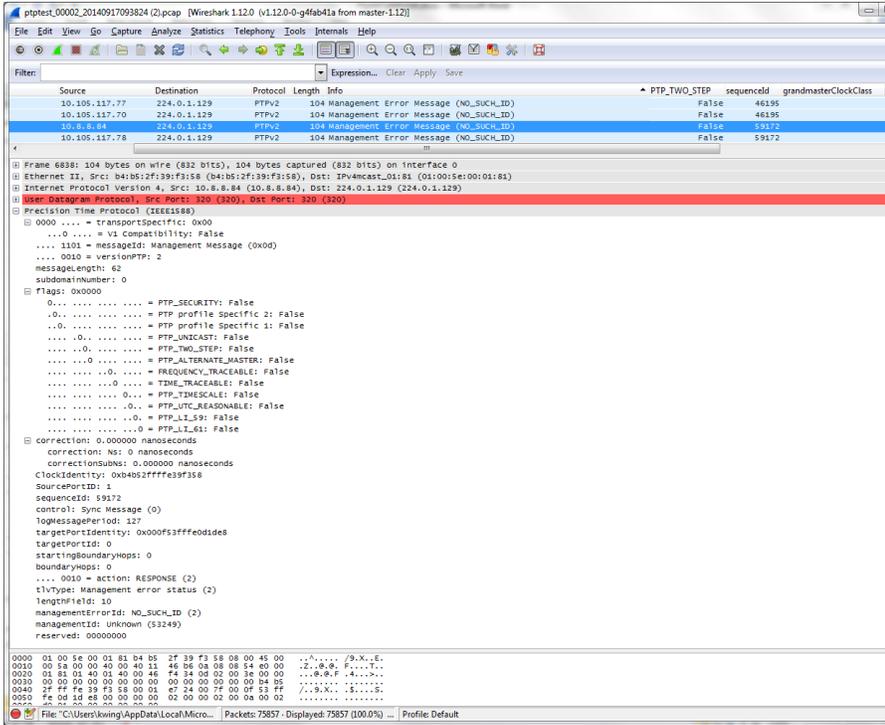
Per Michel (22 Sept 2014) The malformed Management GET packets (sent by 10.105.110.117 and 10.105.110.119) have no impact because the master is able to parse and reject them (because these packets are not so malformed).

Info field: "Management Error Message (No_Such_ID)"

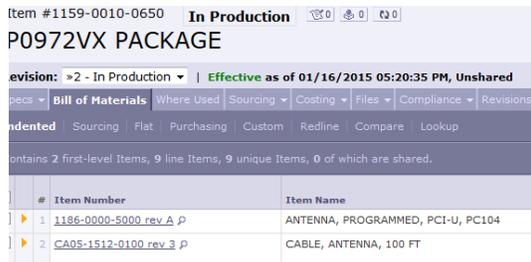
P0972VX (1159-0010-0650) (Rev 2): Invensys package (no timing board) antenna cable and **Acutime GG Smart antenna** (P/N 1186-0000-5000) (no Timing board)

#	Item Number	Item Name
1	1186-0000-5000 rev A P	ANTENNA, PROGRAMMED, PCI-U, PC104
2	CA05-1512-0100 rev 3 P	CABLE, ANTENNA, 100 FT

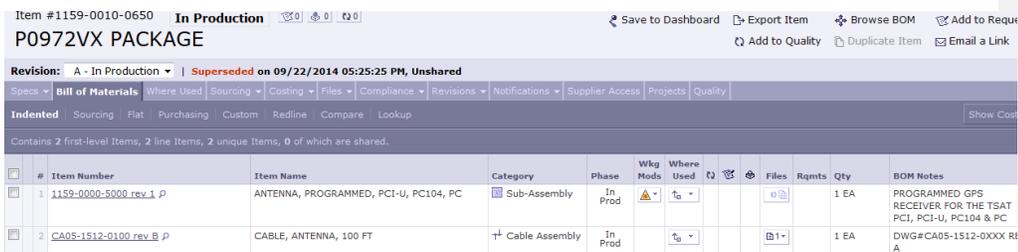
P0972VX (1159-0010-0650) (Rev A): Invensys package, (no timing board) antenna cable and **Acutime Gold antenna** (P/N 1159-0000-5000)

#	Item Number	Item Name	Category	Phase	Wkg Mods	Where Used	Files	Rqmts	Qty	BOM Notes
1	1159-0000-5000 rev 1 P	ANTENNA, PROGRAMMED, PCI-U, PC104, PC	Sub-Assembly	In Prod					1 EA	PROGRAMMED GPS RECEIVER FOR THE TSAT PCI, PCI-U, PC104 & PC
2	CA05-1512-0100 rev B P	CABLE, ANTENNA, 100 FT	Cable Assembly	In Prod					1 EA	DWG#CA05-1512-0000 REV A

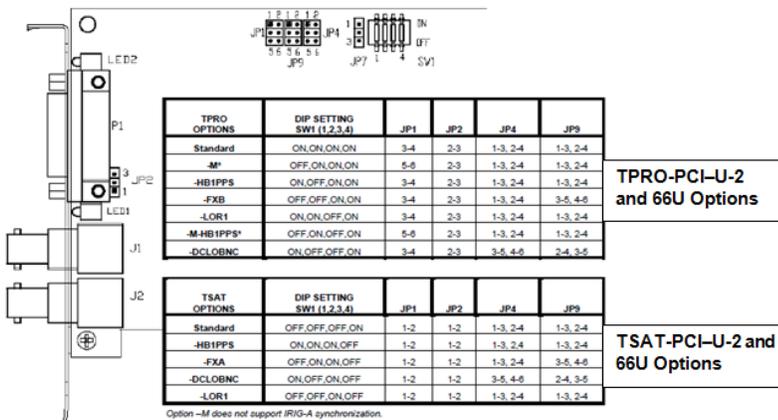
- Also refer to the manual for more info on available Options.
- In the earlier PCI series, options need to be added at the factory.
- With PCI-66U and PCI-U-2 boards, the Options can be configured via jumper/switch settings.

All available options can now be added /removed in the field, using Jumper and DIP switches on the timing board. Refer to Section 9 of the user manual for more information on configuring the options.

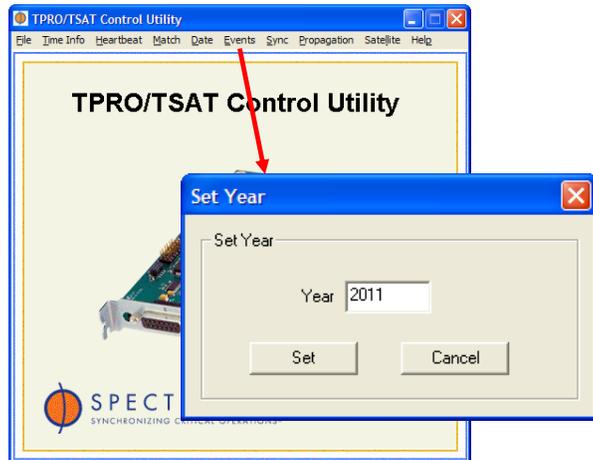
There are a couple of ways the year can be set in a TPRO timing board, each time it powers up. One of these methods is via the Windows Control Utility, when the timing board is installed in a Windows PC (and the Windows PCI driver has been installed).

Use the: "Date" -> "Set Year" menus

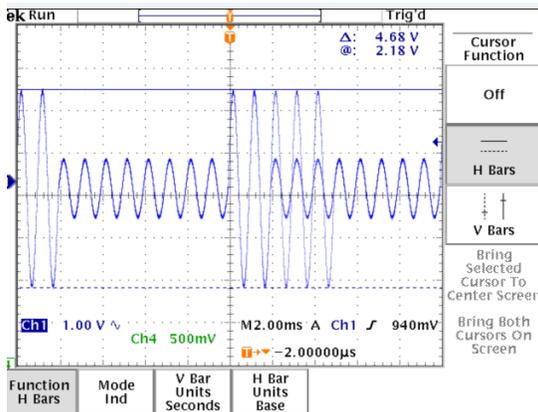
- IRIG B AM input only (does not accept IRIG DCLS)
- Automatically detects (): **IRIG A132, IRIG B122 or NASA36.** (According to Tim Tetreault) Should also accept **B120.**

Note about B120: IRIG B122 is BCD data only (no CF control field or SBS bits). IRIG B120 contains the CF and SBS bits, but the card should also be able to ignore these additional bits and still sync to a B120 input.

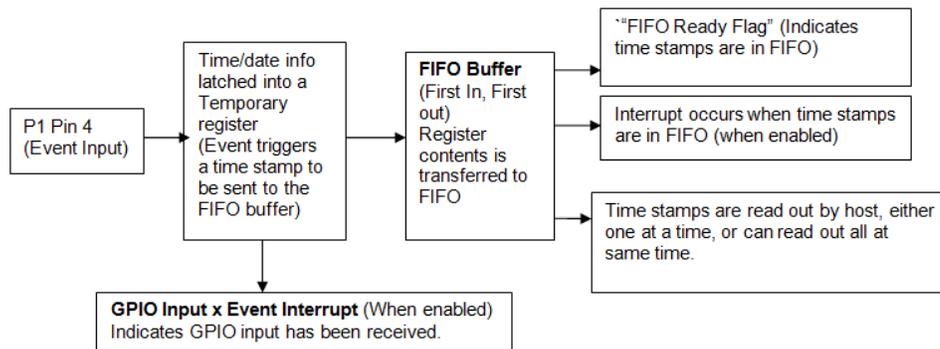
**TimeTag (Timetagging/time stamping/Timestamping)

Notes about Timetag (for both PC104 and PCI series timing boards)

- Time Tag for both PC104 and PCI series timing boards is the same.
- When the rising edge of the Time Tag Input (P1 Pin 4) occurs, the clock time is latched into a temporary register, and this register is then loaded into the FIFO buffer.

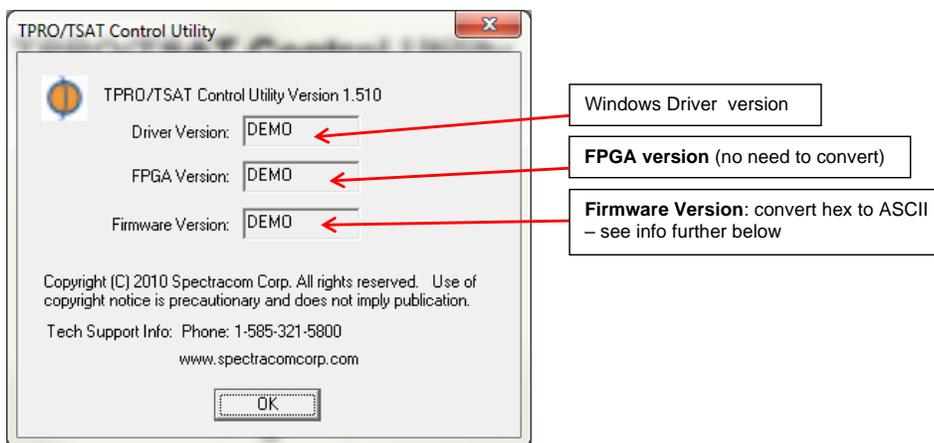
A) Use the Windows Control Utility, if board is installed in Windows PC

- **Help -> About** menu

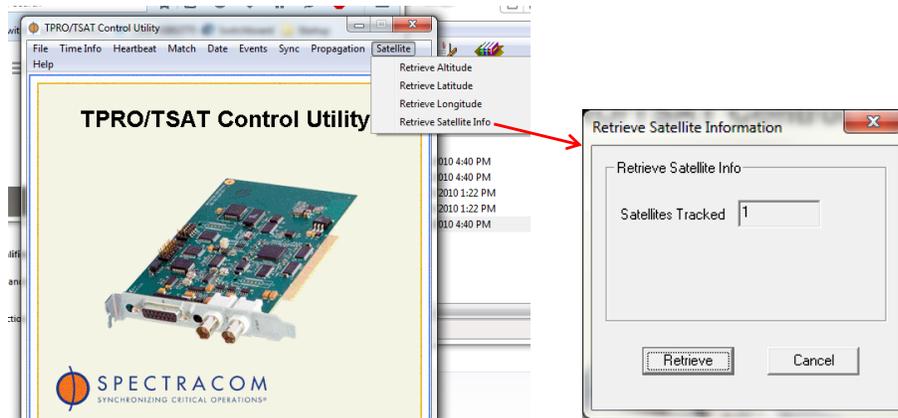
A) GPS info via Windows Control Utility

Satellite -> Retrieve Satellite info menu

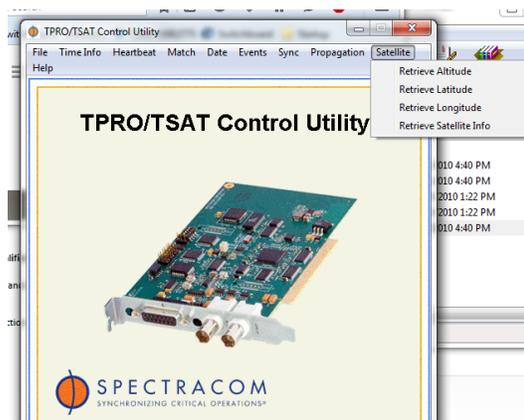
Lat and long can be obtained by Windows Control utility (Windows driver only)

Satellite -> Retrieve Satellite info menu

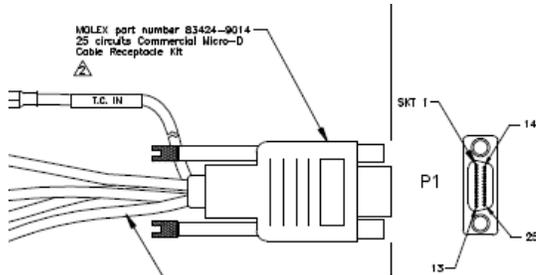
TPRO/TSAT-PMC boards

- Timing connector is a **25 pin** female subminiature D connector
- Mating connector for PMC Timing connector = **Molex P/N 83424-9014** or equivalent

Both the TPRO-PMC and TSAT-PMC have a 25 pin commercial Micro-D receptacle (timing) connector. The pinout of this connector is the same for both TPRO-PMC and TSAT-PMC:

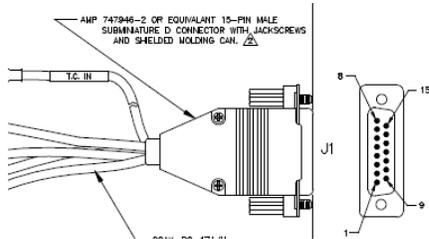
TPRO/TSAT-cPCI boards

- Timing connector is a **15 pin** female subminiature D connector
- Mating connector for cPCI timing connector = **Amphenol 747946-2** or equivalent

Pin	Function	Type
1	Time Code Input+	Differential Analog
2	Timecode Input-	Differential Analog
3	Signal Ground	—
4	Time Code Output	Single-ended Analog
5	Signal Ground	—
6	Match Output	TTL Output
7	Signal Ground	—
8	Oscillator Output+	RS-422 Output
9	In-Sync Output Open	Open Collector
10	Time-Tag Input	TTL Input
11	1PPS Sync Input	TTL Input
12	1PPS Output+	RS-422 Output
13	1PPS Output+	RS-422 Output
14	Heartbeat Output	TTL Output
15	Oscillator Output-	RS-422 Output

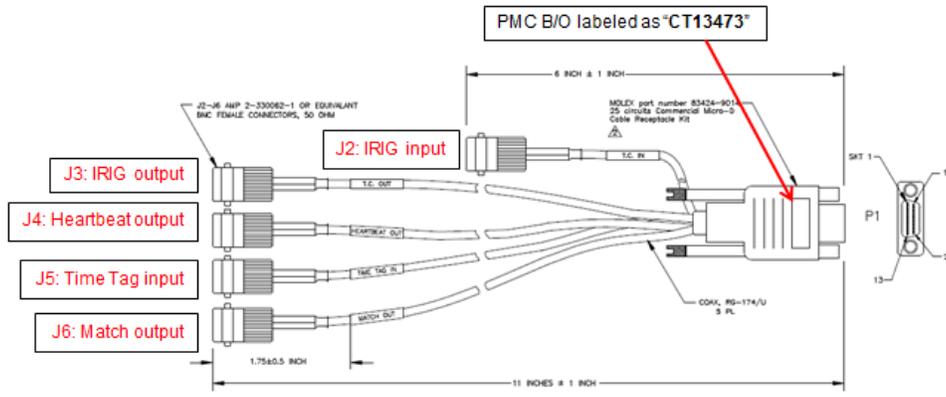
Email from Dave L regarding a PMC board - "The correct cable you should have received is labeled CT13473 on the Micro-D connector. Can you please tell me what the numbers are on the cable you received? It is either labeled on the Micro-D connector or around the bunch of wires leading from the Micro-D connector. I will be able to identify what you have from these numbers. The correct cable has just 5 BNC Connectors. There should be no DB-9 connectors."

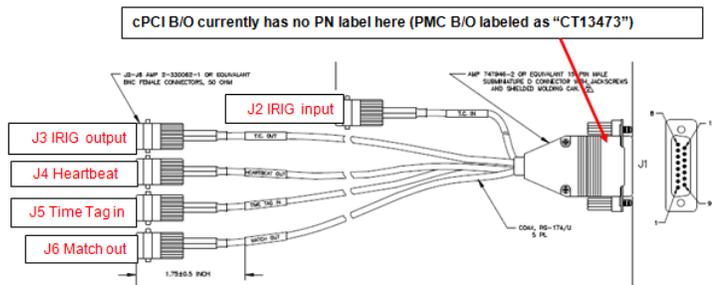
E) TPRO/TSAT-cPCI breakout cable (not PMC cable)

- Our P/N: 0810545 (note the cPCI cable has no label on the DB15 connector- the PMC cable has a sticker with a "CTxxxxx" number on it)
- Link to cable drawing: <I:\New Released\Cable Drawings\0810545> or <I:\Customer Service\EQUIPMENT\SPECTRACOM EQUIPMENT\Timing boards\TPRO-TSAT\PMC and cPCI>

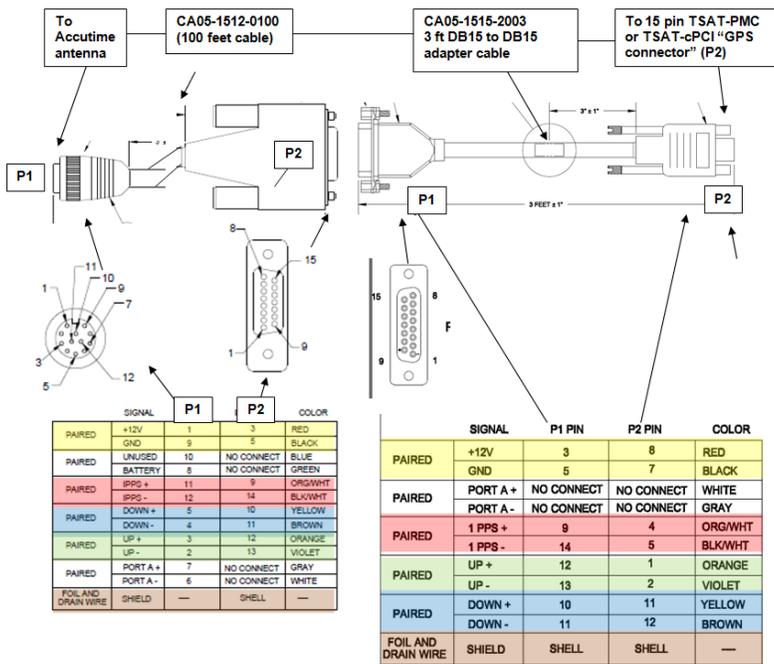
TSAT-PMC and TSAT-cPCI ship with (as shown further below):

- a 100ft CA05-1512-0100 which connects to the Acutime GPS antenna.
- a short 3 ft adapter cable (CA05-1515-2003) which connects the 100 cable to the TSAT board.

Pin-out for the GPS antenna connector (P2) on TSAT-PMC or cPCI board

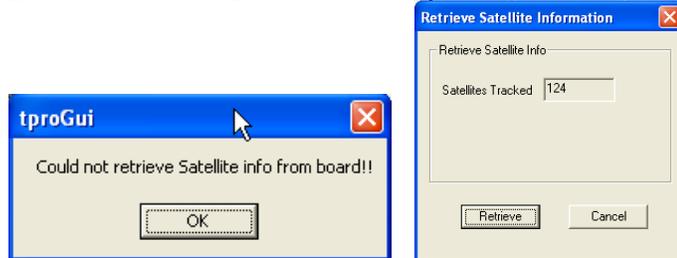
Email Keith sent on 11 Jan 2013 to a customer that was seeing the following screenshots in the Control Utility"

Based on the screenshots you had sent from the Control Utility (showing "124" satellites being tracked), and other error intermittent "error" messages being reported when trying to communicate to the GPS antenna (which also houses the GPS receiver), we are

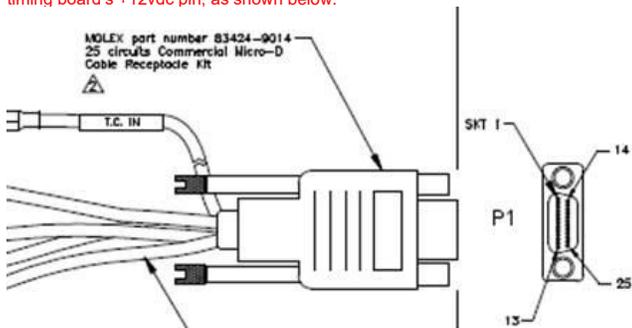
With the GPS antenna cable still disconnected from the timing board, if you have access to a multimeter, measure the 12vdc on the timing board's +12vdc pin, as shown below:

Might be wrong picture. Should be DB15 not DB25??

+12vdc is on pin 8
Ground is on pin 7

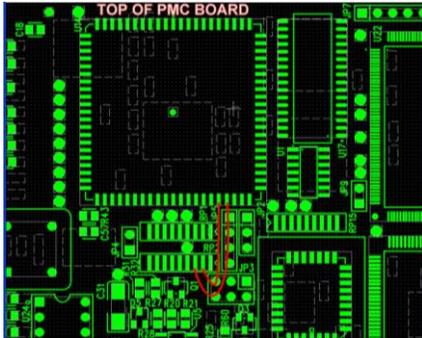
The first change adds two small jumper wires to the top of the board. The two jumper wires should go between the IC labeled "U14" and the resistor pack labeled as "RP2". Below is a picture of the top of the board. The two red lines indicate the location of where these two jumper wires should be added on your board.

Picture is from I:\New Released\PCB Documentation\1153-0002-F000 Rev D\Assembly Drawing

The other modification that needs to be performed is the two sides of one component are soldered onto the two leads of another component. Resistor "R24" should have one side of a capacitor connected to each side of the resistor (the capacitor is in parallel with the resistor). With the ECN changes added, the PMC/cPCI boards sync up moments after IRIG input of about 1.2vp-p or higher is applied.

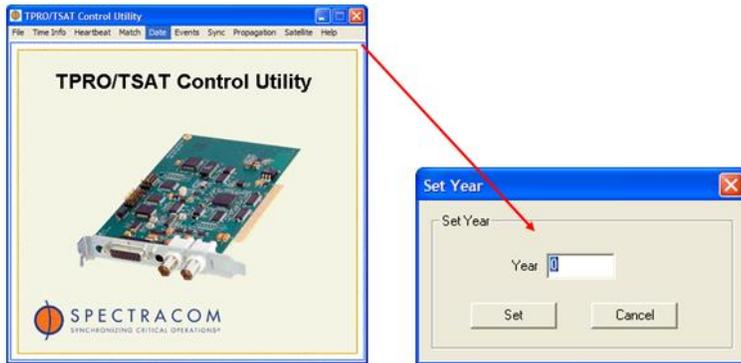
The current year can be manually set in the TPRO timing boards (or the TSAT timing board when only using IRIG input instead of GPS input) using the Windows Control Utility (also installed as part of the Windows driver) - in the **Date -> Set Year** menu (the year can be read back via the **Date -> Retrieve Gregorian Date** menu). Or, the year can also be set using the API call of **TPRO_SetYear** (this command can be run in application software to automatically set the year).

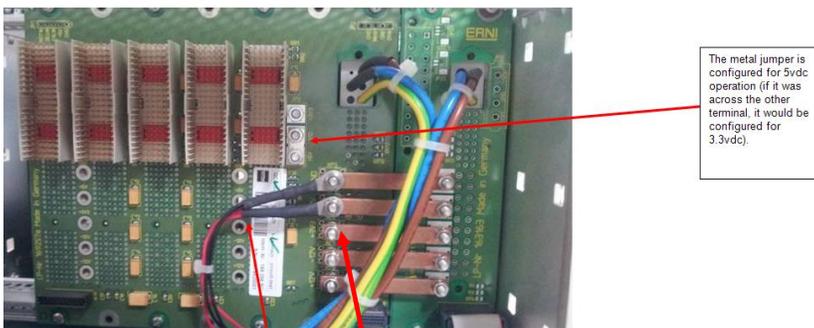
- The KONTRON chassis needs to be configured for 5vdc operation (the other jumper setting is 3.3vdc operation). There is likely a metal jumper in the chassis for this configuration, as shown in the photo below of the backplane.

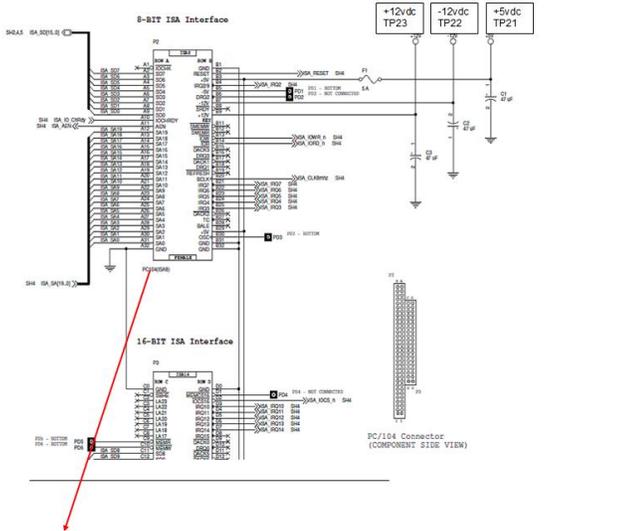
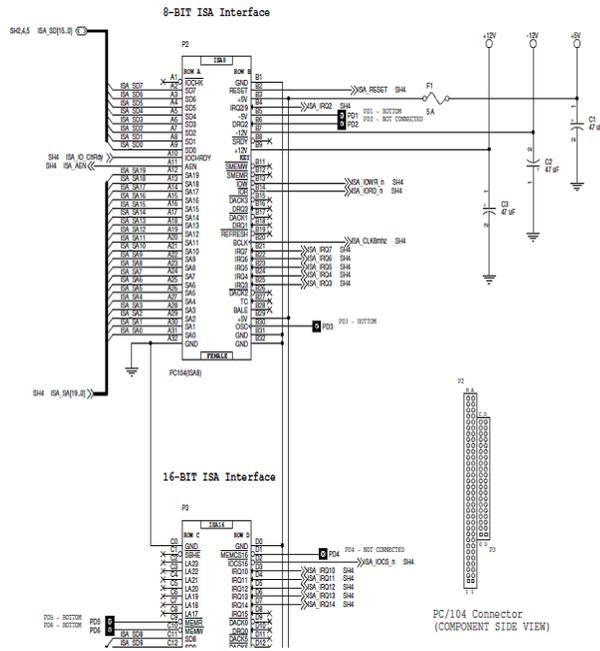
F1 (5A) for +5vdc input from PC104 bus
F2 (0.75A) for +12vdc to Timing connector pin 3

+5, -12v and +12vdc power connector pins for PC104 bus:

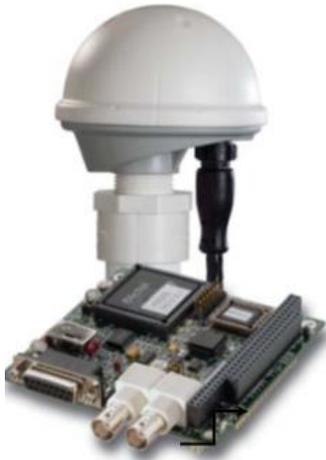
****GPS input (TSAT-PC104 boards only)**

P1 Connector (DB-15F)
 GPS antenna / Timing connector with TSAT or the timing connector with TPRO
 (Attaches to Acutime antenna using cable P/N CA05-1512-xxxx)
 (Refer to P1 connector pin-outs section further below)

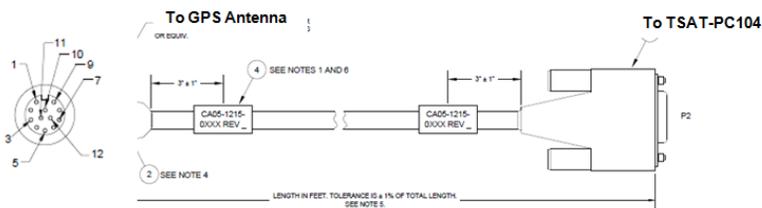
- TSAT-PC104 ships with a standard 100 ft antenna cable (**CA05-1512-0100**) to attach the antenna to the board

SIGNAL	ITEM 2	ITEM 3	COLOR
PAIRED	+12V	1	3	RED
	GND	9	5	BLACK
PAIRED	UNUSED	10	NO CONNECT	BLUE
	BATTERY	8	NO CONNECT	GREEN
PAIRED	IRPG +	11	9	ORGWHT
	IRPG -	12	14	BLKWHT
PAIRED	DOWN +	5	10	YELLOW
	DOWN -	4	11	BROWN
PAIRED	UP +	3	12	ORANGE
	UP -	2	13	VIOLET
PAIRED	PORT A +	7	NO CONNECT	GRAY
	PORT A -	6	NO CONNECT	WHITE
FOIL AND DRAIN WIRE	SHIELD	---	SHELL	---

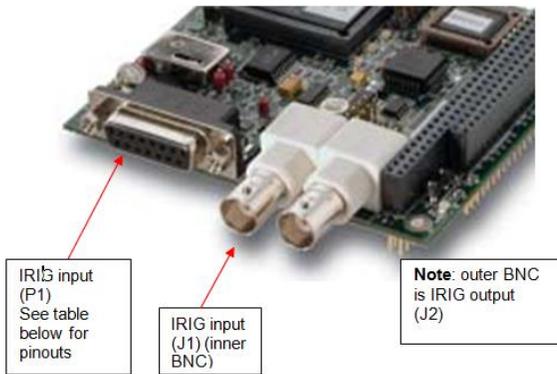
- IRIG input automatically detects and accepts IRIG A, IRIG B and NASA36
- Can connect to either:
 - BNC connector (J1)
 - DB15 connector (P1)

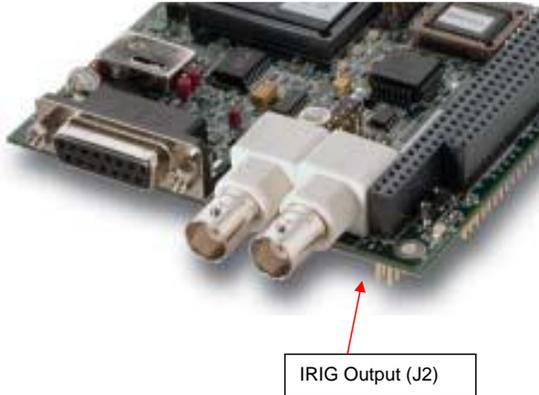
Code Format	IRIG-B (B122)
Amplitude (mark)	2.6 Vp-p (type)
Modulation Ratio	3:1
Output Impedance	600 ohms

- IRIG output BNC connector (J2) provides only IRIG B122 (AM modulation) at about 2.6vpp into 600 ohms

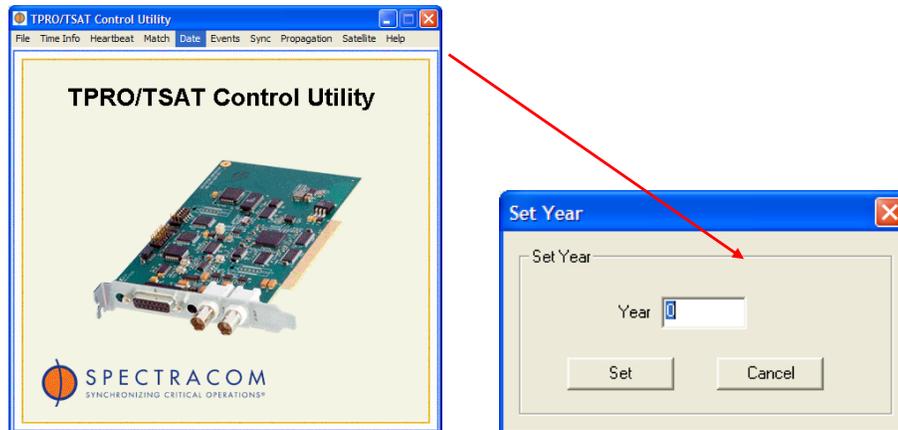
The current year can be manually set in the TPRO timing boards (or the TSAT timing board when only using IRIG input instead of GPS input) using the Windows Control Utility (also installed as part of the Windows driver) - in the **Date -> Set Year** menu (the year can be read back via the **Date -> Retrieve Gregorian Date** menu). Or, the year can also be set using the API call of **TPRO_SetYear** (this command can be run in application software to automatically set the year).

With the TPRO/TSAT-PC104 timing board synced to the IRIG generator and with the year set using either of the methods mentioned above, the Clock Daemon program or Service can be used to periodically sync the Windows PC. Note that both Clock Daemons can be accessed via **Start / All Programs / Spectracom Corp / PCI**.

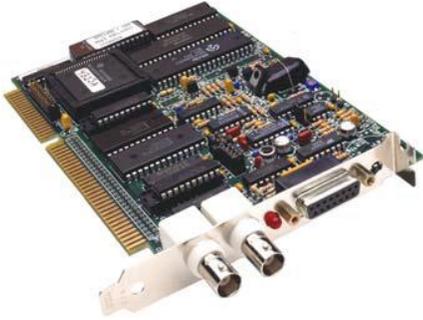
TPRO/TSAT-PC (discontinued/no longer supported)

This is a board we inherited when we purchased the KSI timing board line.
