# VersaSync

## Software Version 1.11.0: Release Notes

Safran Trusted 4D (Orolia/ Spectracom) released a software update for VersaSync. Customers can download this software update at no charge from the Safran Trusted 4D website (see [Downloading the Software Update](#)). This software update will upgrade the unit's system software to **Version 1.11.0**.

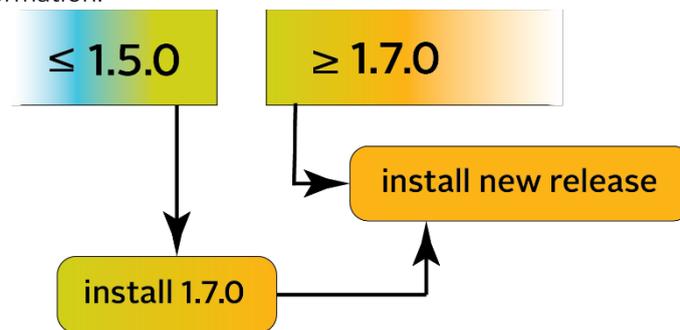
**Note:** if your unit is currently on a software version below 1.7.0, it is necessary to upgrade to 1.7.0 before proceeding further (see image below). The upgrade to 1.7.0 includes significant system changes and does not allow downgrading to earlier versions. Refer to the upgrade warnings section of the 1.7.0 release notes in this document for specific information.

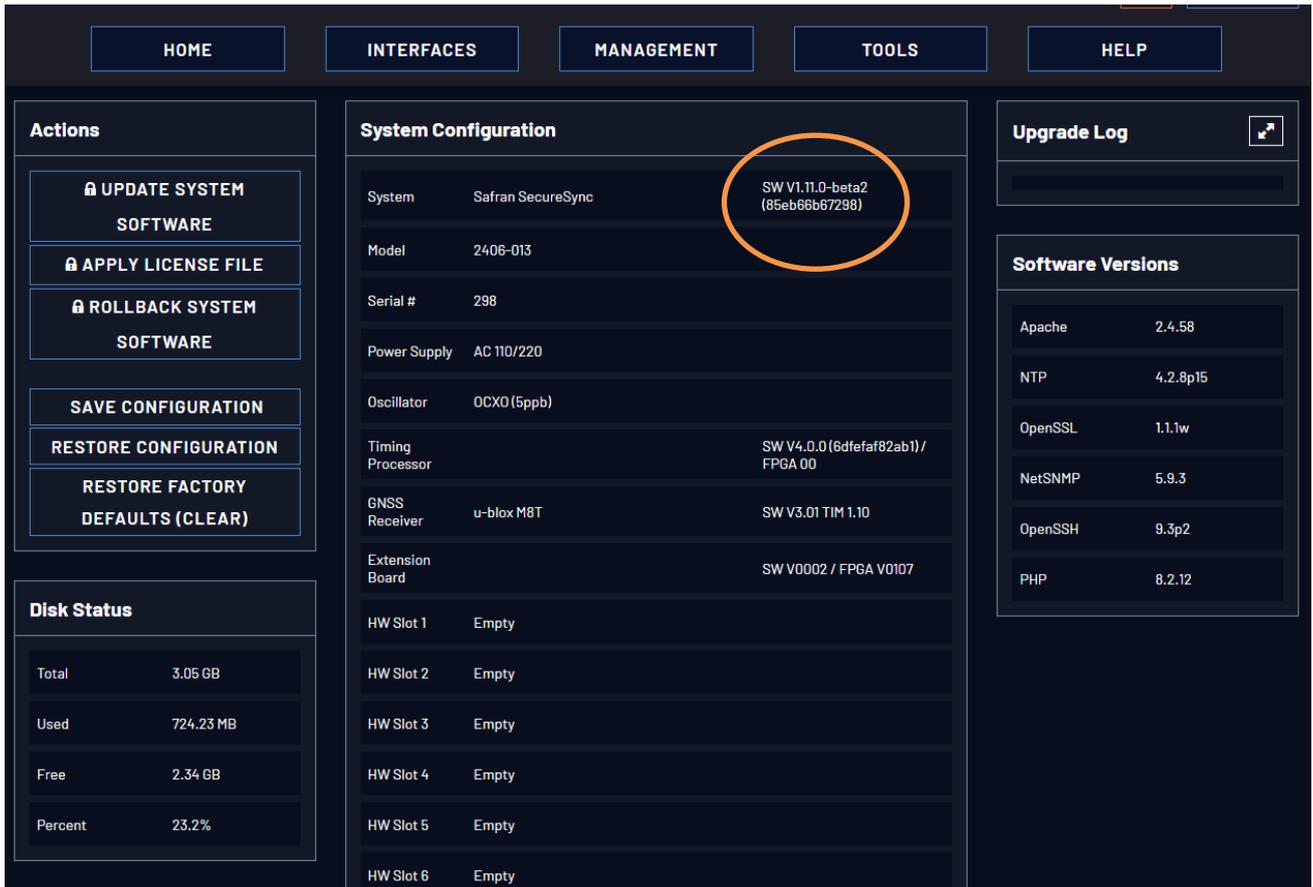
1. Login to the unit's Web UI
2. Navigate to Tools > Upgrade/Backup. The System Configuration panel in center of the screen displays the current version number under System:

The screenshot displays the VersaSync Web UI interface. At the top, there are navigation tabs: HOME, INTERFACES, MANAGEMENT, TOOLS, and HELP. The main content area is divided into three columns. The left column contains 'Actions' (UPDATE SYSTEM SOFTWARE, APPLY LICENSE FILE, ROLLBACK SYSTEM SOFTWARE, SAVE CONFIGURATION, RESTORE CONFIGURATION, RESTORE FACTORY DEFAULTS (CLEAR)) and 'Disk Status' (Total: 3.05 GB, Used: 724.23 MB, Free: 2.34 GB, Percent: 23.2%). The middle column is titled 'System Configuration' and lists various system parameters. The 'System' parameter is circled in orange and shows 'Safran SecureSync' with the version 'SW V1.11.0-beta2 (85eb68b67298)'. Other parameters include Model (2408-013), Serial # (298), Power Supply (AC 110/220), Oscillator (OCX0 (5ppb)), Timing Processor (SW V4.0.0 (8dfefaf82ab1) / FPGA 00), GNSS Receiver (u-blox M8T, SW V3.01 TIM 1.10), Extension Board (SW V0002 / FPGA V0107), and HW Slot 1-6 (all Empty). The right column contains 'Upgrade Log' and 'Software Versions' (Apache: 2.4.58, NTP: 4.2.8p15, OpenSSL: 1.1.1w, NetSNMP: 5.9.3, OpenSSH: 9.3p2, PHP: 8.2.12).

Parameter	Value
System	Safran SecureSync SW V1.11.0-beta2 (85eb68b67298)
Model	2408-013
Serial #	298
Power Supply	AC 110/220
Oscillator	OCX0 (5ppb)
Timing Processor	SW V4.0.0 (8dfefaf82ab1) / FPGA 00
GNSS Receiver	u-blox M8T SW V3.01 TIM 1.10
Extension Board	SW V0002 / FPGA V0107
HW Slot 1	Empty
HW Slot 2	Empty
HW Slot 3	Empty
HW Slot 4	Empty
HW Slot 5	Empty
HW Slot 6	Empty

*To determine the software version currently installed on your unit:*
