# Software Version 1.9.0: Release Notes

Orolia released a software update for VersaSync. Customers can download this software update at no charge from the Orolia website (see [How to download and install the new SW](#)). This software update will upgrade the unit's system software to **Version 1.9.0**.

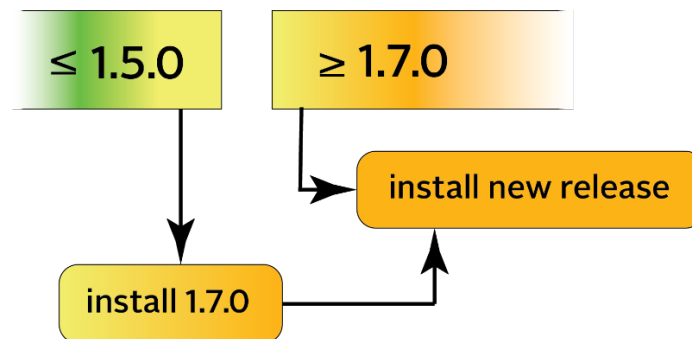
Note: if your unit is currently on a software version below 1.7.0, it is necessary to upgrade to 1.7.0 before proceeding further (see image below). The upgrade to 1.7.0 comes with significant system changes and does not allow downgrading to earlier versions. Refer to the upgrade warnings section of the 1.7.0 release notes in this document for specific information.
